AmeriSpec Home Inspections
2829 Perry Street Suite 100
Madison, WI 53713
Ph#: (608) 276-8060

SUMMARY ITEMS

Doc #: 27216

Dwelling Address: 906 Williamson Street
Madison, WI 53703

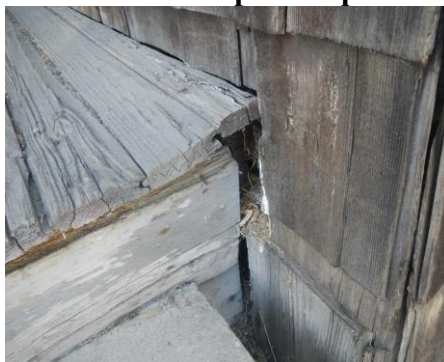
| 1121. | Porch | Defect. Wood. Wood deterioration observed. Structure of the front porch is starting to fail, porch structure may need completely rebuilt. Suggest review by a qualified contractor for repairs/replacement, as needed. |

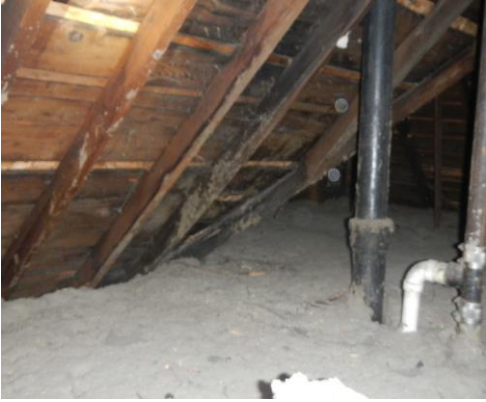
1352. Framing **Defect. Rafters. Severe bowing and cracking of almost every rafter. Years of heavy snow and too many layers of shingles have taken their toll on the roof structure. Recommend review by a structural engineer or other qualified professional for repair or replacement, as necessary, prior to close.**

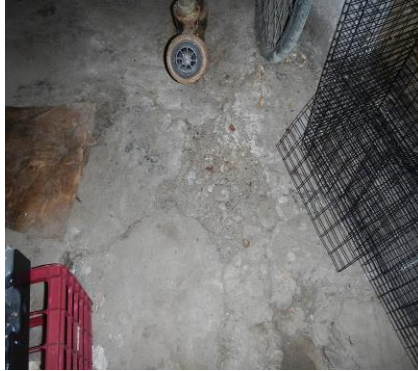
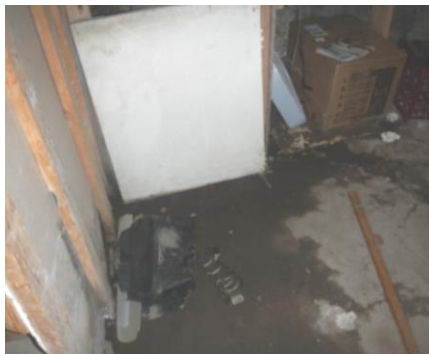
1603. Floor **Defect. Concrete. Active leaks observed at the time of inspection. Cracks/deterioration observed. In the Inspector's opinion, the floor is near the end of its useful life. Recommend review by qualified professional for repair or replacement, as necessary.**

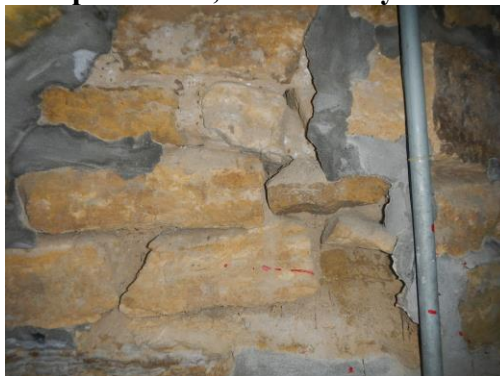
1604. Walls **Defect. Stone. Damaged/deteriorated mortar observed; suggest tuck pointing, as necessary, to prevent further damage. Active leaks observed at the time of inspection. Recommend review by licensed professional for repair or replacement, as necessary.**

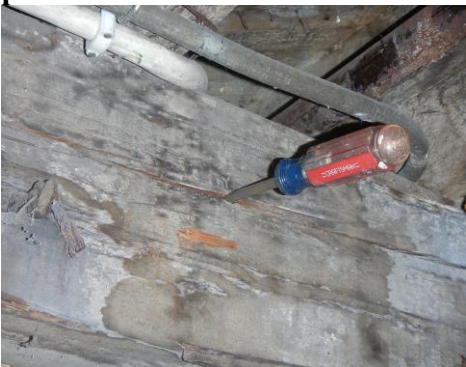
| 1611. | Beams | Defect. Wood. Beams are sagging and rotten; review by licensed building contractor is needed for corrections prior to close. |

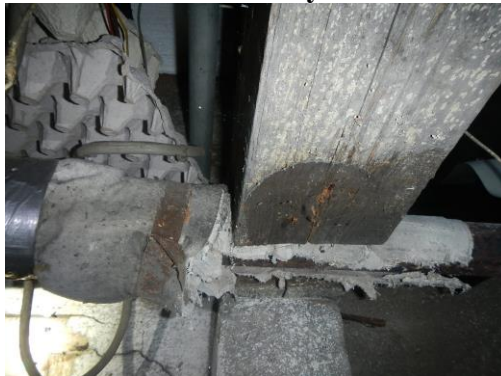
Defect. Pipes/Radiators. Possible asbestos materials observed. The materials were torn, ripped, or damaged at the time of inspection. This is a possible safety hazard. Suggest further review by a licensed asbestos testing lab be performed prior to closing for repairs/replacement needed to ensure safety.

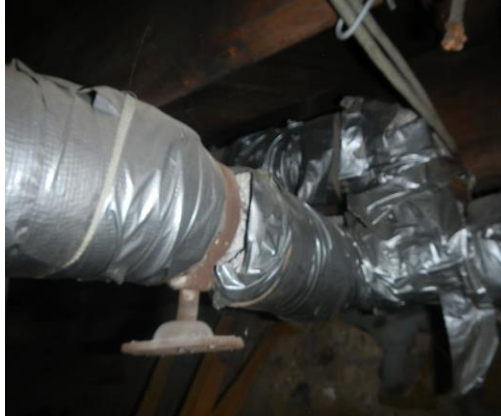
1909. Distribution / Ducting **Defect. Pipes/Radiators. Possible asbestos materials observed throughout the house. The materials were torn, ripped, or damaged at the time of inspection. This is a possible safety hazard. Suggest further review by a licensed asbestos testing lab be performed prior to closing for repairs/replacement needed to ensure safety.**

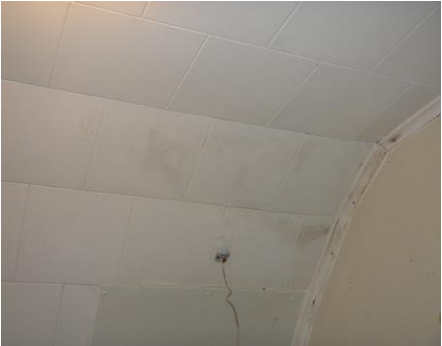
2302. Walls **Defect. Stains, discoloration, growth and/or evidence of moisture observed. These conditions may indicate mold and/or fungus growth and were discovered during the home inspection. Because certain types of mold may be toxic and result in adverse health effects, it is strongly recommended that a mold inspection be performed by a qualified professional to determine the presence of, and types of, mold in the house and that corrective measures be taken to limit moisture inside the home.**
