Property Condition Report

Stratford Apartments

433 W. Gilman St.

REPORT DATE – 4 / 1 / 2026.

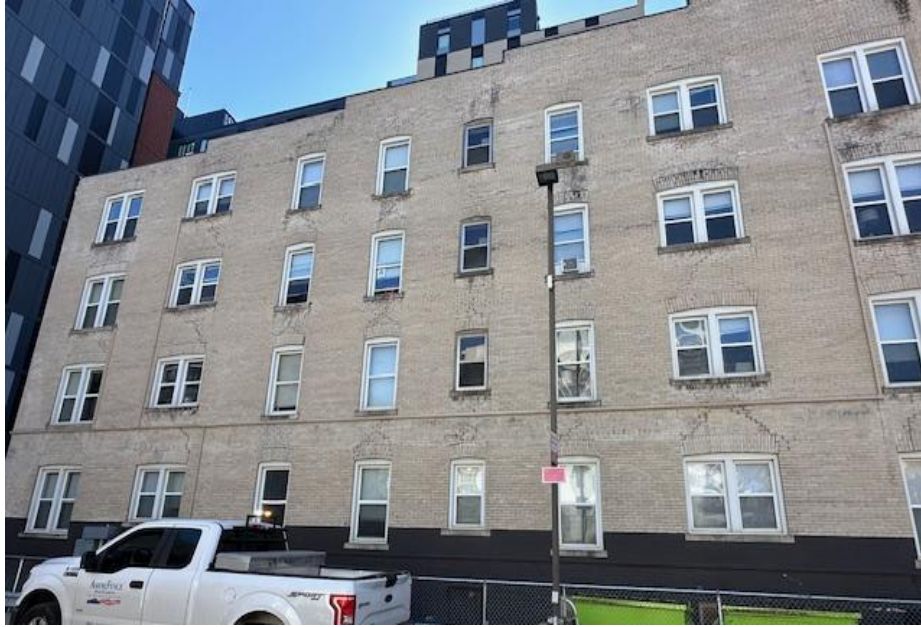
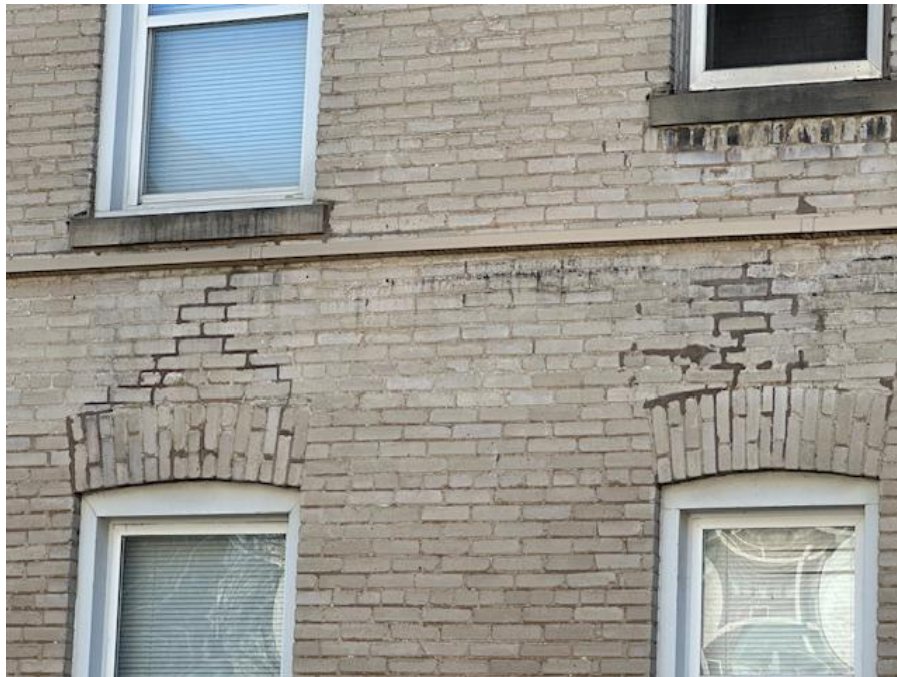
Previous tuckpointing repairs are visible in the exterior brick façade on the 3 sides that were visible.

The exterior walls are constructed of multi-wythe brick. The walls are not insulated. Within the apartment units the brick exterior walls have a plaster finish. The exposed foundation walls in the lower level are cast in place concrete.

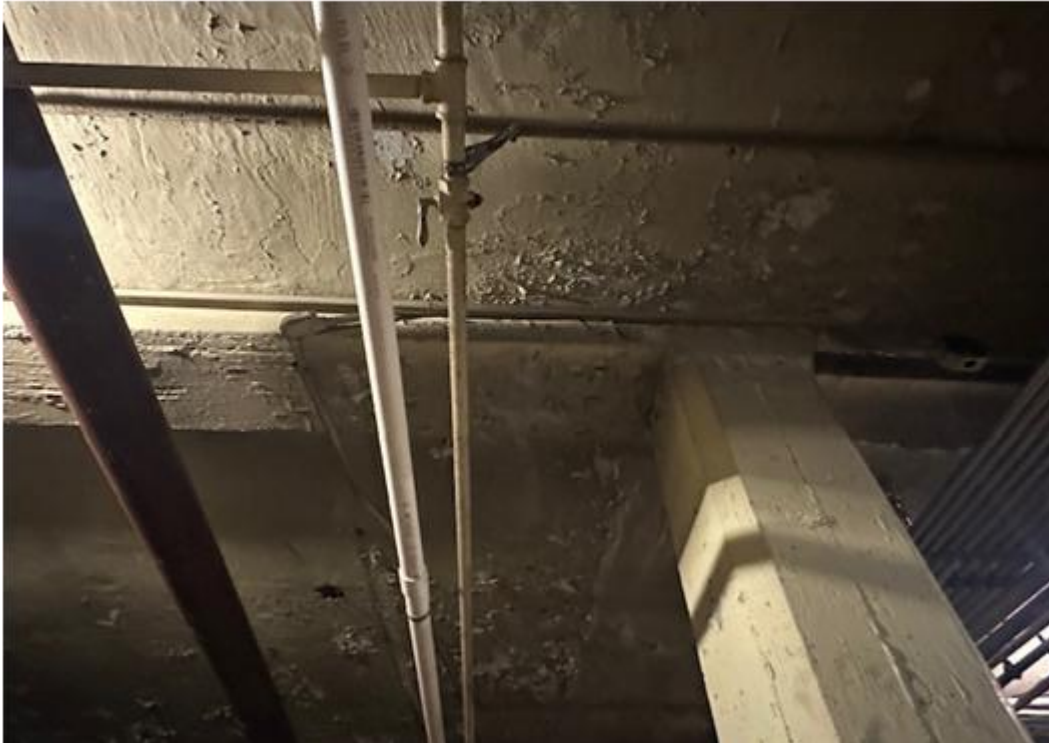
The first-floor structure is exposed in the mechanical room and laundry room located on the partially exposed lower level. The existing concrete beam and clay pot floor system is supported by interior bearing walls or concrete columns and beams.

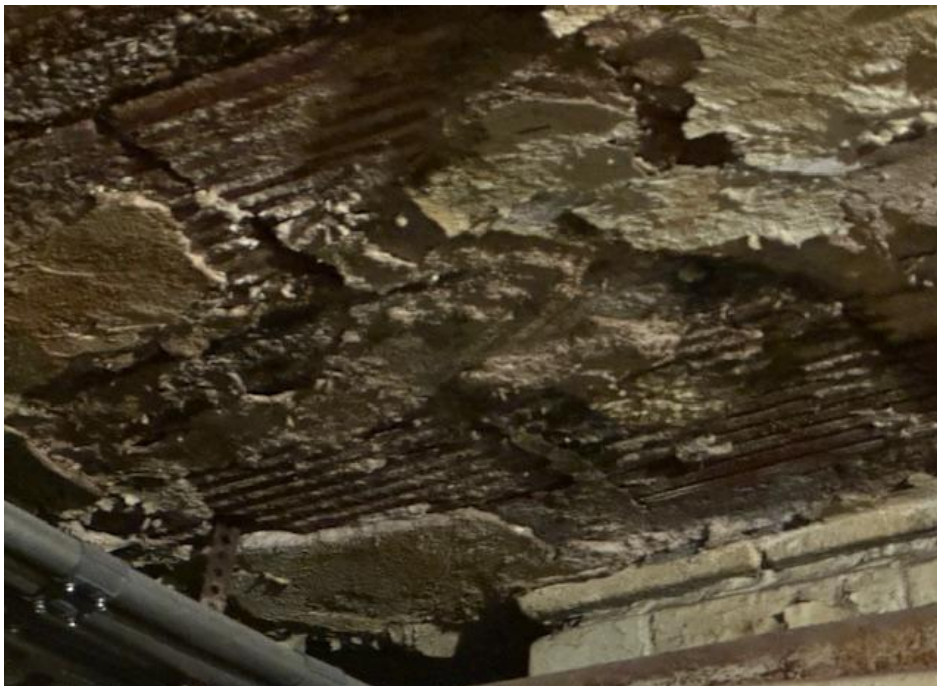
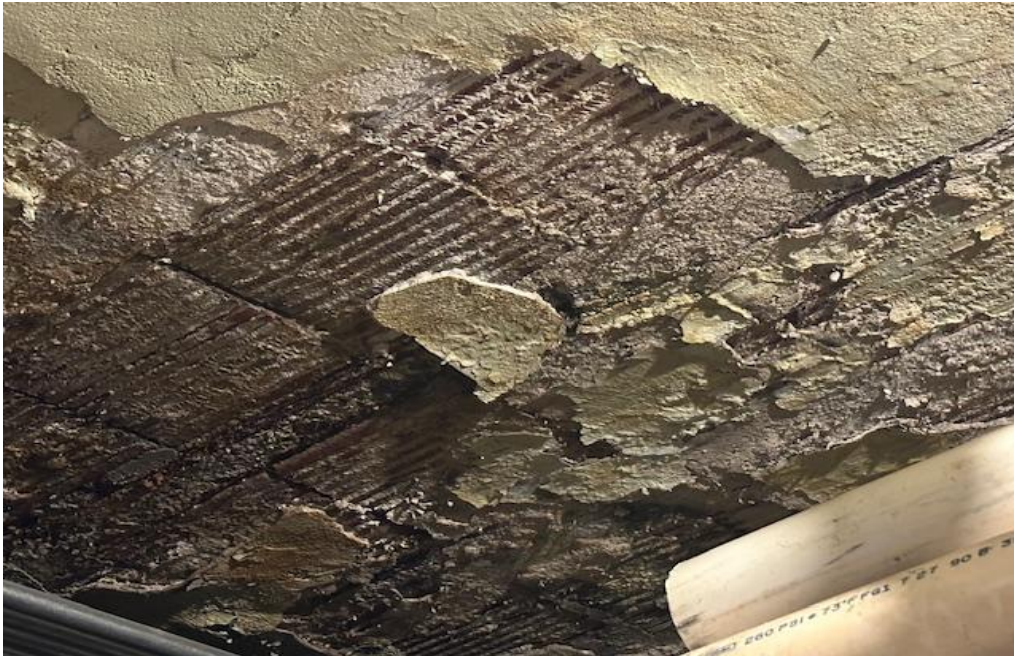
At the lower level where the underside of the clay pot and beam floor is exposed to view, there are numerous areas of plaster failure on the underside of the floor system,

COMPLIANCE / REPAIR ISSUES	FEASABILITY	ESTIMATED COST
STRUCTURAL CONDITION / FAÇADE REPAIR AND MAINTENANCE	Monitor hairline cracking occurring on exterior masonry walls. Monitor spauling occurring on the underside of floor deck.		Yearly basis-\$7,000 Impending major repair-\$50,000
ACCESSIBILITY	Create an accessible route from the entrance to the 5 floors	The access from the city sidewalk will not allow for an ADA compliant path of travel into the vestibule; secondly due to the stair shaft configuration for both the front and rear entrances, there is not enough space for the lift or elevator to be installed.	Not Structurally Possible
RESIDENTIAL UNITS	Expansion of unit's bathrooms would require extensive demolition and construction within each unit to provide a code compliant bathroom.	Scope of renovation is inclusive of all MEP trades as well as structural modifications to interior wall and floor framing. Renovation work including floor and wall finishes	\$1,500,000

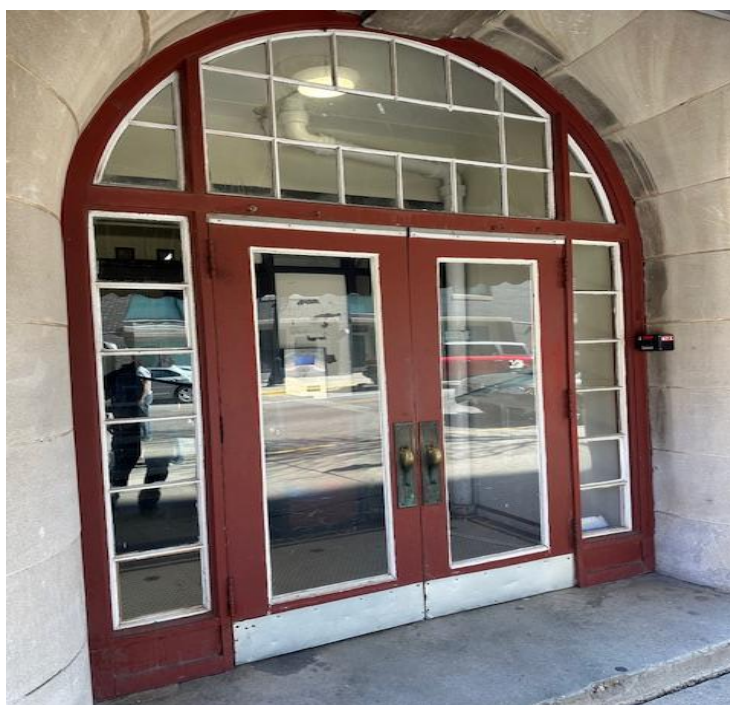
The entrance to the building from Gilman St. is located on a landing between the first and second floor. The Gilman St vestibule is elevated from the exterior

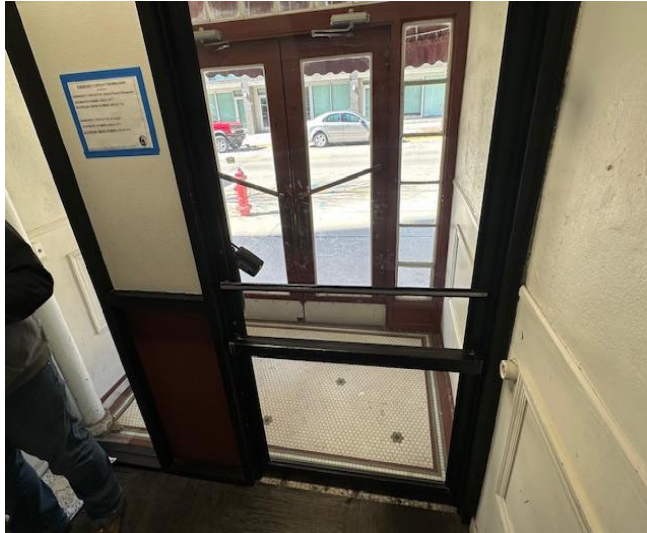
The main vestibule does not provide the required separation between egress doors in a series, nor is there the required turnaround radius space.

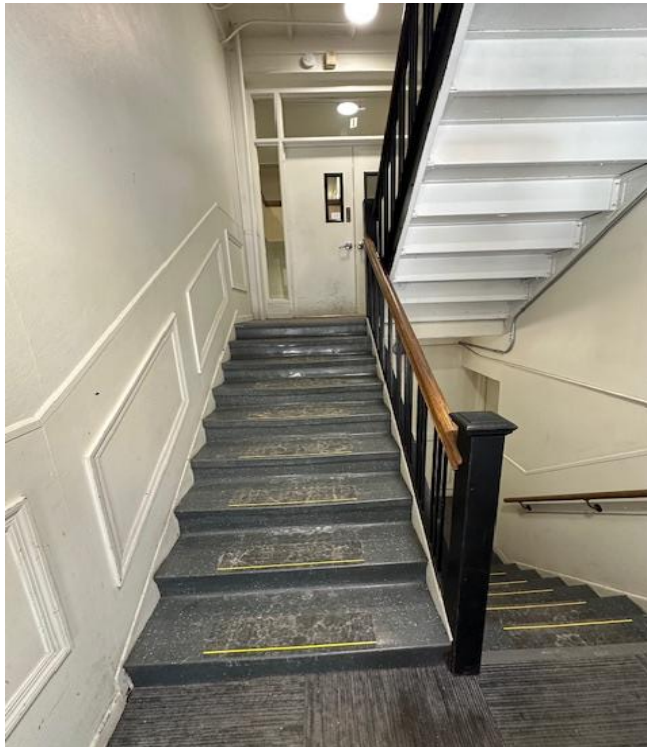
Once occupant pass through the entry vestibule, occupants must either transverse stairs upwards or downwards to their desired destination, as an elevator is not present to take occupants to the other floor levels.

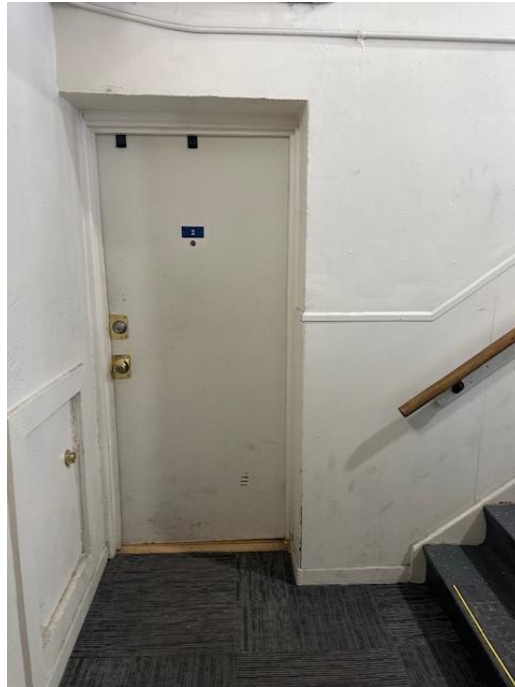
Installation of a limited-use/limited-access elevator is not feasible due to the space limitations at the vestibule landing. Furthermore, the access into many of the units do not meet building code clearances. The interior apartments are spacious and could be converted to meet accessibility requirements, but the inability to provide an accessible path of travel to the units makes any such conversion useless.

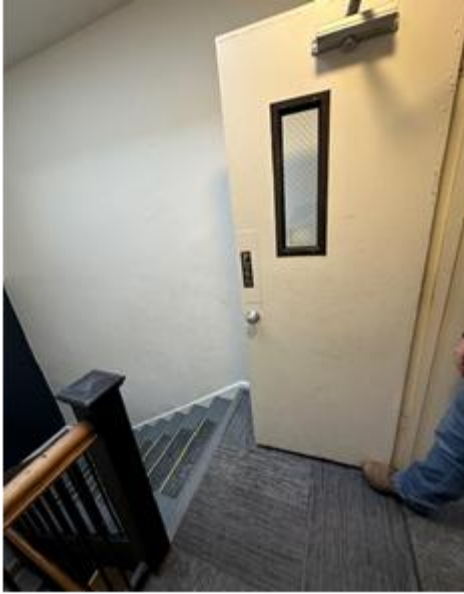
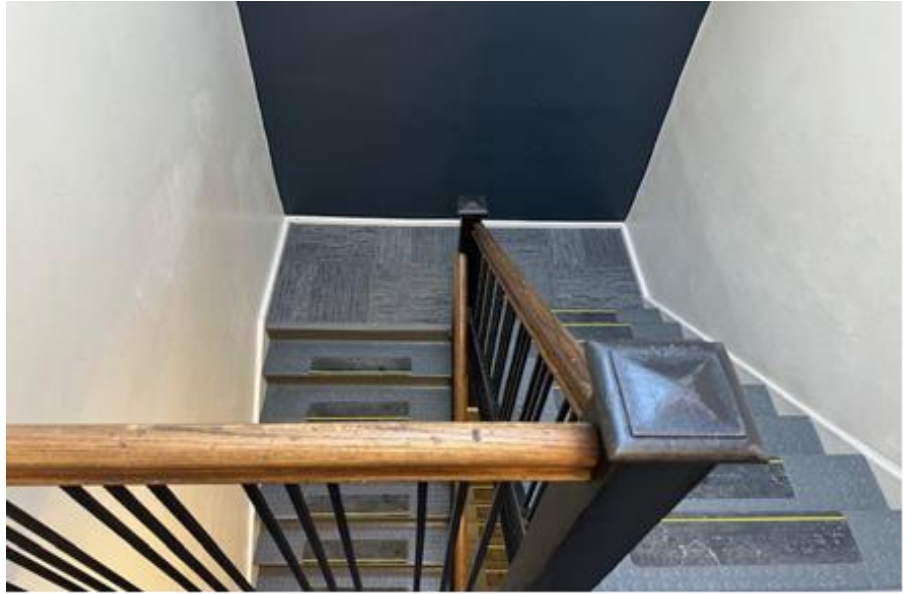
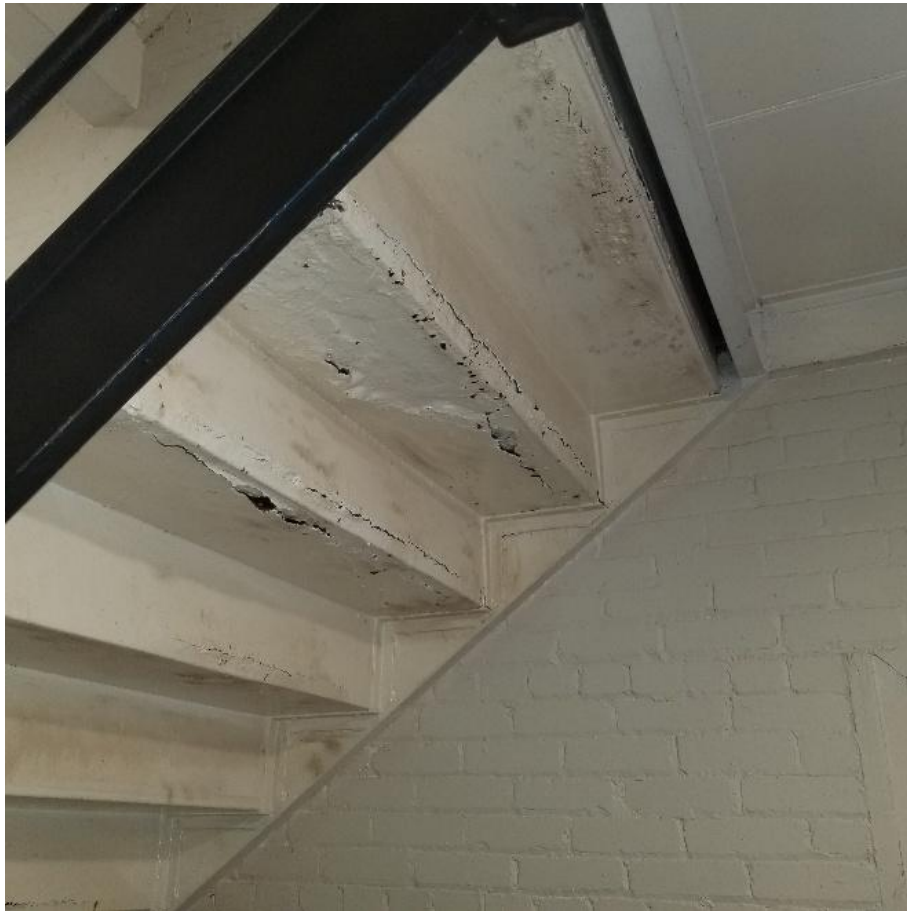
The existing stair assemblies located at the north and south end of the building consist of concrete-filled steel pan stairs. Neither stair is located in a rated shaft and neither stair has a fire-rated entry door serving them. The stairs extend from the bottom level to the top level of the building. The existing landings do not provide the required area of refuge for disabled building occupants to find safe harbor during emergencies.

The existing stair tread depth, riser height, and landing depths are not code compliant.

The existing guardrails are 34 inches tall, which is below the minimum guardrail height of 42 inches. Handrails within the stairs are not code compliant and dual handrails are not present within either stair tower.

Modification of the handrails is not feasible removal and replacement of the architectural guardrails with code compliant guards and handrails. Reconstruction of the stairs is not feasible due to the existing loadbearing shaft construction and space limitations. (see photos included on pages 8 & 9)

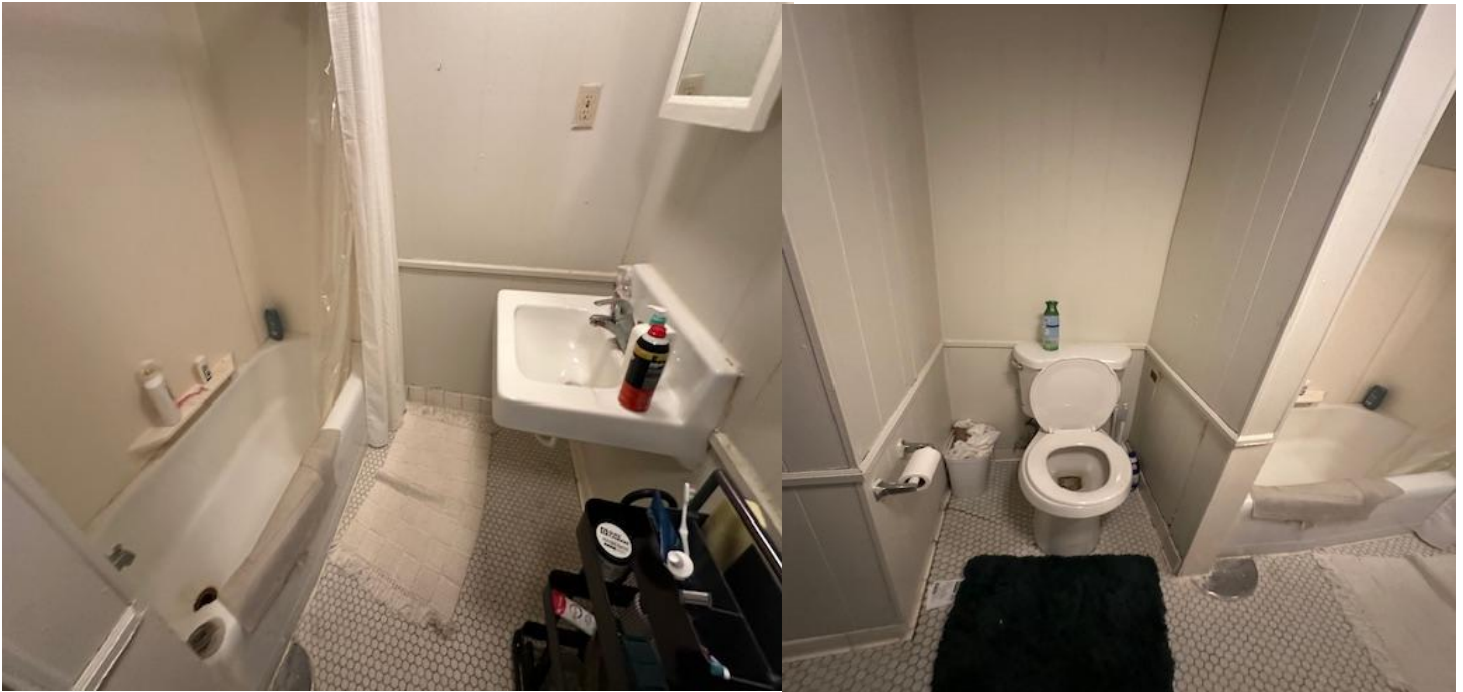
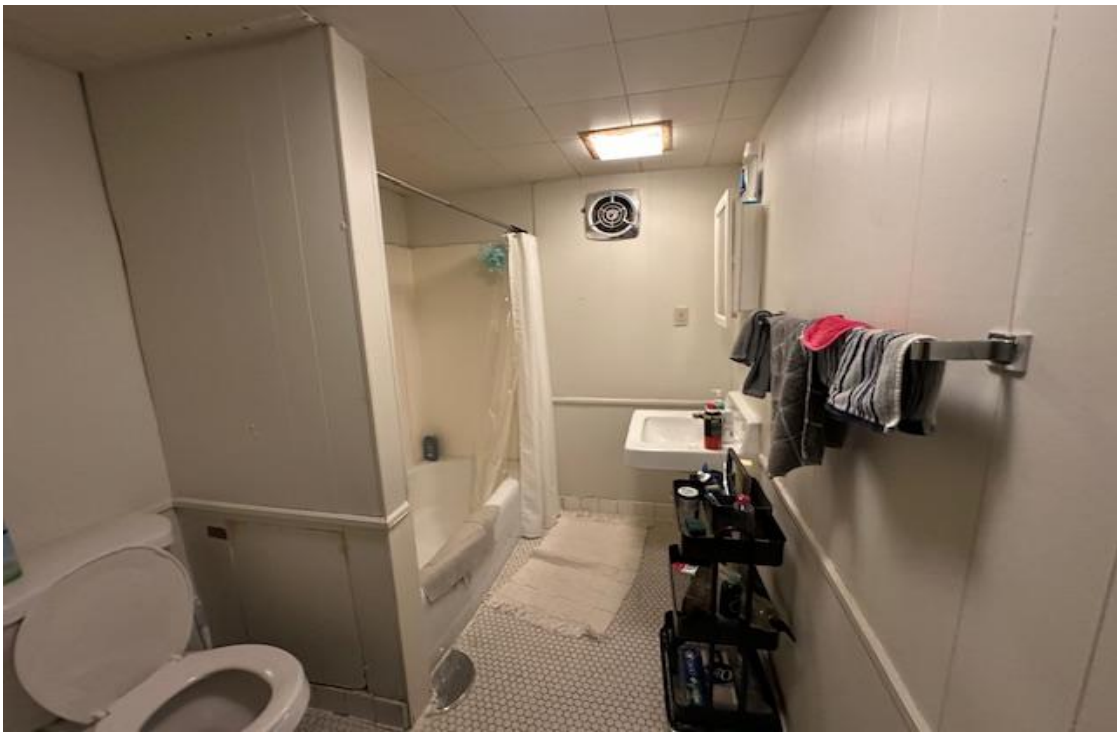
None of the interior apartments meet accessibility standards. The existing bathrooms all contain tub/ shower units that do not meet the required footprint dimensions or approach clearance requirements. Space limitations within the units do not allow for expansion of the restrooms to meet building code clearances.

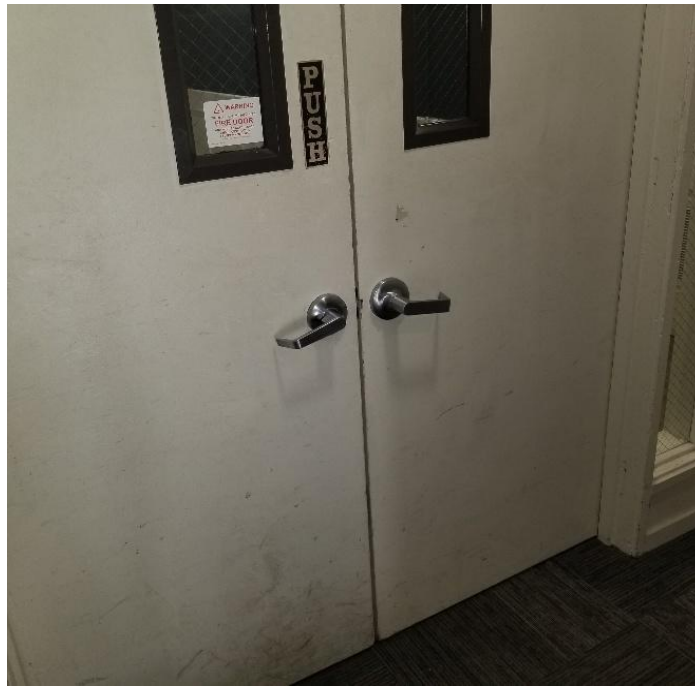
Non-fire-rated doors between front stairwell and apartment unit atrium.

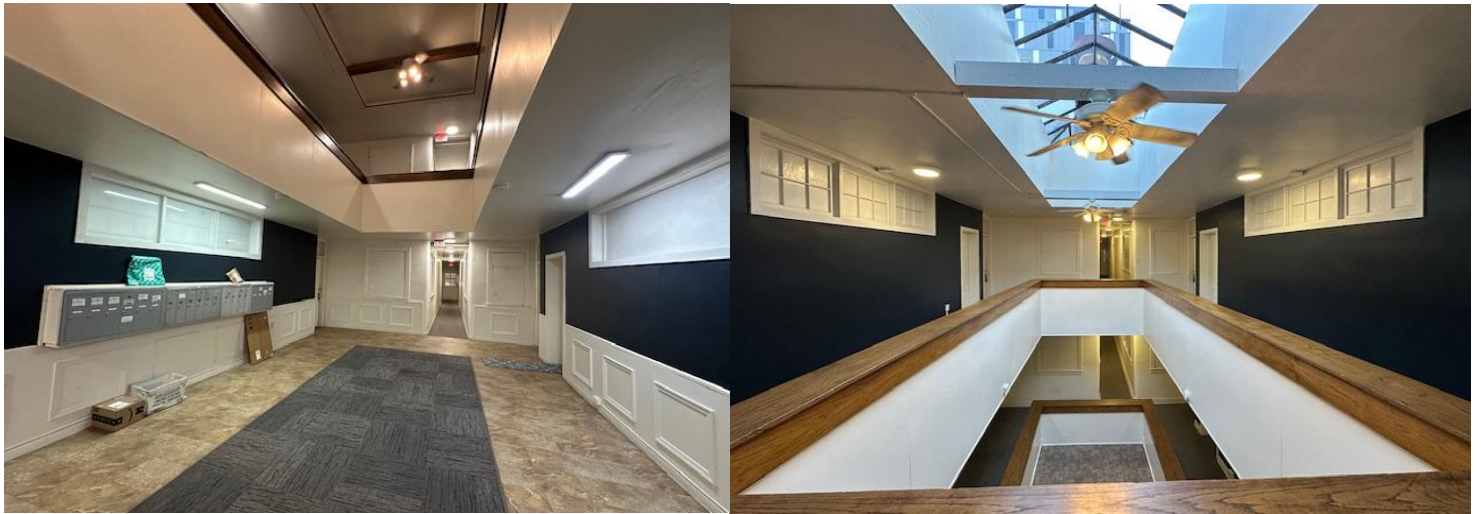
Non-separated floor between apartment unit levels.
