Olbrich Botanical Gardens

Facility Assessments

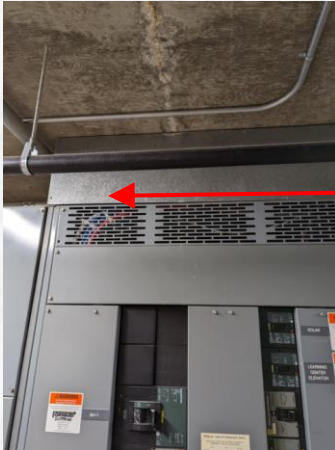
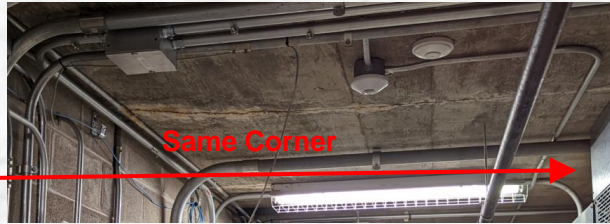
Water leaks from planter box over main electrical distribution box

- Install an exterior ships ladder to allow better maintenance access to the cupola mechanical systems.
 - Install new water barrier systems in upper planer beds to prevent leakage of water into mechanical and electrical rooms below.

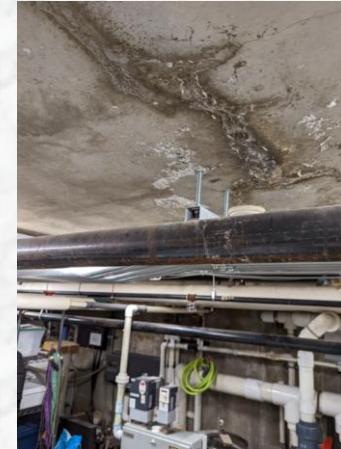
Water leaks from planter box and/or upper waterfall over plumbing mechanical equip.

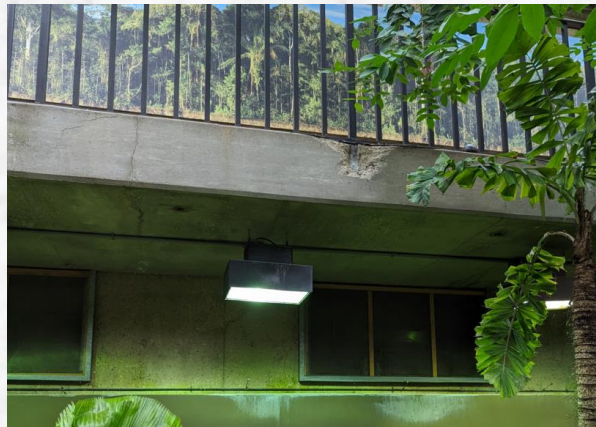
Cracks and spalling at elevated walkway

- Remove and replace elevated concrete walkway to improve drainage and widen walkway to ADA standards.
- Remove and replace existing precast stair treads and landing.

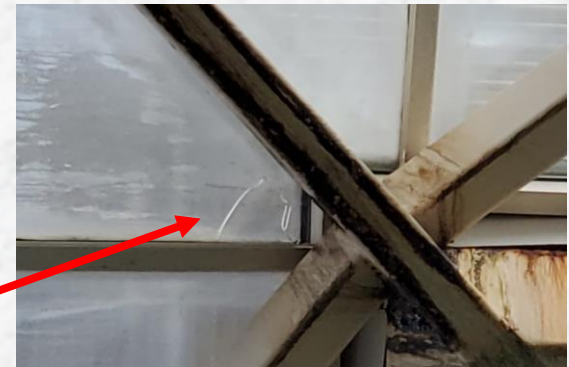
This photo was taken by Olbrich staff during a major rainstorm event outside. Through our assessment we believe the driving rain was either coming through the base of the Cupola or at a compromised glazing seal and traveled down structural members inside the Bolz Conservatory until it got to a drip point.

- Scope of work includes all of the following:
 - Cupola, reconstruction and insulation of the cupola to ensure it remains weather tight.
 - Structural framing, clean, repair, prime and paint all steel connections as needed including welded joints and bolted connections.
