## Building Inspection Division

**DATE:** February 23, 2015  
**TO:** Plan Commission  
**FROM:** Matt Tucker, Zoning Administrator

**SUBJECT:** Request for PD Alteration, 520-524 E. Johnson Street

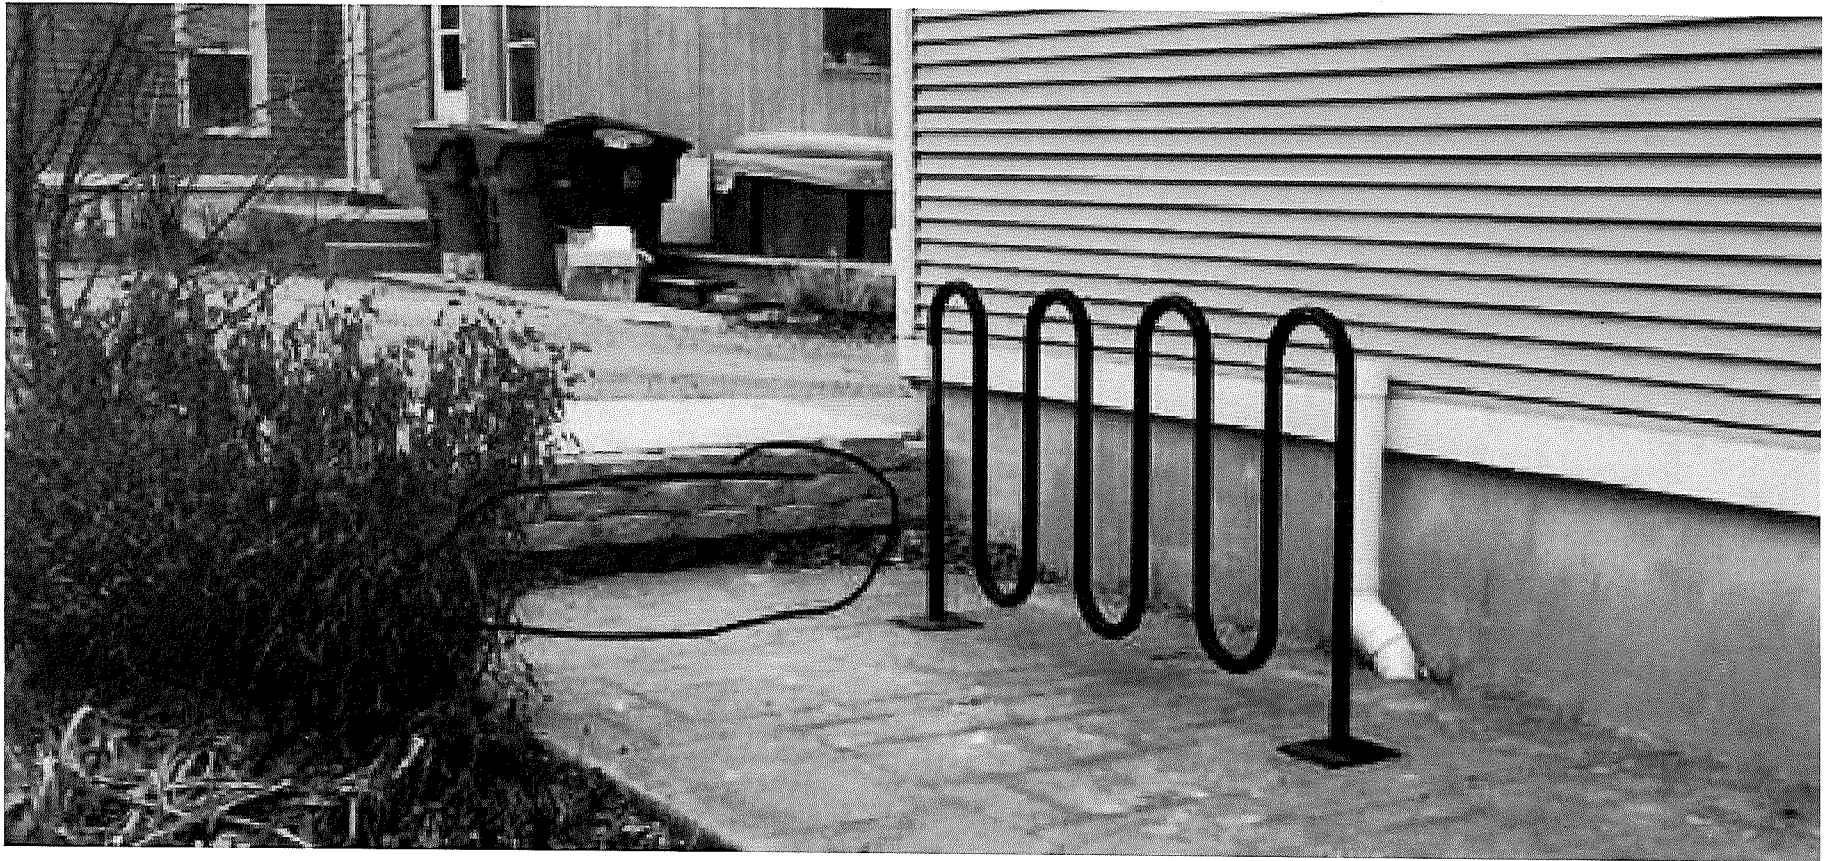
The bike parking access issue could be fixed if one added a step/steps in the retaining wall, so a person need not climb such a rise with a bike to get to the path leading to Blair Street.

- Re-orient bike parking in this area to a compliant configuration that maintains the required access.
- Install a course of block at the front of the retaining wall to create a “step” that one may use to carry their bicycle between the driveway and the bike parking area.
- Provide a detail of the bike rack, showing the rack in compliance with Zoning Ordinance requirements.

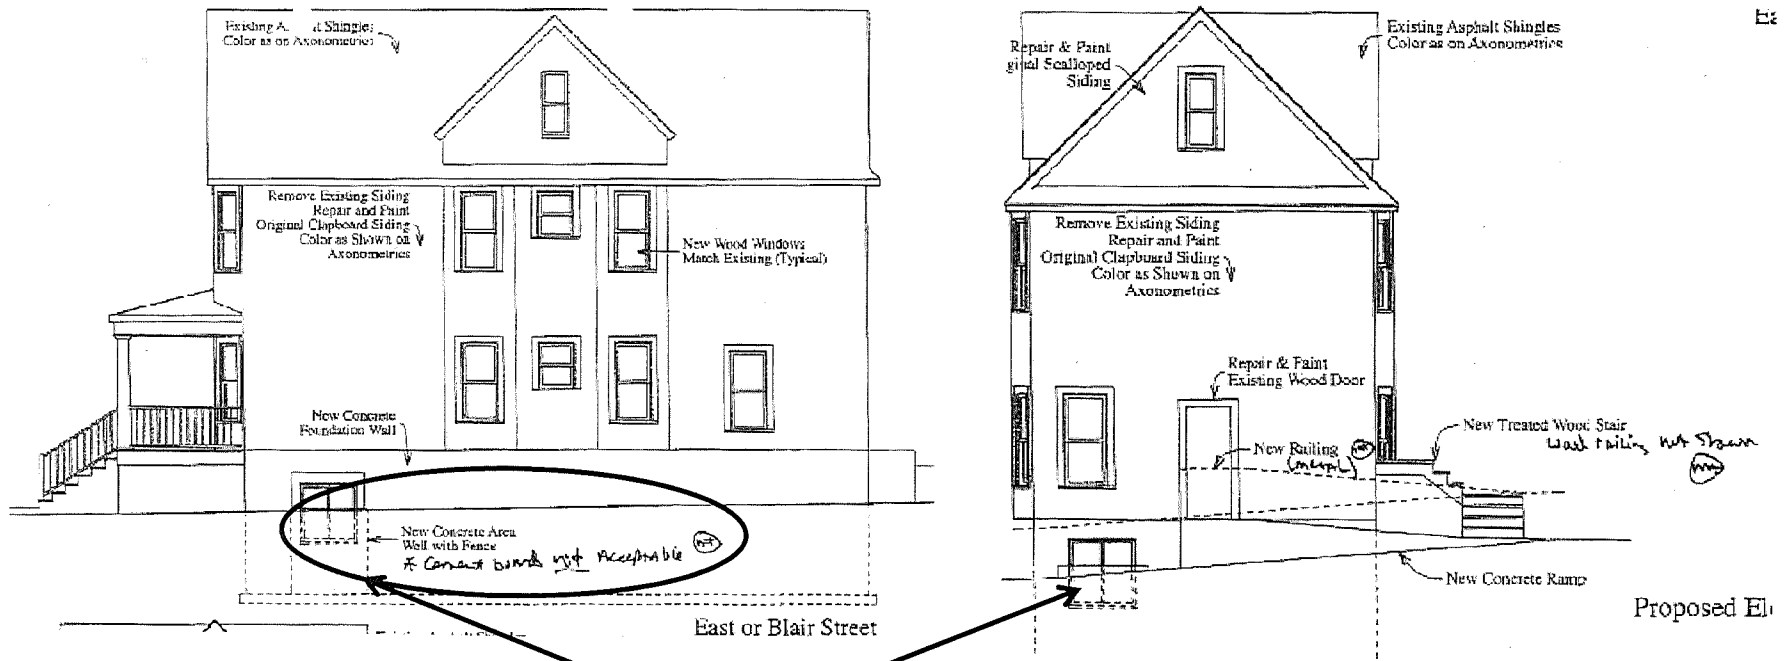
# Approved plans for window well installation

Unacceptable window wells installed here

- Reconstruct the window wells of masonry/concrete or another acceptable durable material.

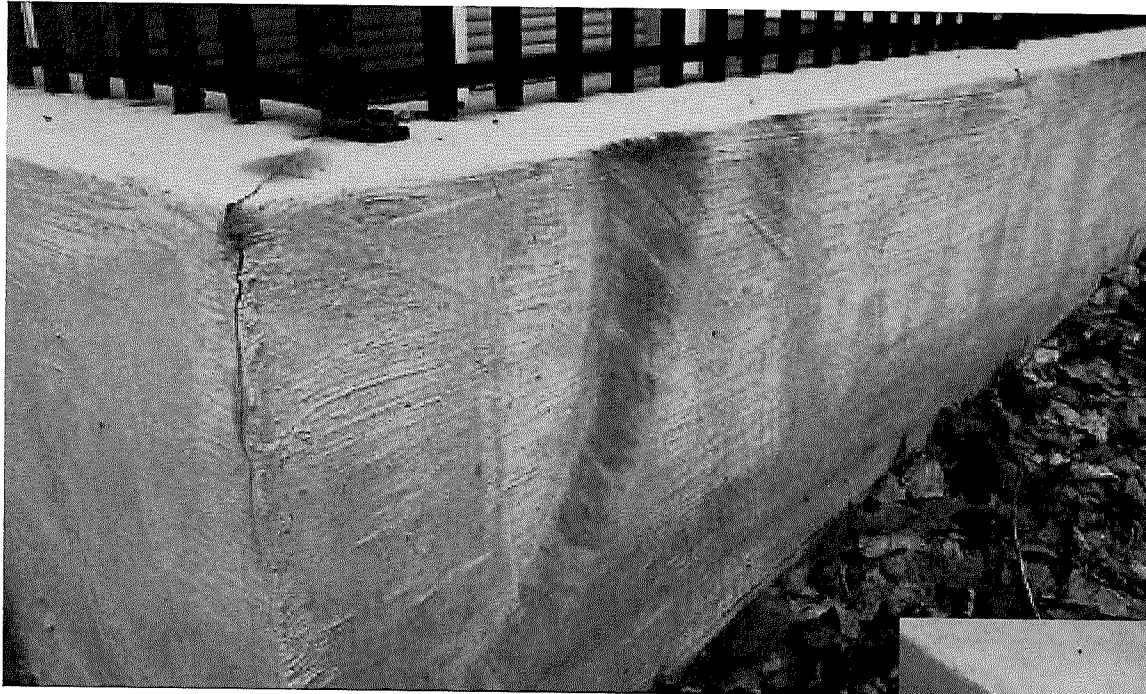
Here is the well by the sidewalk of N. Blair St., it already has a few marks where something hit it.
