## Certificate of Appropriateness for 2115 Kendall Ave.

September 16, 2019

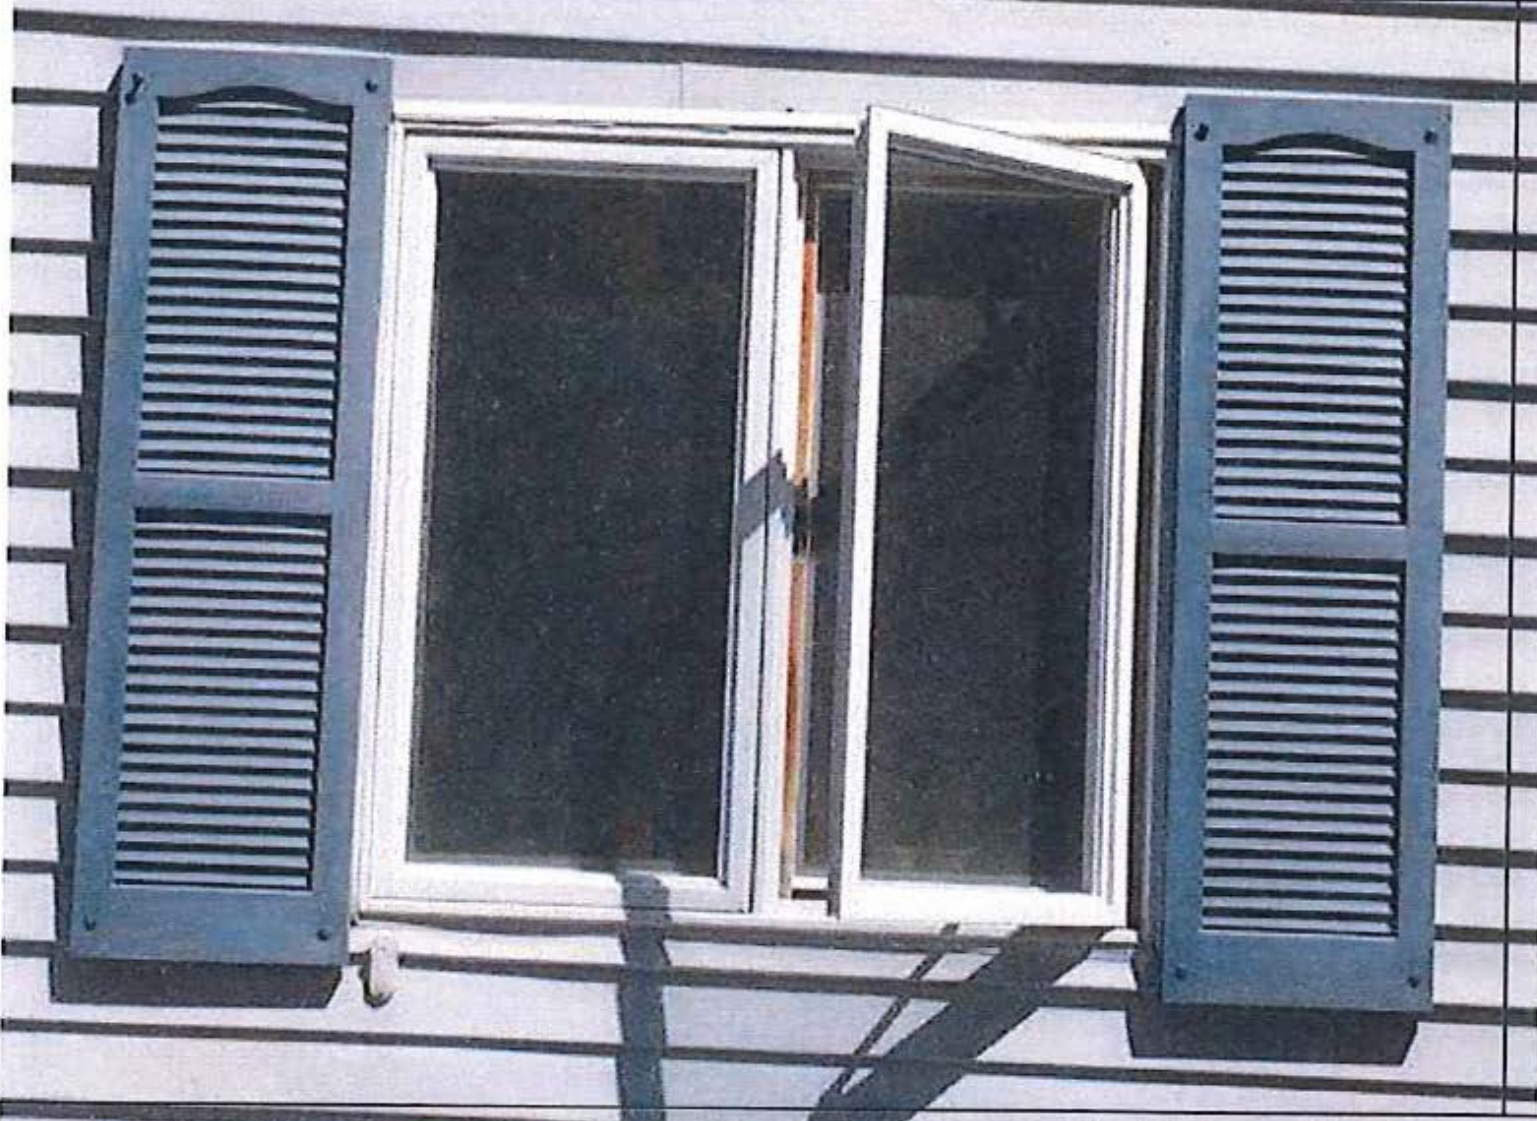
Window 9: Kitchen, south-facing, 38" by 38"

This window is of undetermined date (not an original window, vinyl/aluminum exterior). One pane, designed to open, is inoperable.

Replace with: similar dimension 38" by 38" slider Okna 500 series.

1. Replacement of gutters with materials-in-kind, color to match trim
2. Replacement of window 9 with proposed slider window
3. Replacement of windows 7, 8, 11, 12 and 15 due to deterioration
4. Repair or replacement of window frames and sills as necessary with cedar, painted to match existing
5. Repair remaining historic windows

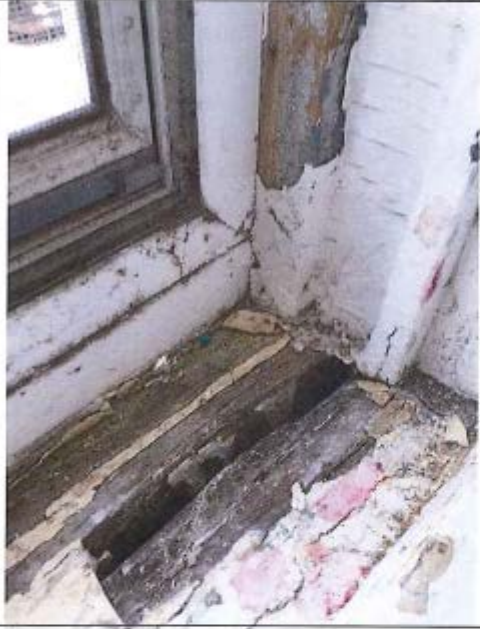
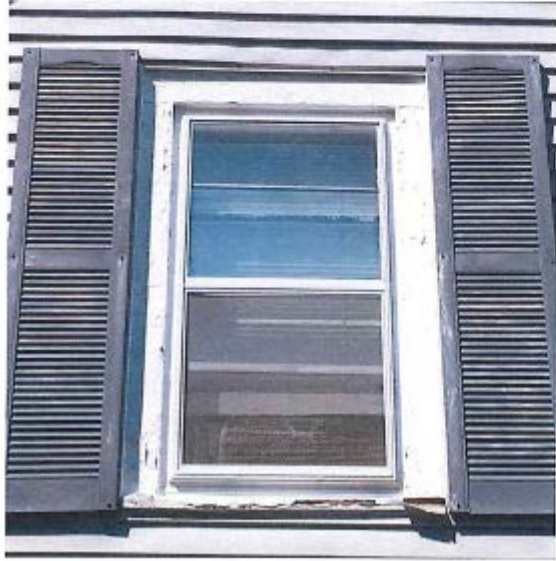
Window 11 bedroom 1, driveway facing 28" by 55"

Major rot and chipping on external frame and sill. Lead swab test positive.

Replace with: similar dimension 28" by 55" double hung Okna 500 series.

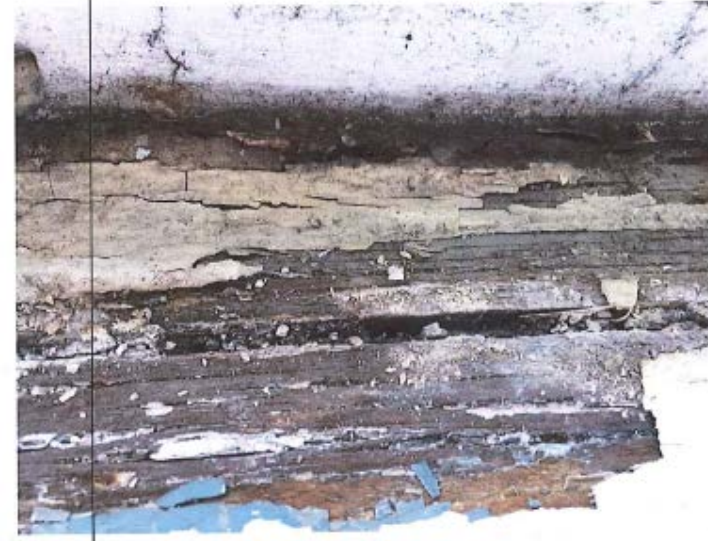
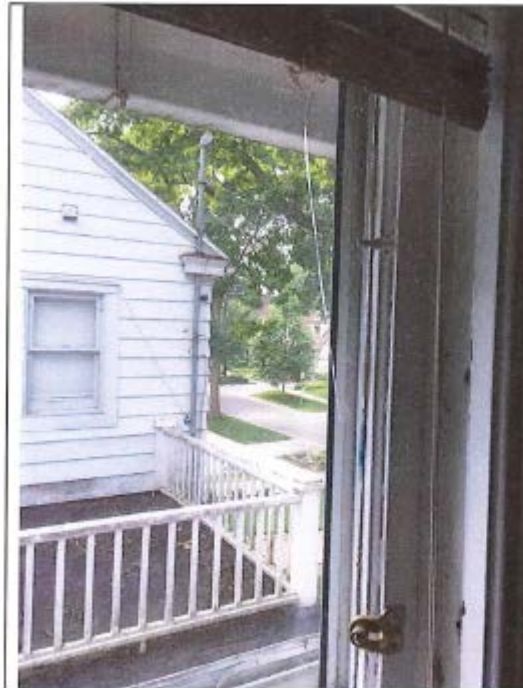
Window 15 Bedroom 3, west-facing 28" by 55"

Broken pane. Chipping. Rot.

Replace with: similar dimension 28" by 55" double hung Okna 500 series.

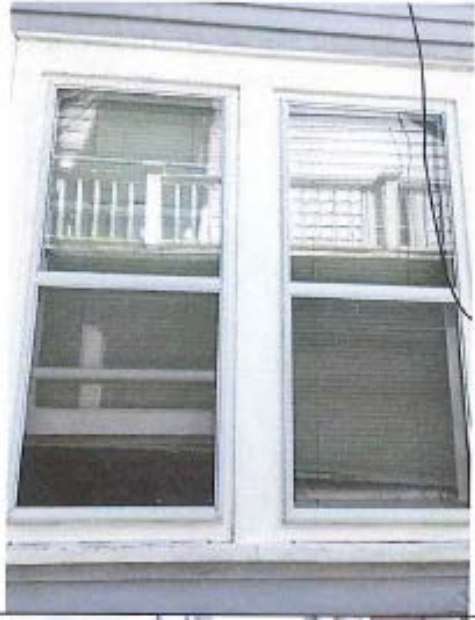
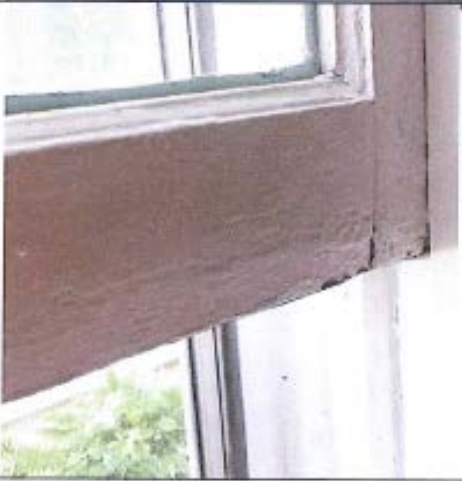
Window 5 & 6: Downstairs dining room, west-facing, both approx. 28" by 61"

Some chipping and wear. Lock mechanisms are broken.

Replace with: similar dimension 28" by 61" double-hung Okna 500 series.

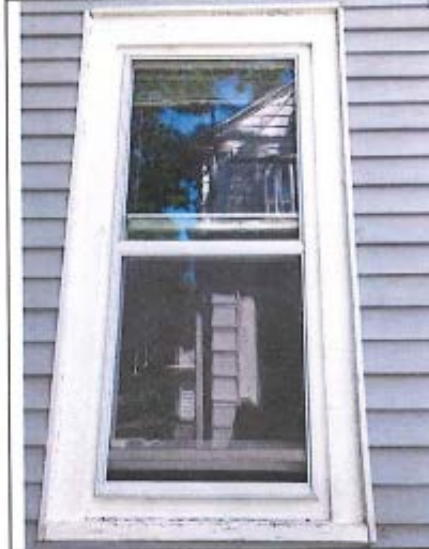
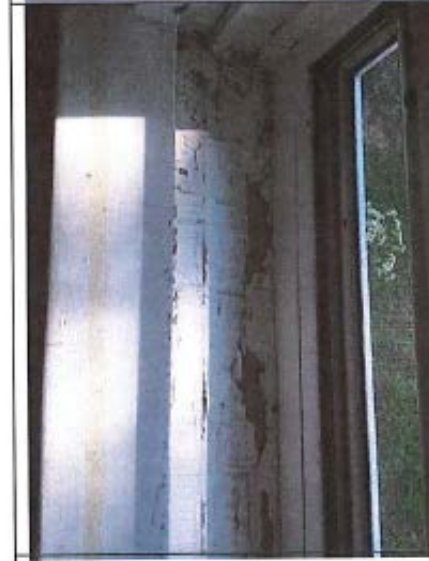
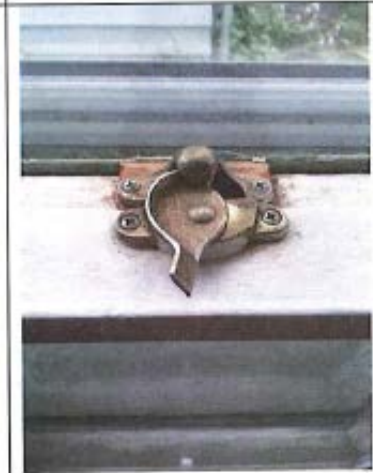
Window 4: Living room west-facing, approx. 28" by 61"

This window has significant paint chipping on the sill and external frame. Opens (doesn't stay open), but lock mechanism was altered and is unstable.

Replace with: similar dimension 28" by 61" double-hung Okna 500 series.
