ITEM #20

May 3, 2016

At your request I have today joined you and architect Mr. Ed Linville at the proposed residential building site at 201 Larkin Street, Madison. You have asked me to examine and comment on the landscape trees currently growing around the existing house. It is my understanding that the existing house will be demolished and that some of the existing trees will be removed to allow new home construction. Following are my observations and comments (microdrill testing graphs are enclosed for illustration):

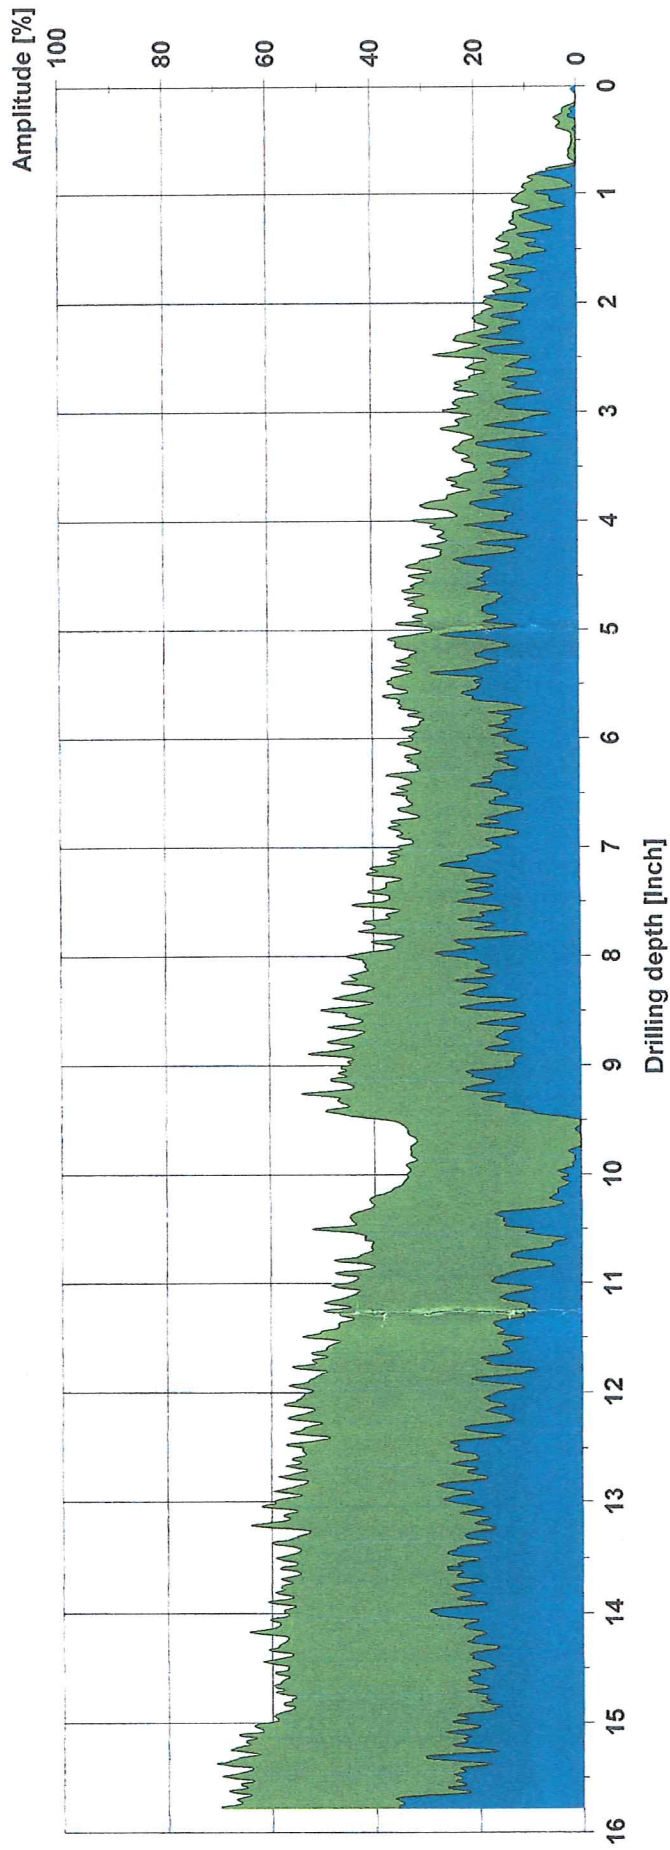
Measurement no. : 1	Needle speed : 5000 r/min	Diameter :
ID number :	Needle state : ---	Level :
Drilling depth : 15,780 "	Tilt : ---	Direction :
Date : 03.05.2016	Offset : 97/336	Species :
Time : 12:18:12	Avg. curve : off	Location :
Feed speed : 20 "/min		Name :

1. white oak behind the garage; 16 inch trunk diameter (DBH) to the south has a flat root collar area lacking taper on the west trunk side nearest the garage foundation indicating some prior root plate disturbance, the microdrill resistance test using an IML PD400 instrument indicates solid wood with a small pocket of decay or cavity around 9.5 inch depth.

white oak 201 Larkin, 16 inch DBH behind garage - south radial - entry at 10 inch elevation small area of soft wood, decay near center 9.5 inch depth in area tested

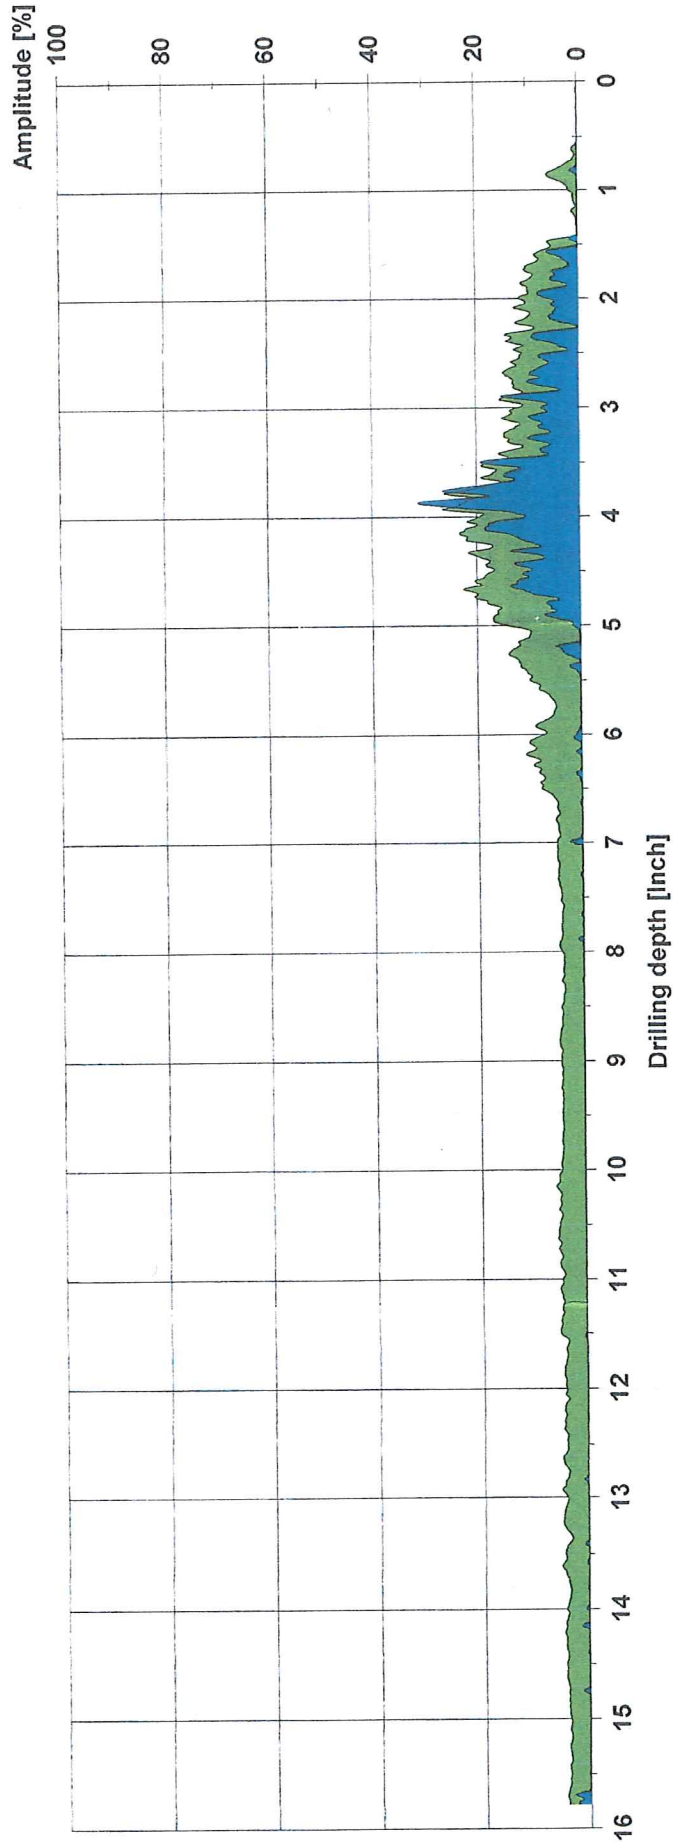
Measurement no. :	2	Needle speed :	5000 r/min	Diameter :	
ID number :		Needle state :	---	Level :	
Drilling depth :	15,780 "	Tilt :	---	Direction :	
Date :	03.05.2016	Offset :	95/356	Species :	
Time :	12:21:28	Avg. curve :	off	Location :	
Feed speed :	20 "/min			Name :

2. white oak behind the garage; 30 inch DBH has crown dieback, a large *Ganoderma applanatum* fungal conk and extensive heartwood decay and cavity as evidenced by the microdrill test; prompt removal for safety recommended.

201 Larkin white oak 30 inch DBH behind garage with large fungal conk (Ganoderma applanatum) on northeast side. East radial entry at 10 inch elevation reveals extensive heartwood decay and cavity. Very high risk of failure and targets include neighbor house.

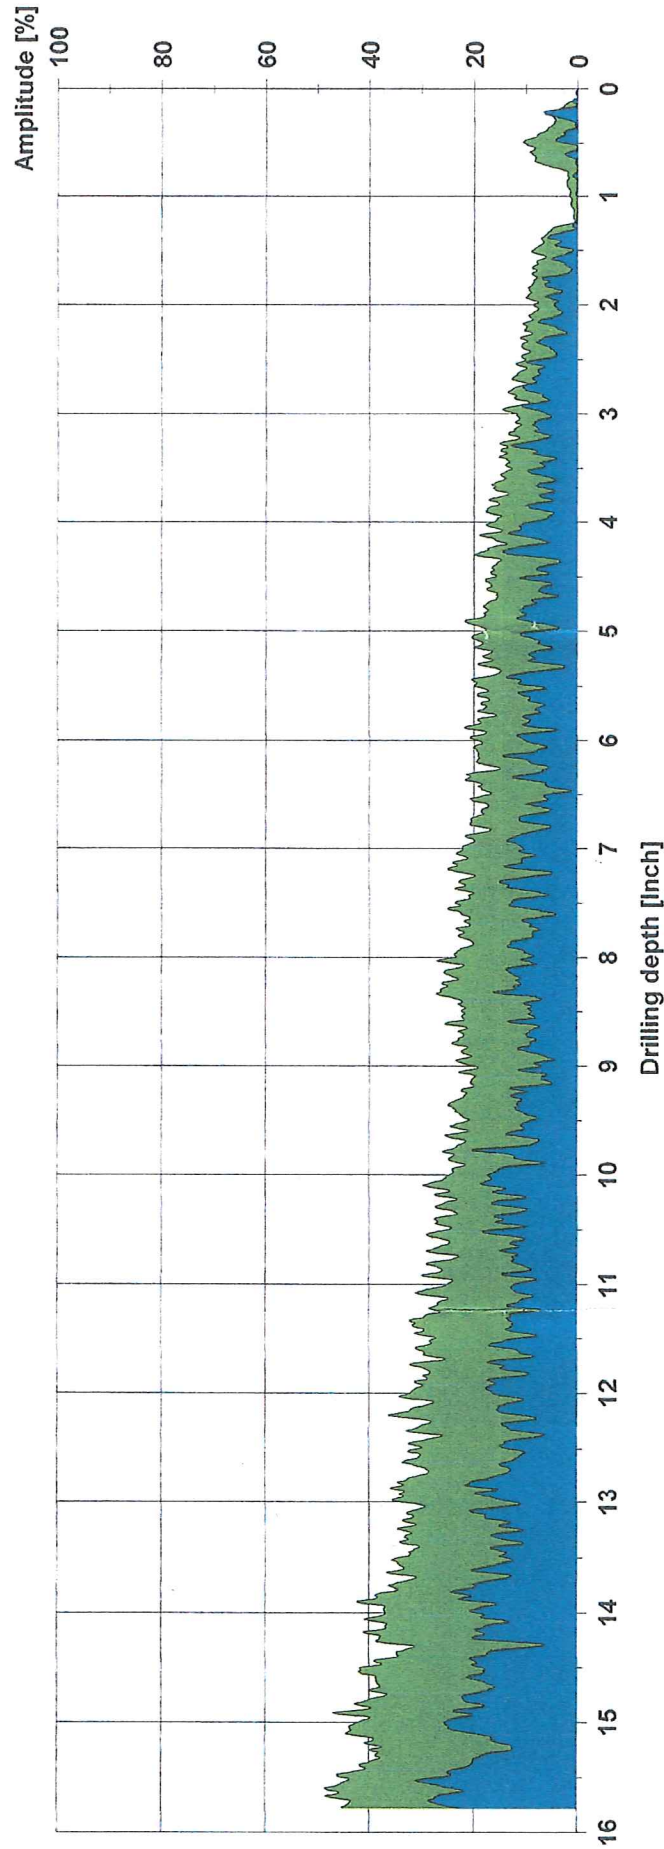
Measurement no. :	4	Needle speed :	5000 r/min	Diameter :	
ID number :		Needle state :	---	Level :	
Drilling depth :	15,780 "	Tilt :	---	Direction :	
Date :	03.05.2016	Offset :	84/352	Species :	
Time :	12:26:01	Avg. curve :	off	Location :	
Feed speed :	20 "/min			Name :

4. bur oak (34 inch DBH) at the northwest corner of the house with central crown branch dieback and accumulated deadwood some falling on the roof; microdrill resistance test east entry at ground level does not reveal decay or cavity in the area tested; there are small canker areas at the soil line but no observation of *Armillaria mellea* root rot rhizomorphs; there is normal bud break on other parts of the crown but lack of leaf development this early in the season prevents additional observations to diagnostically explain the significant crown dieback; both safety

201 Larkin, bur oak 34 inch dbh at northwest corner of house. Center crown dieback indicating root stress, accumulated deadwood in crown with debris on roof, normal budbreak on other parts of crown, small cankers at base but east radial entry at 10" solid wood

pruning of all deadwood and a significant reduction of live branches for roof clearance will be required.
