**SPRING HARBOR
OUTFALL WALL REPAIR &
HARBOR MAINTENANCE
DREDGE**

OUTFALL WALL REPAIR

HARBOR DREDGING

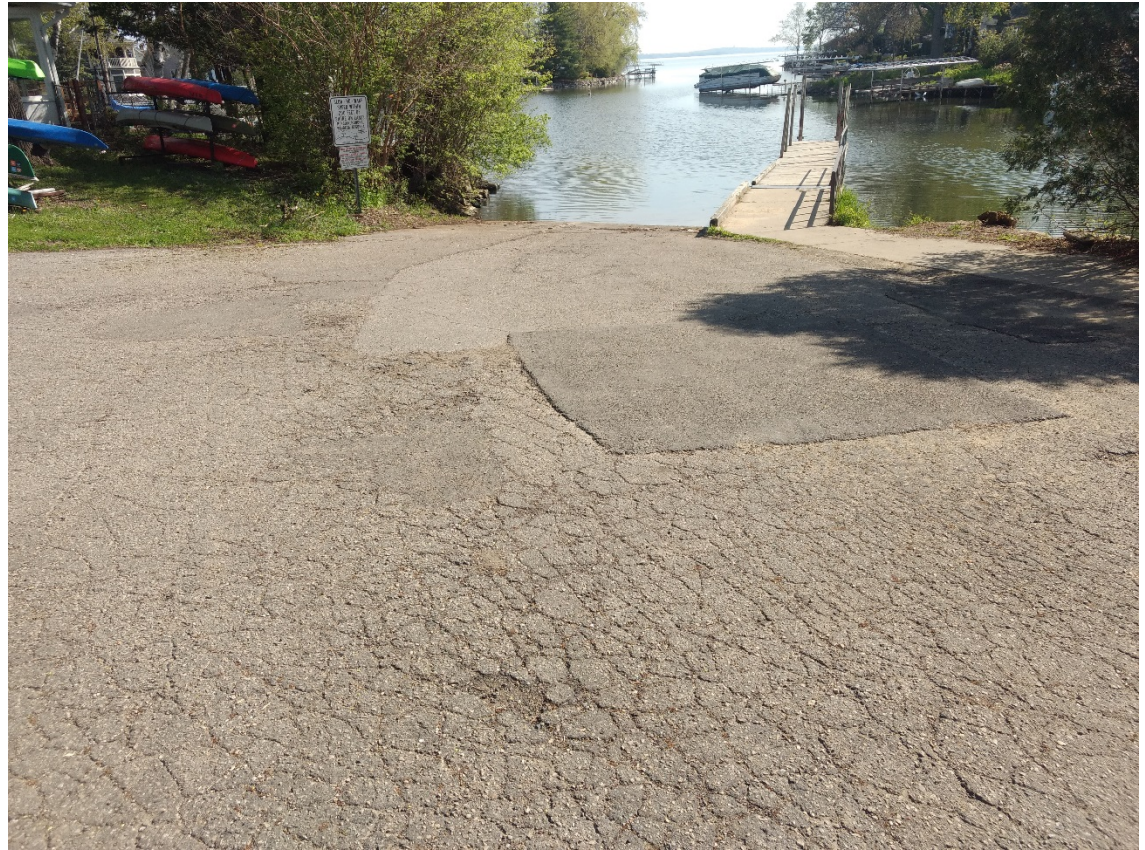
EXISTING CONDITIONS: BOAT LAUNCH

- Unknown age of existing pavement
- Multiple repairs and “alligatored” surface

PULVERIZE AND RESURFACE
ASPHALT BOAT LAUNCH
ADD CURB AND GUTTER

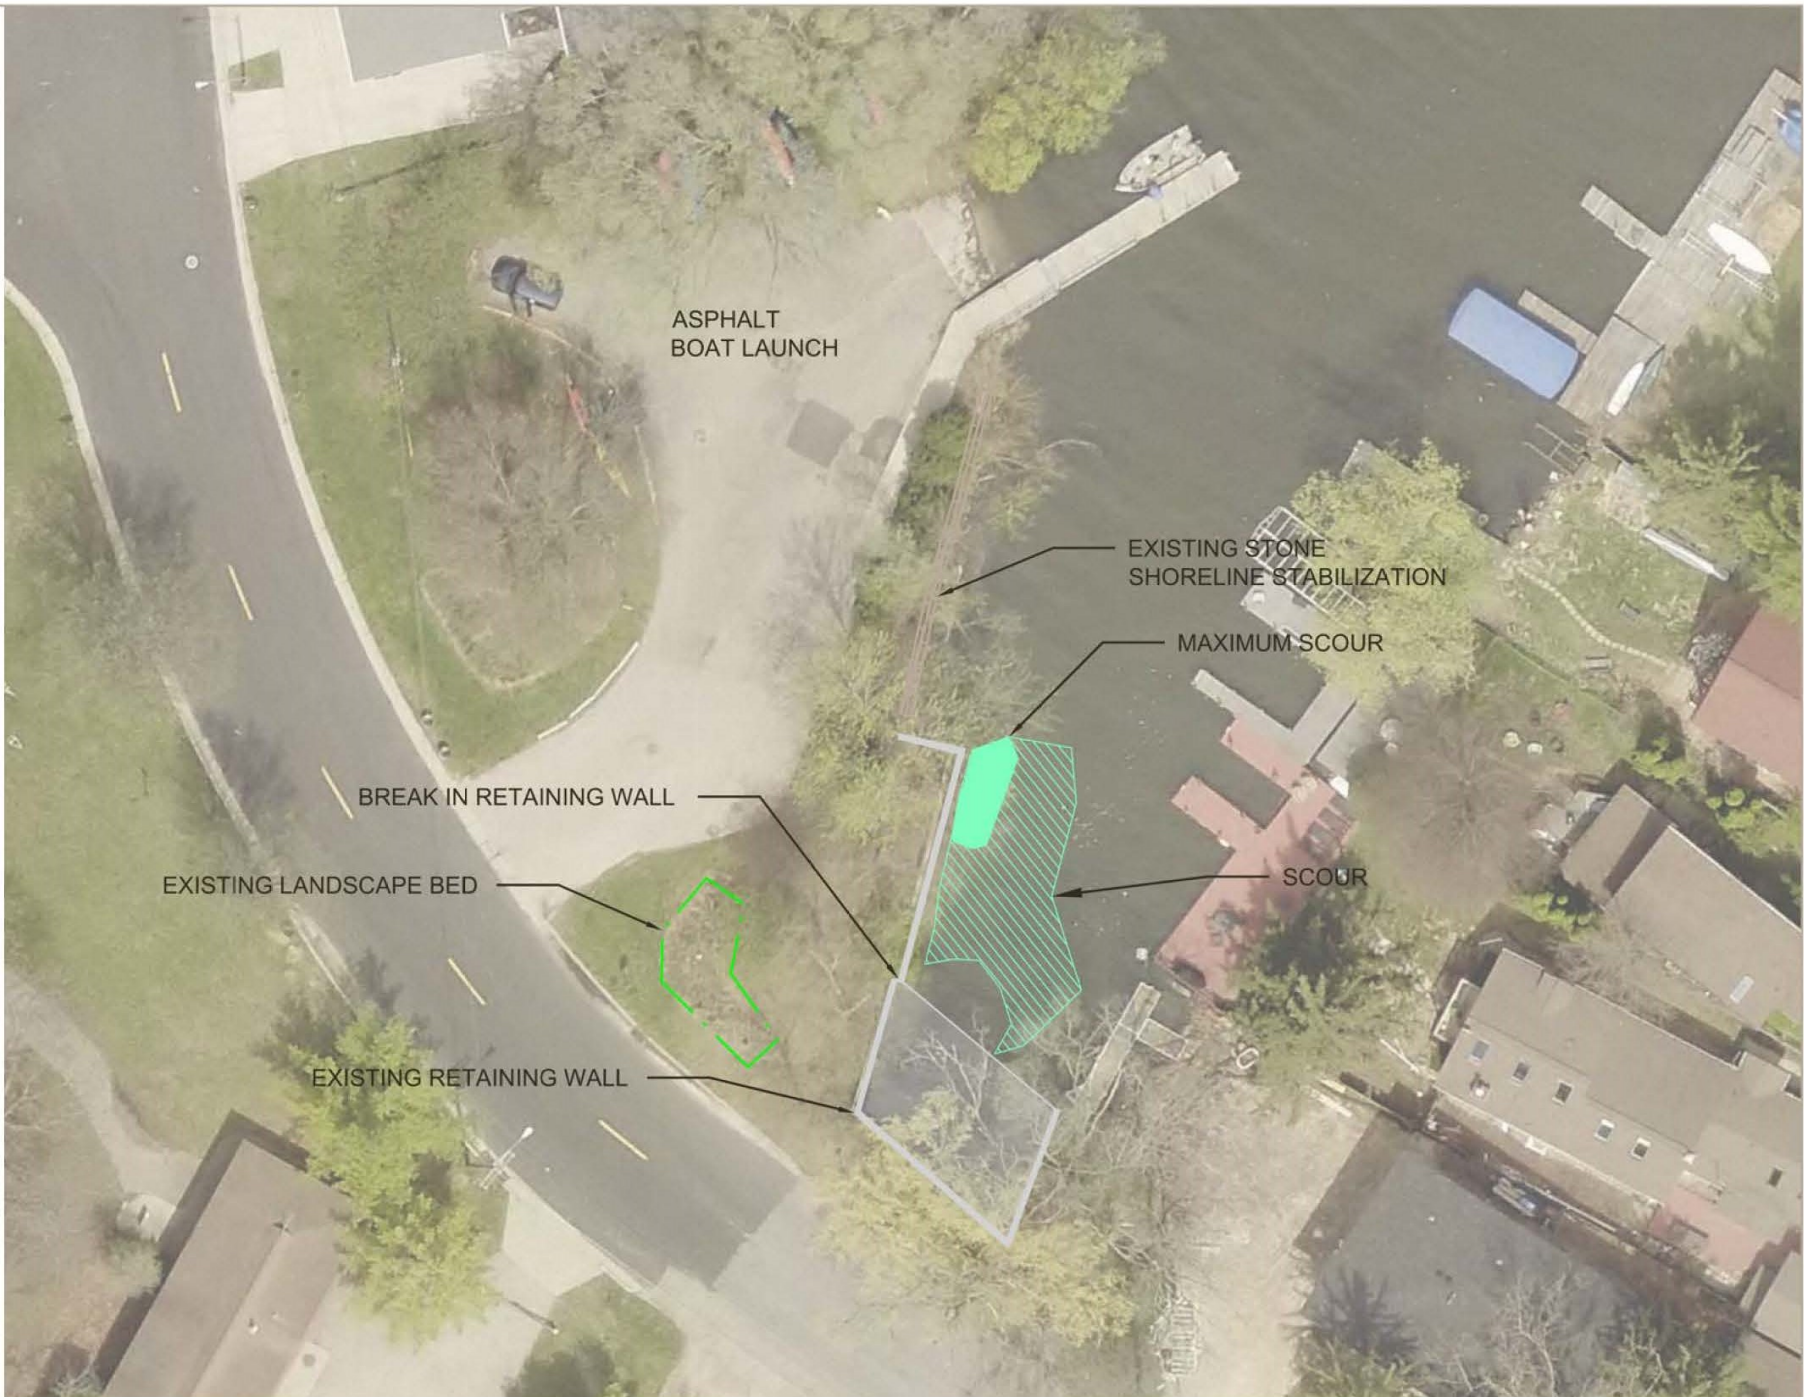
MAXIMUM SCOUR

SCOUR

BREAK IN RETAINING WALL

RETAINING WALL REPAIR

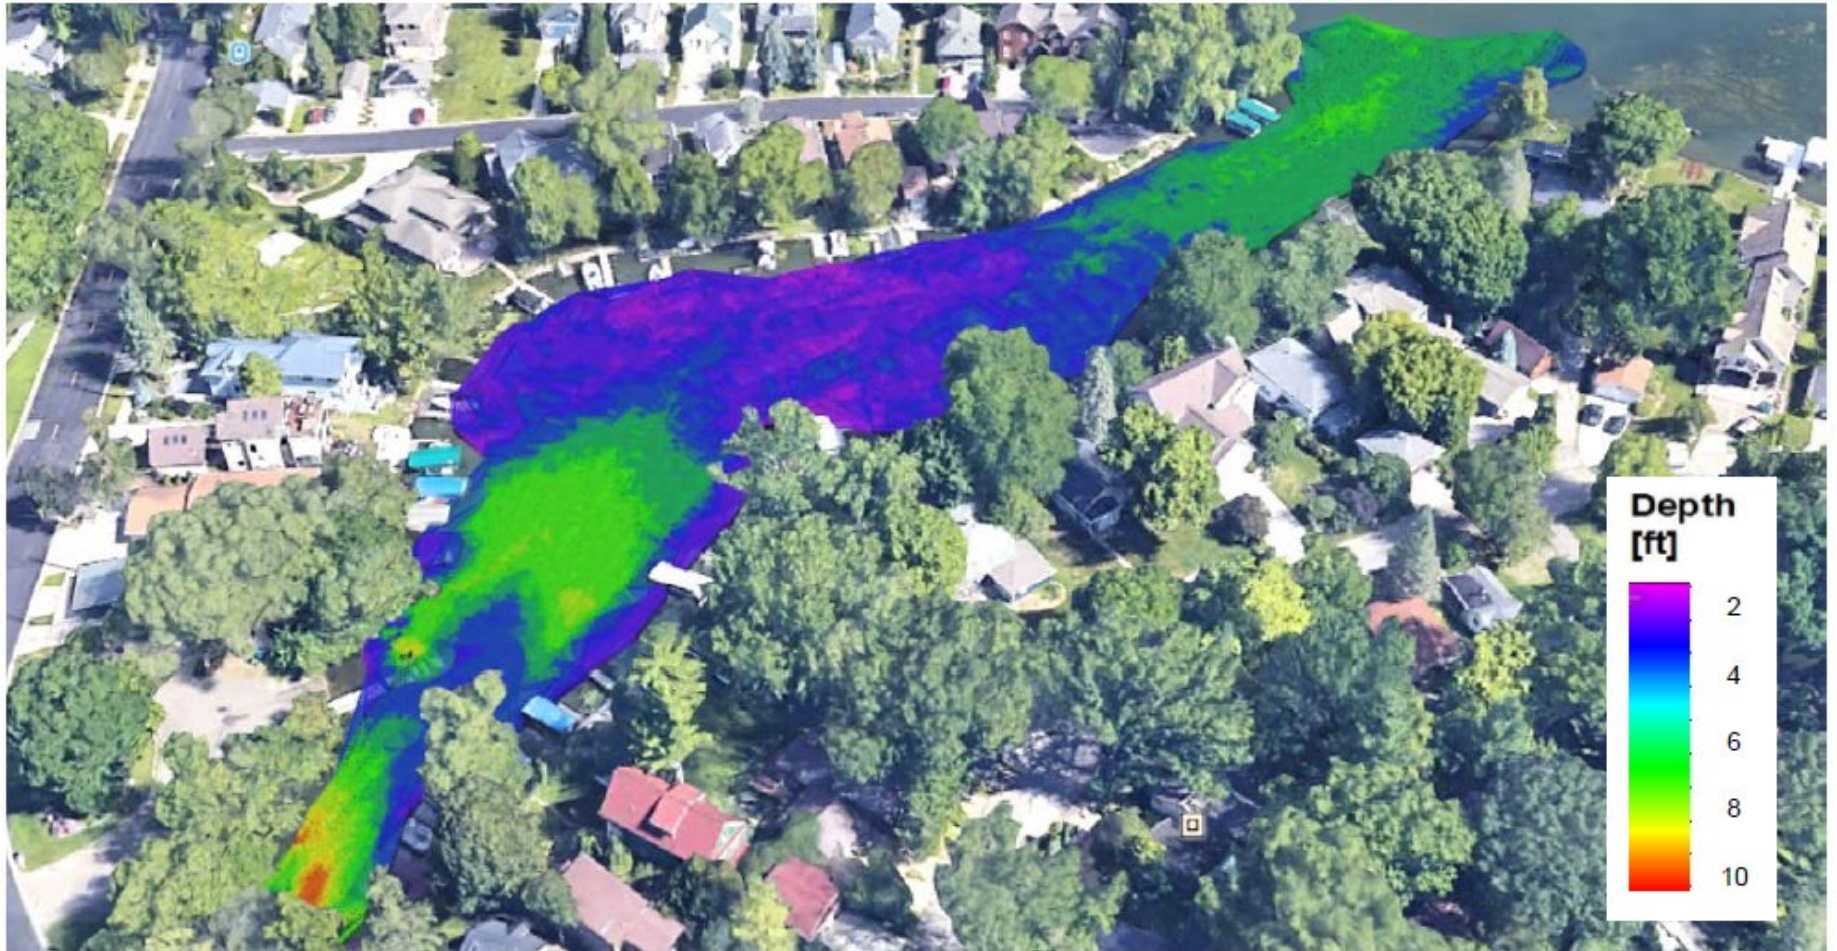
Figure 3. Visualization of the hydrographic survey data collected by FreshWater Engineering on 29 May 2020 in Spring Harbor.

Harbor depth is averaging only 2.5 feet due to accumulating sediment coming in from a major outfall located just east of the boat launch and directly discharges to Spring Harbor. Last dredge performed only near ramp in 2011.

This sediment is impacting recreational use of this boat launch and impacting the general use, water quality and aquatic habitat of the harbor.
