EXISTING BUILDING REVIEW

117-119 State Street

Name: Haswell Furniture Co.

117–119 State Street – Architectural Review

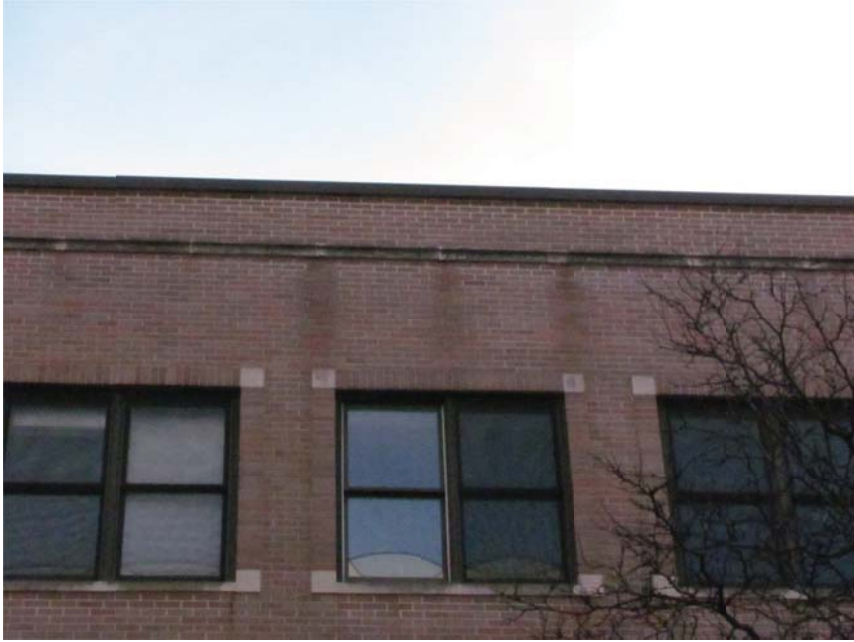
The State Street facade consists of manufactured polished stone panels and brick and cast stone masonry (Figure 1). Except for a limestone belt course and balustrade at the third floor (Figure 2), this facade was completely reconstructed in the 1990s. The only visible distress observed on this facade is localized water rundown staining below the stringcourse at the parapet wall (Figure 3).

Figure 3. Water runoff staining below the stringcourse at the parapet wall.

Based on this limited survey, the State Street facade does not require any significant repairs at this time. The building roof should be surveyed and any maintenance needs addressed.

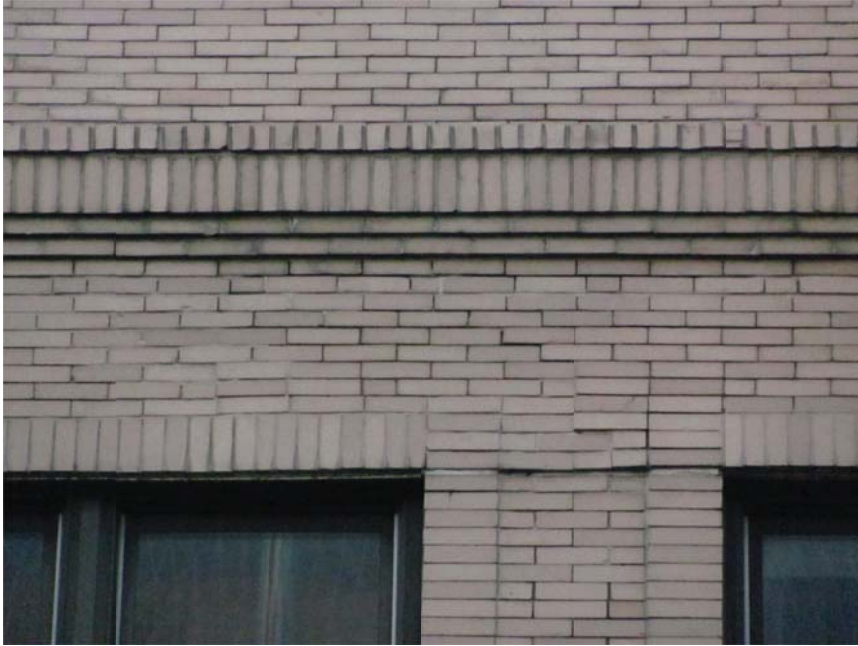
The Fairchild Street facade primarily consists of the original brick masonry facade, although the areas around the entrance doors were apparently altered as part of the 1990s renovation (Figure 4). Limestone is used for window sills at this facade. Cracking and displacement of brick masonry above window heads was observed, likely related to corrosion of embedded window lintels (Figure 5).

Figure 5. Cracking and displacement of brick masonry above window heads.

Masonry repairs are required at the party walls and the Fairchild Street facade. Areas of cracked masonry should be rebuilt, and areas of open or eroded mortar joints should be repointed. At the obtuse corners of the party walls, installation of backer rod and sealant in the continuous vertical crack may be appropriate to accommodate movement and provide a weather tight joint. Repairs are required at bearing locations of window lintels on the Fairchild Street facade; additional investigation is needed to evaluate the condition of the steel lintels and determine the scope and extent of the required repair.

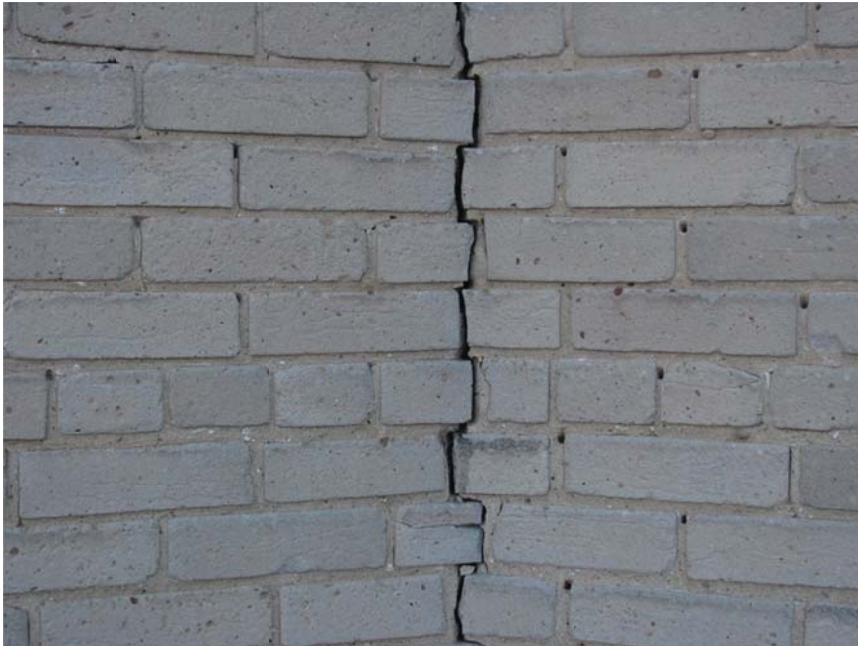
Figure 6. Vertical cracking at an obtuse corner in the brick party wall.

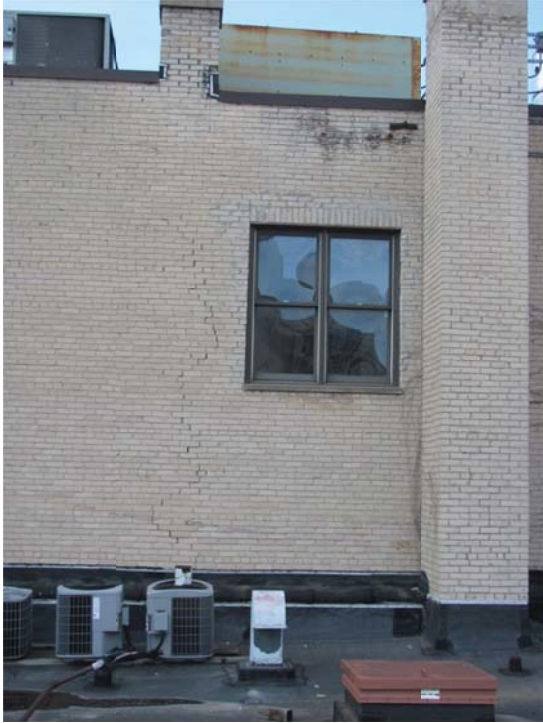
Figure 7. Left. Vertical cracking and localized damage in the brick masonry party wall, which is visible where it extends above the roofs of the adjacent buildings.

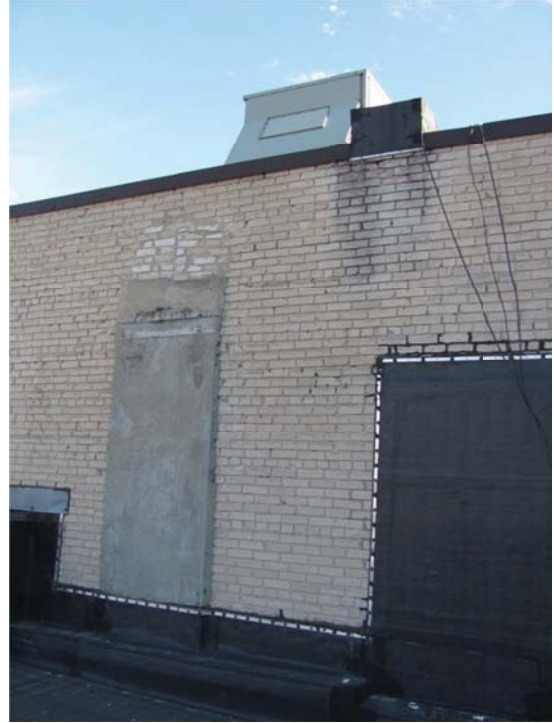
The brick masonry party walls at the sides of the building were reviewed from lower roofs of adjacent buildings, where these walls extend and are exposed above the adjacent roof levels. Vertical cracking was observed at multiple locations in both party walls, especially at obtuse angle changes in the plane of the wall (Figure 6 and Figure 7). Also, some areas of poorly matched repairs and areas overclad with an EPDM rubber roof membrane were observed (Figure 8). Erosion of mortar joints and water rundown staining was also observed at the party walls.

Figure 8. Right. Some areas of poorly matched repairs and areas overlaid with an EPDM rubber roof membrane were observed at the party walls. Also note rundown staining and open mortar joints.

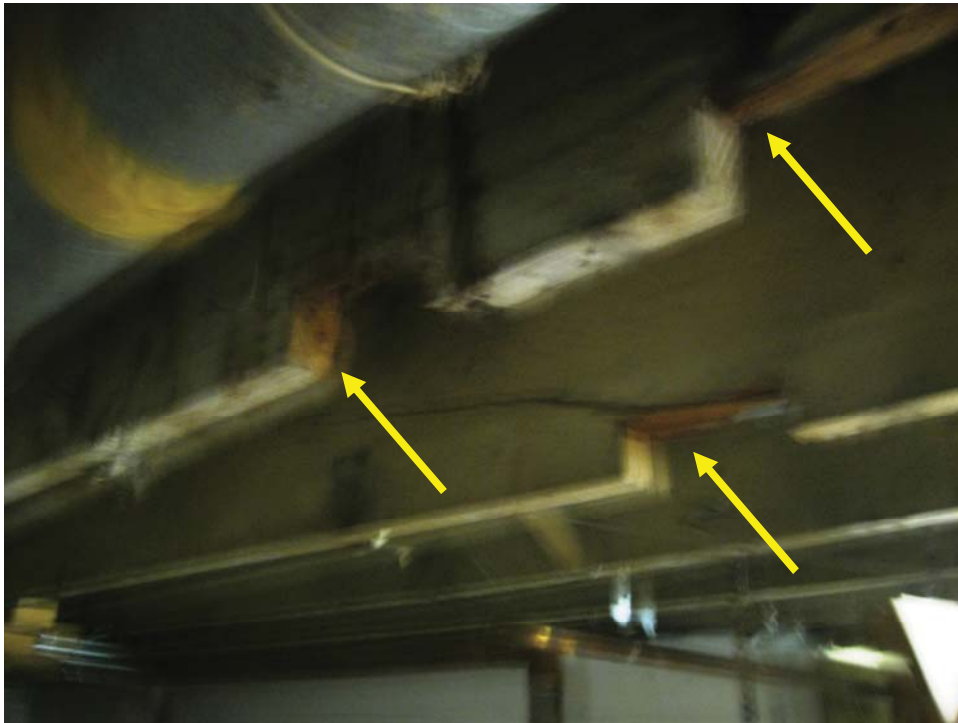
3. Areas of Compromised Structure
 - a. Numerous structural revisions have been made which are outlined in the body of the report.
 - b. Floor joists in the basement for the first floor framing have been cut and notched over the years for the passage of piping. Shores have been placed to prop some of these areas up. These areas are outlined in the body of the report.

Photo 6 – Notched 1st floor joists

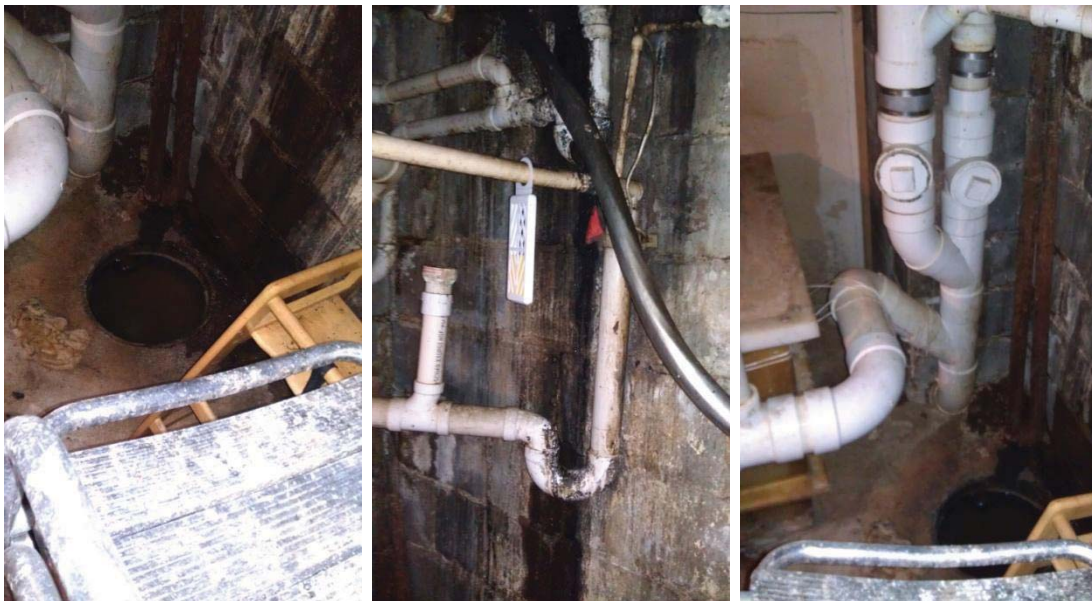
Poor condition of sanitary piping

The basement water heater appears less than 10 years old and is in good condition. Domestic hot and cold water piping is a mix of new and old in the basement due to renovations/remodeling over the years but it is expected that much of the piping on the upper floors is original or very old. Similarly, the sanitary piping from the kitchen in the basement is PVC due to recent modifications, but ties into original cast iron mains and under floor laterals. The domestic water heater on the upper floor appears to be fairly new, probably less than 5 years old.

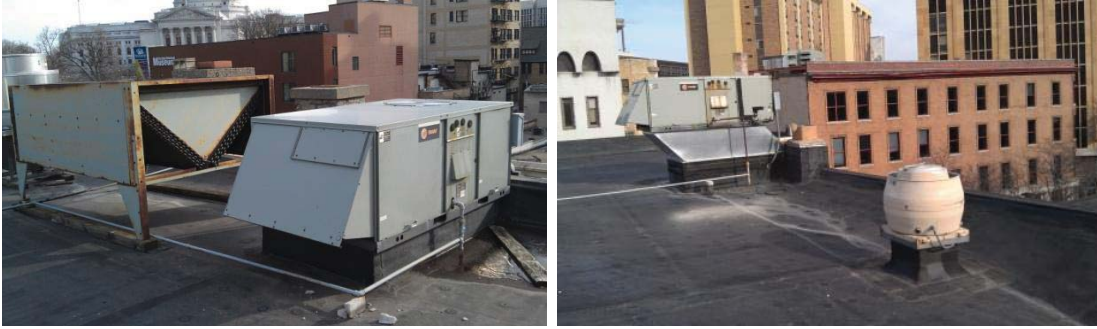
Existing rooftop equipment

The rooftop air handling units are estimated to be about 20-25 years old. That is past the typical average useful life for this type of equipment. The kitchen hood exhaust fan is newer, probably around 5 years old or less.

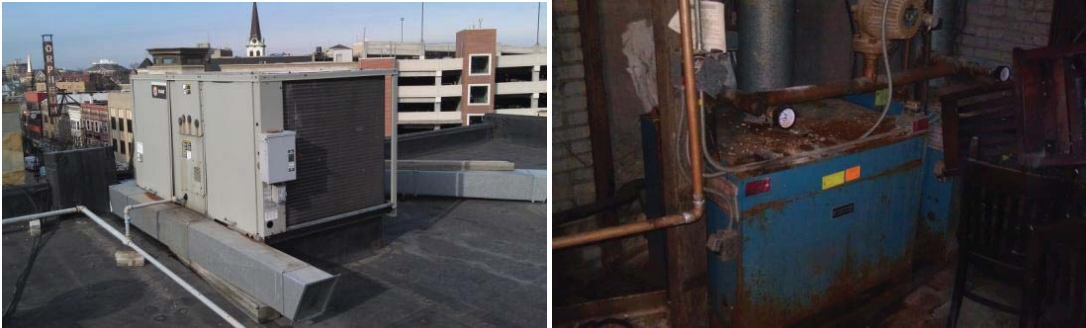
Basement Boilers

The boilers are estimated to be 25-30 years old and are in poor condition. Some of the hot water piping is new but it is expected that most is original. Some may contain asbestos insulation. It appears that piping that was replaced was due to repairs and/or equipment replacements.

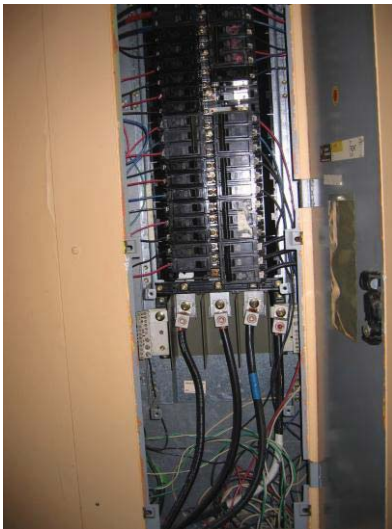
The branch panel on the 2nd floor was missing the interior trim cover, resulting in exposed wiring terminations when the panel front was opened. Since the current condition is a potential safety hazard the building manager brought this deficiency to the attention of the restaurant manager to replace the trim cover that was removed.

Electrical panel on 2nd floor restaurant missing interior trim cover.
