## Structural Conditions

## KJWW Draft Condition Assessment Report

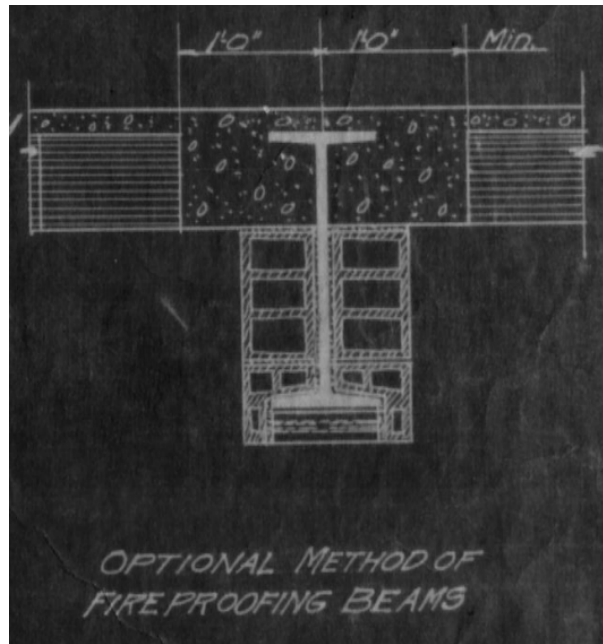
The existing drawings note that the concrete around the steel framing is for fireproofing. An alternate fireproofing detail is shown, using clay tile block, which indicates the steel and concrete were likely not designed to work together as a composite section.

Alternate Fire Proofing Detail from Existing Drawings

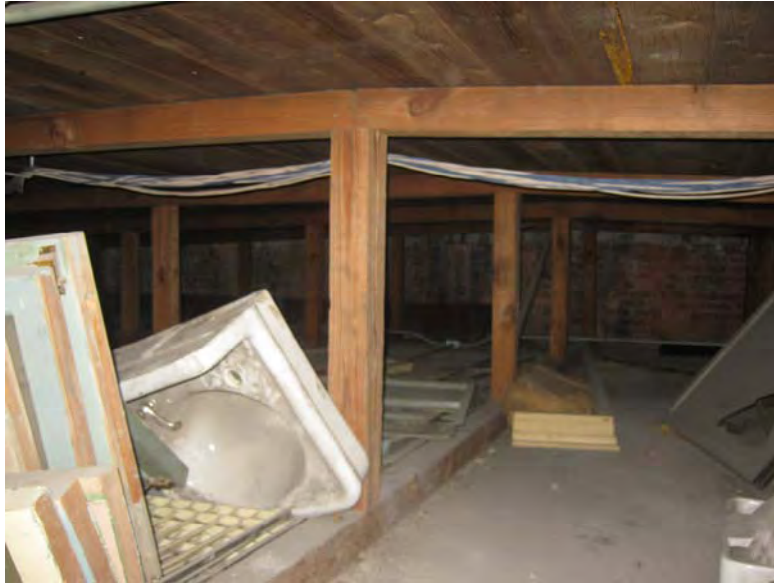
At the high roof and low roof on second floor, there is a pitched wood post and beam roof system built-up on top of the existing concrete slab.

**Underside of Pitched Wood Roof Framing**

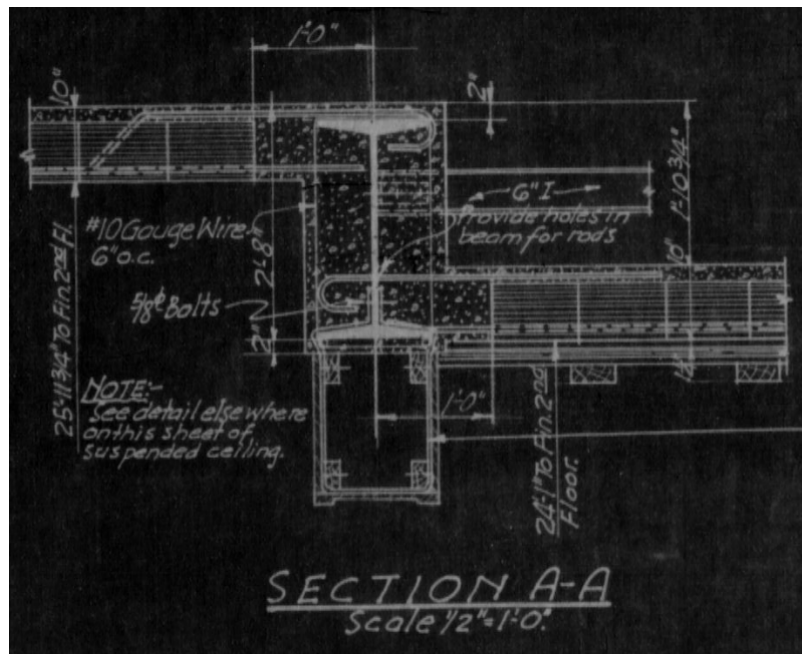
The old court room on second floor is a two story space. There is an opening in the third floor slab for this space and the existing drawings indicate the roof slab is recessed  $1'-10\frac{3}{4}"$ .

**Recessed Roof Slab at Court Room from Existing Drawings**

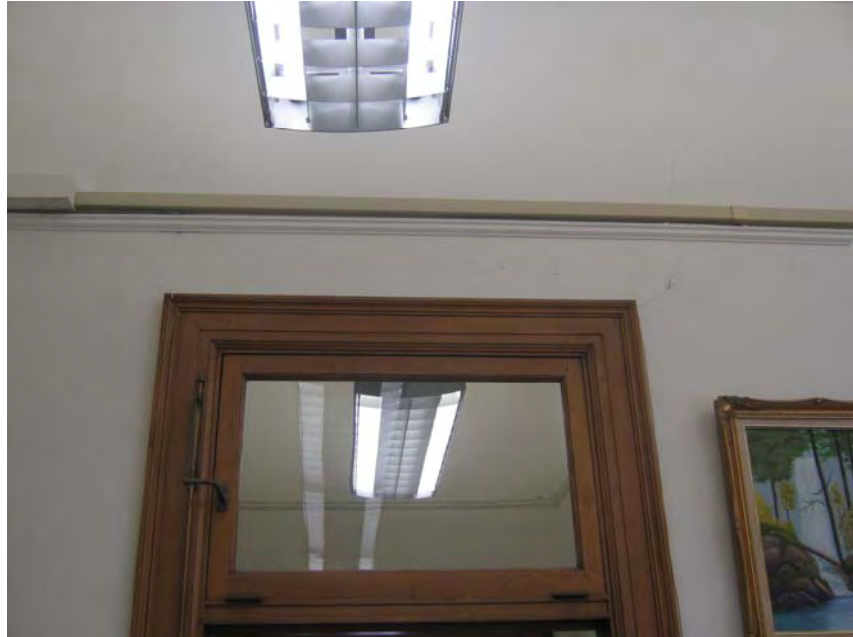
Plaster cracking was observed at the upper corners of multiple doors on third floor. This is to be expected given the age of the building and the flexible nature of the steel beam support girders.

**Plaster Cracking at Corners of Third Floor Door**

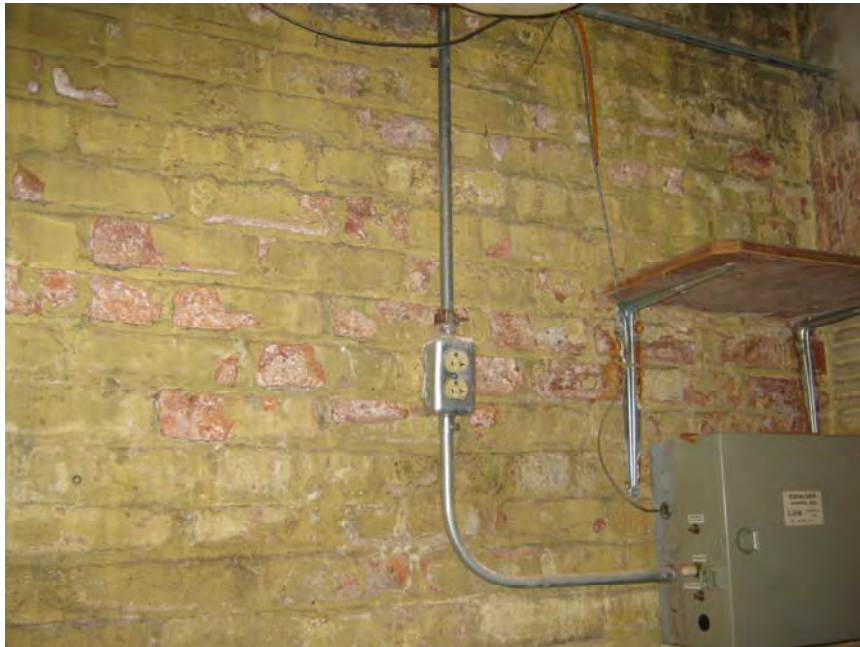
Where visible, the exterior basement walls appear to be multi-wythe brick walls. At the water service room in the west corner of the building, there is evidence of water damage to the existing brick. The paint is delaminating and portions of the brick faces have popped off.

**Existing Brick Basement Wall Water Damage**
