700 E Johnson Project – Demolition Report

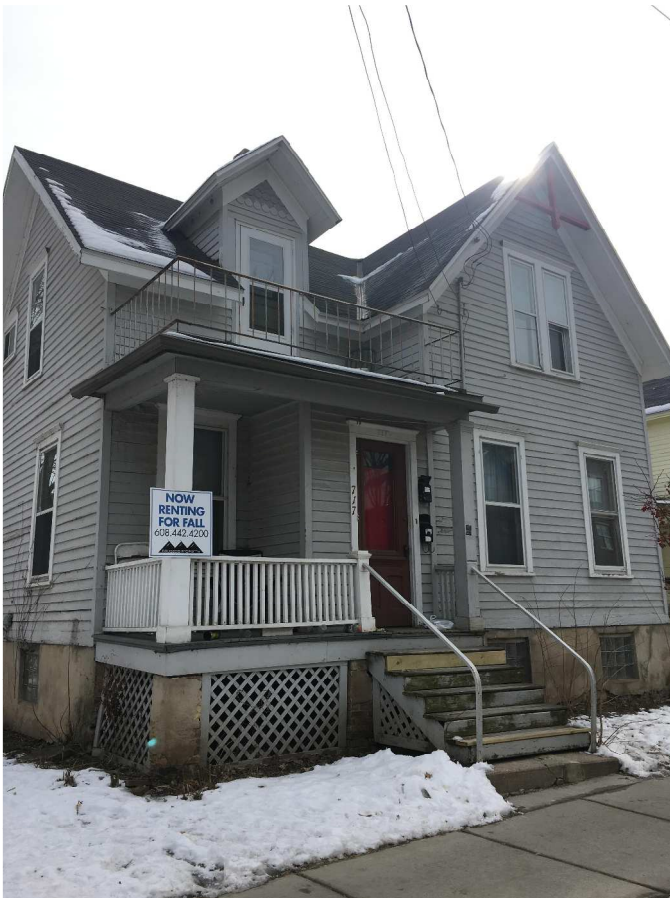
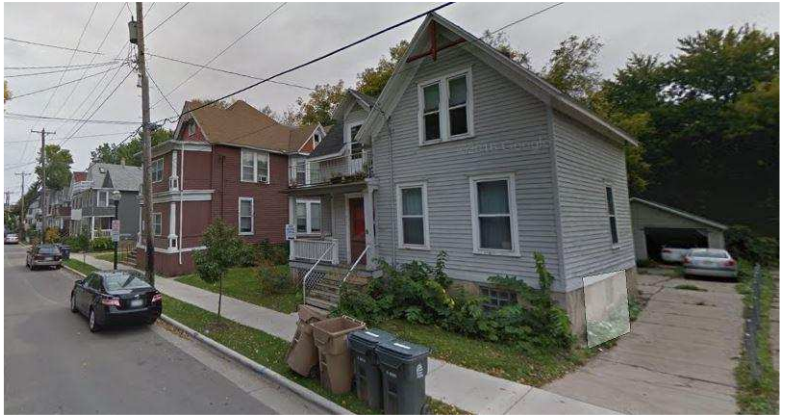
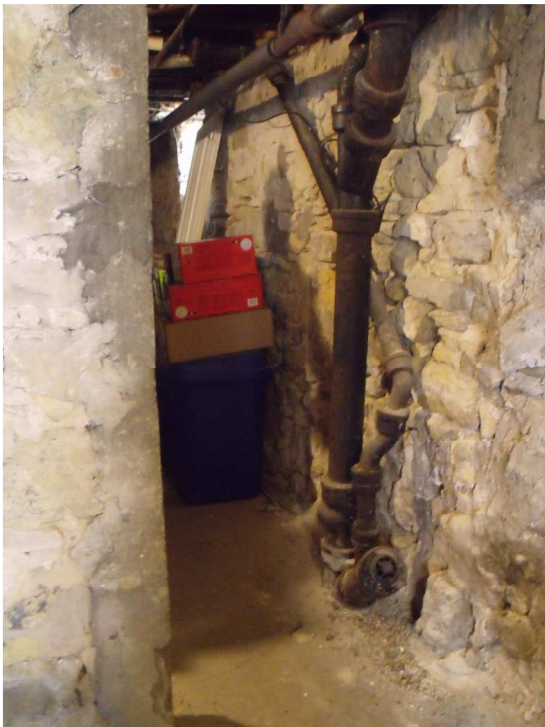
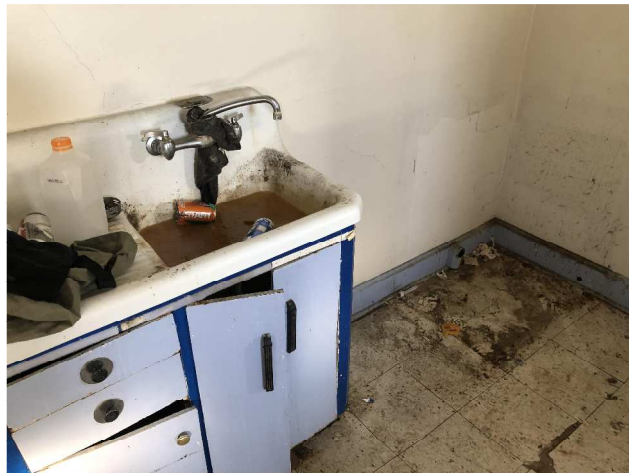
717 E Johnson St - Demolition

- Roofing nearing the end of its life.
- Siding was not properly maintained allowing water infiltration to structure.
- Inefficient windows and doors in poor condition.
- Balloon frame construction with little to no insulation.
- Knob and tube wiring throughout the structure.
- Brittle plumbing drain lines and original galvanized water service lines.
- Heating system in poor condition.
- Foundation walls have settled making floors unlevel.
- Vagrants have broken into the house multiple times destroying the finished condition of the interior.

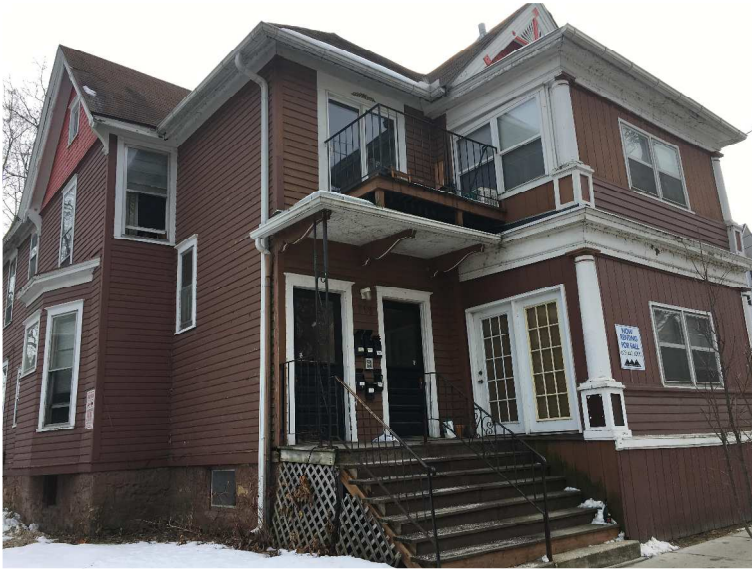
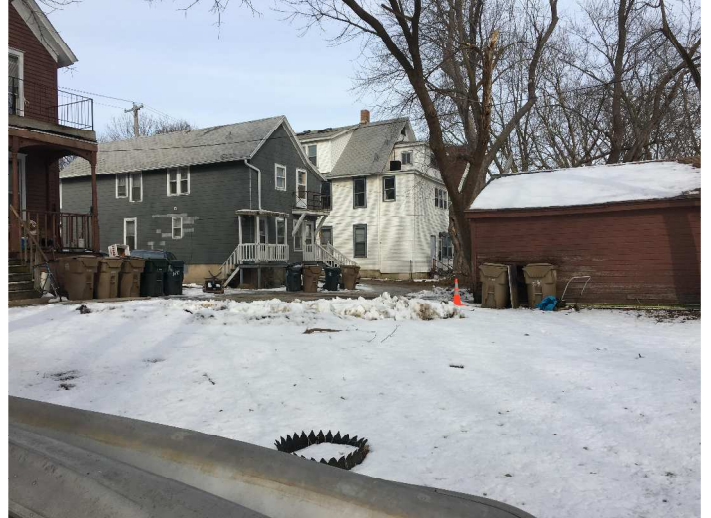
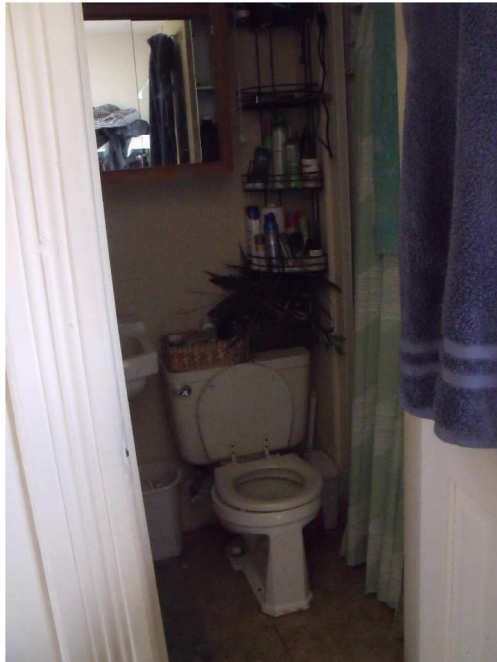
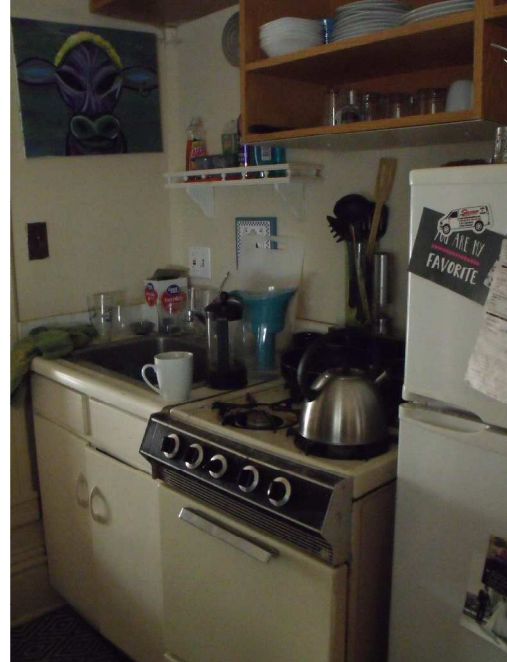
719 E Johnson St - Demolition

- Roofing nearing the end of its life.
- Majority of the siding is rotten allowing water infiltration to the structure.
- Inefficient windows and doors in poor condition.
- Balloon frame construction with little to no insulation.
- Knob and tube wiring throughout the structure.
- Brittle drain lines and original galvanized water service lines.
- Heating system in poor condition.
- Foundation walls in very poor condition.
- Areas of the foundation have settled making doors and windows unsafe to use.
- Vagrants have broken into the house multiple times destroying the finished condition of the interior.

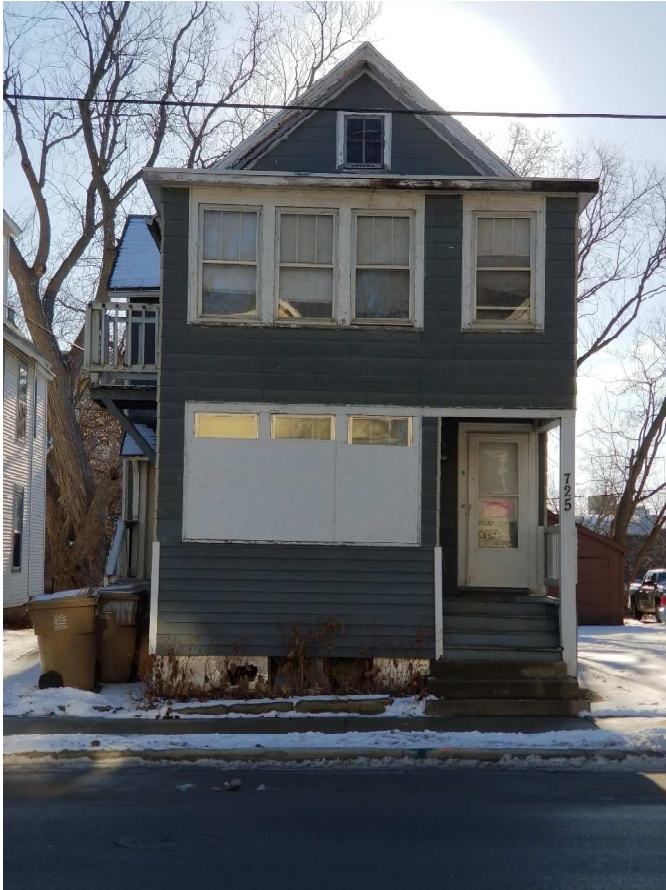
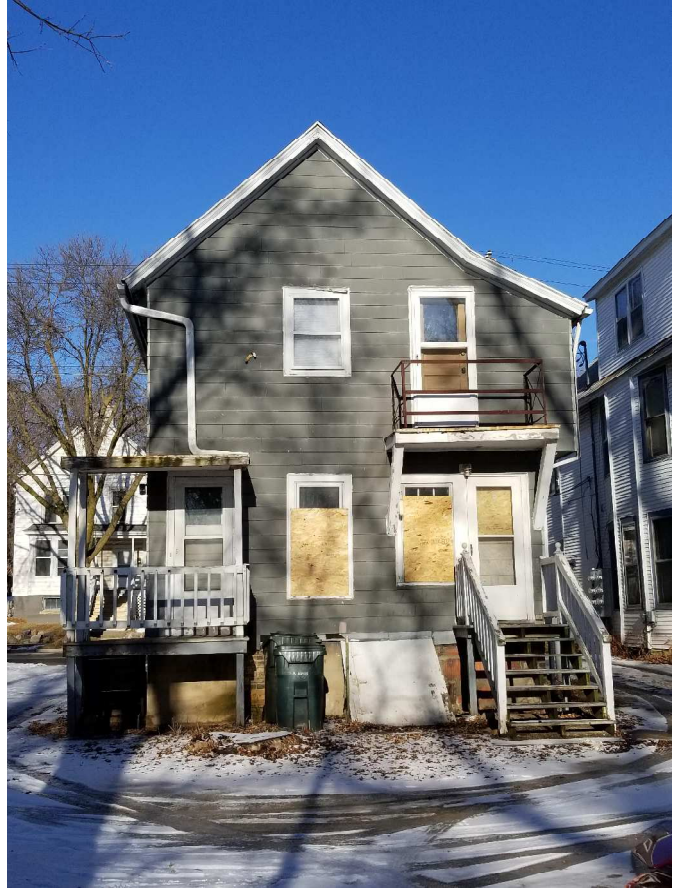
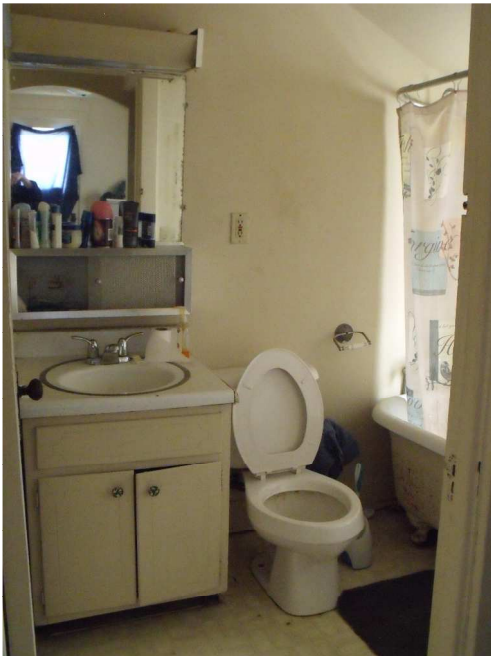
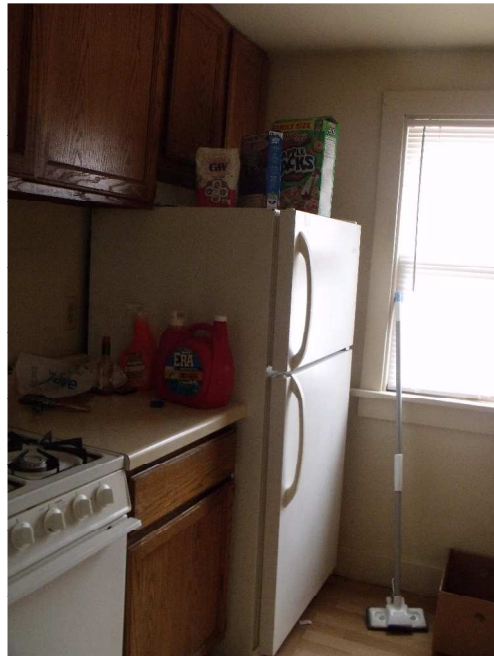
725 E Johnson Street - Relocation to 827 E Gorham Street

- Roofing nearing the end of its life.
- Siding needs repair.
- Rear porches unsafe.
- Inefficient windows and doors in poor condition.
- Balloon frame construction with little to no insulation.
- Knob and tube wiring throughout the structure.
- Original character removed when units were updated in the 1970-1980s.
- Heating system inoperable.
- Entire structure is leaning to one side out of plumb.

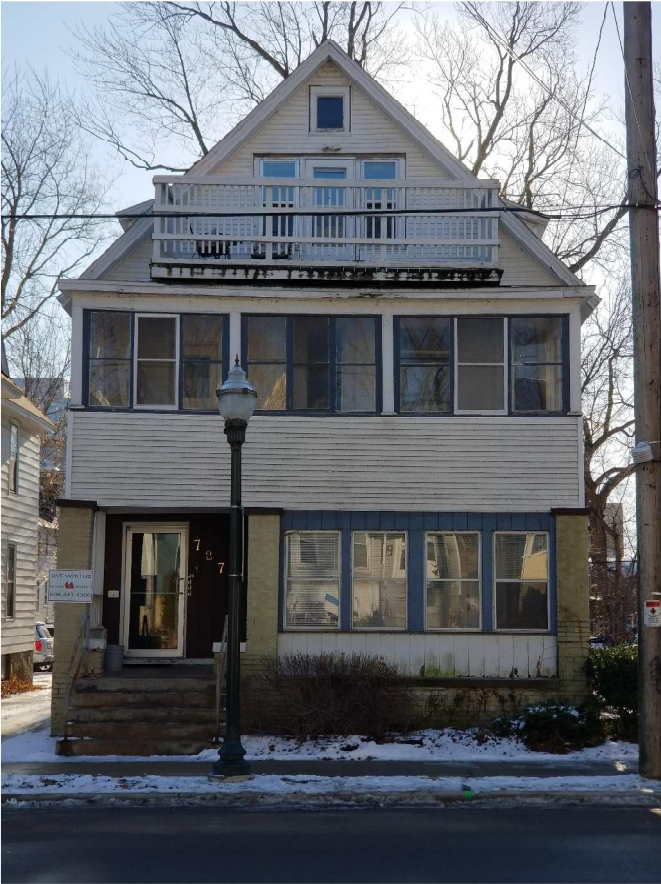
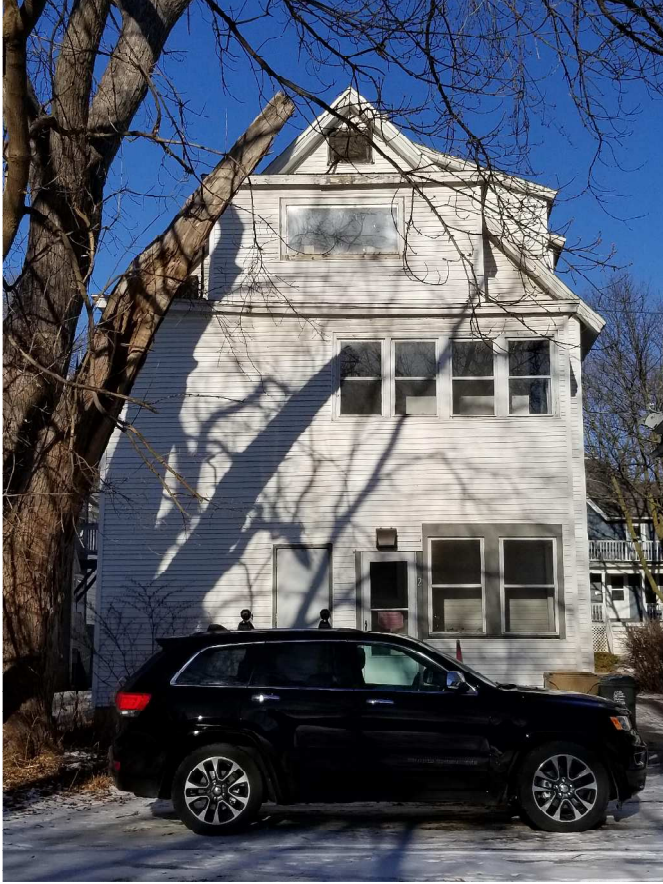
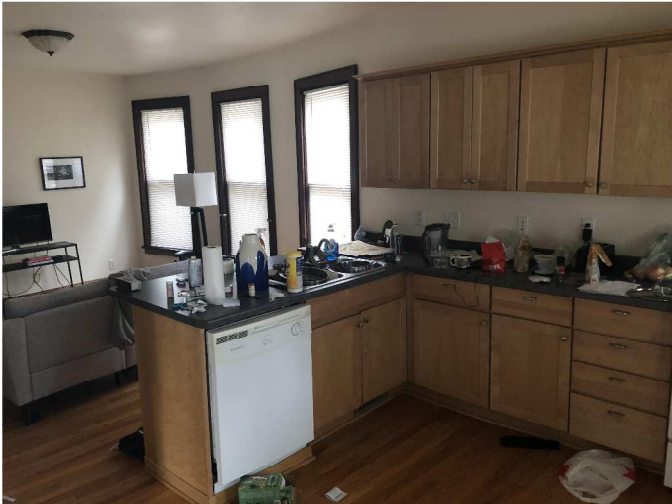
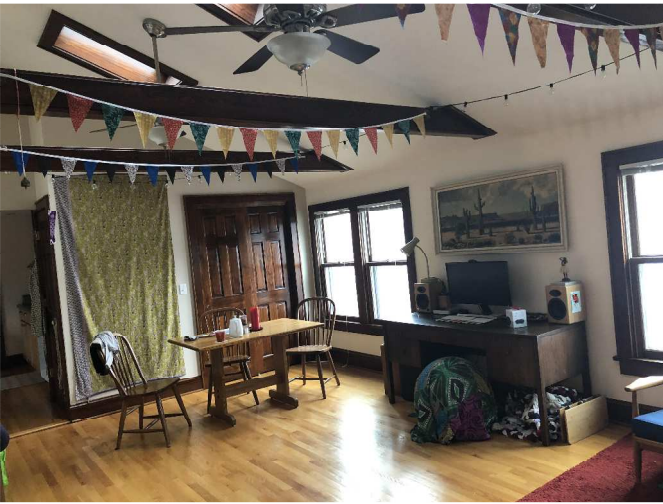
727 E Johnson Street - Relocation between 745 E Johnson St and 753 E Johnson St

- First floor and top floor units have man updates including kitchens, bathrooms, flooring.
- Queen Anne architectural finishes in all units have been maintained.
- Updated siding has preserved the structural integrity of the building.

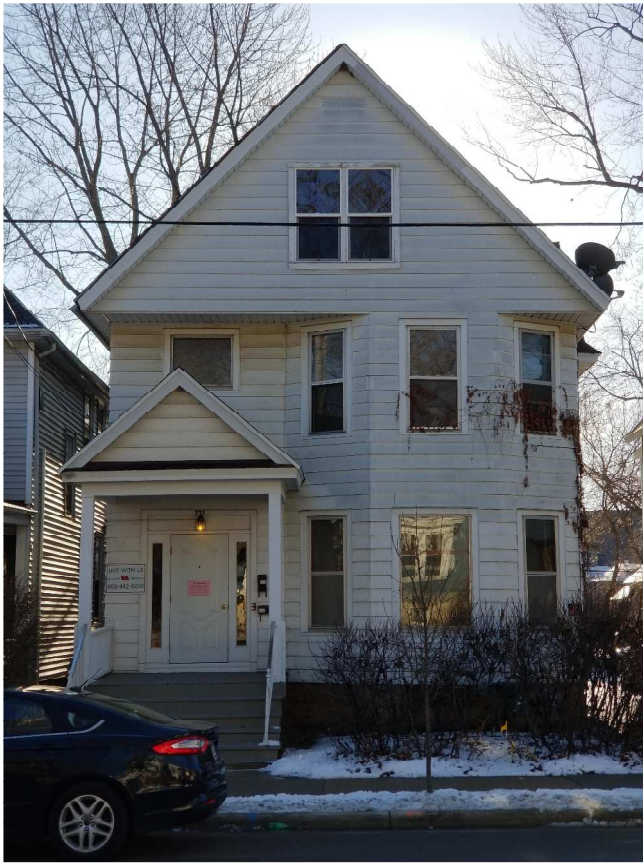
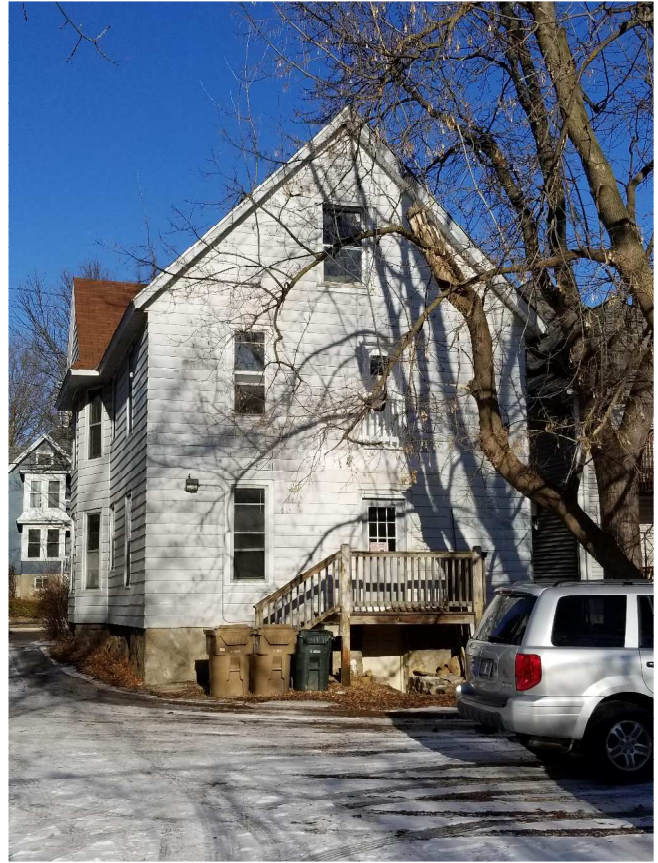
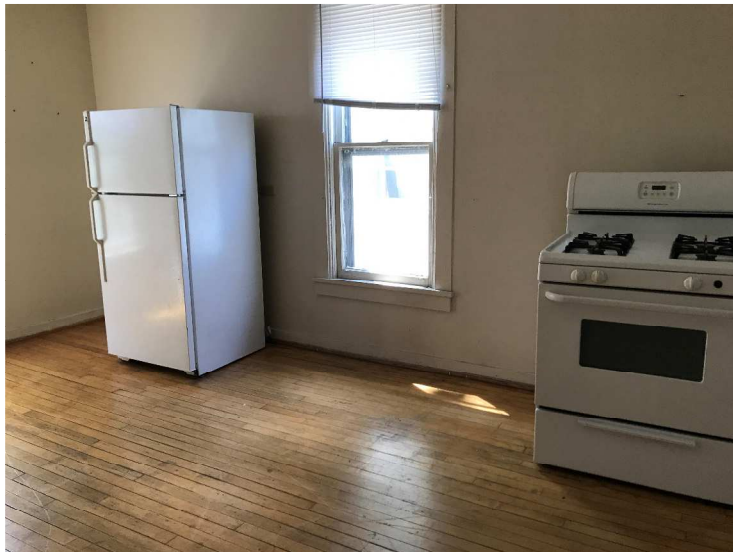
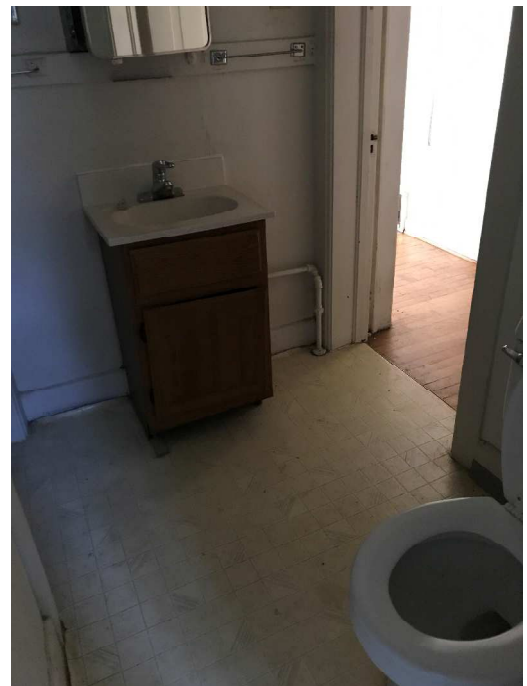
731 E Johnson Street - Demolition

- Roofing nearing the end of its life.
- Rear porch removed due to unsafe conditions.
- Inefficient windows and doors in poor condition.
- Balloon Frame construction with little to no insulation.
- Knob and tube wiring throughout.
- Heating system in poor condition.

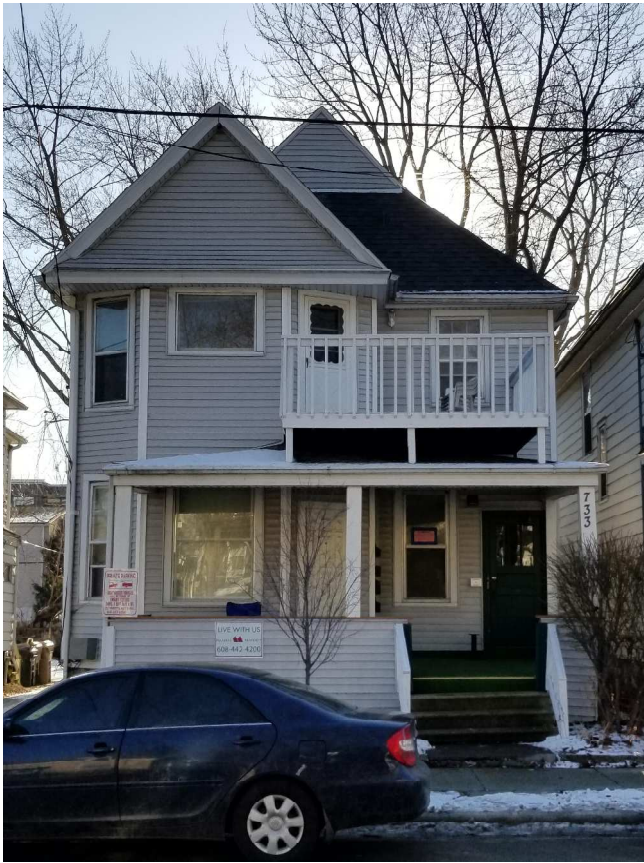
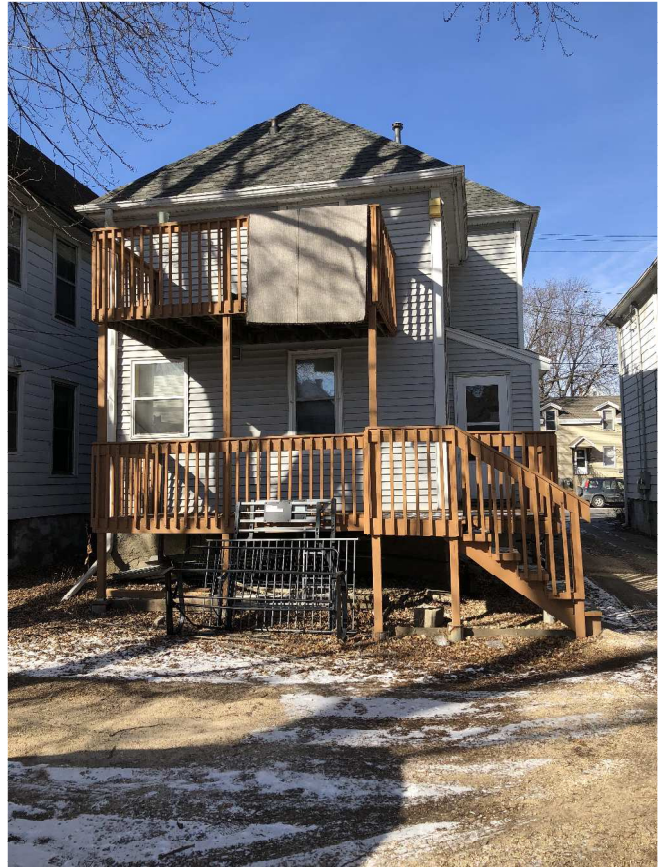
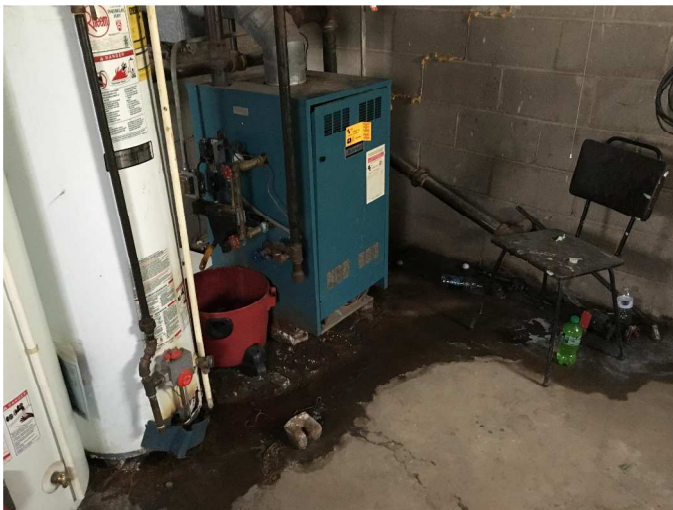
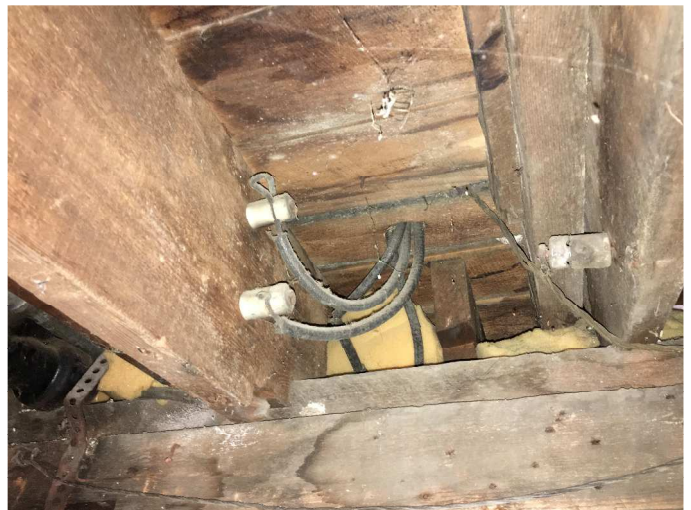
733 E Johnson Street - Demolition

- Roofing nearing the end of its life.
- Vinyl siding was not installed properly allowing water infiltration to the structure.
- Inefficient windows and doors in poor condition.
- Balloon frame construction with little to no insulation.
- Knob and tube wiring throughout.
- Brittle plumbing drain lines and original galvanized water service lines.
- Original character removed from exterior when siding was replaced.
- Interior character removed when structure was cut up into 1 bedroom apartments.

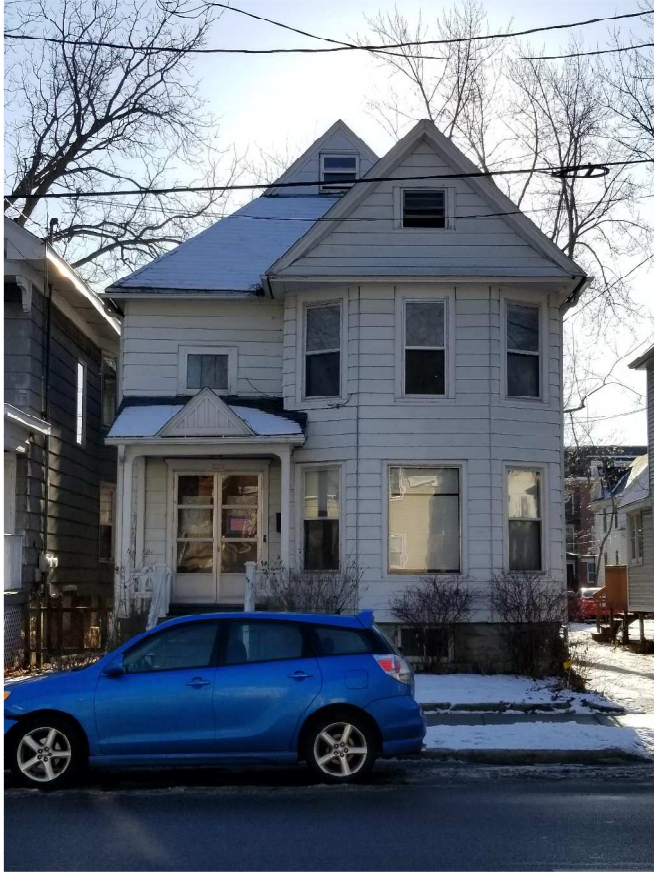
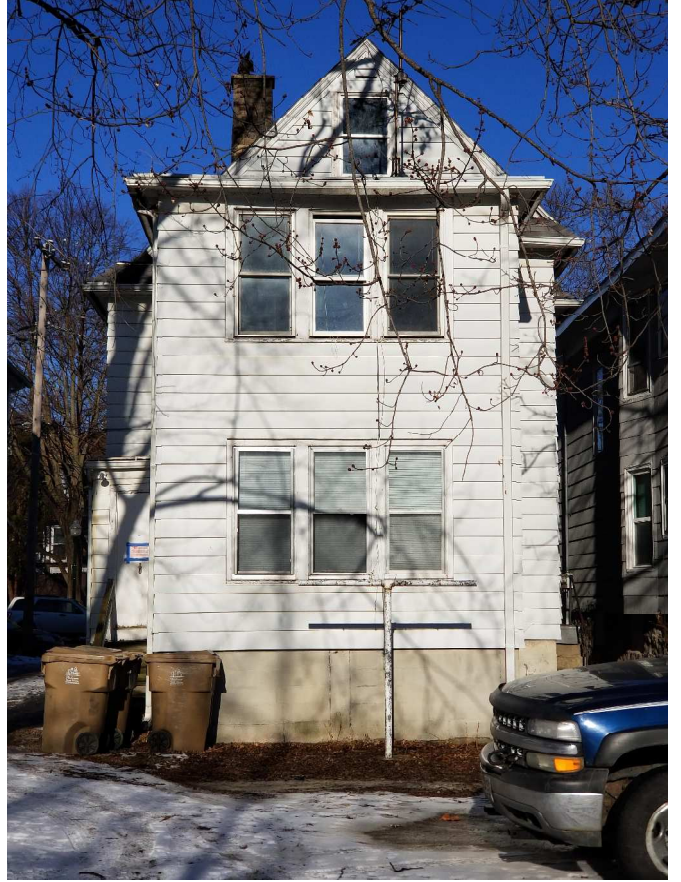
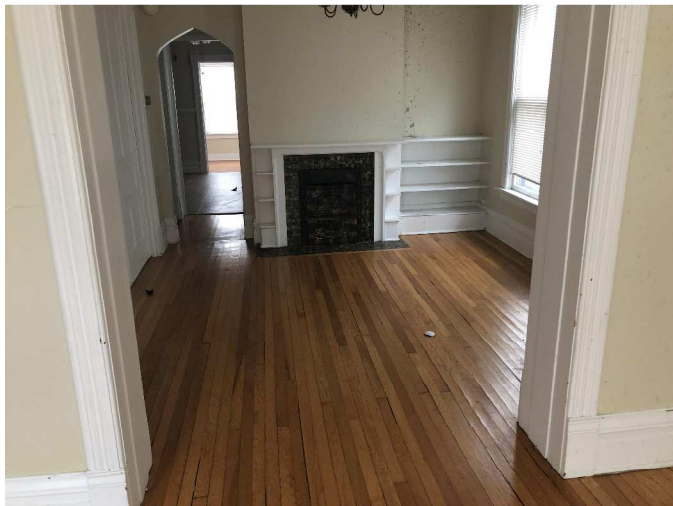
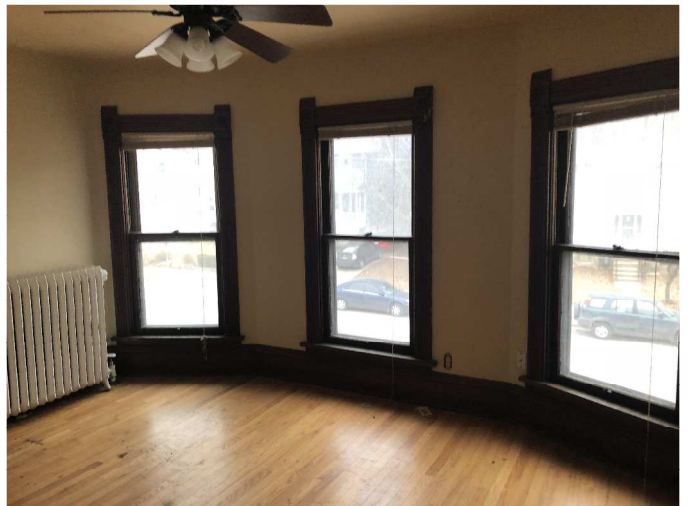
737 E Johnson Street - Relocation to 827 E Gorham Street

- Original Queen Anne Character and finishes have been preserved.
- Updated siding has preserved the structural integrity of the building.
