March 7, 2018

3014 Worthington Avenue
Madison, Wisconsin 53714
Parcel No. 071005211017

BUILDING CONDITION REPORT

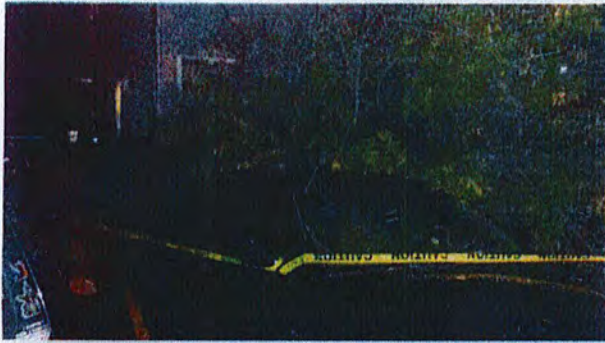
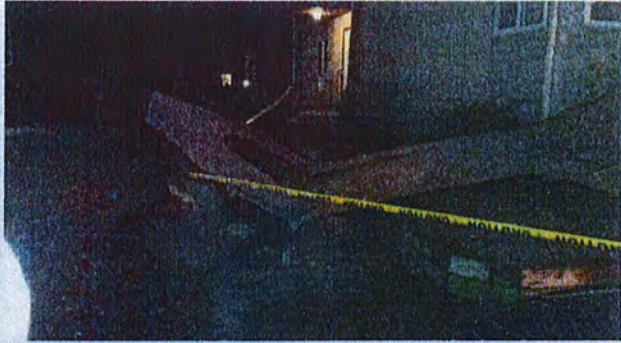
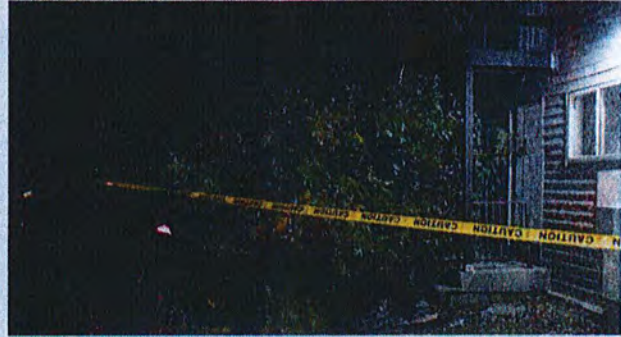
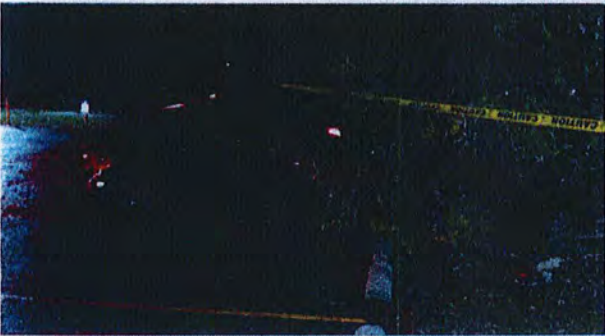
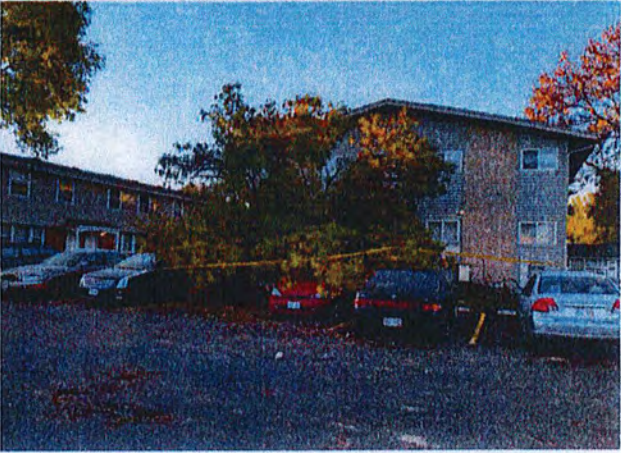
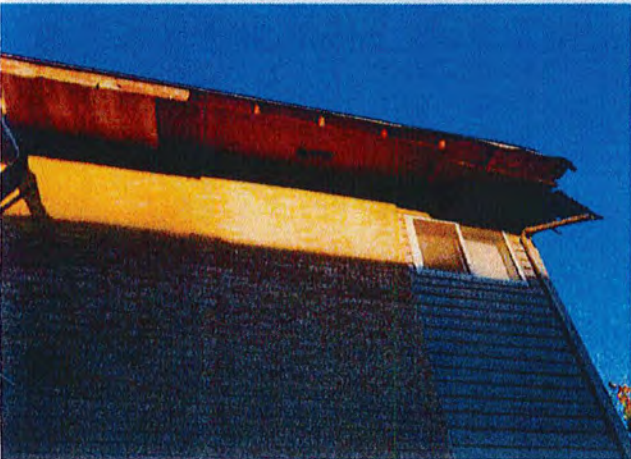
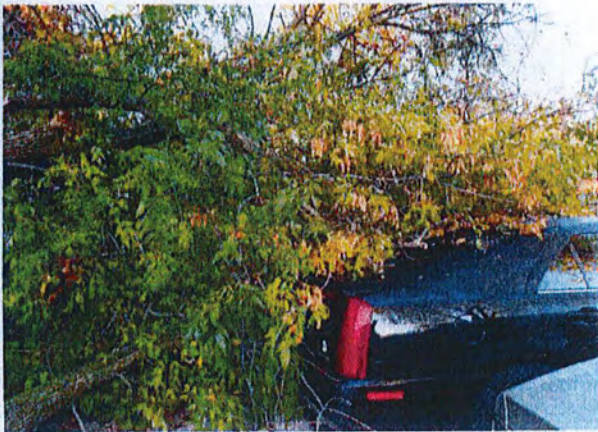
Porchlight tornado damage October 7, 2017:
