# THE REHABILITATION APPROACH

The rehabilitation of the Edgewater will be undertaken according to the Secretary of the Interior Standards and Guidelines for Rehabilitating Historic Buildings. The specific recommendations which are being applied in this restoration are described as they relate to the sections into which the Standards are divided.

## MASONRY: BRICK AND TERRA COTTA AT THE EDGEWATER

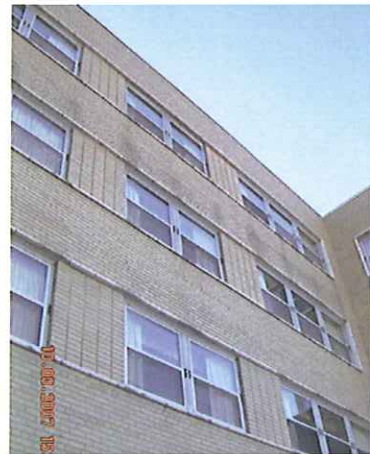
#### Detail area showing required cleaning

Intent: It is the specific intent of this Section to provide for removal of stains from masonry surfaces in order to produce uniformly clean surfaces without blotches, streaks, runs, overly cleaned areas, or any other kind of spotty or uneven appearance and without damaging or deteriorating underlying materials.

1. Cleaning of 100% brick and terra cotta masonry.
  - a. Remove general soiling, efflorescence, biological growth, and staining from masonry using approved chemical stain removers and pressurized water rinsing.
  - b. Remove rust stains from masonry using approved chemical stain removers and pressurized water rinsing. Poulticing with approved chemical stain removers may be necessary to remove heavy staining.
  - c. Remove dripped mortar, sealant drips, and paint from previous repointing and repairs using mechanical scraping or chemical strippers and water rinsing.
2. All masonry cleaning shall be completed prior to repointing the building and masonry restoration.

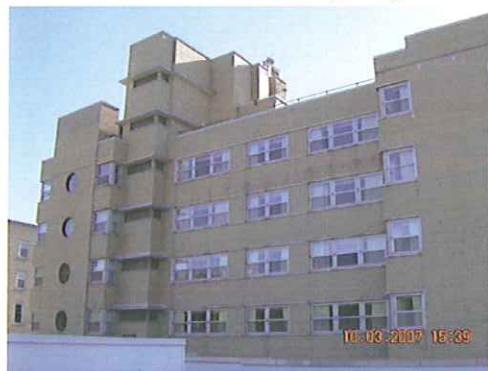
#### Overall east elevation with consistent masonry staining

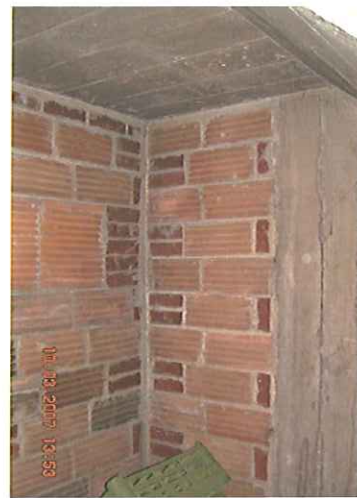
### Existing masonry walls without interior finishes

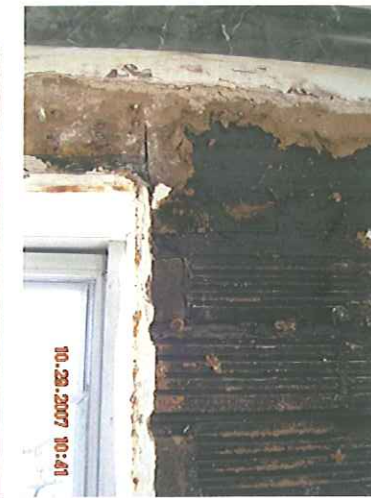
### Existing masonry walls with damaged interior finishes

Photographs indicate how areas of the wall with interior finishes have trapped migrating moisture and have created both rot and mold conditions. Once that all existing interior finishes have been removed, the masonry substrate will be cleaned and prepared for a new insulation barrier that creates a seamless, monolithic protection against water and air infiltration. New interior metal stud framing will help control the continuous depth of insulation and will provide the support for all new interior wall finishes.

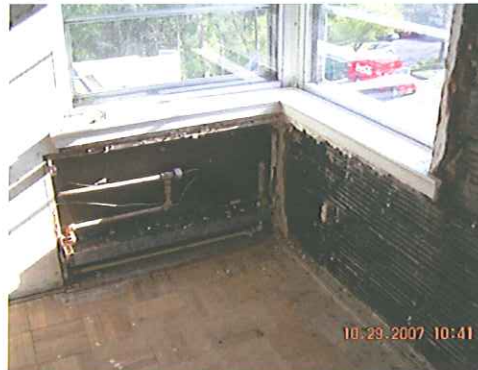
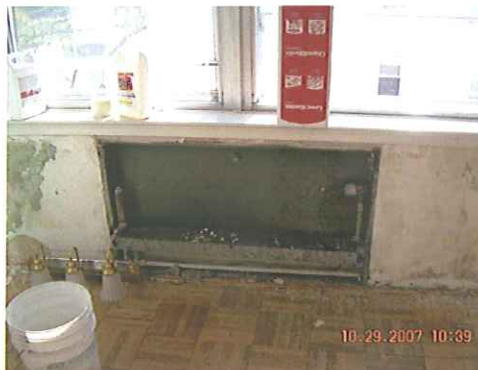
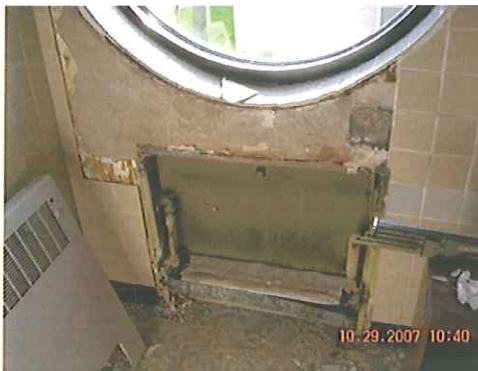
### Existing masonry walls damaged by moisture penetration and compromised by mechanical installation

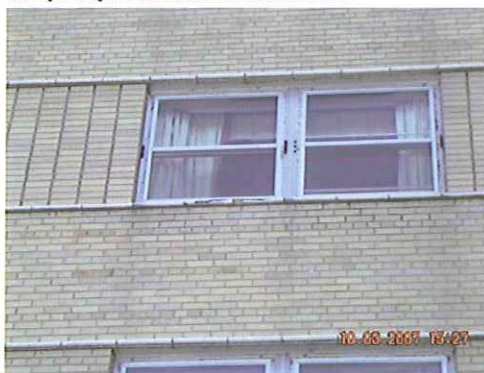
### Example of spalled terra cotta at window sill trim

1. Injecting epoxy adhesive into cracks in terra cotta units.
2. Routing and grouting cracks in terra cotta units to match adjacent surface.
3. Patching terra cotta spalls with composite patching material and coating patches with breathable acrylic coating to match adjacent cleaned surface.
4. Coating glaze spalls with breathable acrylic coating to match adjacent cleaned surface.
5. Cleaning terra cotta masonry surface in accordance with the provisions in Section 04 01 30.91.
6. Pointing open joints in terra cotta.

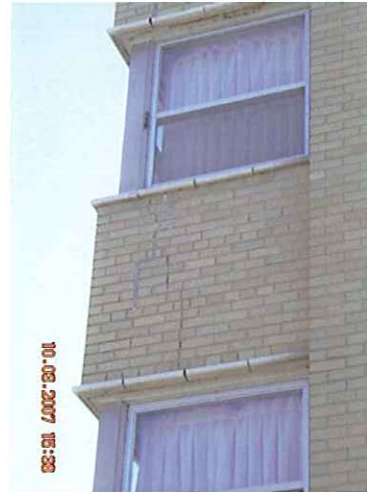
Example of cracking masonry caused by wall compromising existing mechanical installations

1. Repair brick masonry with continuous cracks running through three (3) or fewer courses by routing out cracks and filling cracks with custom-colored composite patching mortar to match adjacent surface.
2. Repair brick masonry with continuous cracks running through four (4) or more courses by removing cracked brick and replacing them with new brick to match adjacent original bricks.
3. Replacement of eroded, spalled, previously patched, broken, mismatched and missing bricks with a mix of salvaged and new bricks to match original bricks in color, texture, and profile.

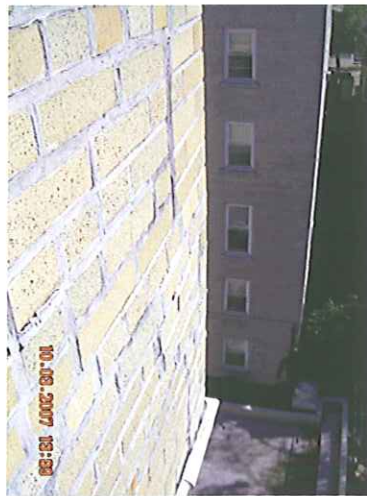
Example of brick crack repairs using sealants, now hardened over time

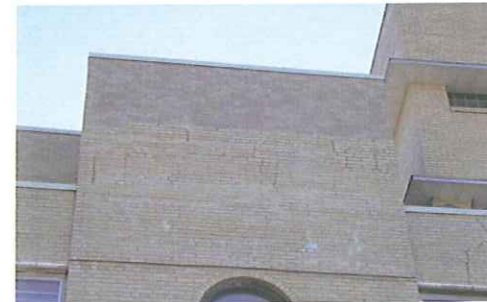
This approach will be significant where the building parapets are concerned. The existing parapets have continued to be source of water penetration into the entire exterior masonry system.

Significant continuous cracking in the facade immediately below roof parapets may require parapet replacement. Additionally, we should be able to improve the matching of the original brick masonry.

### Example of parapet areas requiring masonry replacement

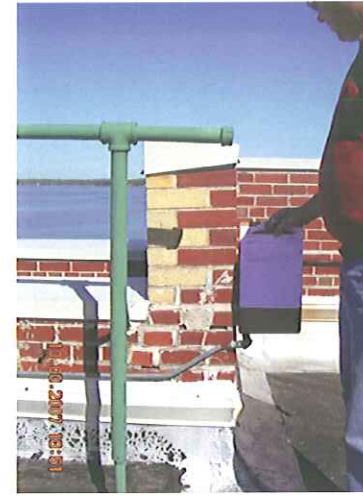
Example of parapet where masonry and roofing installation allow water penetration

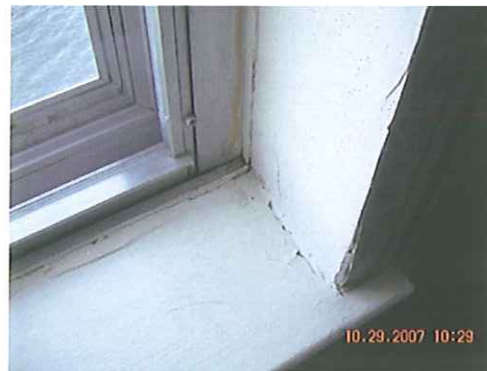
Existing interior window profile with typical adjacent jamb and sill deterioration

A survey of the window systems at the Edgewater reveal that the windows and the glazing at the Edgewater cannot be successfully be repaired and that *Replacement in Kind* is required.

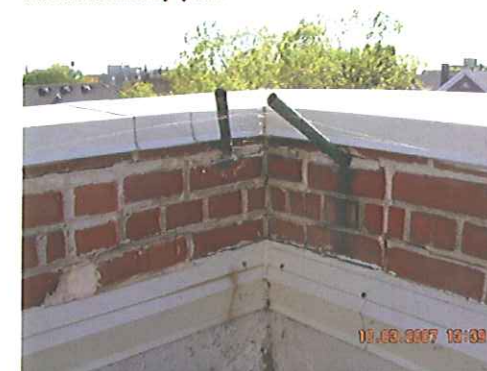
The Standards that do apply relate to the Protection and Maintenance of Exterior Masonry. This is particularly true at building parapets where the exposed masonry face does not protect water from entering the entire exterior masonry wall system.

Existing roofing termination which promotes water infiltration into the exterior masonry system

New roofing systems will be installed to meet current energy efficiency standards. New rigid insulation will be provided per code requirements and the roof surface will have a high light reflectance value to meet environmental standards.

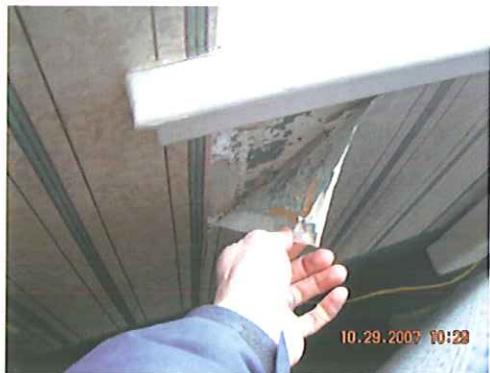
Existing damage at interior sills due to water migration through window frames

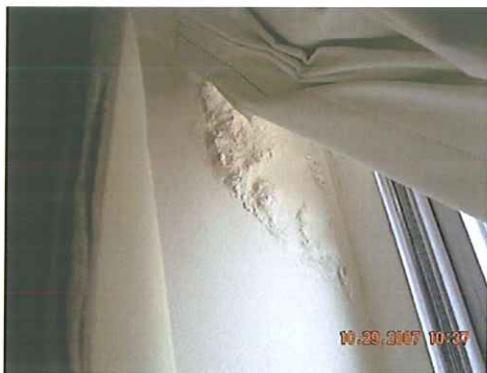
Existing damage at interior jambs due to water migration through window frames

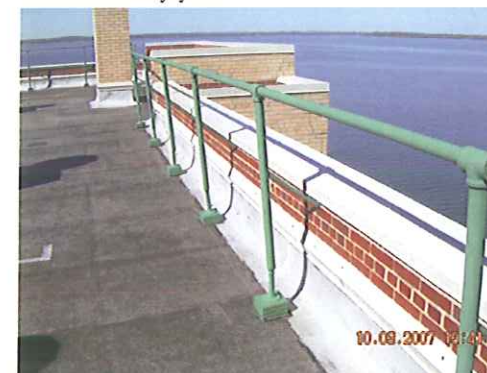
Existing roofing termination which promotes water infiltration into the exterior masonry system
