935 W. Johnson, Madison WI

Architecture and History Inventory (AHI) No. 106263

Photo documentation and construction details

April 7, 2020

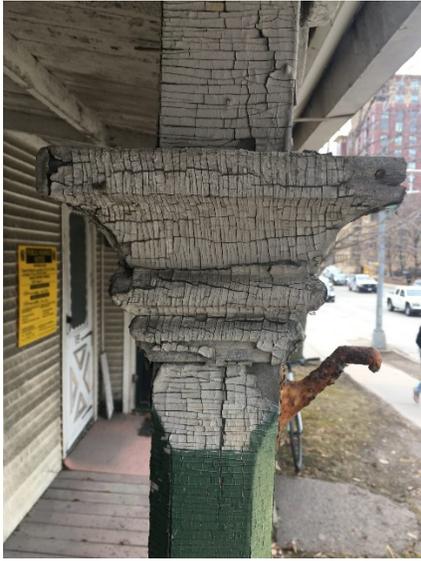
Front porch posts: Two central wood posts have multiple layers of heavy peeling paint, suggesting that they may date to early construction. Simple capitals on the posts may be the only significant architectural exterior ornamentation extant. All other exterior surfaces are covered in vinyl siding.

Fig 3: Porch column detail

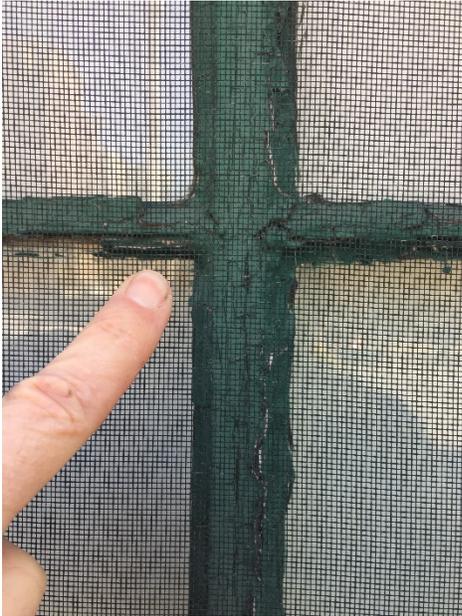
Exterior windows: All exterior windows are double-hung single glaze, with a 4 over 4 muntin configuration. The vertical muntin is wider than the horizontal muntin in all exterior windows—suggesting that perhaps a whole-house window replacement has occurred.

Fig. 11: Muntin detail on window, showing wider vertical member.

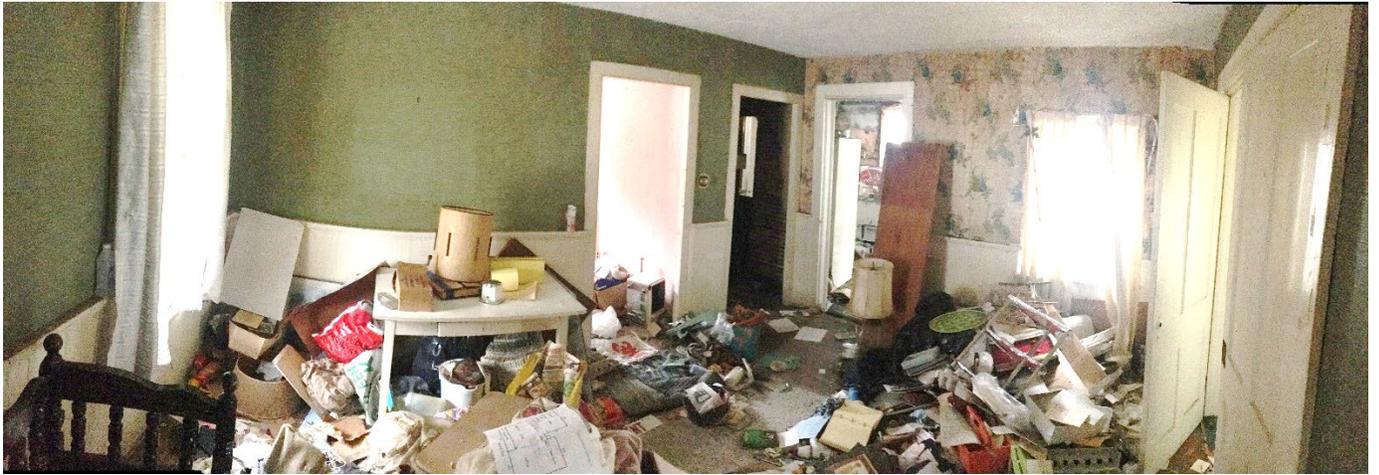
Interior surface treatments: Ceiling in LR is a heavy textured plaster. Kitchen originally had plaster lath, followed by wall paper and then covered by embossed tin. Living room area has half wall painted wainscoting.

Fig 13 : Interior panoramic view, living room. Bedroom door is left center. Kitchen door is right-center. Bathroom door is to right. Half wall wainscoting.

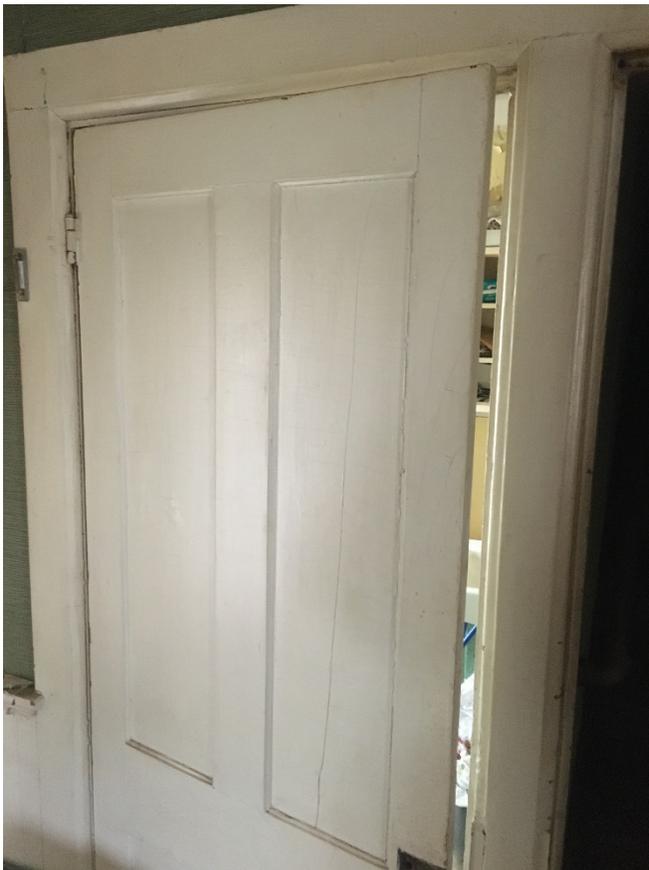
Interior doors: Approx. 5 painted doors extant (all are 4-recessed panel). Narrow door thickness (approx. 1.5 in.) All knob hardware has been removed. Door hinges are shorter than current standard.

Fig. 14: Detail of solid, 4-panel interior door and casing, leading to bathroom.

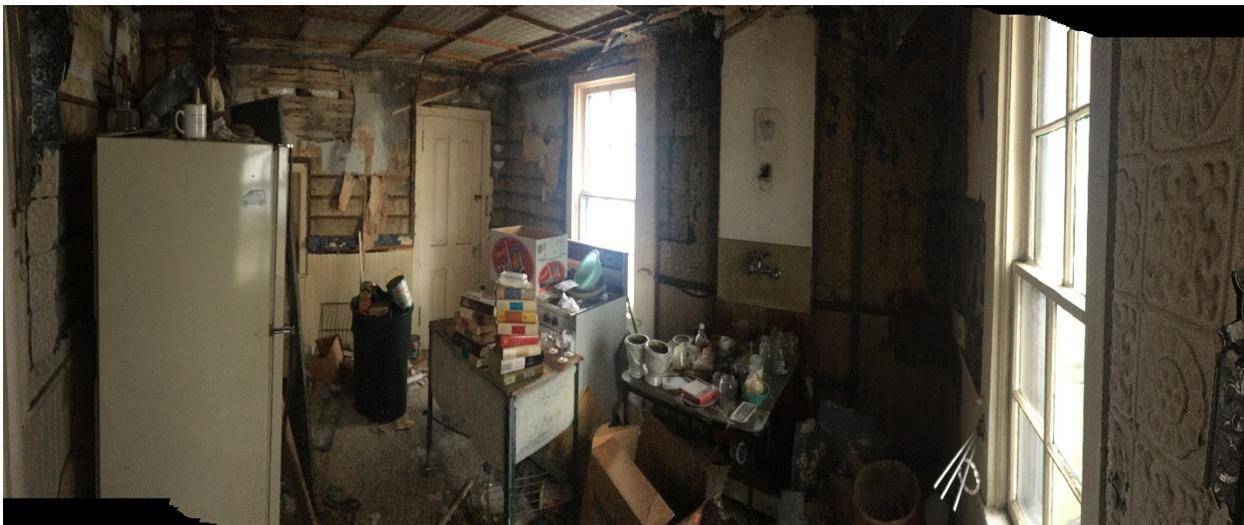
Fig. 16: Interior panoramic view, kitchen. Walls and ceiling formerly covered with embossed tin panels, now mostly removed to expose plaster and wood lath walls.

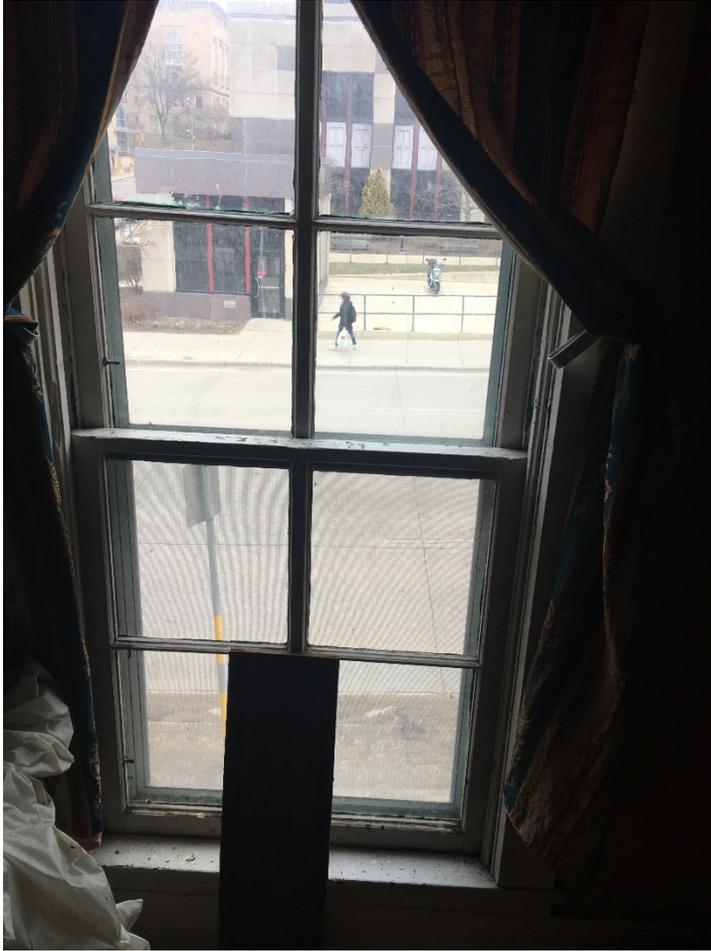
Fig. 17: Interior detail of double hung wood sash window.
