Prepared For

**MIDWEST PROPERTY GROUP, LTD.  
920 NORTH YORK ROAD  
SUITE No. 300  
HINSDALE, ILLINOIS 60521**

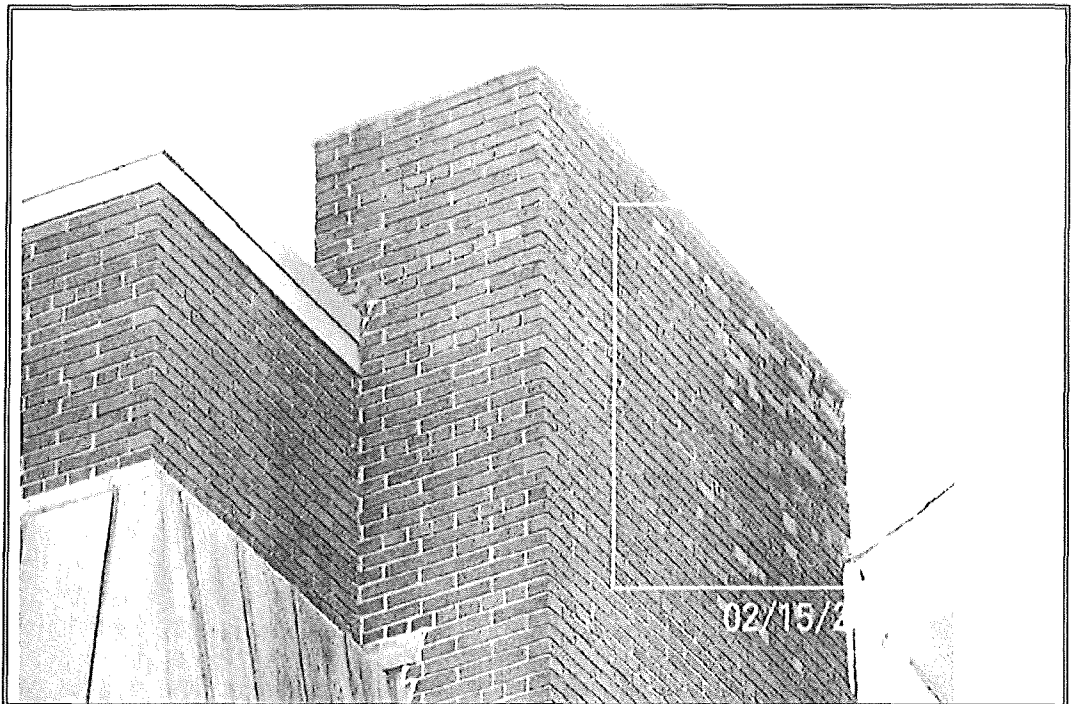
Photograph Number 8: Apparent face brick veneer spalling at the east side chimney.

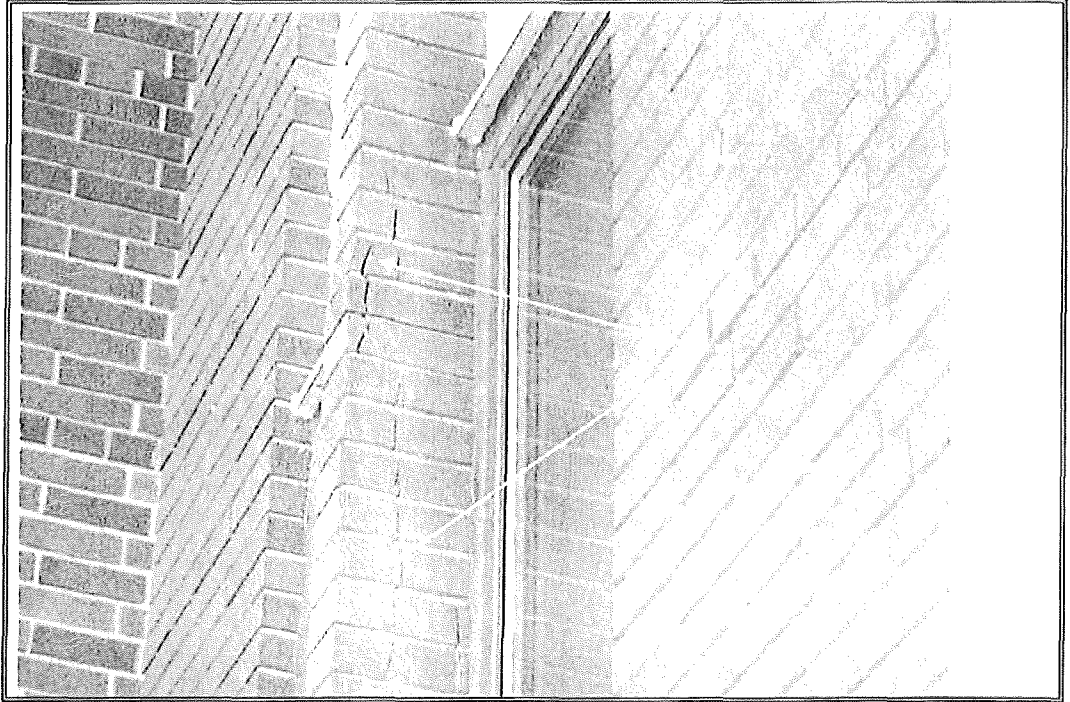
Photograph Number 9: Masonry veneer cracks and spalling.

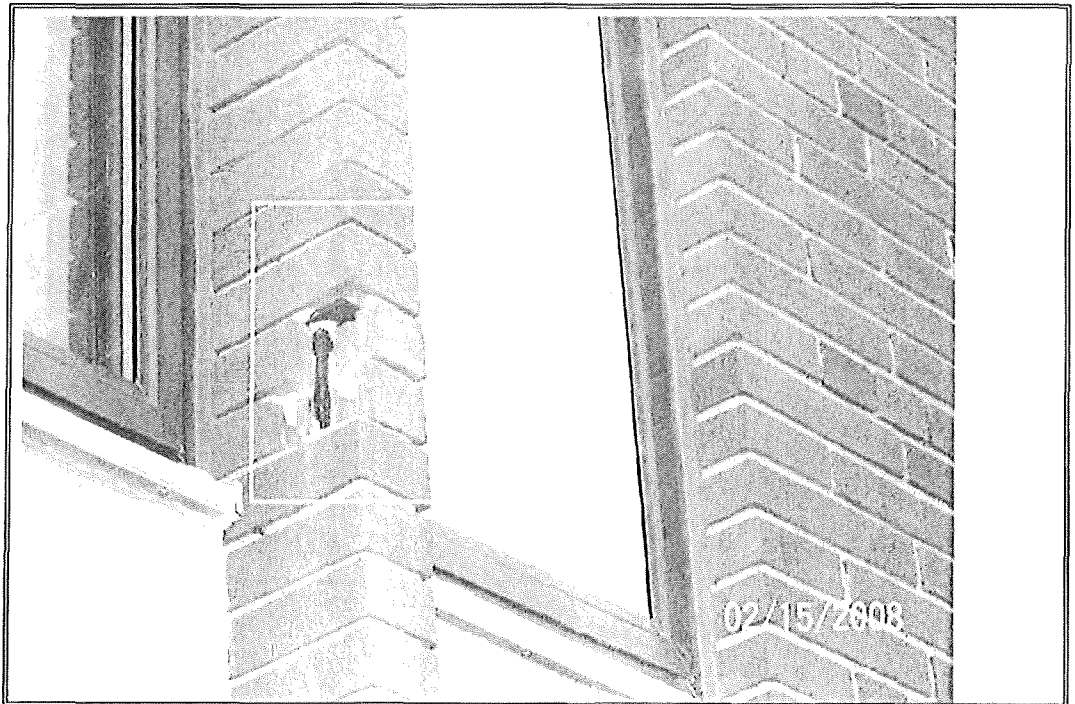
Photograph Number 10: Masonry veneer cracks and spalling.

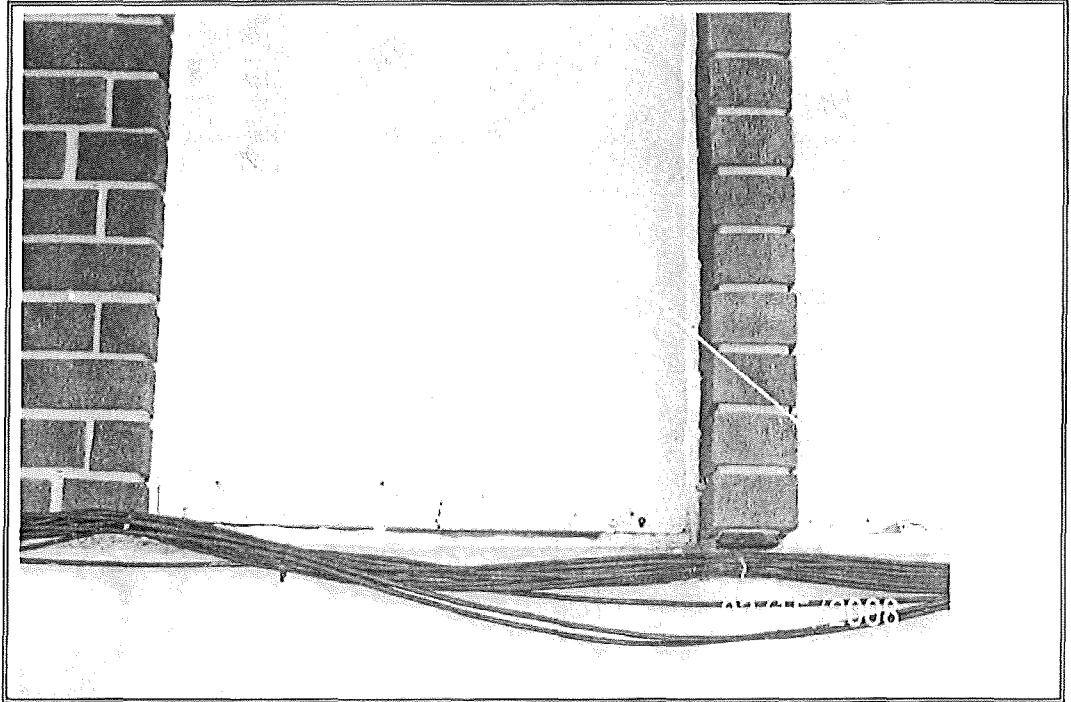
Photograph Number 11: Gaps and / or openings at missing sealants.

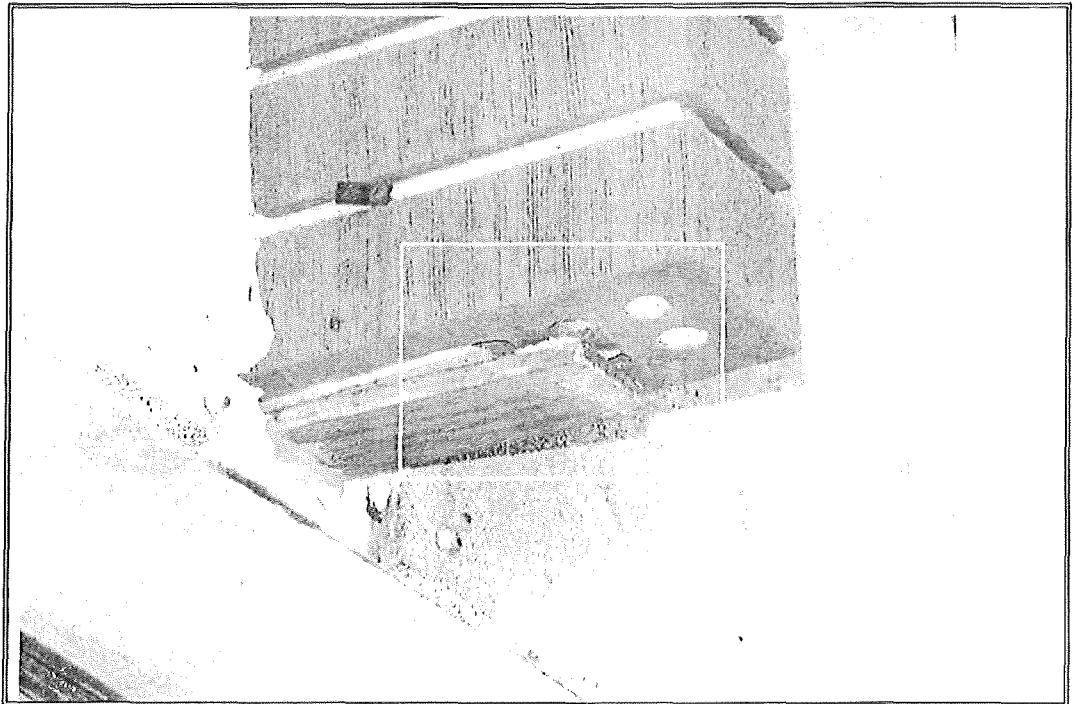
Photograph Number 12: Significant loss of bearing at cantilevered veneer bearing.

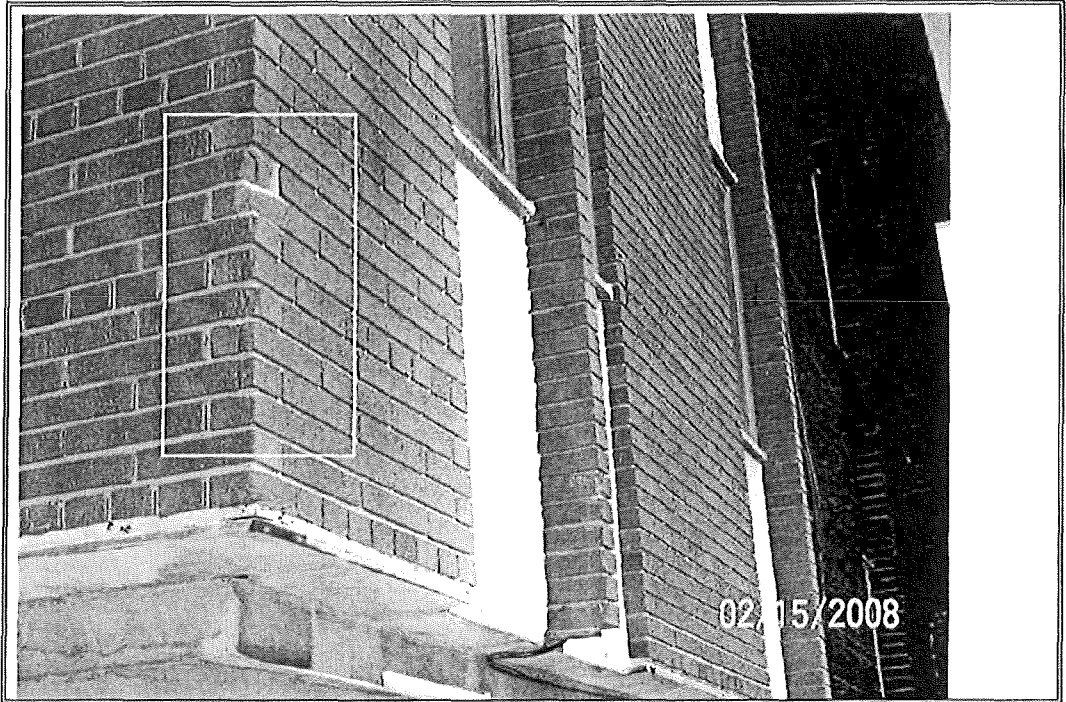
Photograph Number 13: Masonry veneer cracks and spalling.

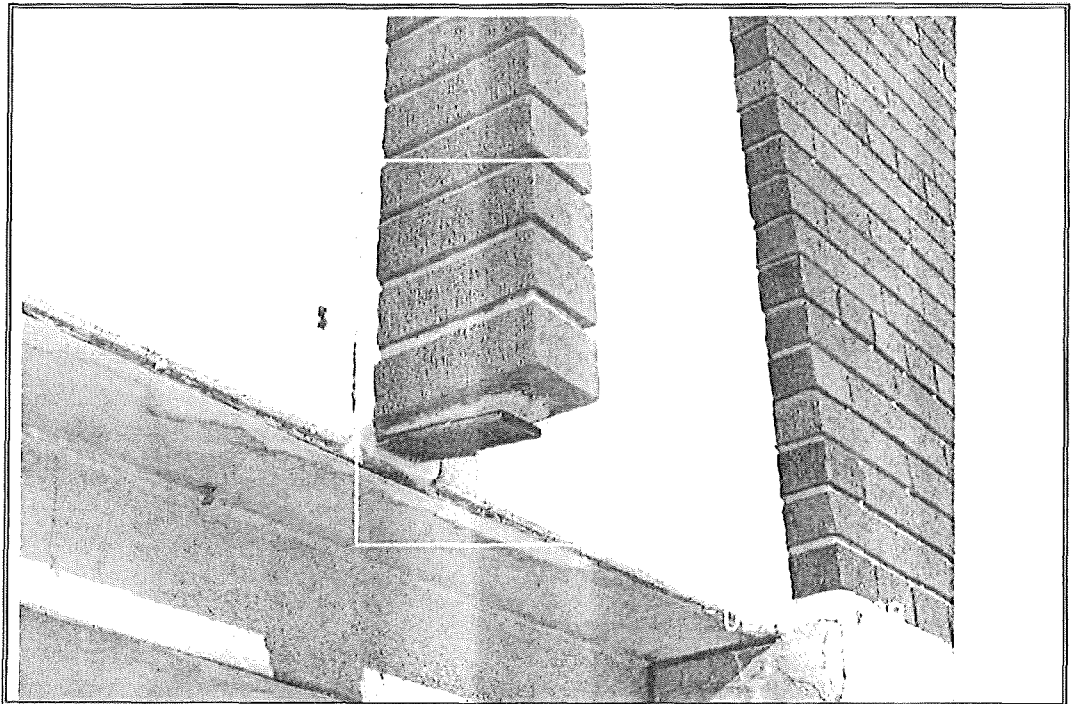
Photograph Number 14: Significant loss of bearing at cantilevered veneer bearing.

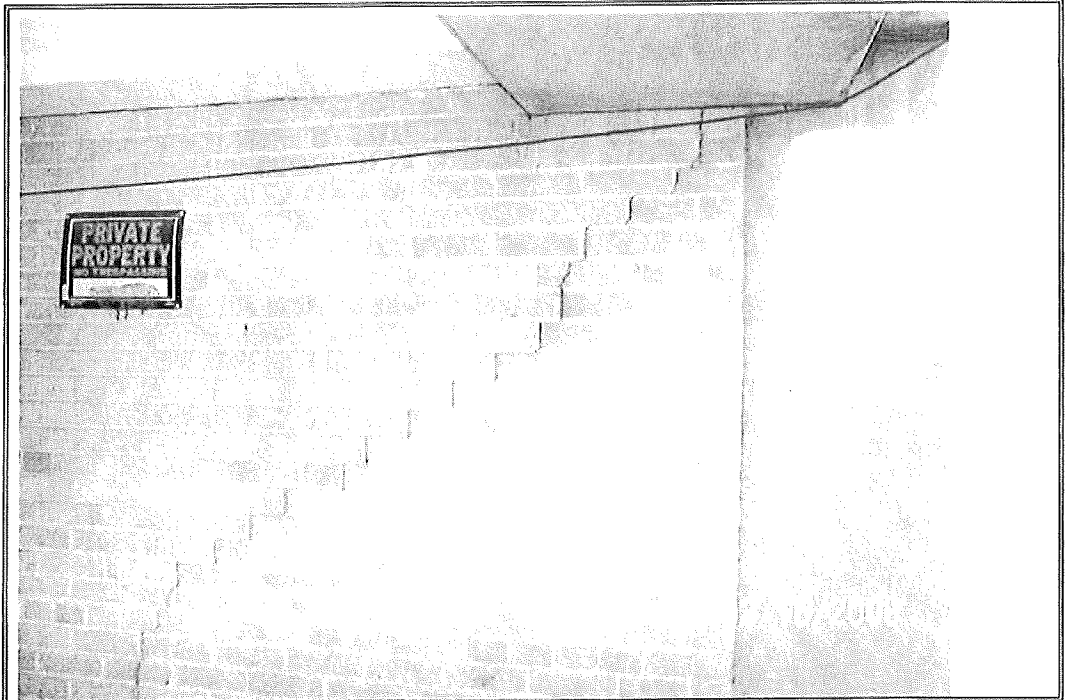
Photograph Number 15: Stepped masonry veneer cracks at east wall of carport.

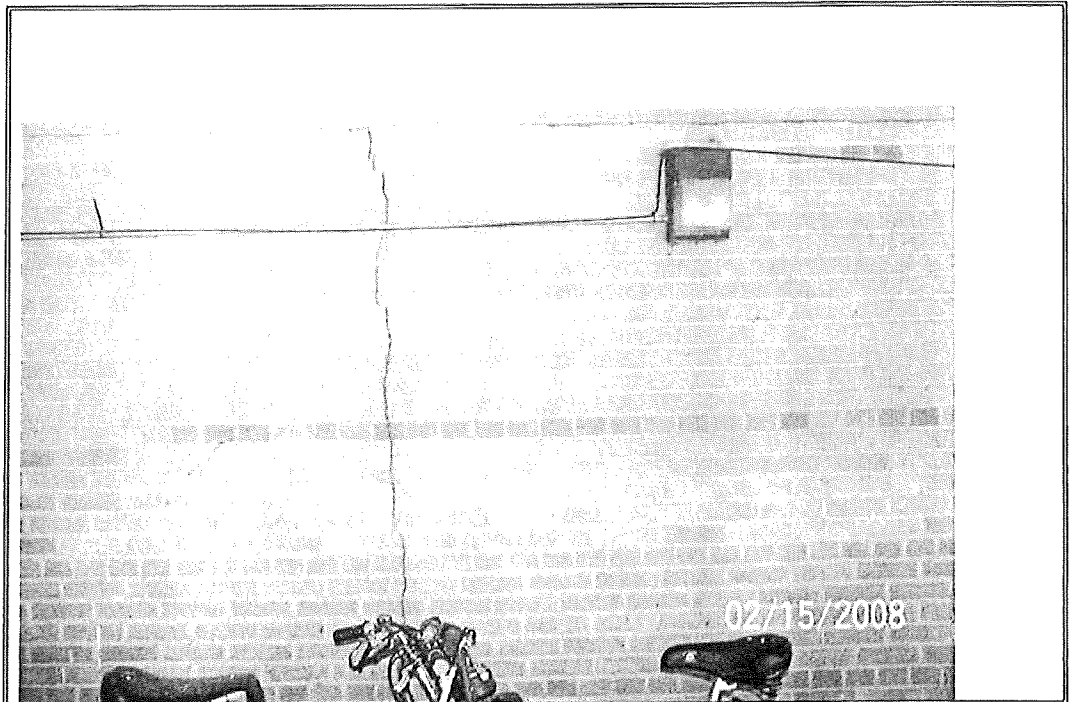
Photograph Number 16: Vertical masonry veneer cracks at east wall of carport.

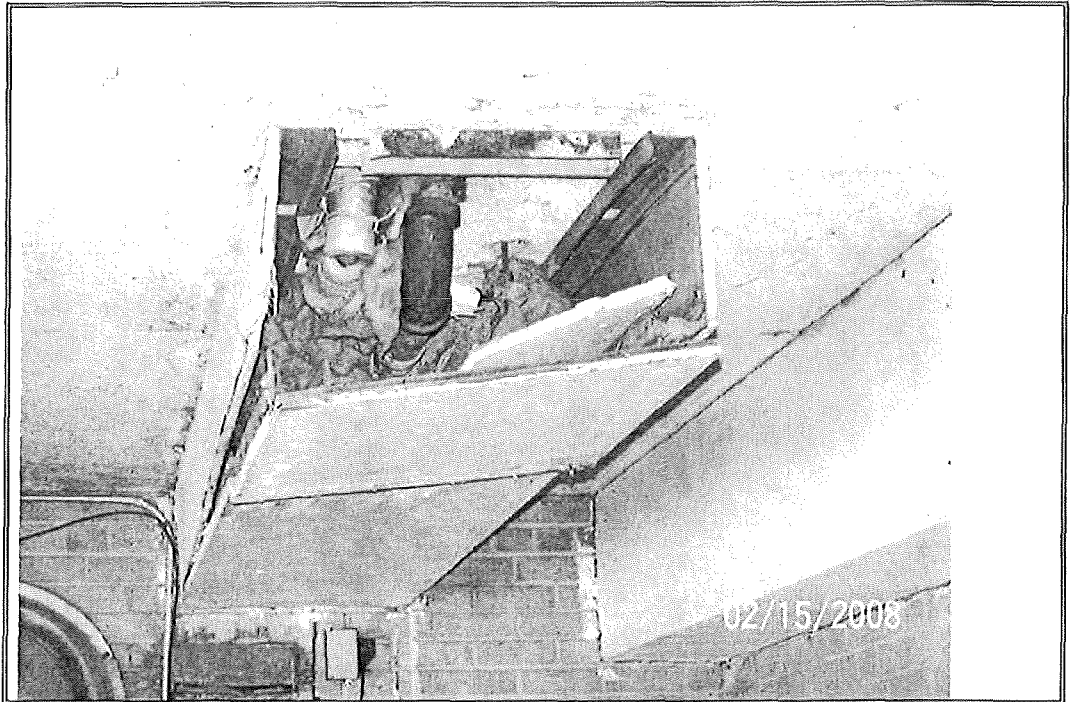
Photograph Number 17: Plumbing exposed to exterior due to damaged enclosure provisions.

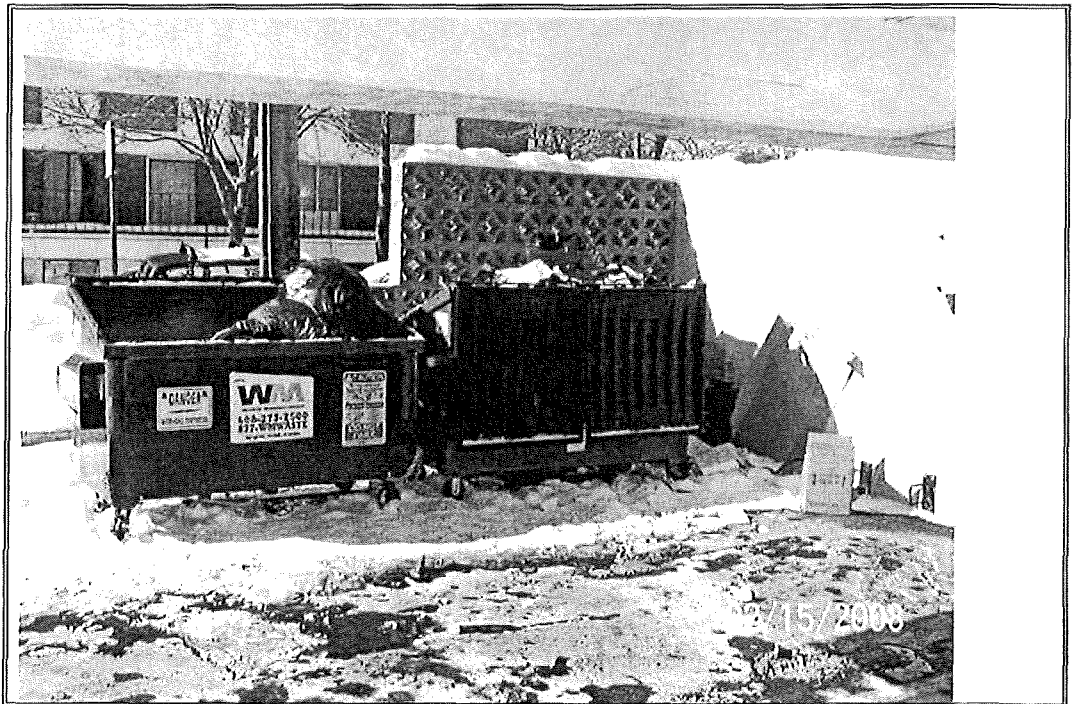
Photograph Number 18: Solid waste disposal area at the west side of the carport area.

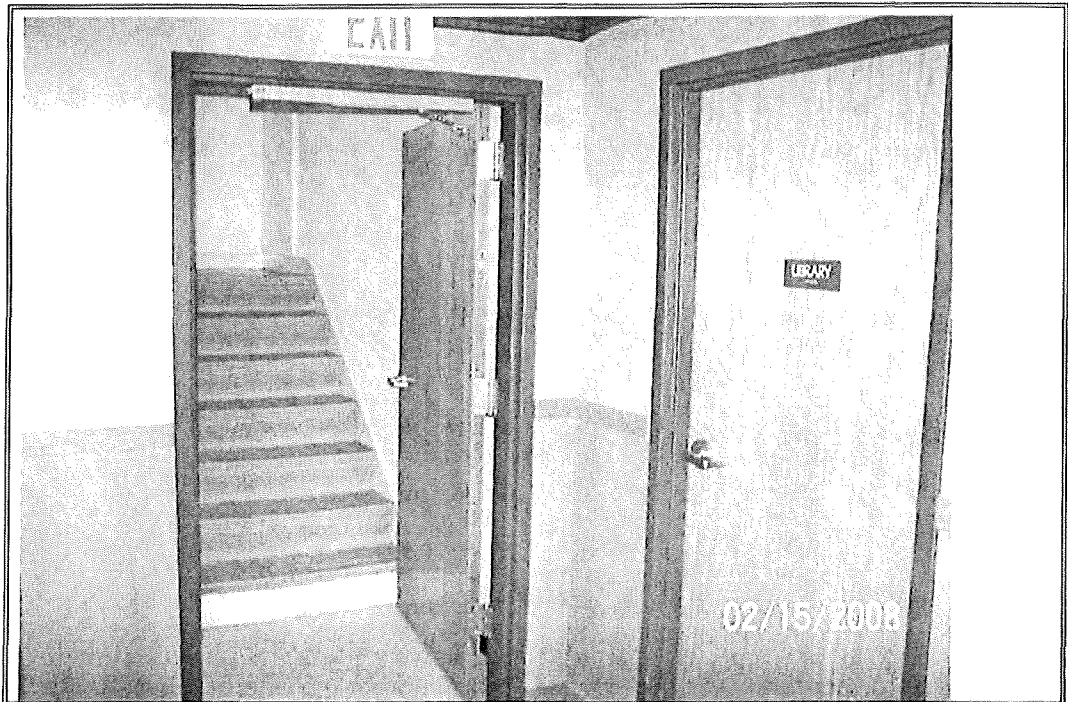
Photograph Number 21: Typical stairwell conditions.

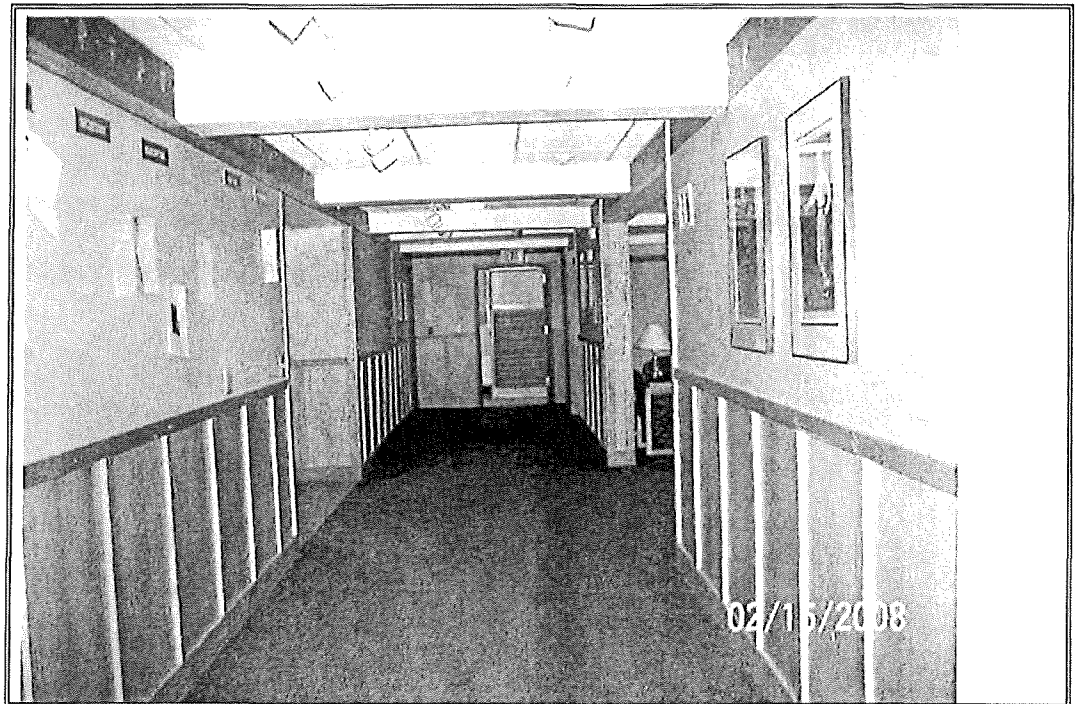
Photograph Number 22: Typical first floor hallway conditions and finishes.

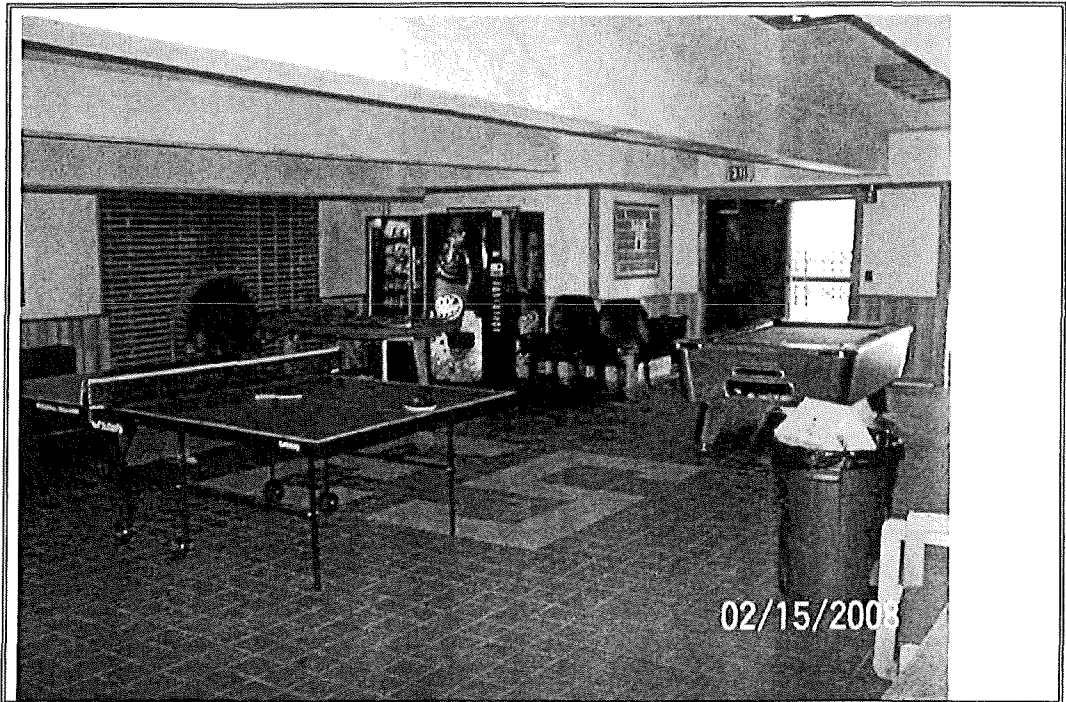
Photograph Number 23: Typical lower level game / recreation room.

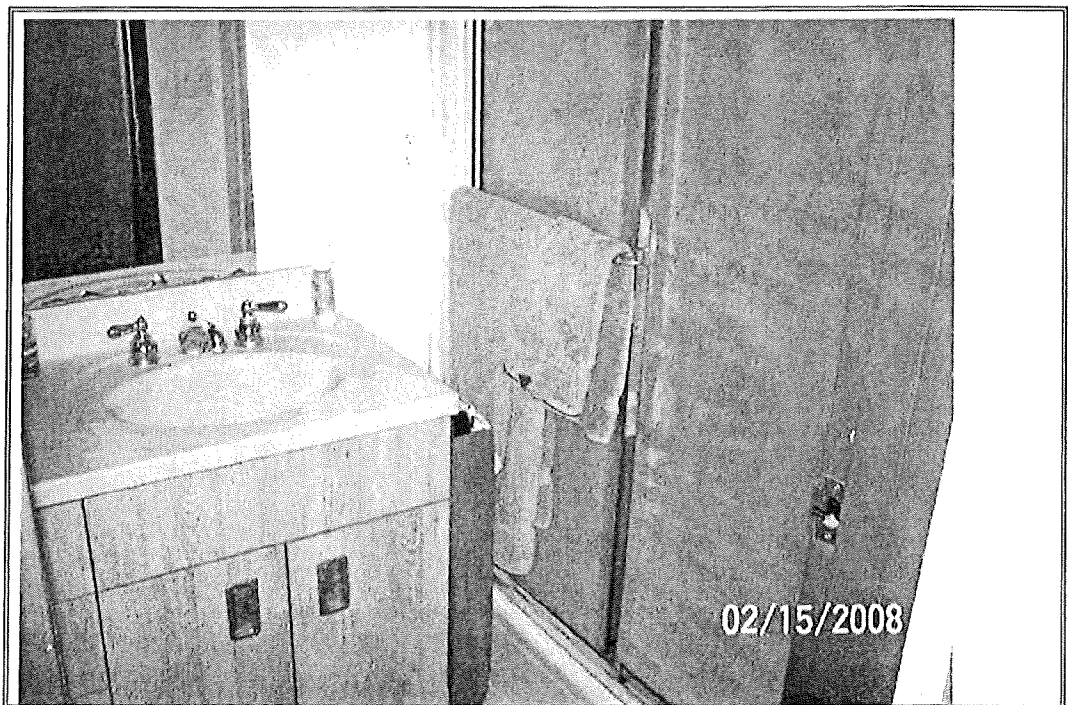
Photograph Number 28: Typical resident room ( single ) bathroom conditions.

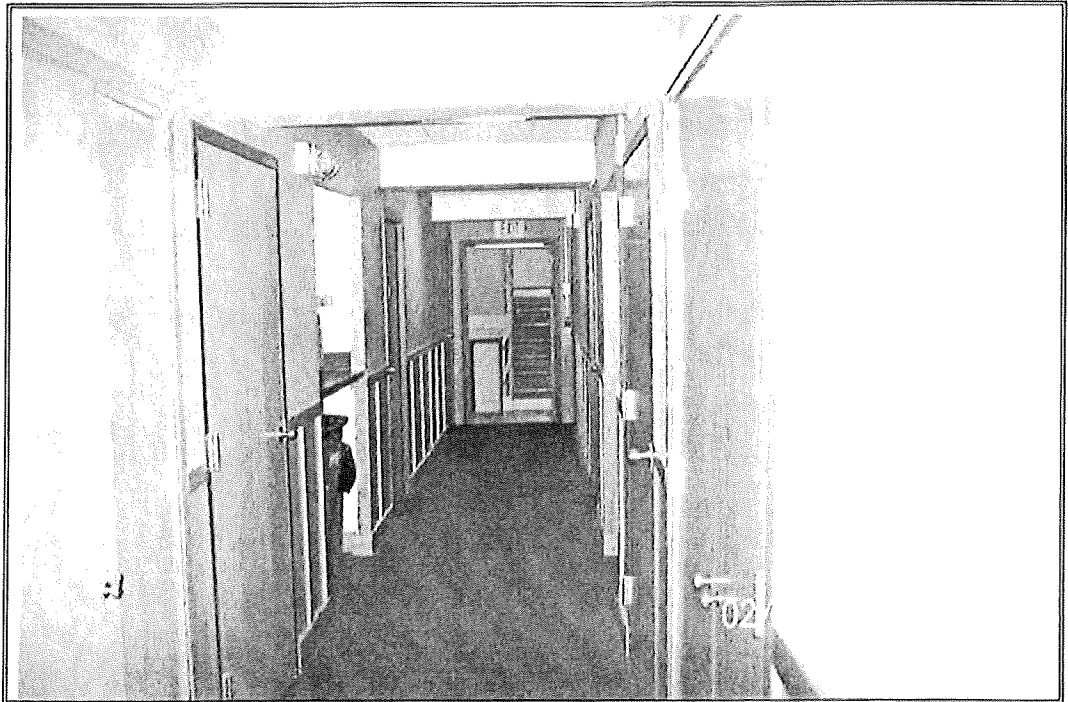
Photograph Number 29: Typical second and / or third floor hallway conditions.

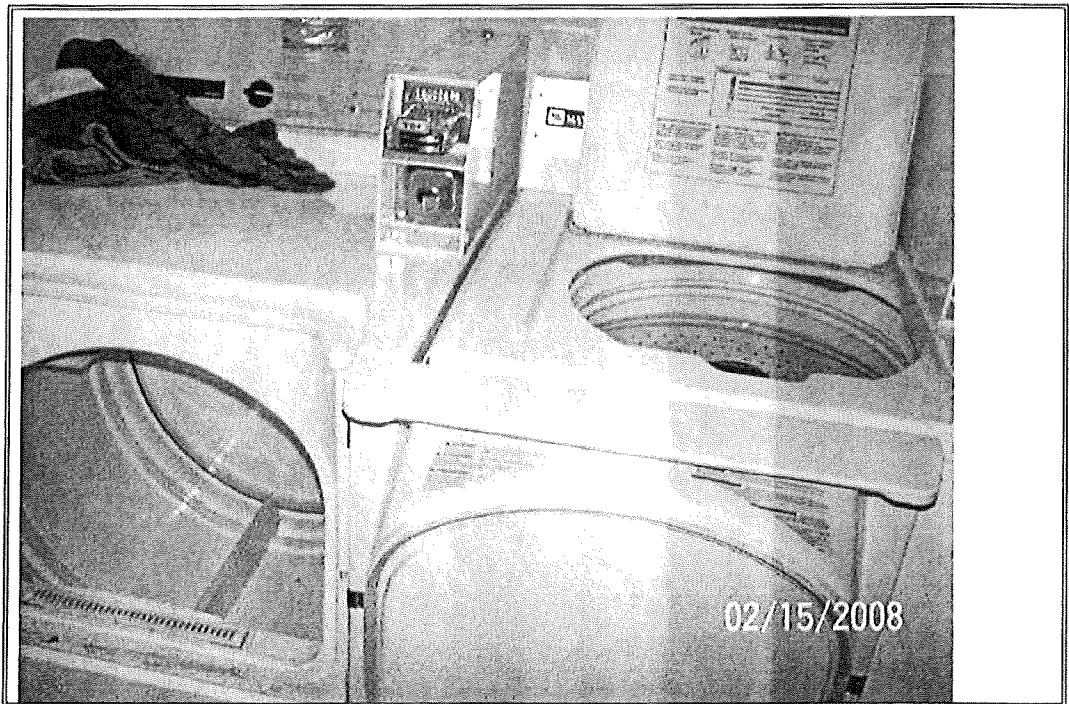
Photograph Number 30: Typical second and / or third floor laundry provisions.

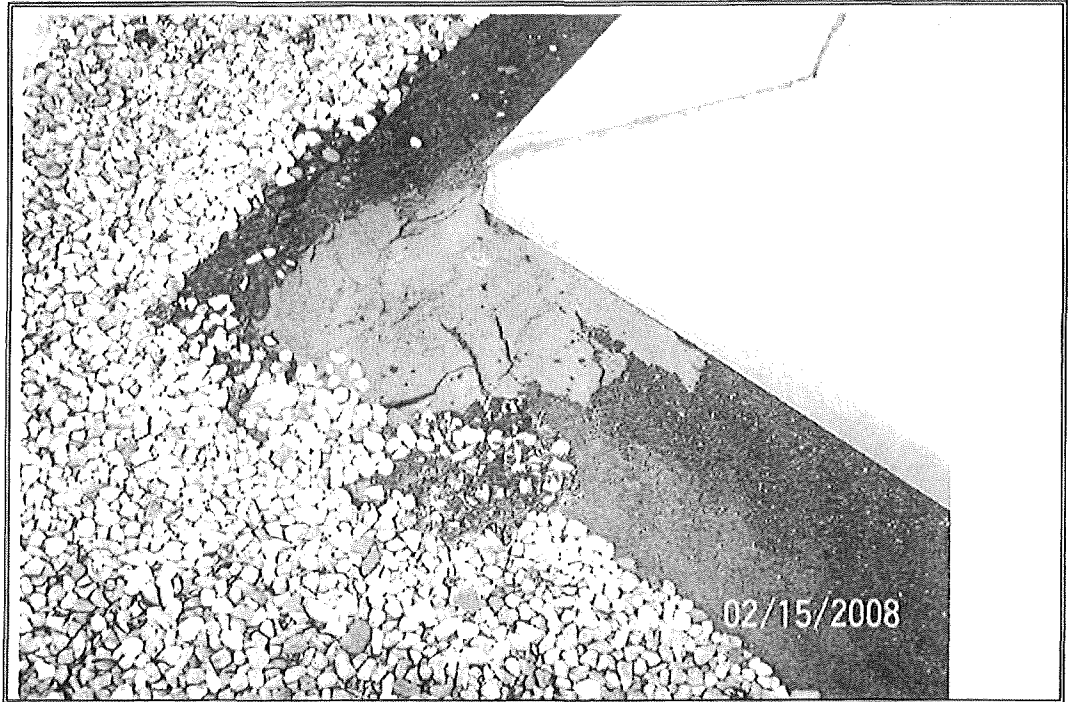
Photograph Number 41: View of deterioration / cracks of the exposed flashing areas.

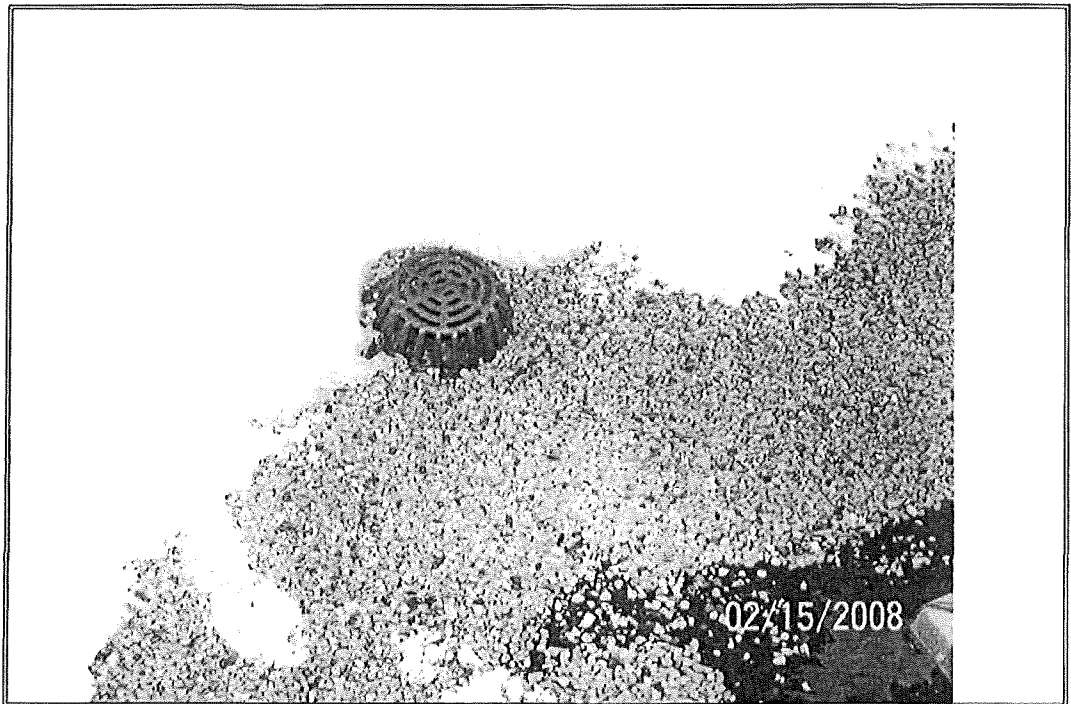
Photograph Number 42: View of roof drain without proper sump provisions.
