LEGISTAR 82987

Olbrich Botanical Gardens Conservatory Assessment Phase 2

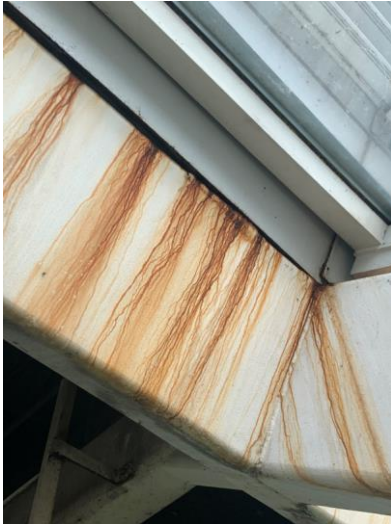
In the winter the exhaust fans rarely run so when the moist air hits cold steel it immediately condenses. Over the last 32 years the condensation has created problems as shown and explained in the next several pictures.

“Tear staining” of surface rust on the structural tubular steel.

- Remove blistered paint and surface rust to bare metal
 - Assess metal framing and siding, replace as needed
 - Assess main structural elements, repair as applicable or plan for future repairs

- Re-prime and paint steel members for protection
 - Re-insulate
 - Inspect all glass panels and sealants. Reseal as needed, provide a schedule of panels needing replacement

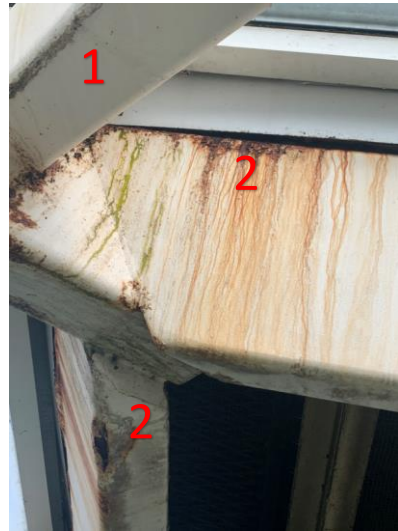
1. General dirt streaking.
2. Rust forming below paint and pitting the tubular steel.

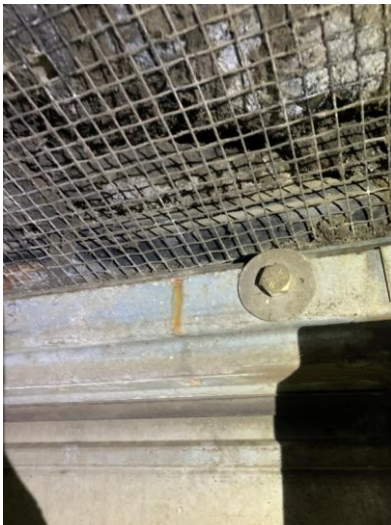
Moldy, deteriorating insulation in the cupola roof.

- Subject of this resolution (Legistar 82987)
 - This was one of the smaller projects identified by IMEG in 2023.
- Work to be completed:
- Remove existing moldy insulation

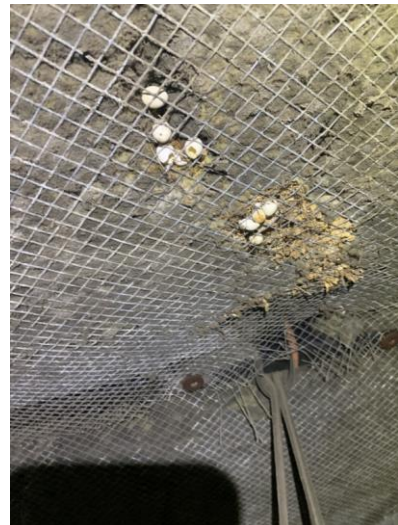
Mushrooms growing in the cupola insulation.

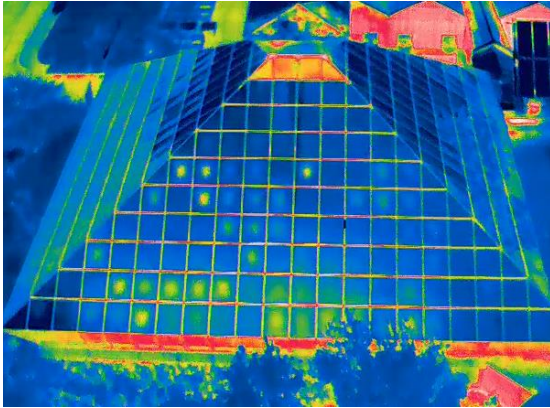
Southeast face, (main entrance side)

Below are some thermal images taken during the 2023 general conditions assessment. Blue indicates COLD (good thermal retention) red/orange indicates HOT (poor thermal retention).

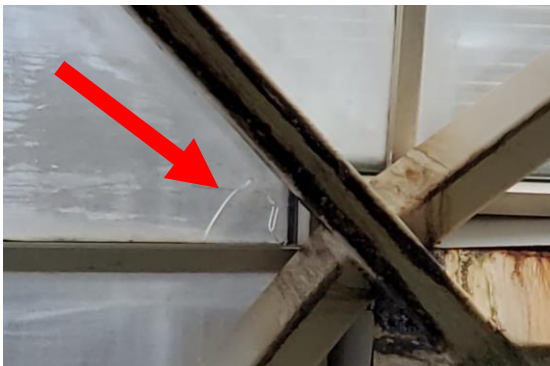
Cracked glass near cupola

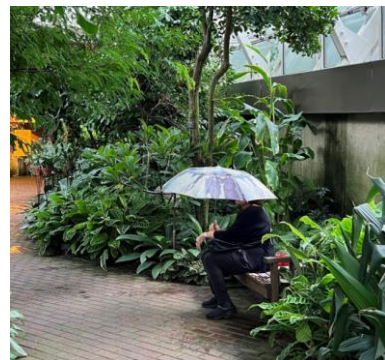
Failed sealant, raining inside
