# LEGISTAR 82987

### Olbrich Botanical Gardens Conservatory Assessment Phase 2

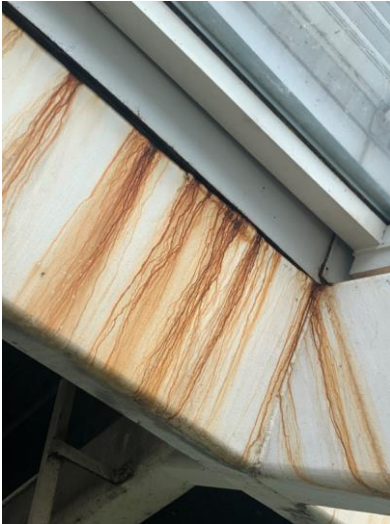
In the winter the exhaust fans rarely run so when the moist air hits cold steel it immediately condenses. Over the last 32 years the condensation has created problems as shown and explained in the next several pictures.

**"Tear staining" of surface rust on the structural tubular steel.**

- Remove blistered paint and surface rust to bare metal
  - Assess metal framing and siding, replace as needed
  - Assess main structural elements, repair as applicable or plan for future repairs

- Re-prime and paint steel members for protection
  - Re-insulate
  - Inspect all glass panels and sealants. Reseal as needed, provide a schedule of panels needing replacement

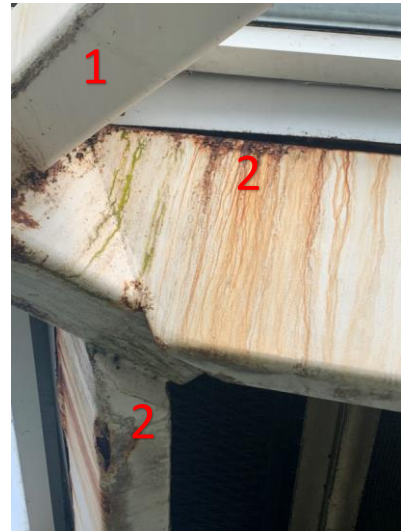
1. General dirt streaking.
2. Rust forming below paint and pitting the tubular steel.

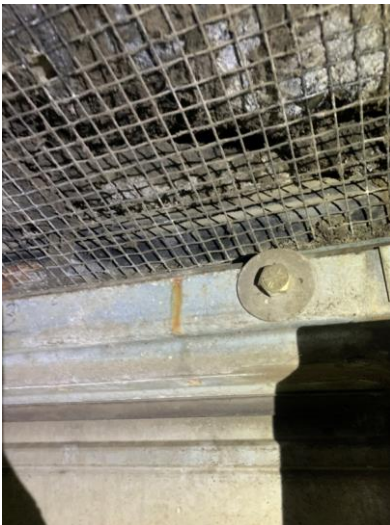
**Moldy, deteriorating insulation in the cupola roof.**

- Subject of this resolution (Legistar 82987)
    - This was one of the smaller projects identified by IMEG in 2023.
- Work to be completed:
- Remove existing moldy insulation

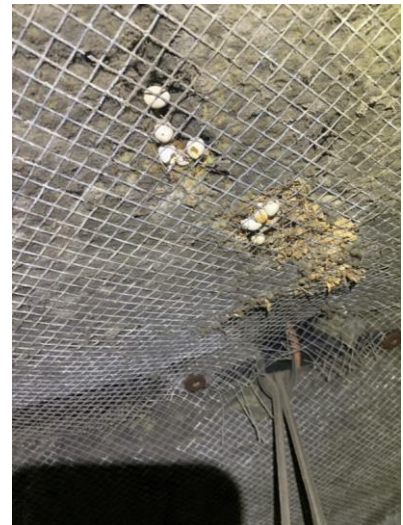
**Mushrooms growing in the cupola insulation.**

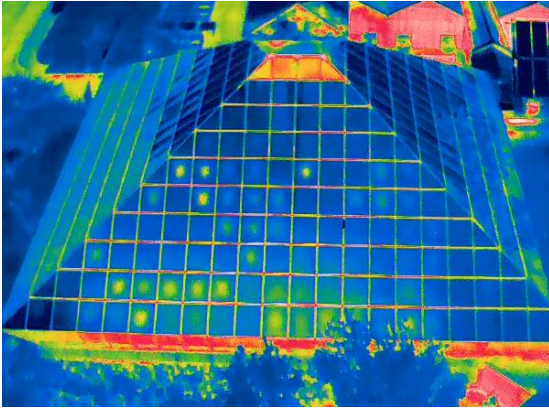
Southeast face, (main entrance side)

Below are some thermal images taken during the 2023 general conditions assessment. Blue indicates COLD (good thermal retention) red/orange indicates HOT (poor thermal retention).

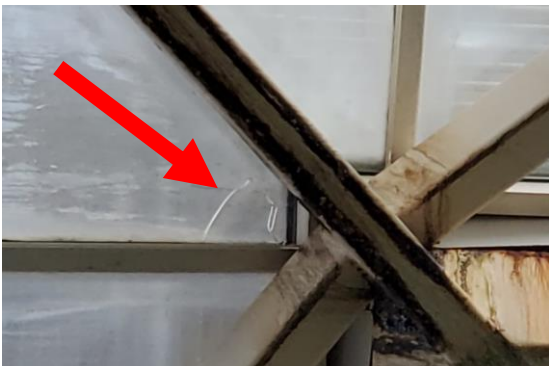
Cracked glass near cupola

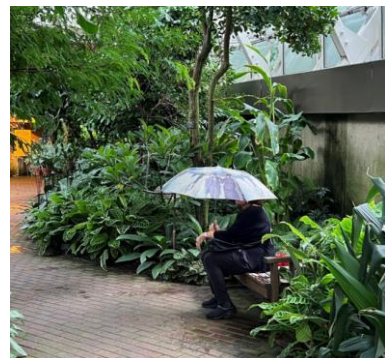
Failed sealant, raining inside
