Property Condition Report

Master Hall Apartments

415 W. Gilman St.

REPORT DATE – 4 /1 / 2026

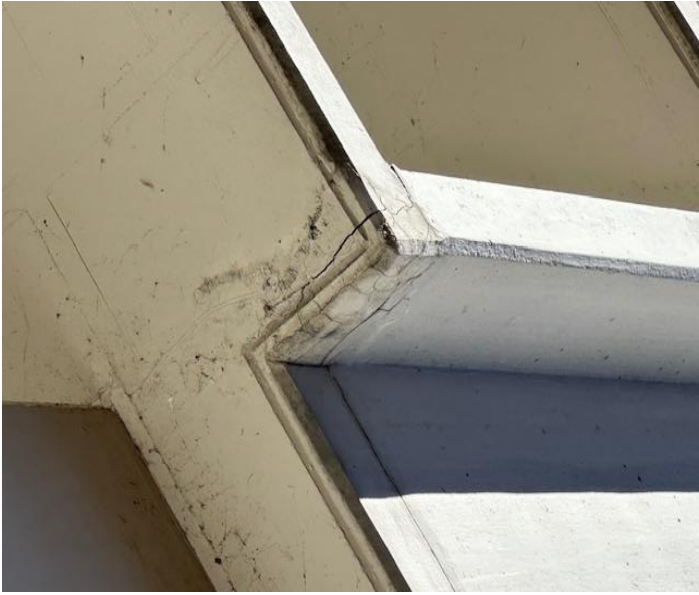
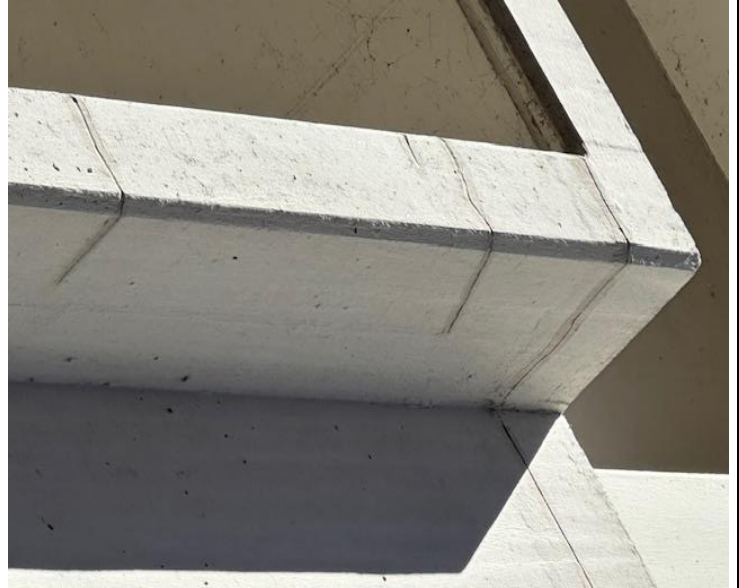
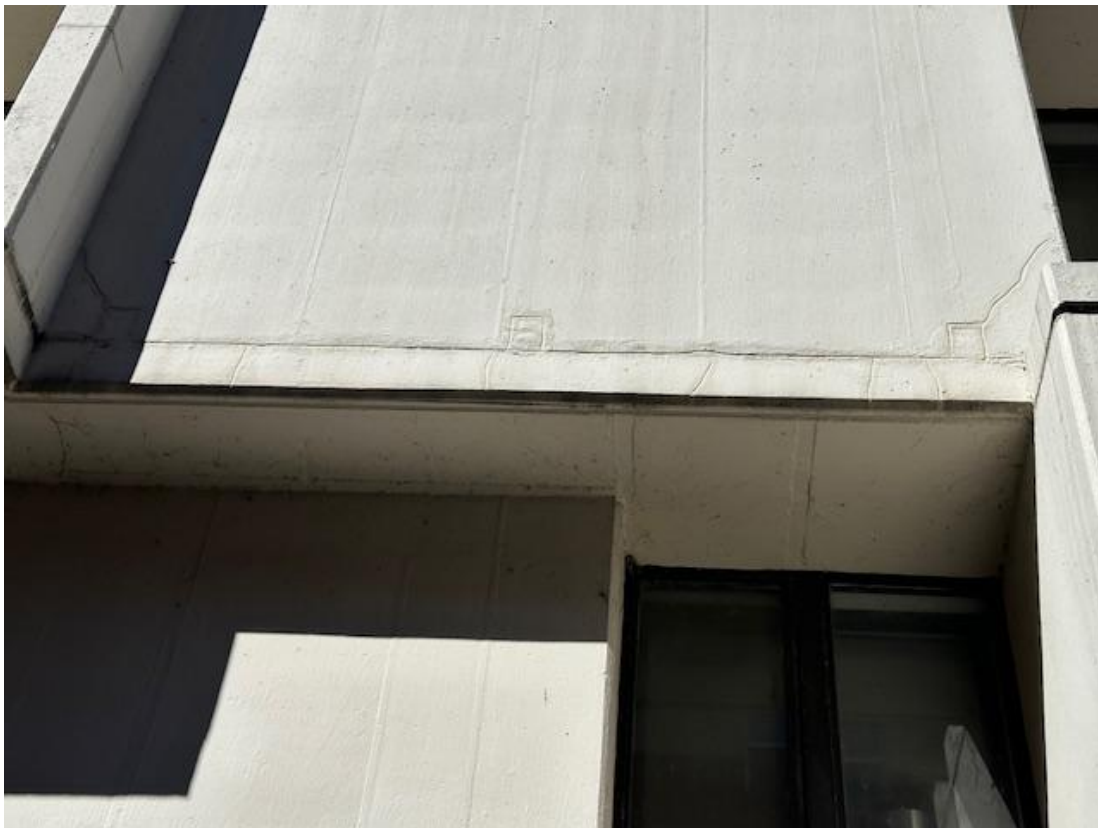
Hairline cracking was observed in the reinforced concrete exterior walls and floors. These cracks have been filled with joint sealant and painted.

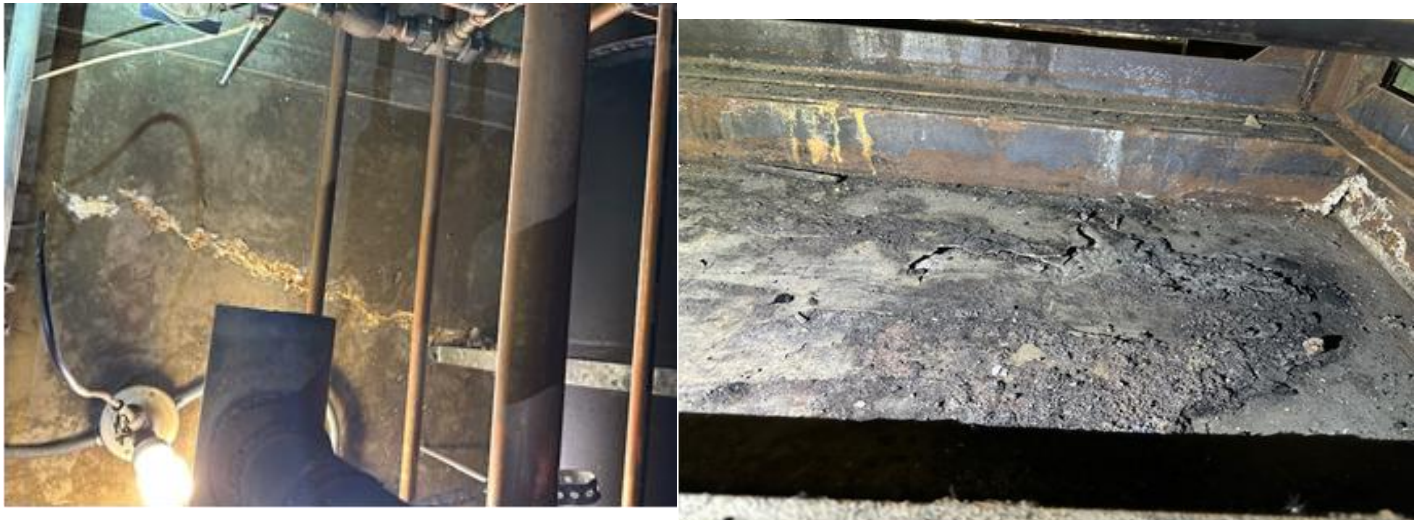
The penthouse floor has experienced water damage in the form of spalled concrete and exposed reinforced steel. Calcification at hairline cracks in the penthouse roof are visible and indicative of previous water leaking. The main roof of the building is located beneath an adhered EPDM roof membrane placed over rigid insulation. Roof leaking was present during the inspection. It is uncertain if same spalling and deterioration of reinforcing steel, indicative of the Penthouse roof condition, is present at the top surface of the roof level but it is highly probable based on adjacent areas.

Calcification at underside of penthouse roof / Spalling of penthouse floor deck - Roof deck.

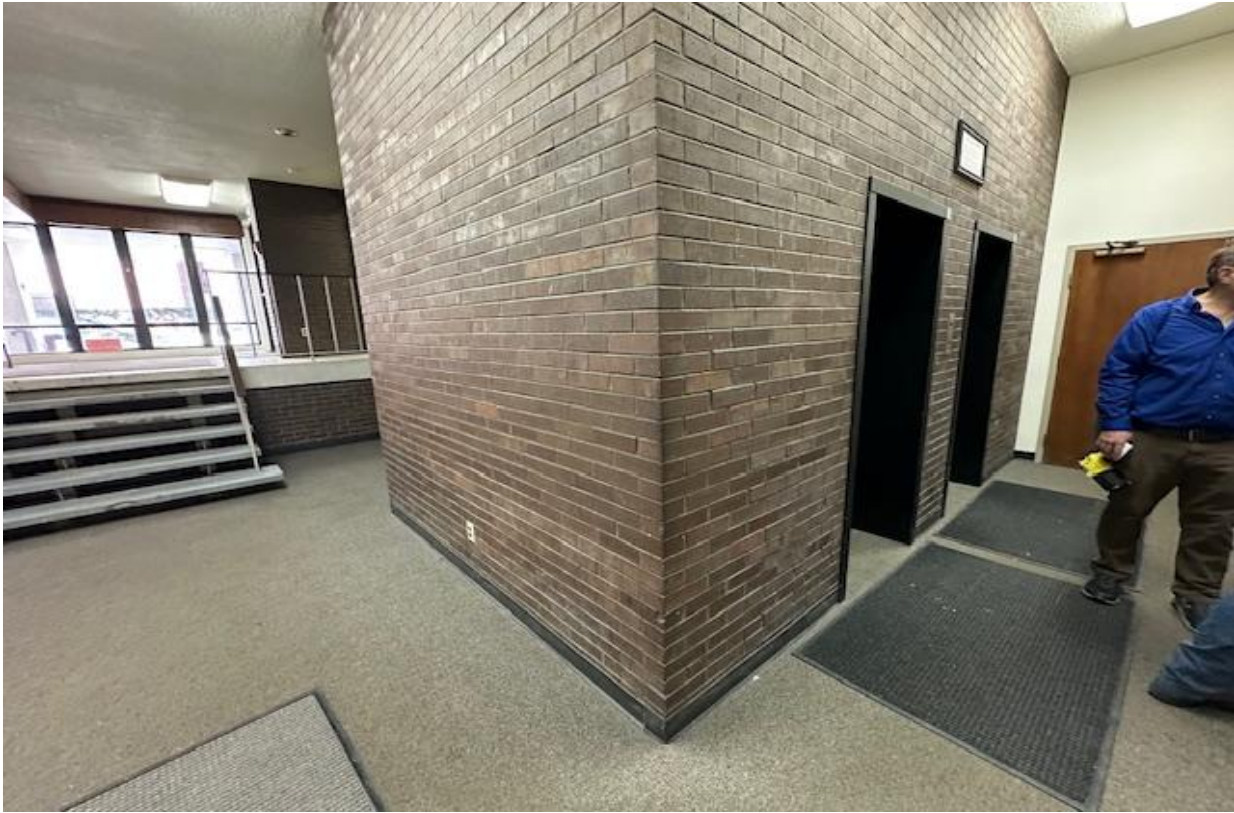
The main entry lobby is located at a split-level, requiring guests and patrons to descend a flight of stairs to access the first-floor apartments and elevators. While installation of a limited-use/limited-access (LULA) elevator could theoretically provide an accessible entrance point to the first floor, space limitations do not allow for a LULA without interfering with the door swing of the stair towers. Furthermore, the solid concrete construction of the building would not accommodate the structural modifications necessary to install a LULA, making this solution infeasible on both spatial and structural grounds.

Insufficient available space for LULA elevator between vestibule lobby and first floor.

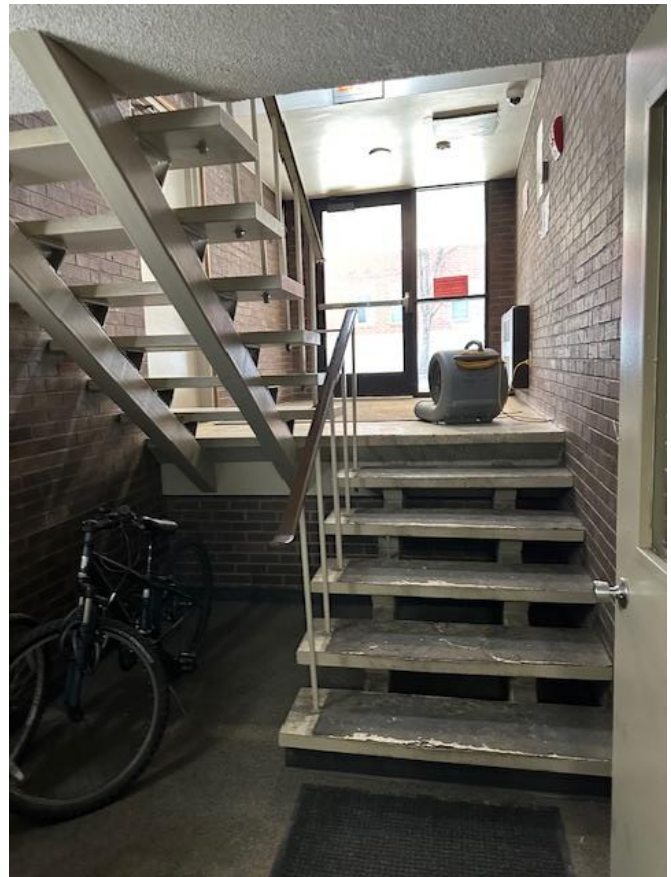
Egress stairs from vestibule lobby to first floor.

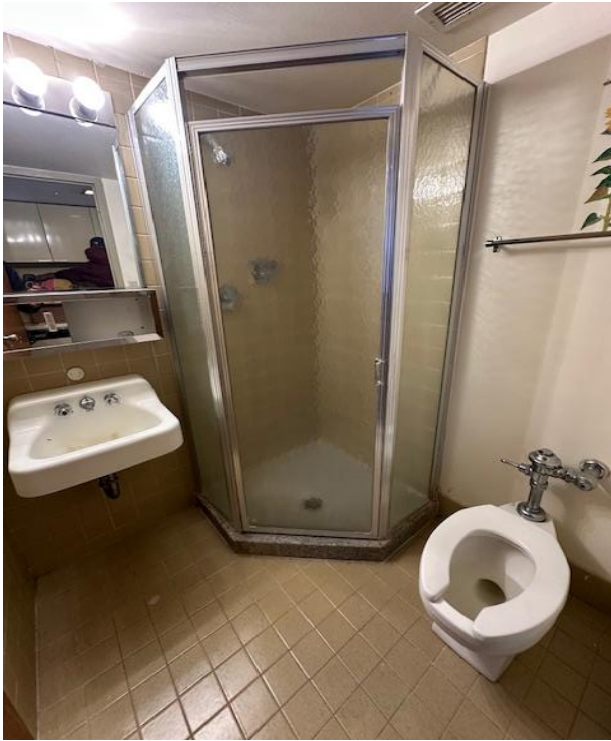
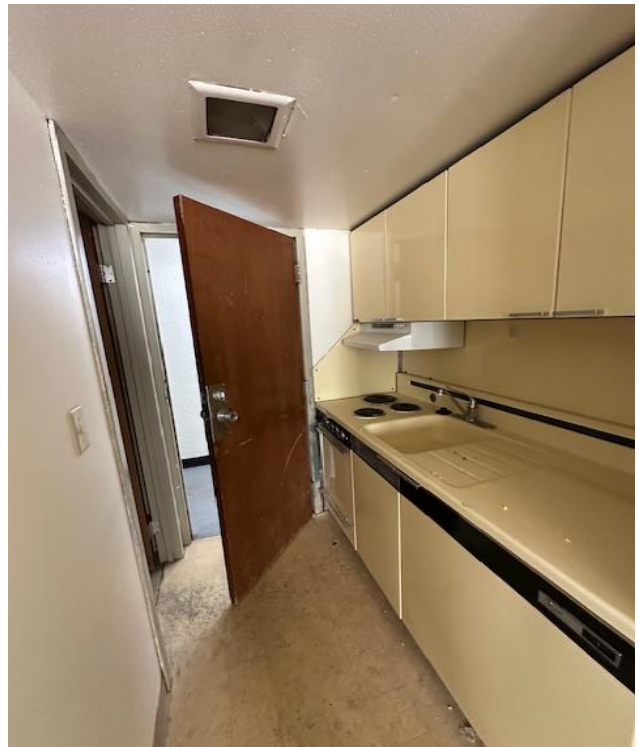
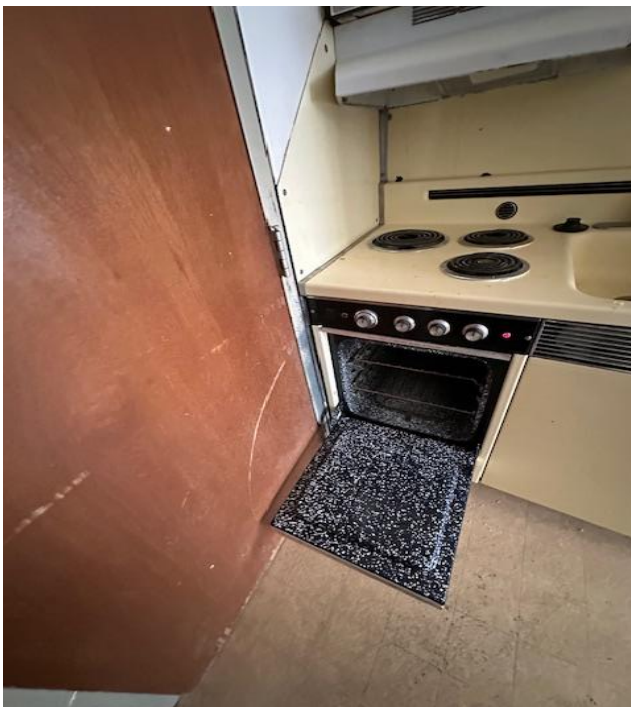
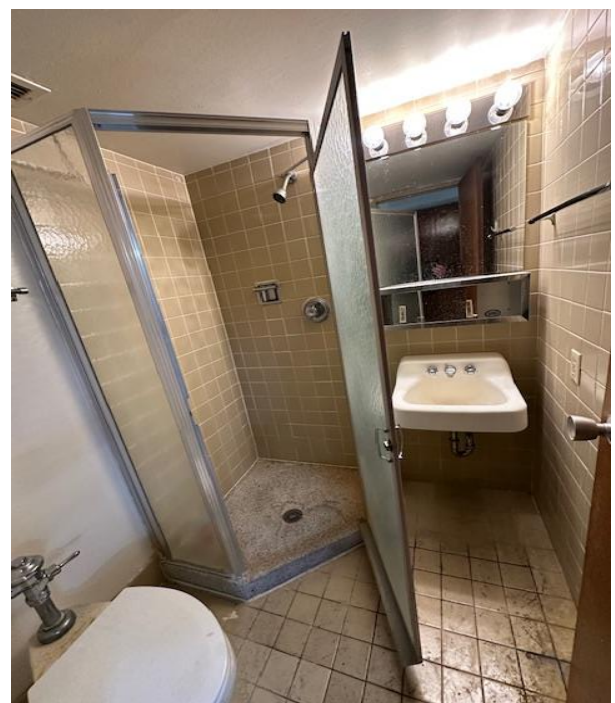
None of the interior apartments meet accessibility standards, and would not be physically accessible or useable for many persons with disabilities. For example, The existing bathrooms all contain stand-up showers that do not meet the required footprint dimensions or approach clearance requirements. Space limitations within the units do make it impossible to expand the restrooms or Kitchens to meet required ADA or other Wisconsin building code clearances.

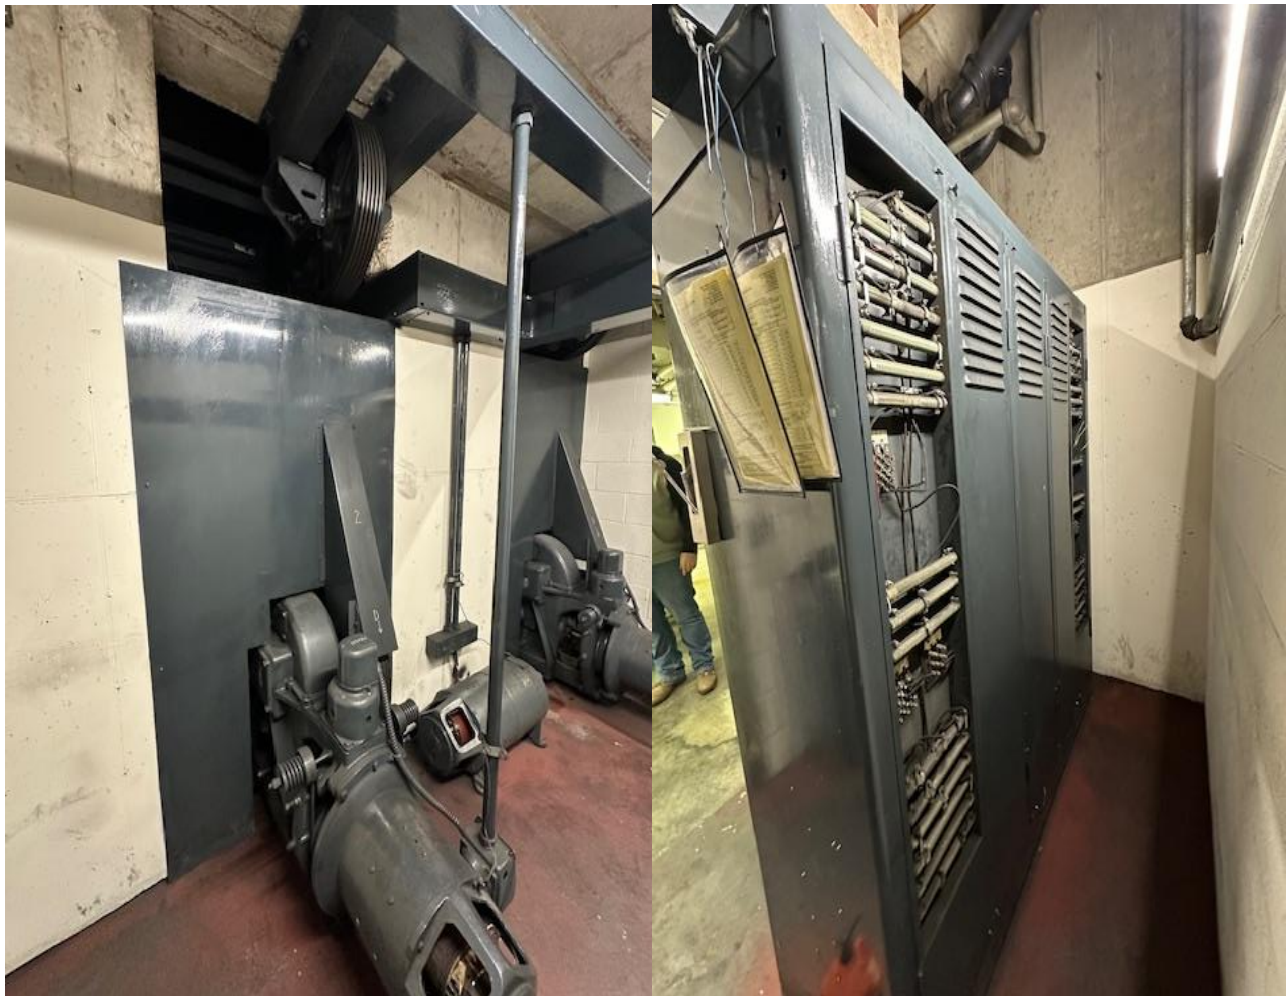
The existing pair of elevators are not ADA compliant and are obsolete. The interior dimensions do not meet the minimum requirements prescribed in ANSI 117.1 for accessible use. The elevators are located within a concrete shaft extending from the bottom level to the top floor of the building. Removing the existing elevator system to install an ADA compliant pair of elevators will require removing the existing concrete elevator shaft walls, enlarging the current floor openings for the elevator shaft and rebuilding the elevator shaft walls. The existing shaft walls are load bearing. Reconstruction of the elevator shaft walls (enlargement) is not structurally possible due to the existing loadbearing shaft construction and space limitations.

The original elevators are over 60 years old and parts are either no longer available, or in scarce supply. The elevators are not connected to an emergency back-up power generator and cannot be used for emergency ingress and egress, which means the two stair towers are the only means of emergency access to and exit from the building.

ELEVATORS	The elevators as they currently stand are obsolete and need to be replaced. This is not optional. We would install larger elevator cabs that are sized for ADA compliant	The existing shaft walls are load - bearing. Reconstruction of the elevator shaft walls	The cost of elevator replacement, enlarged elevator floor openings, and

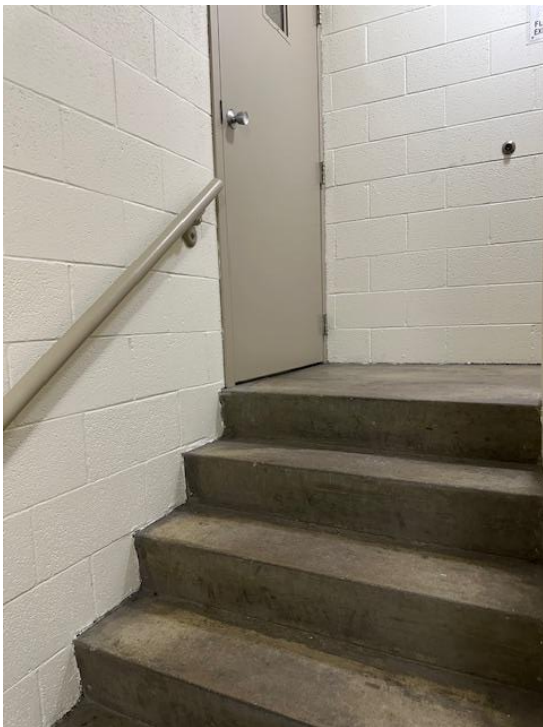
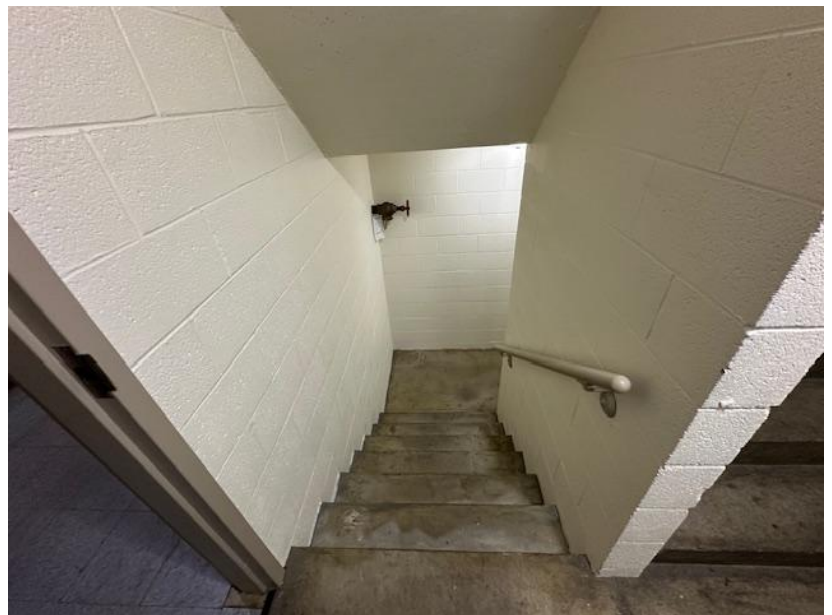
The existing stairs are constructed of reinforced concrete and are located within reinforced concrete shaft walls. The stairs extend from the bottom level to the top level of the building. The existing landings do not provide the required area of refuge for disabled building occupants to find safe harbor during emergencies. Additionally, the existing stairs discharge to the recessed first floor level and not to the exterior of the building or to a rated corridor leading to the exterior of the building.

The existing stair tread depth, riser height, and landing depths are not code compliant. Handrails within the stairs are not code compliant. Modification of the handrails is not feasible, as the required extensions would project into the existing door swings within the stair shaft. Reconstruction of the stairs is likewise not feasible due to the load-bearing shaft construction and spatial limitations.

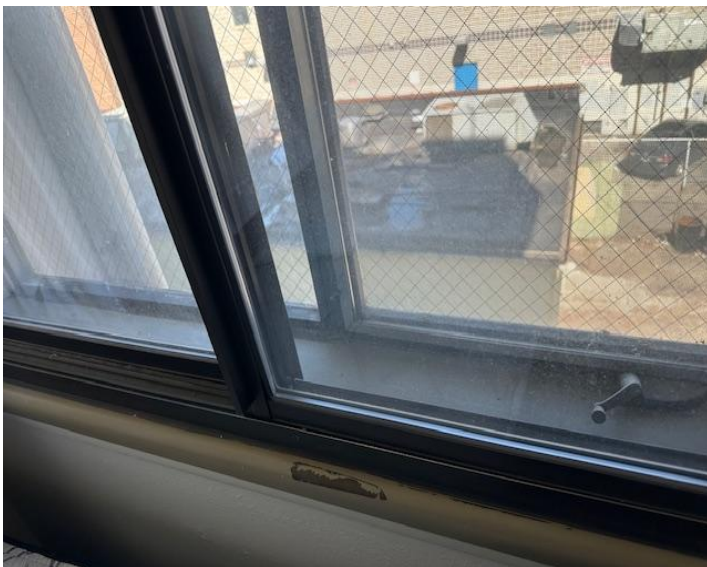
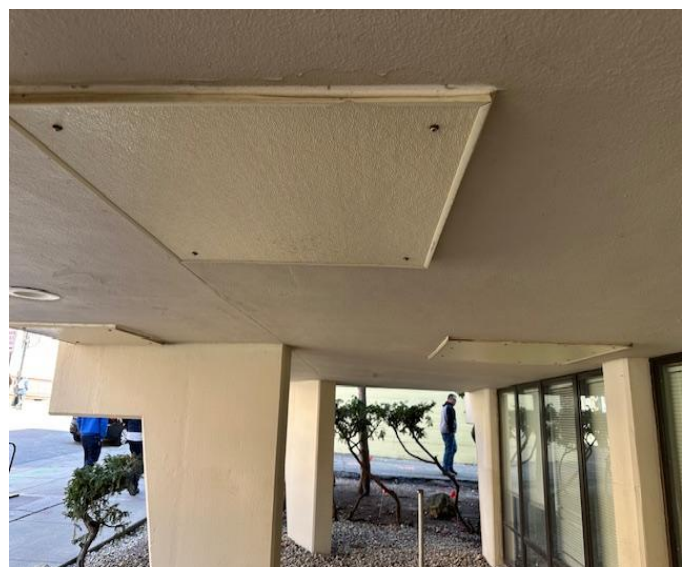
The existing building envelope consists of uninsulated reinforced concrete walls and floors and single-pane glazed window assemblies that do not meet current SPS 363 Wisconsin Energy Conservation Code requirements. The building currently experiences routine freezing of water piping in the end apartments at the north and south ends of the building, as well as in several second-floor units due to the cantilevered floor design. The property owner has been required to cut into the concrete structure to access the constantly freezing piping, with access panels added to the underside of the deck as a recurring measure.

Beyond the building envelope, the overall energy inefficiency of the building extends to its mechanical systems and appliances. Most kitchen appliances are original to the building and are integrated directly into the concrete structure, making replacement with Energy Star or more efficient models not feasible. Similarly, the HVAC and water heating systems are aging and inefficient, contributing to the building's overall poor energy performance. Collectively, these deficiencies make it effectively impossible to bring the building into compliance with modern energy efficiency standards without a comprehensive reconstruction effort.

Bringing the building envelope into compliance would require furring the inside of the exterior walls with 3-5/8" steel studs, insulating with 3-1/2" fiberglass batt insulation, installing a vapor barrier and drywall, and replacing all windows with new double-pane units. However, given that the exterior walls are solid reinforced concrete, it is questionable whether such furring and insulation work is even feasible without compromising the structural integrity of the building. Additionally, any such renovation work would likely disturb asbestos-containing materials present throughout the building, introducing further complexity, cost, and regulatory requirements to an already infeasible scope of work.
