# LANDMARKS COMMISSION APPLICATION

Project Address: 644 FRANCES STREET Aldermanic District: 8

Project Title/Description: DELTA UPSILON EXTERIOR RESTORATION

**Letter of Intent  
City of Madison  
Landmarks Commission**

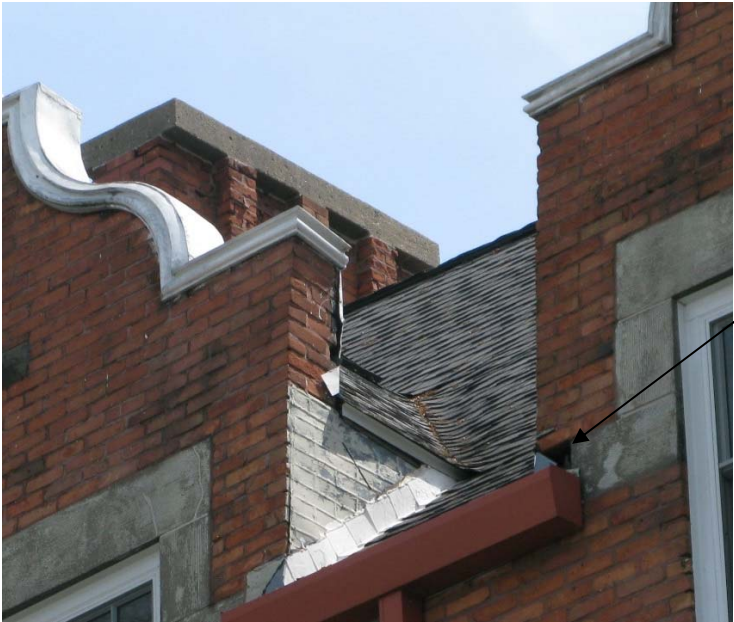
Picture 5971: Immediate Need

Hole in masonry wall

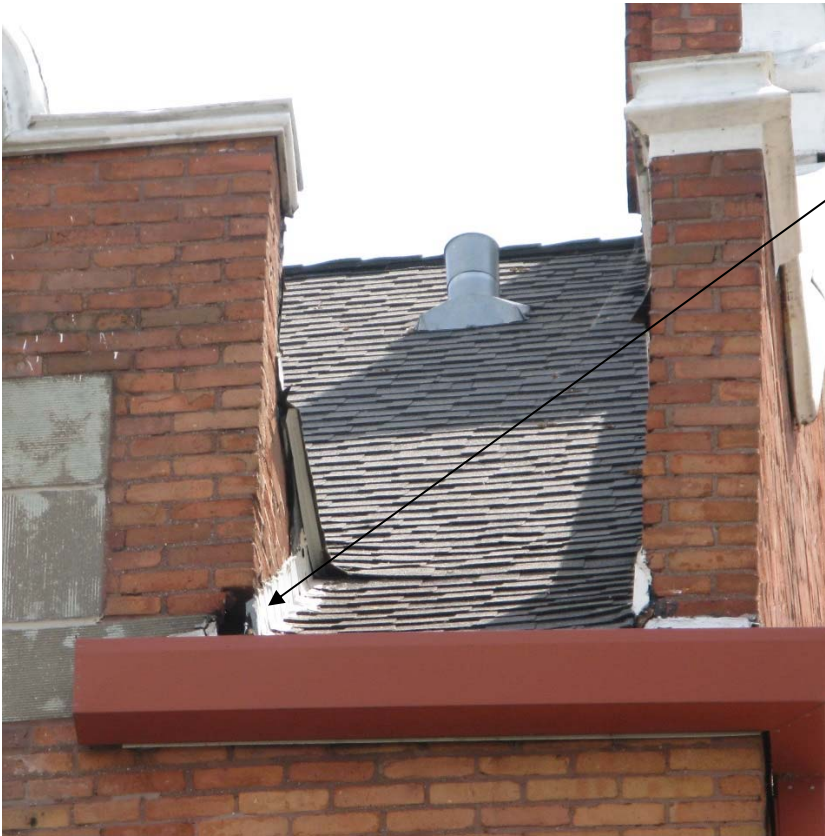
Picture 5976: Immediate Need

Hole in masonry wall

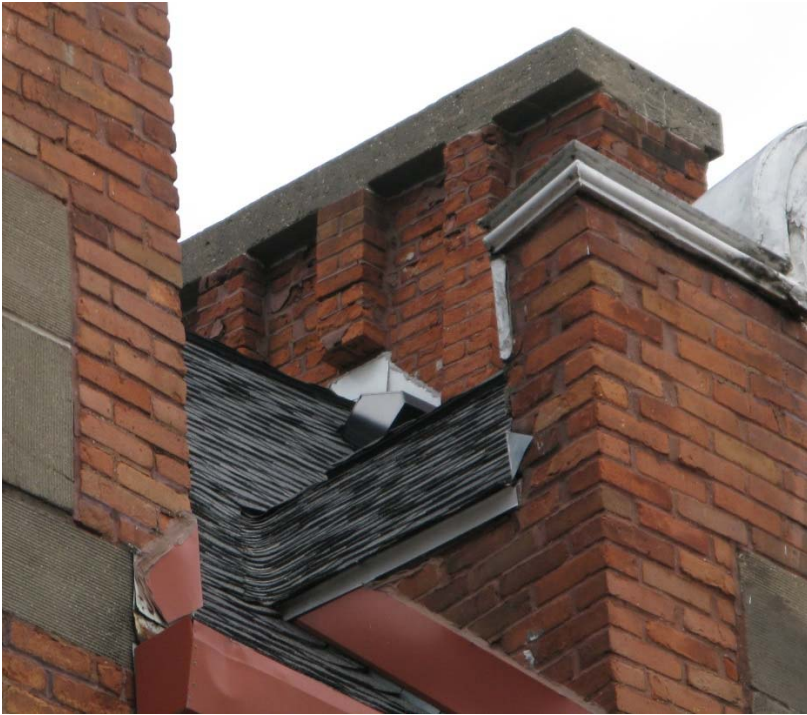
The upper 3 ½-feet of both chimneys need rebuilding. This amounts to 125 square feet of brick and the replacement of the cast stone caps (see below).

Picture 5956: Chimney repair

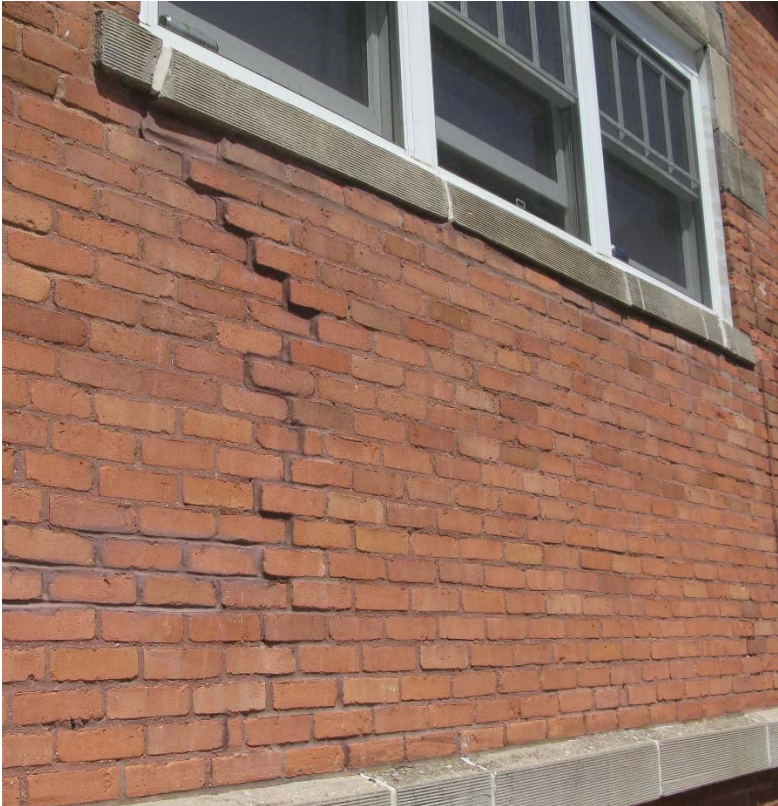
Picture 5960: Crack and bulge

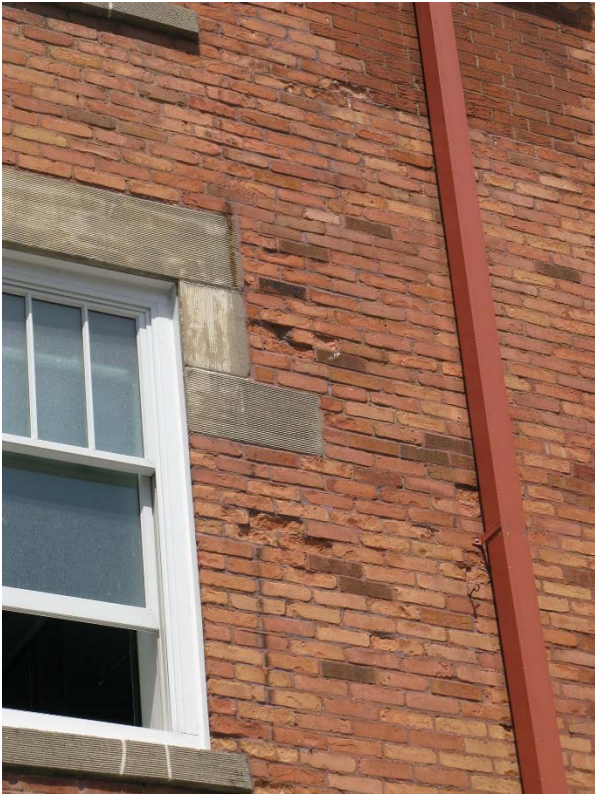
16% to 20% of the brick on the main walls needs replacing. The south elevation has the largest quantity at 270 square feet. The total amount of brick needing replacement is 450 square feet. An additional 200 single brick removal/replacement is needed for miscellaneous deteriorated single brick.

Picture 5961: Typical damaged brick

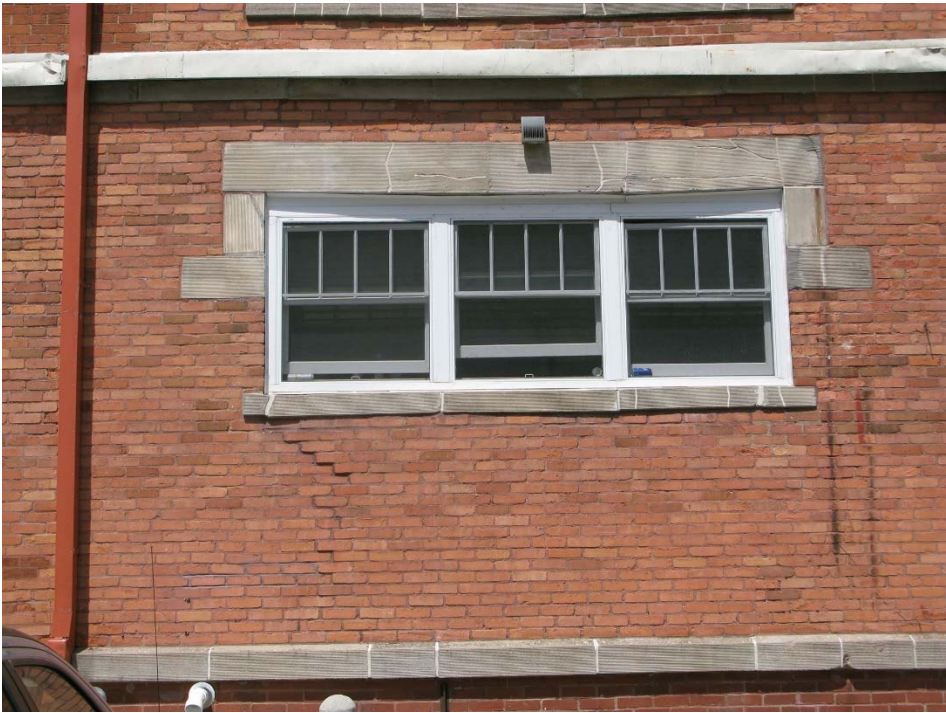
Cast stone is used at each window opening as lintels, sills and accents. The lintels range in size from five-feet long to over twelve-feet long and are self-supporting. At four-inches thick all but one large lintel has failed.

53% (29 out of 55) of the lintels need replacing, 55% (21 out of 38) window sills need replacing, less than 2% (3 out of 168) of the window accents need replacing, 100% of the chimney caps need replacing and 7% of the banding needs replacing. We recommend steel angle lintels be added to the larger window openings to help support the cast stone.

Picture 5963: Typical damaged cast stone lintel

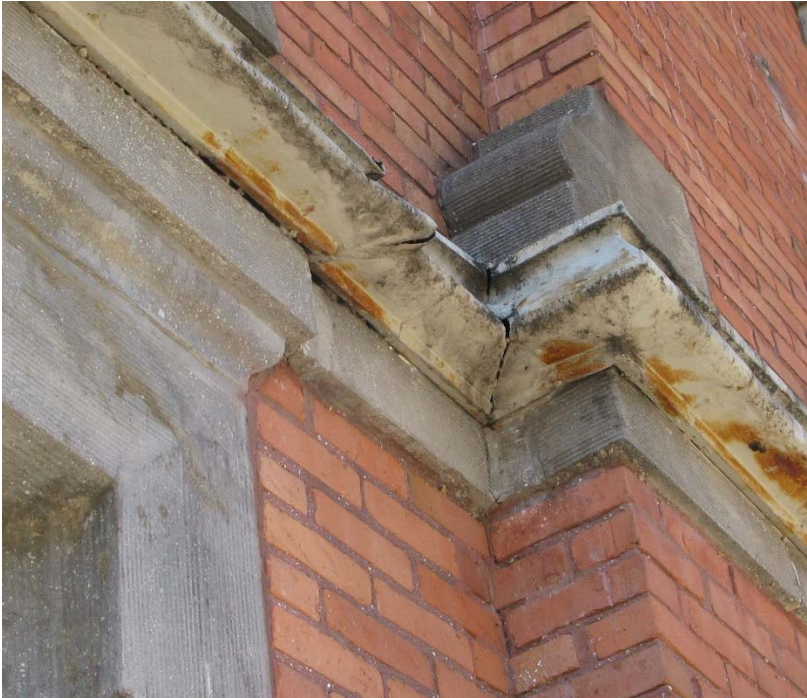
Exterior metal elements include main and small gable coping (caps) and the continuous band located at the third-floor level. 100% of the metal requires replacing. There is 75 lineal feet of main gable coping, 130 lineal feet of small gable coping and 140 lineal feet of banding. Each location has its own profile. The recreation will match the original profiles.

Picture 5913: Damaged original metal banding

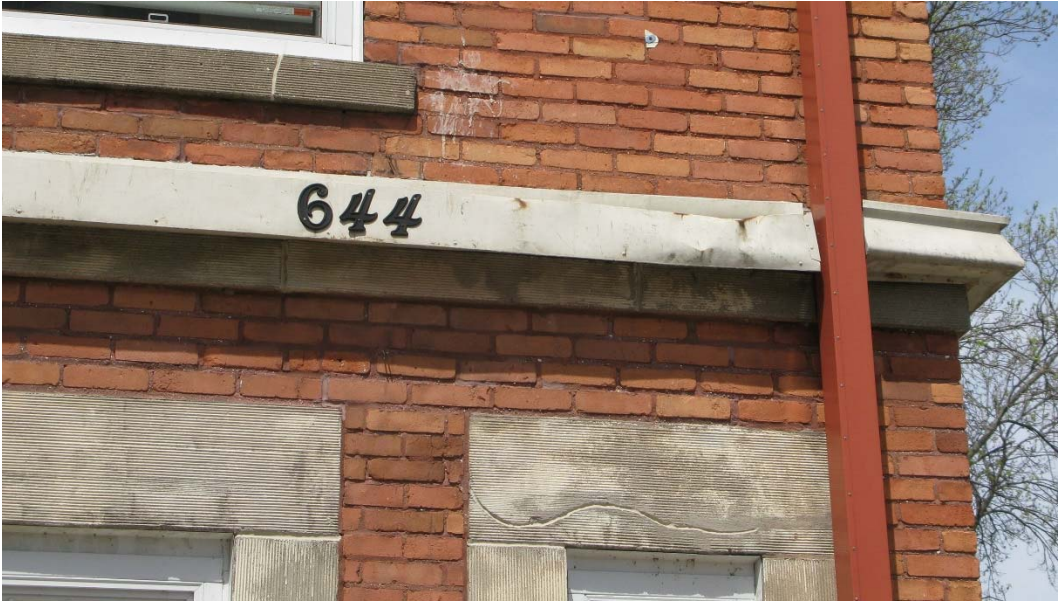
Picture 5977: Damaged non-original metal banding

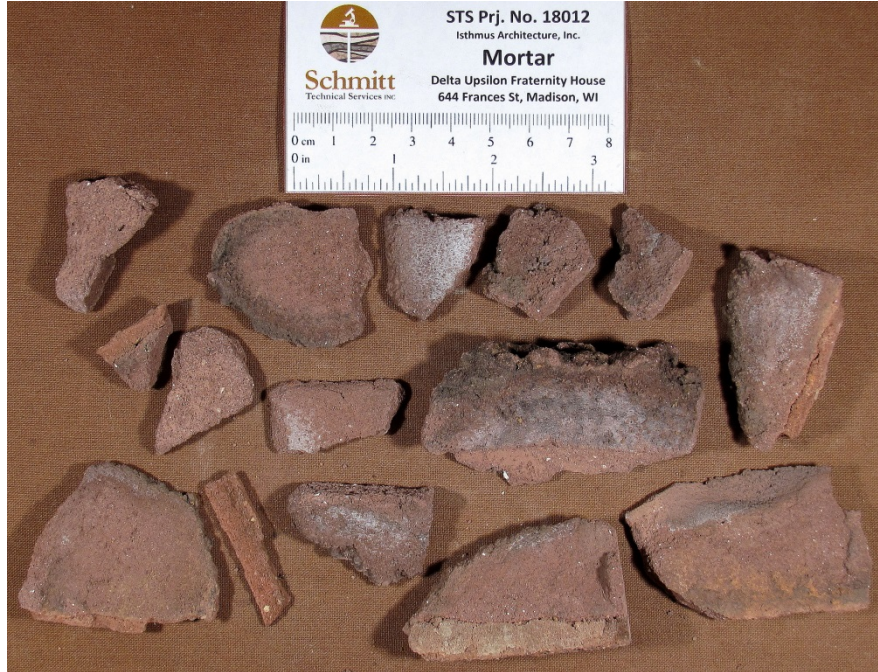
1. Brick test results are reported in the attached Appendix B.
2. The mortar sample is composed of various sized, intact fragments with bed faces intact (Photograph 1). Joint thickness represented by this sample is generally 1/4 to 3/8 in.
3. Some of the mortar fragments have a surface tuckpointing mortar weakly adhering to the exposed face. Tuckpointing mortar thickness ranges from 1/16 to 1/8 in.
4. Bed faces are lightly lined with fine calcium carbonate and ettringite deposits (Photograph 2), indicating significant moisture intrusion with the mortar joints.

Photograph 1. Unlabeled mortar sample in the condition received for testing. Top scale is in centimeters. Bottom scale is in inches.

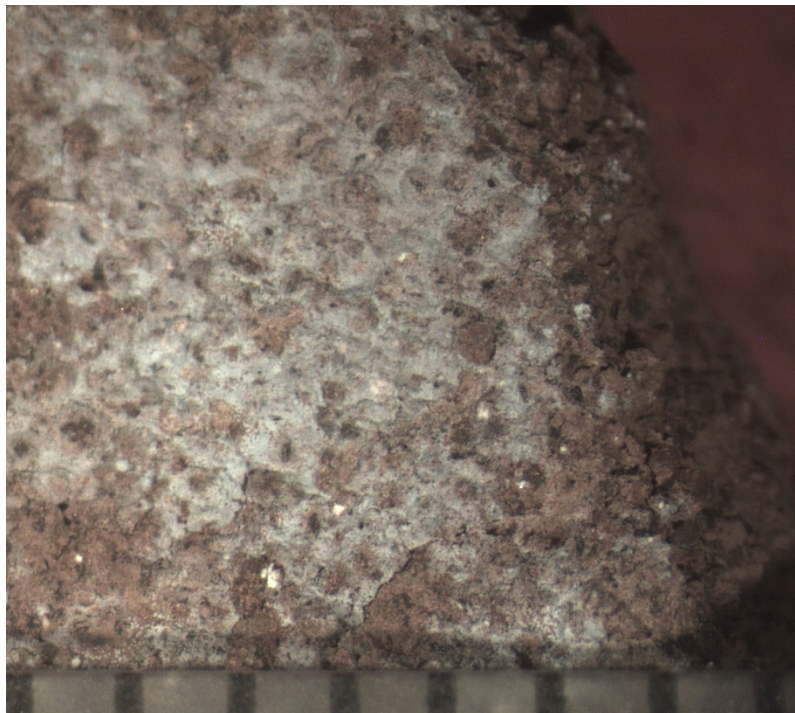
Photograph 2. Photomicrograph illustrating the abundance of white, secondary calcium carbonate along the bed face, indicating significant moisture intrusion along the mortar joints. Scale is in millimeters.

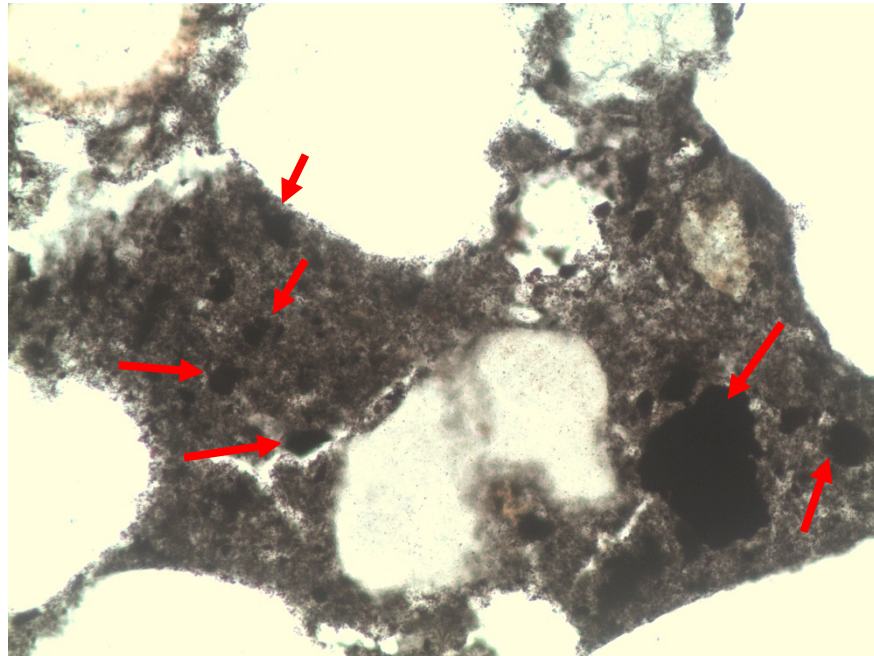
8. The binder or matrix is dark reddish brown due to the presence of naturally occurring hematite as a pigmenting material. The pigment largely masks the microstructural characteristics of the mortar (Photograph 5). The pigment largely ranges from less than 0.001 to 0.010 mm diameter, with some occasional much large particles; and therefore, the pigment grading is poor which is typical of the crude technology of that era. The pigment was likely natural iron ore fines from either the Gogebic or Mesabi Iron Ranges which were both operational at the time of this construction.

Photograph 5. Thin section photomicrograph showing the binder or matrix is dark reddish brown due to the presence of naturally occurring hematite as a pigmenting material (red arrows). The pigment largely masks the microstructural characteristics of the mortar. The pigment largely ranges from less than 0.001 to 0.010 mm diameter, with some occasional much large particles. 200x magnification. Crossed polarized light.

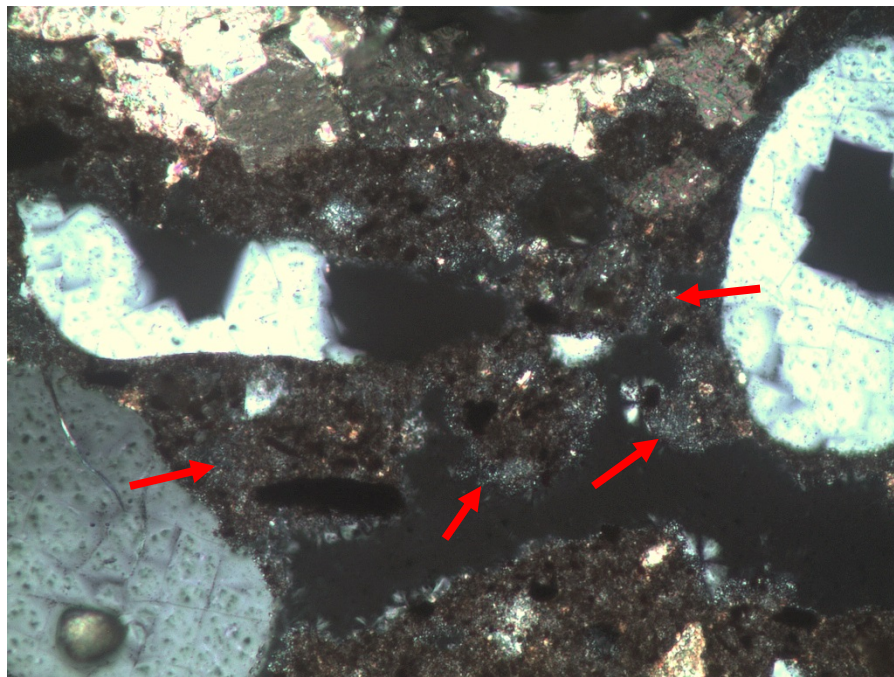
9. Portland cement is not present in the binder. The binder matrix is lime (Photograph 6) and contains the characteristic microscopic shrinkage cracking typical of lime based mortars (Photograph 7). Lime balls and relicts of lime balls are present (Photographs 4 and 8), suggesting incomplete and uneven mixing of the lime. These observations are typical of the period of construction and level of materials technology of the time.

Photograph 6. Thin section photomicrograph showing the grayish color of the matrix that is typical for lime binder mortars (red arrows). 200x magnification. Crossed polarized light.

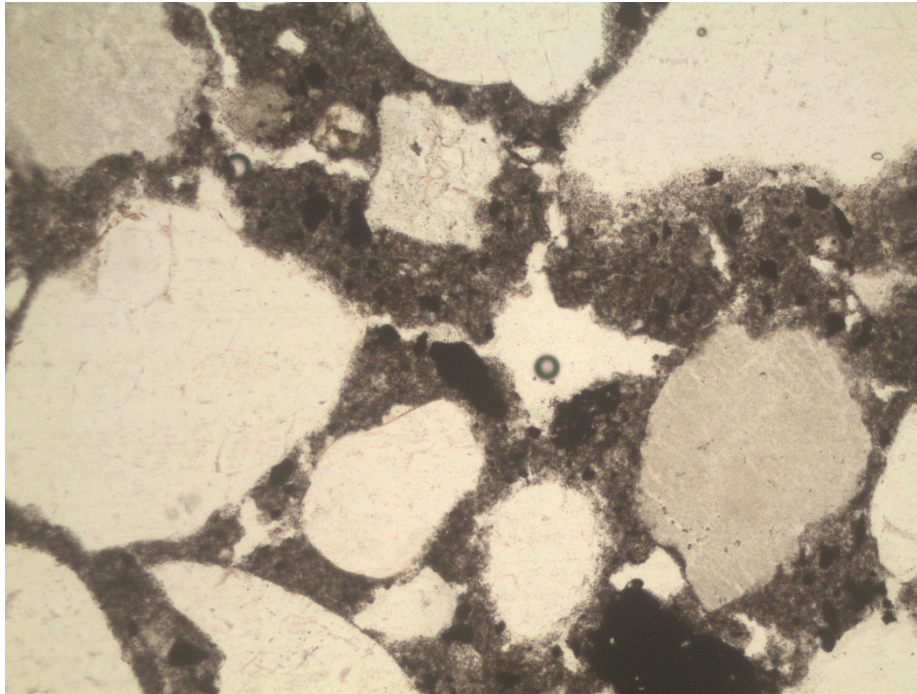
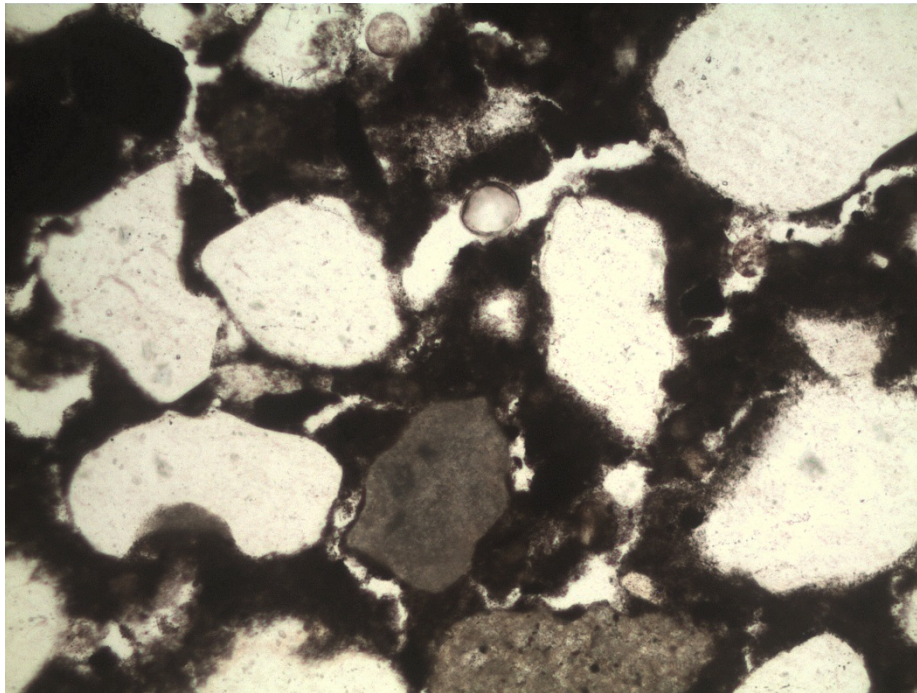
Photograph 7. Thin section photomicrographs depicting characteristic microscopic shrinkage cracking typical of lime based mortars. Plane polarized light. 100x magnification.

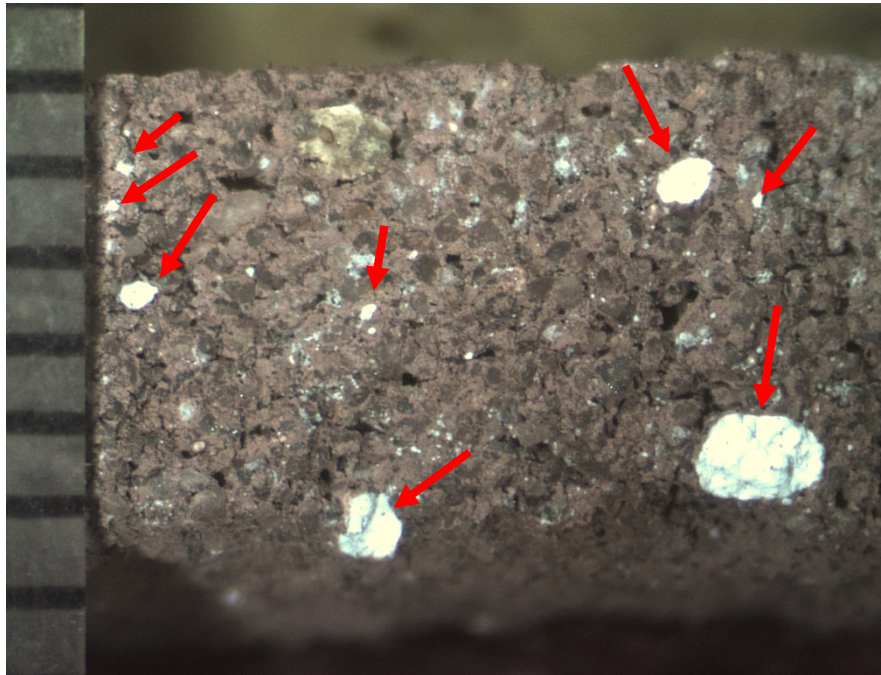
Photograph 8. Photomicrograph illustrating lime balls (red arrows) in the mortar matrix. Scale is in millimeters.
