LANDMARKS COMMISSION APPLICATION

Project Address: 644 FRANCES STREET

Project Title/Description: DELTA UPSILON EXTERIOR RESTORATION

Letter of Intent
City of Madison
Landmarks Commission

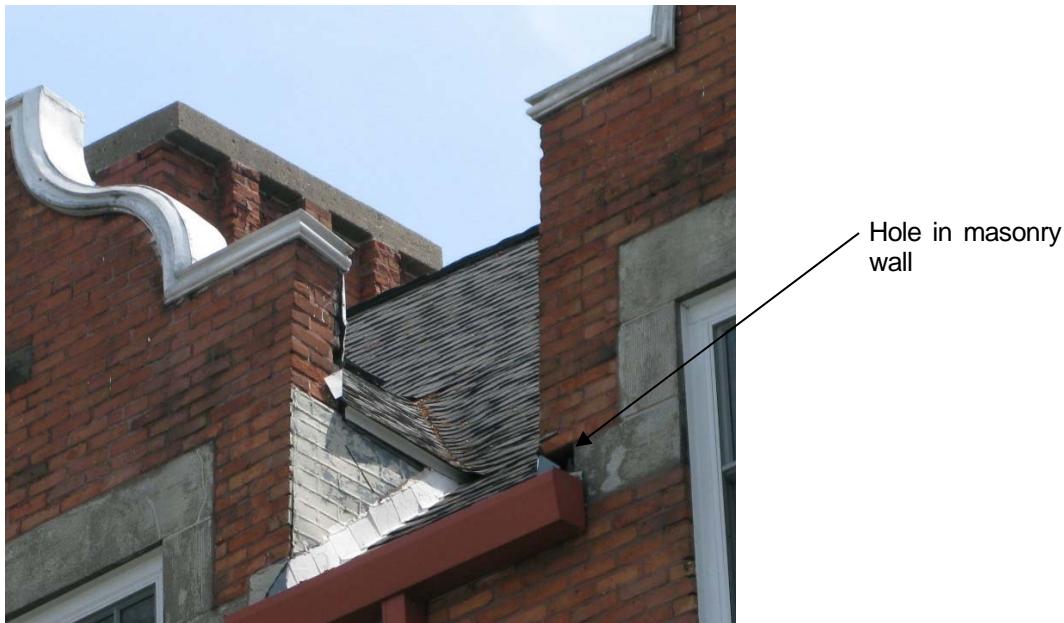
Picture 5971: Immediate Need

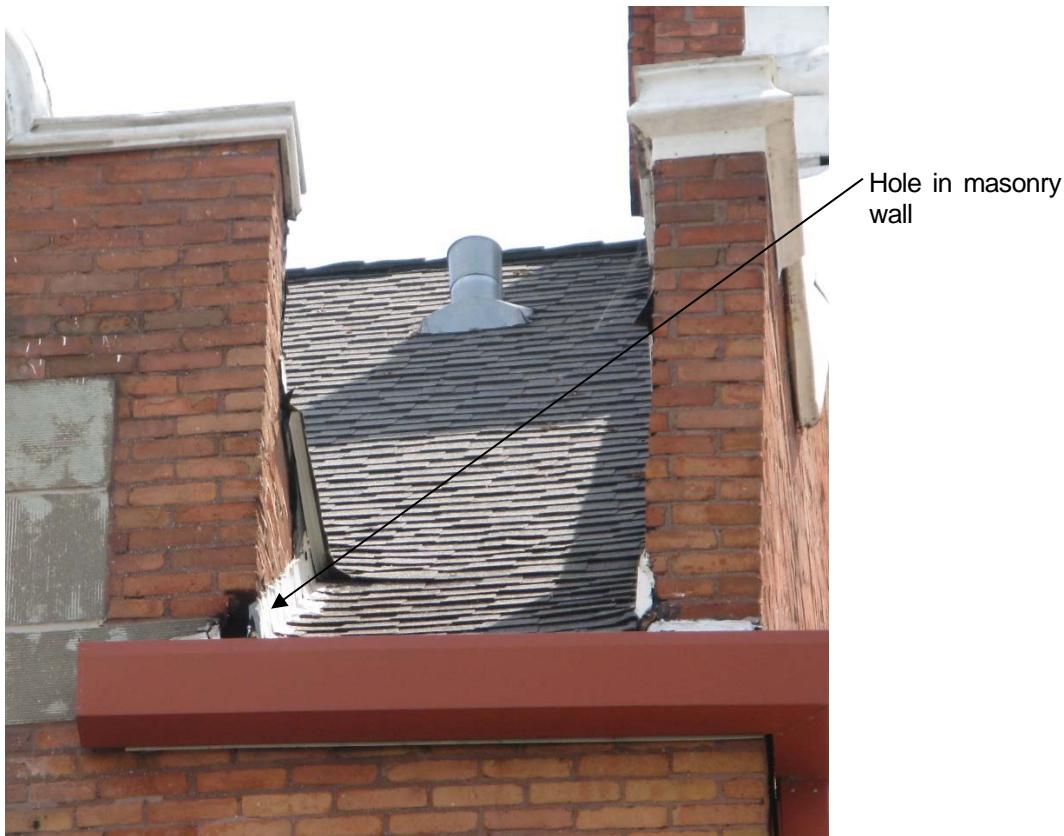
Picture 5976: Immediate Need

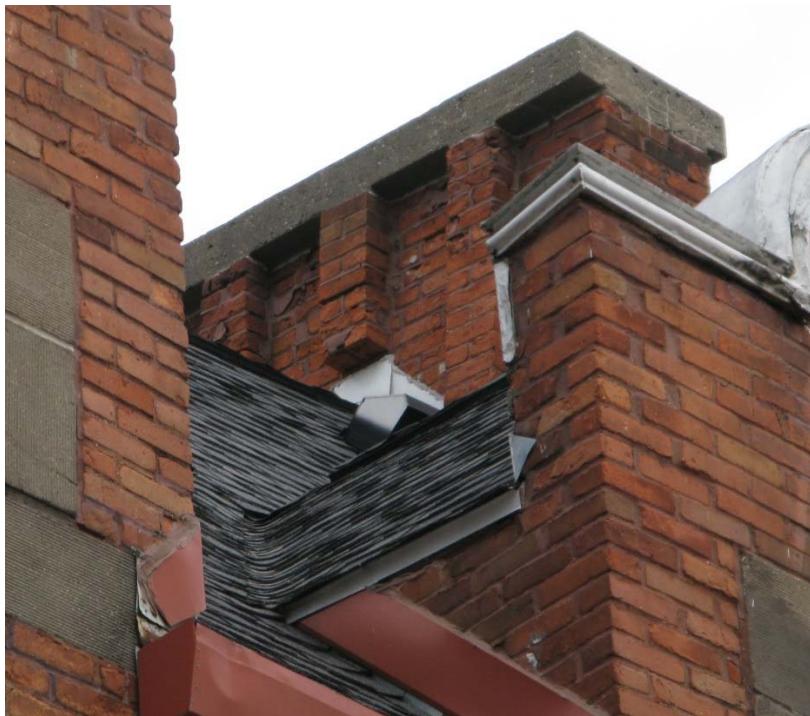
The upper 3 1/2-feet of both chimneys need rebuilding. This amounts to 125 square feet of brick and the replacement of the cast stone caps (see below).

Picture 5956: Chimney repair

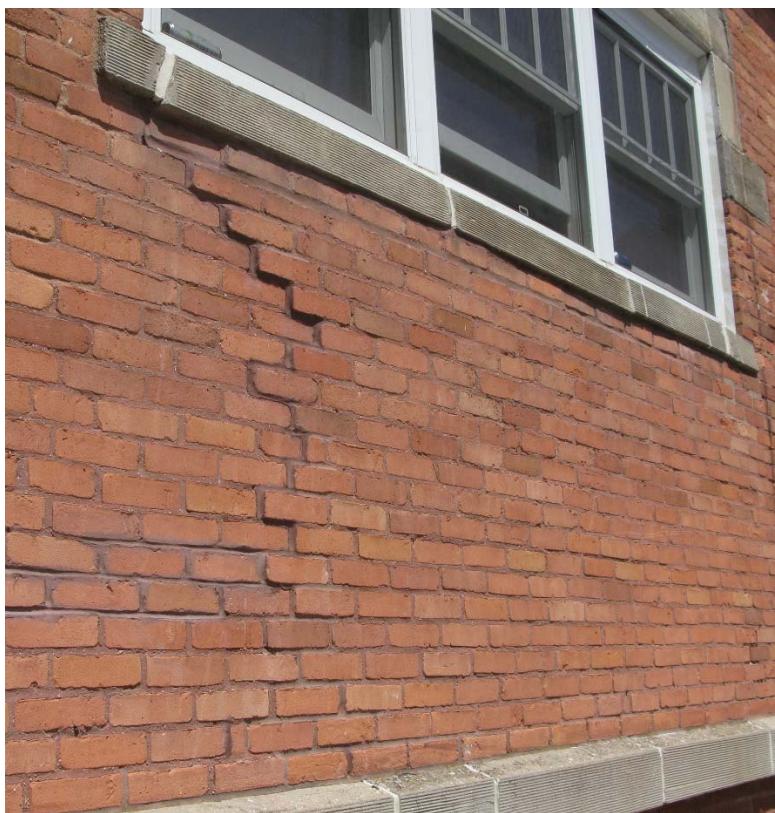
Picture 5960: Crack and bulge

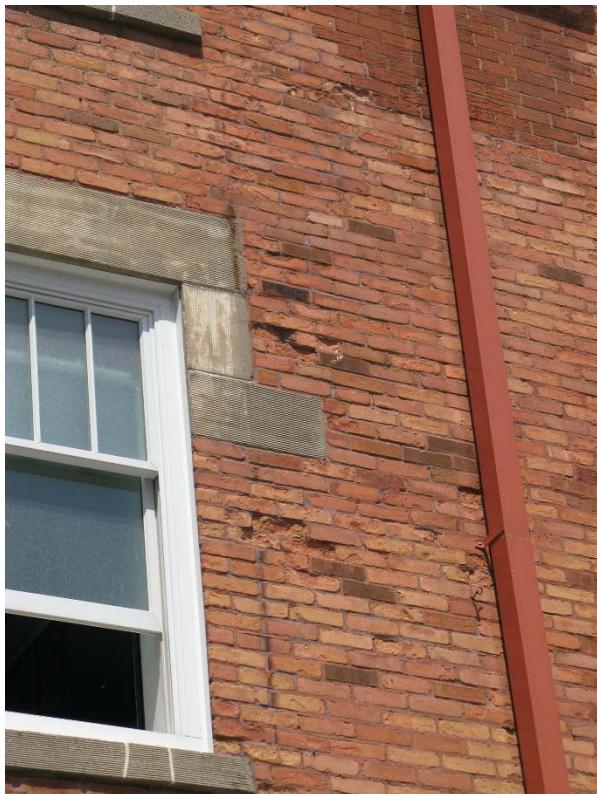
16% to 20% of the brick on the main walls needs replacing. The south elevation has the largest quantity at 270 square feet. The total amount of brick needing replacement is 450 square feet. An additional 200 single brick removal/replacement is needed for miscellaneous deteriorated single brick.

Picture 5961: Typical damaged brick

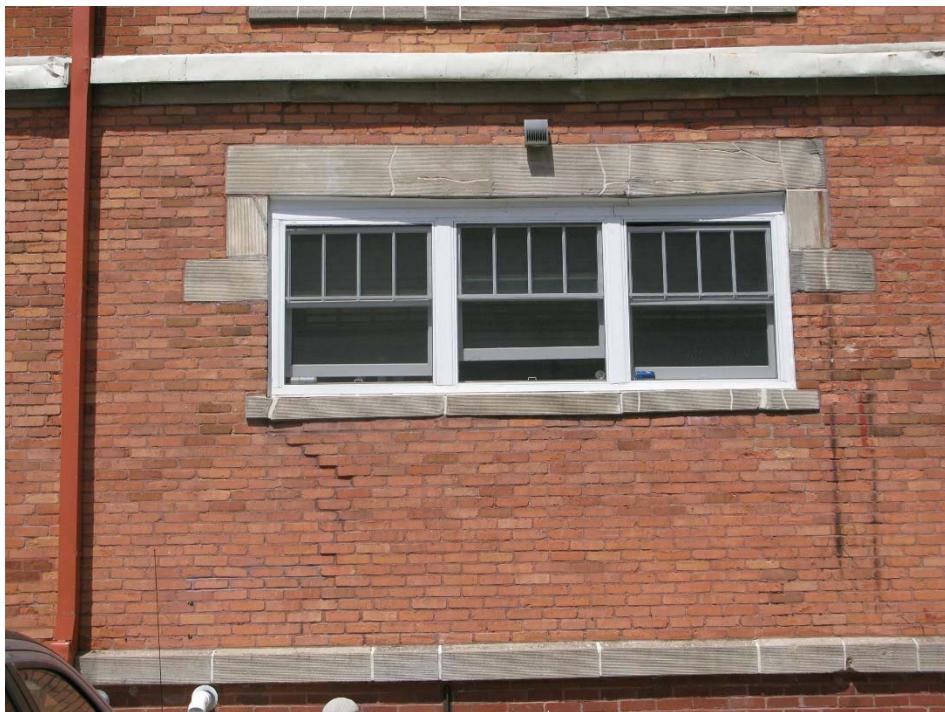
Cast stone is used at each window opening as lintels, sills and accents. The lintels range in size from five-feet long to over twelve-feet long and are self-supporting. At four-inches thick all but one large lintel has failed.

53% (29 out of 55) of the lintels need replacing, 55% (21 out of 38) window sills need replacing, less than 2% (3 out of 168) of the window accents need replacing, 100% of the chimney caps need replacing and 7% of the banding needs replacing. We recommend steel angle lintels be added to the larger window openings to help support the cast stone.

Picture 5963: Typical damaged cast stone lintel

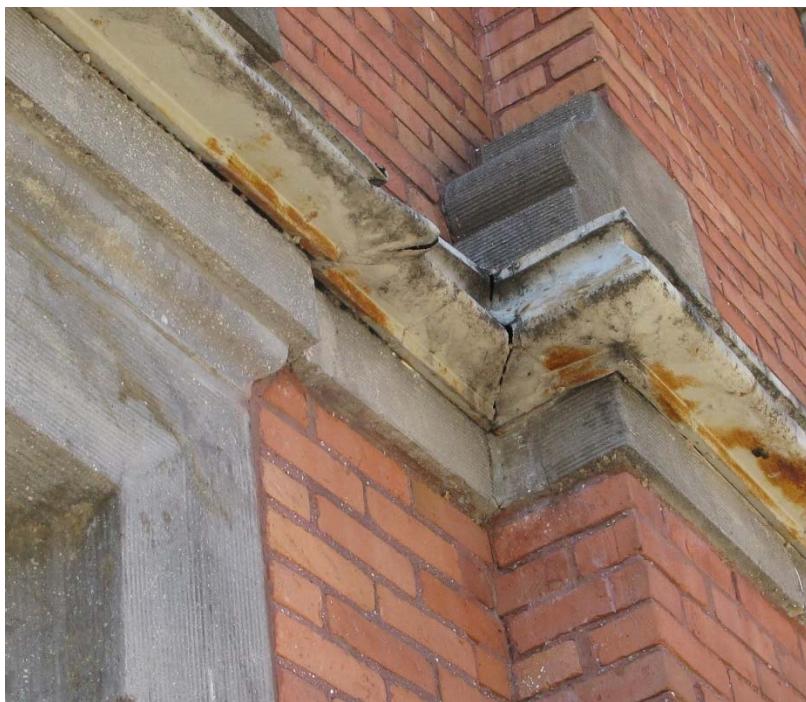
Exterior metal elements include main and small gable coping (caps) and the continuous band located at the third-floor level. 100% of the metal requires replacing. There is 75 lineal feet of main gable coping, 130 lineal feet of small gable coping and 140 lineal feet of banding. Each location has its own profile. The recreation will match the original profiles.

Picture 5913: Damaged original metal banding

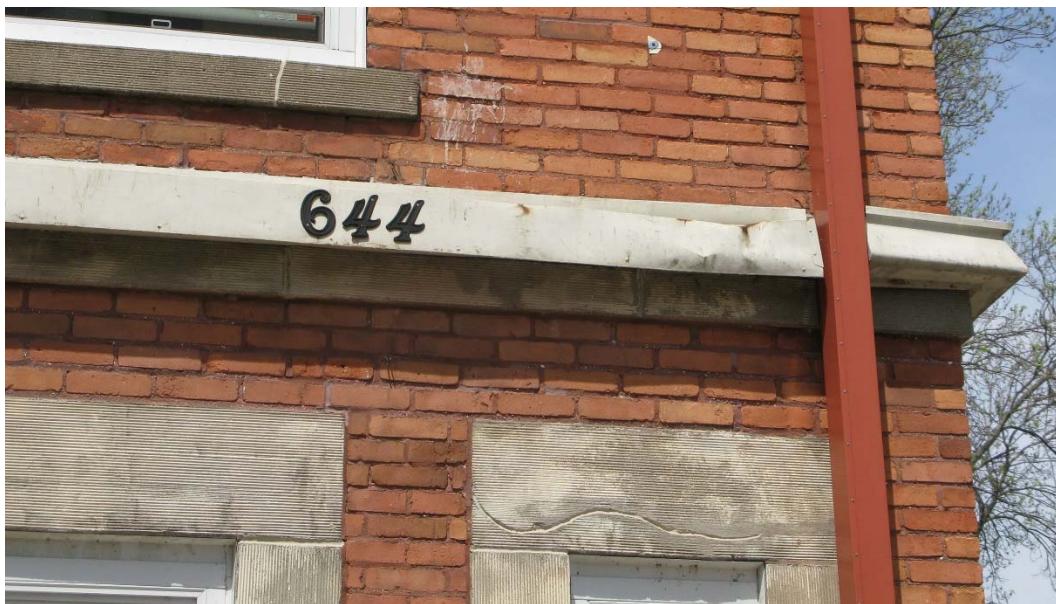
Picture 5977: Damaged non-original metal banding

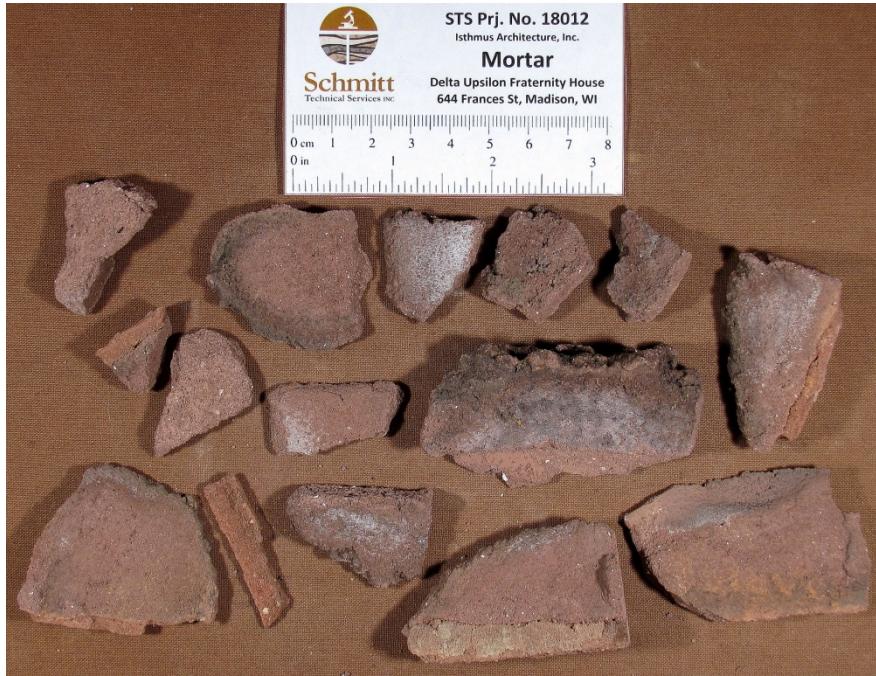
Photograph 1. Unlabeled mortar sample in the condition received for testing. Top scale is in centimeters. Bottom scale is in inches.

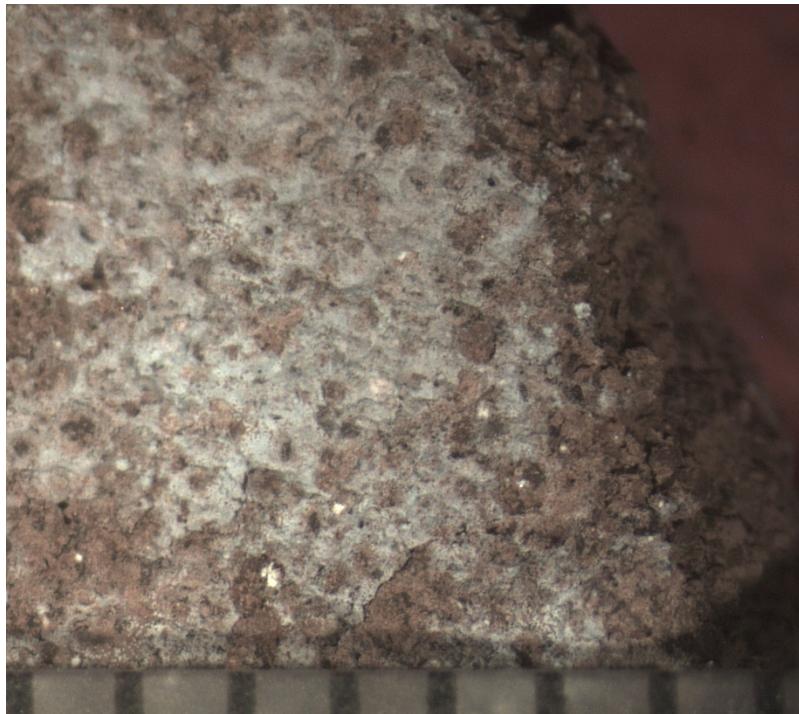
1. Brick test results are reported in the attached Appendix B.
2. The mortar sample is composed of various sized, intact fragments with bed faces intact (Photograph 1). Joint thickness represented by this sample is generally 1/4 to 3/8 in.
3. Some of the mortar fragments have a surface tuckpointing mortar weakly adhering to the exposed face. Tuckpointing mortar thickness ranges from 1/16 to 1/8 in.
4. Bed faces are lightly lined with fine calcium carbonate and ettringite deposits (Photograph 2), indicating significant moisture intrusion with the mortar joints.

Photograph 2. Photomicrograph illustrating the abundance of white, secondary calcium carbonate along the bed face, indicating significant moisture intrusion along the mortar joints. Scale is in millimeters.

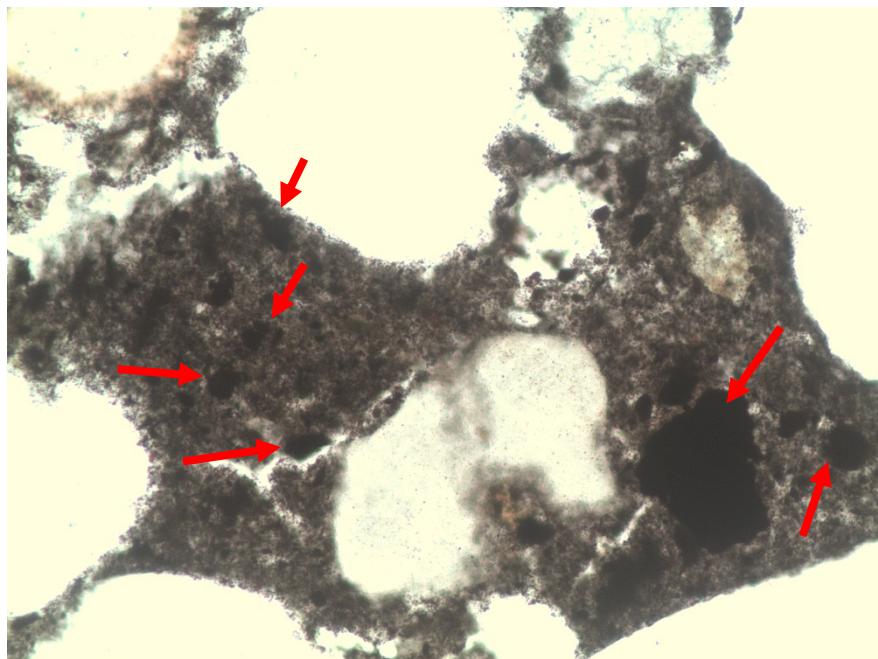
8. The binder or matrix is dark reddish brown due to the presence of naturally occurring hematite as a pigmenting material. The pigment largely masks the microstructural characteristics of the mortar (Photograph 5). The pigment largely ranges from less than 0.001 to 0.010 mm diameter, with some occasional much large particles; and therefore, the pigment grading is poor which is typical of the crude technology of that era. The pigment was likely natural iron ore fines from either the Gogebic or Mesabi Iron Ranges which were both operational at the time of this construction.

Photograph 5. Thin section photomicrograph showing the binder or matrix is dark reddish brown due to the presence of naturally occurring hematite as a pigmenting material (red arrows). The pigment largely masks the microstructural characteristics of the mortar. The pigment largely ranges from less than 0.001 to 0.010 mm diameter, with some occasional much large particles. 200x magnification. Crossed polarized light.

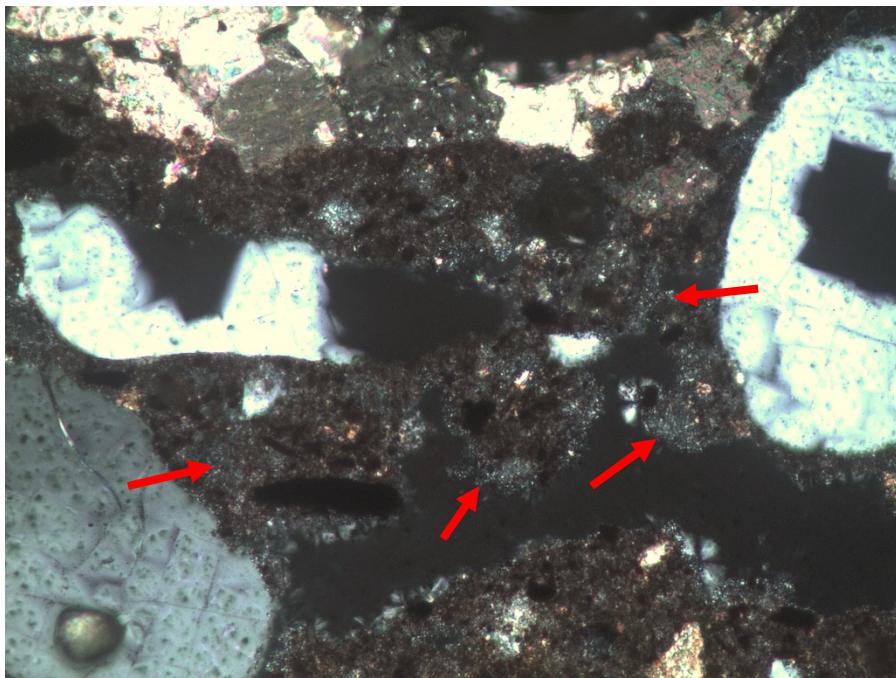
9. Portland cement is not present in the binder. The binder matrix is lime (Photograph 6) and contains the characteristic microscopic shrinkage cracking typical of lime based mortars (Photograph 7). Lime balls and relicts of lime balls are present (Photographs 4 and 8), suggesting incomplete and uneven mixing of the lime. These observations are typical of the period of construction and level of materials technology of the time.

Photograph 6. Thin section photomicrograph showing the grayish color of the matrix that is typical for lime binder mortars (red arrows). 200x magnification. Crossed polarized light.

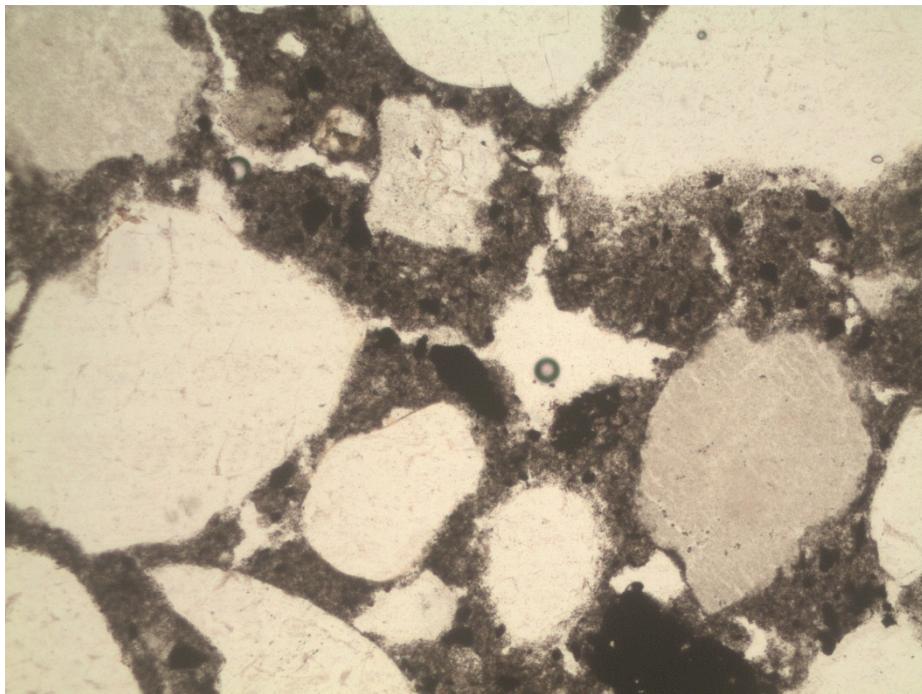
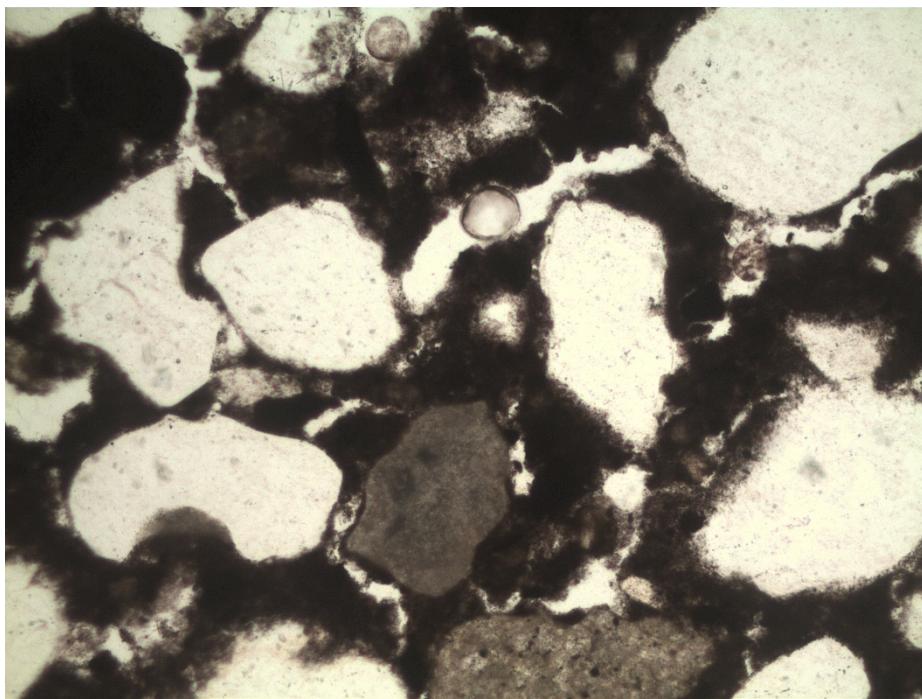
Photograph 7. Thin section photomicrographs depicting characteristic microscopic shrinkage cracking typical of lime based mortars. Plane polarized light. 100x magnification.
