# City of Madison

## Proposed Demolition

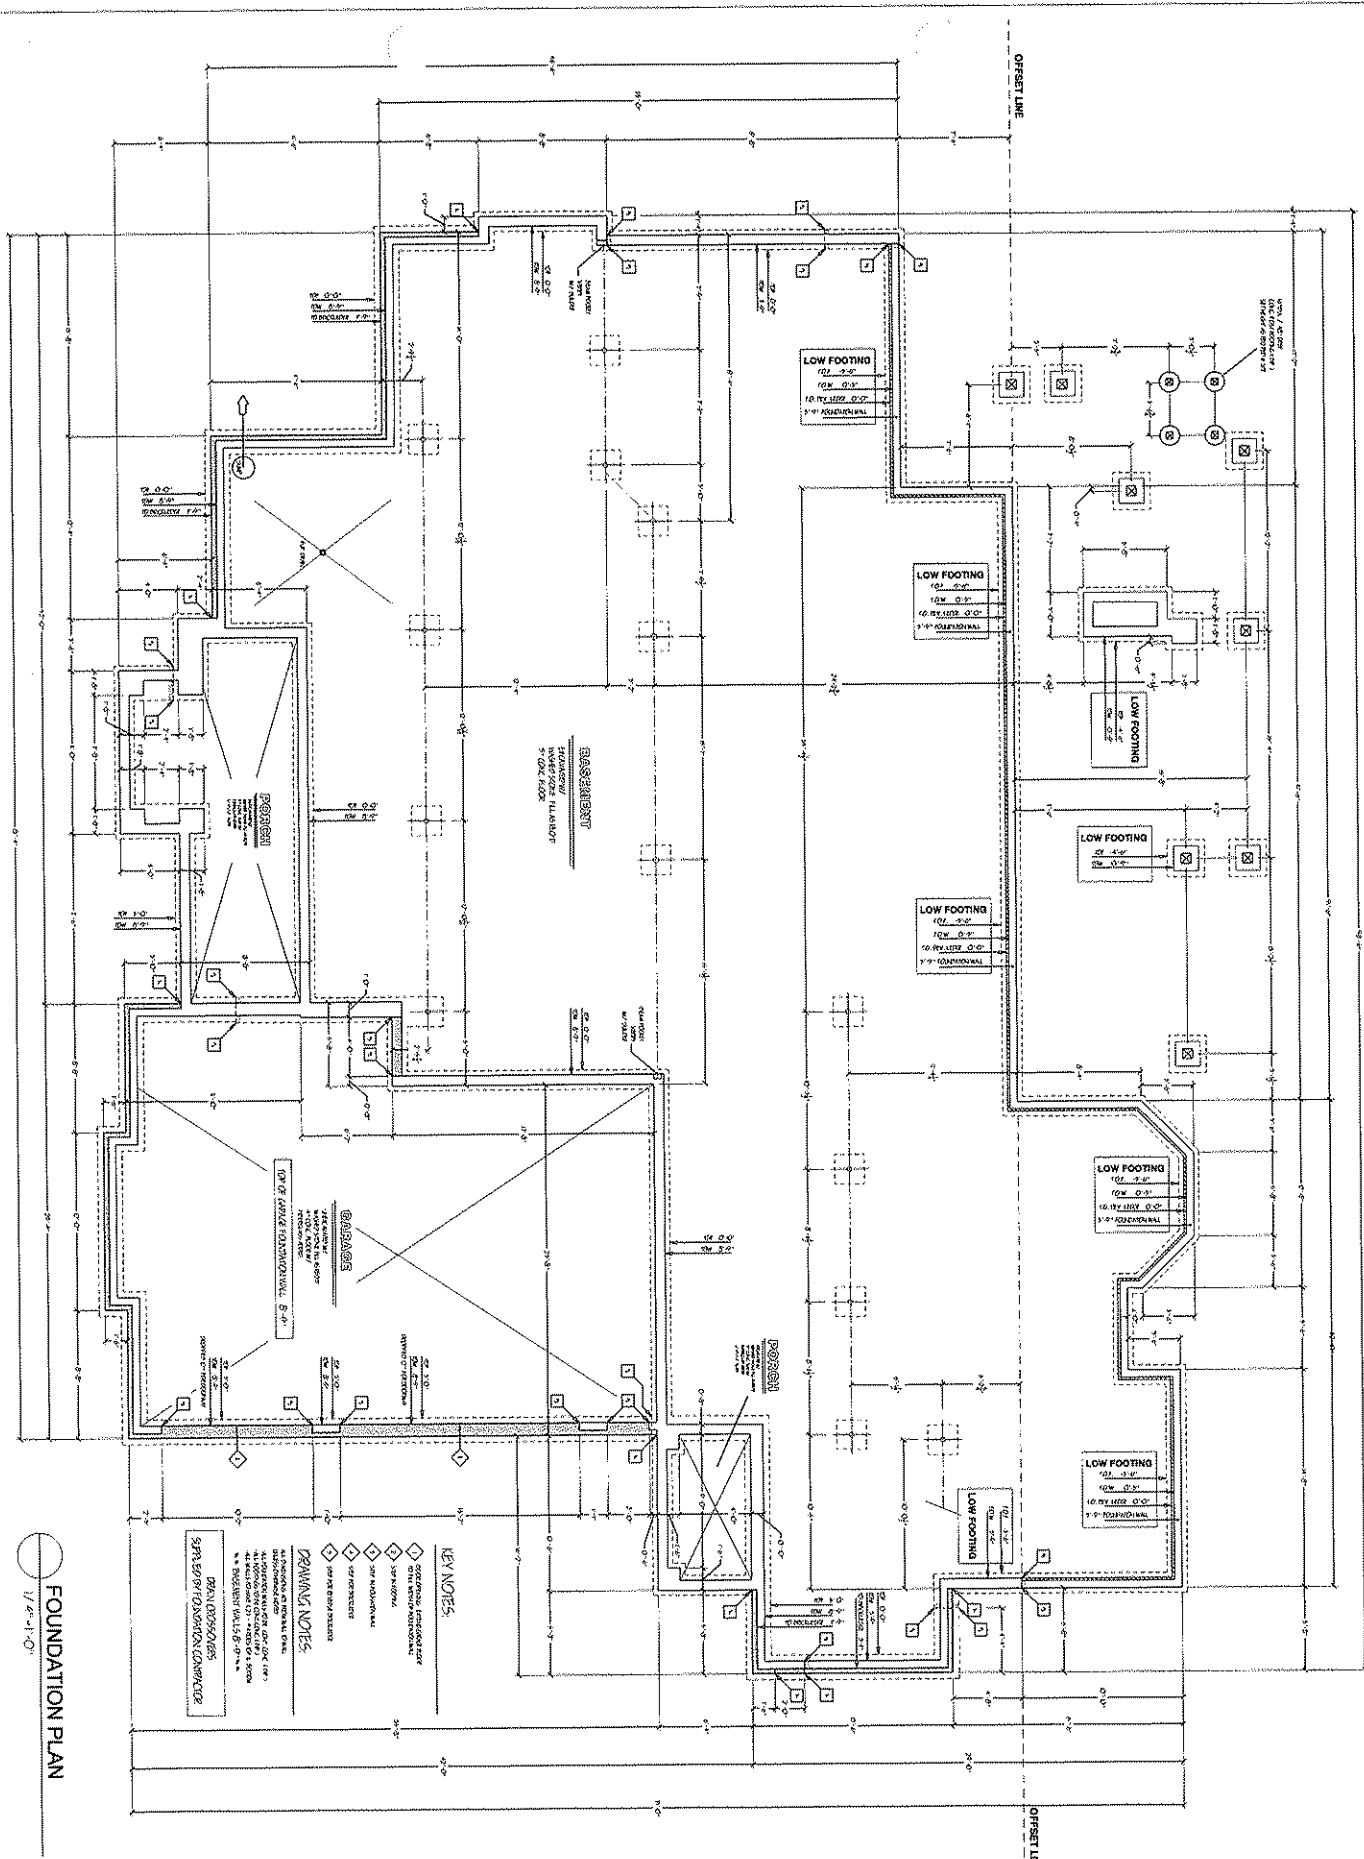
FOUNDATION PLAN  
1/8" = 1'-0"

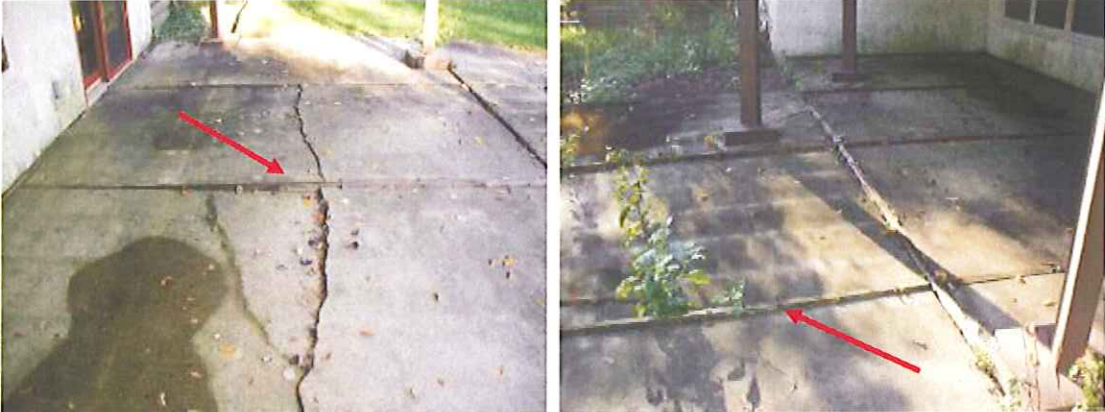
**Concrete patio has cracked and settled towards home creating trip hazards; recommend replacement of patio.**

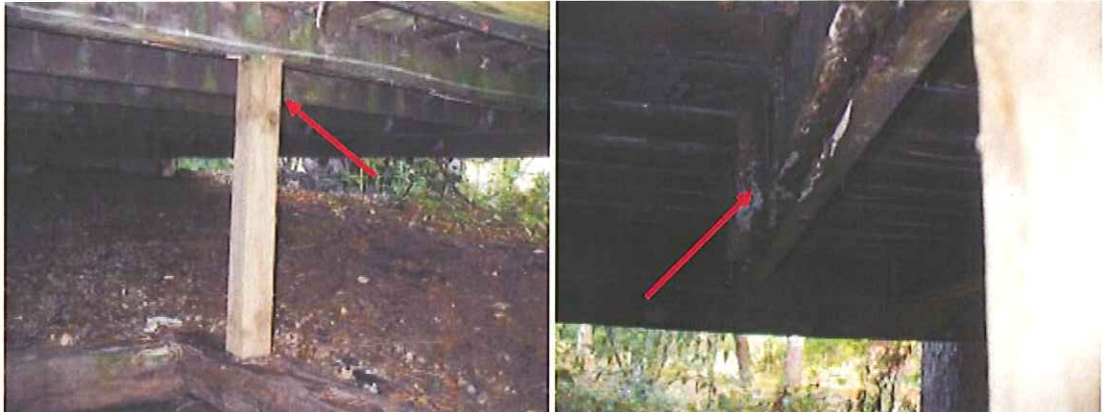
**Severe wood rot to deck floor joists and decking; recommend replacement of decks. Wood support post was added to prevent floor from collapsing.**

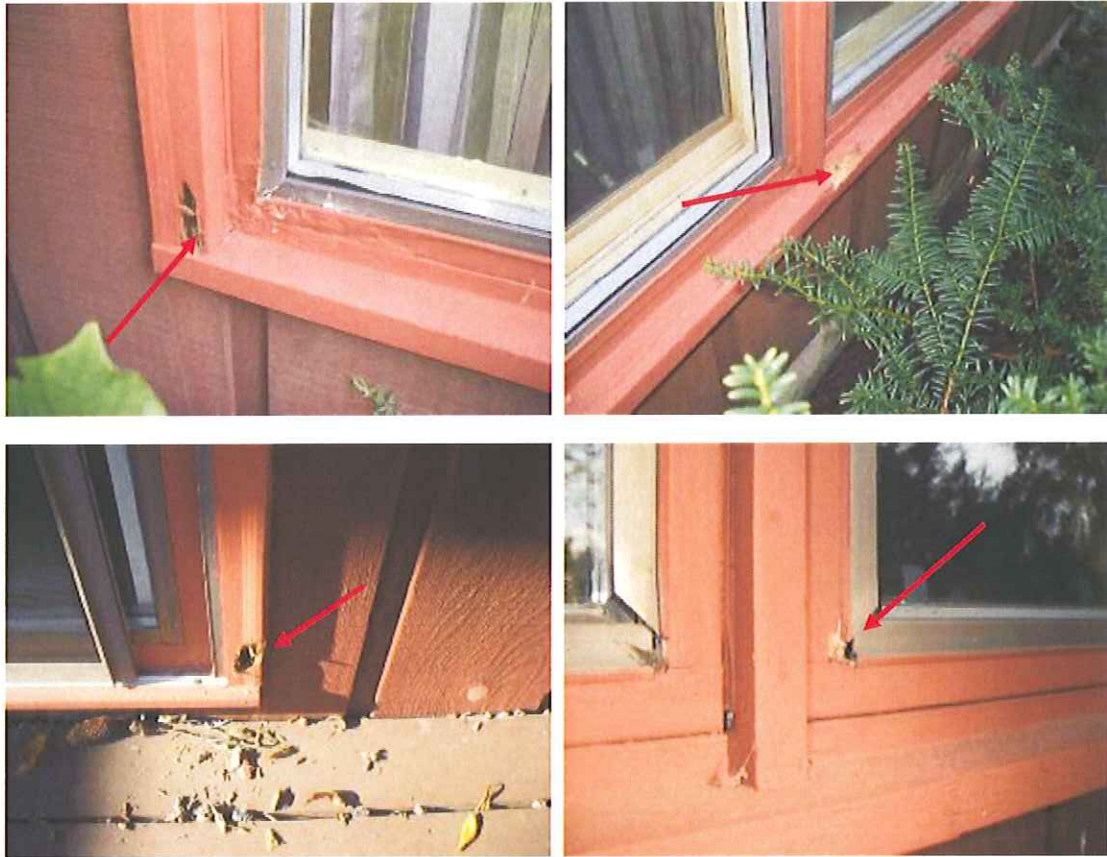
Wood rot around window sills, frames and patio door frames. Wood was painted over to hide wood rot. Majority of windows and door frames are in need of replacement.

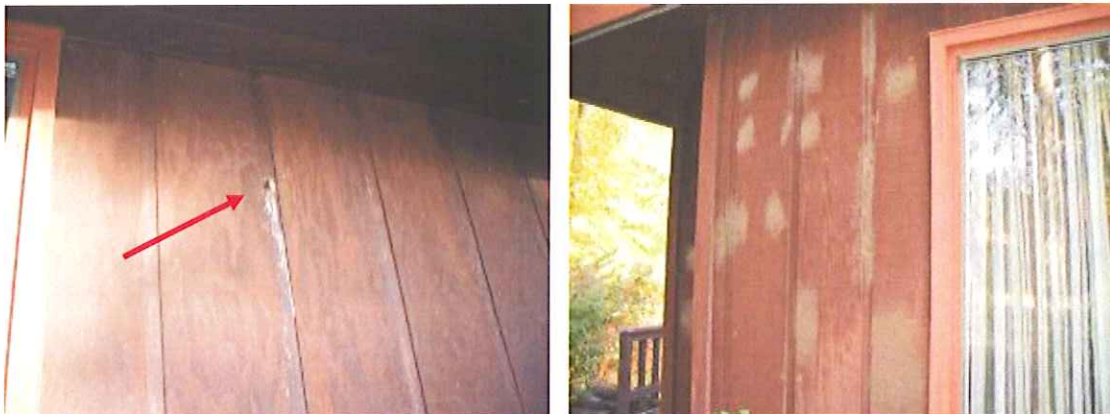
LP T-11 siding manufacturer has had a class action lawsuit against them due to premature rotting and warping of wood. Siding has been damaged over the years by woodpeckers and has large holes in it; recommend replacement.

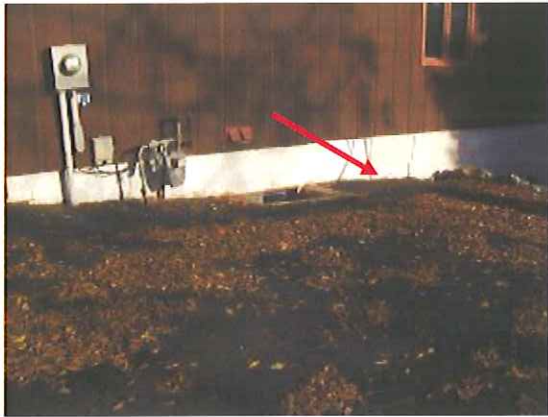
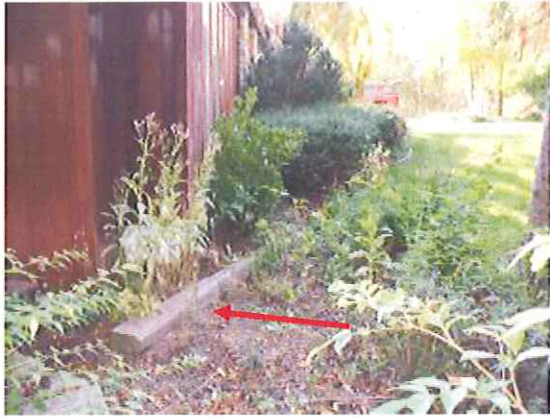
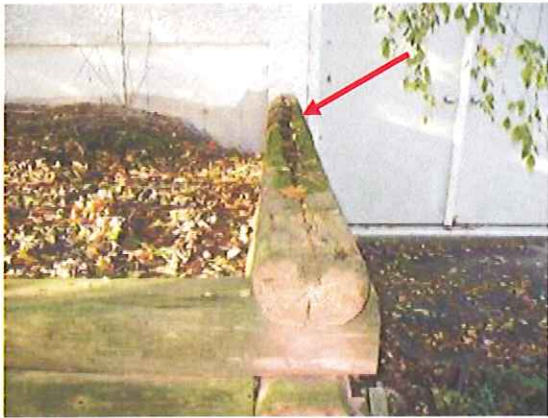
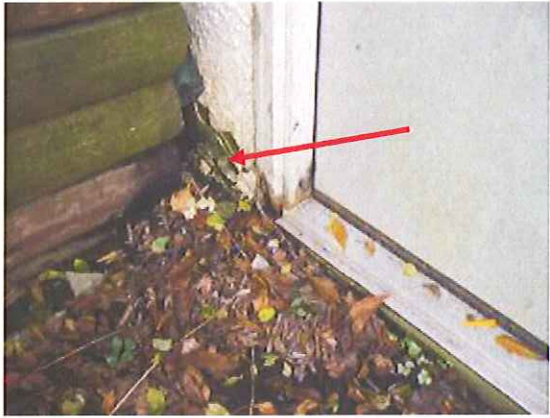
**Improper drainage around exterior of home, landscaping is pitched towards foundation allowing water seepage into basement rotting door frames and wood wall supports. Wood retaining wall is also rotted and is leaning. Recommend re-grading of landscape to maintain positive drainage and rebuilding of retaining walls.**

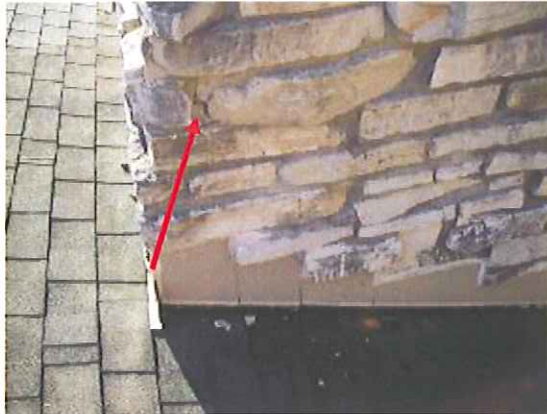
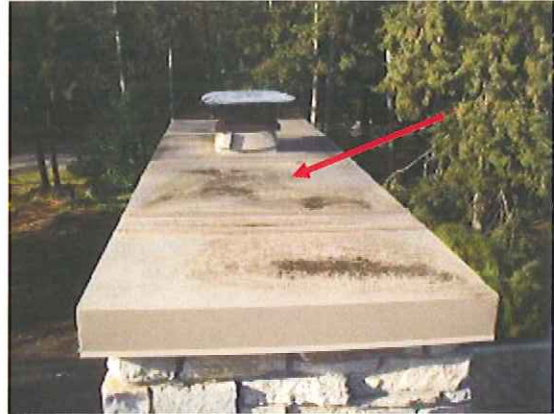
**Mortar around chimney stone is cracking and falling out causing loose stones; recommend professional mason tuck point stone. Metal chimney caps were not properly pitched so water would run off, eventually caps will rust and leakage will occur.**

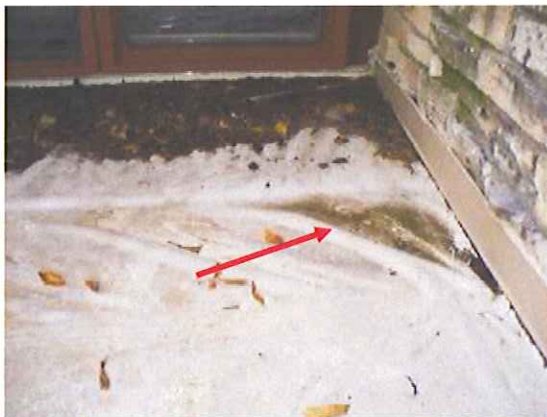
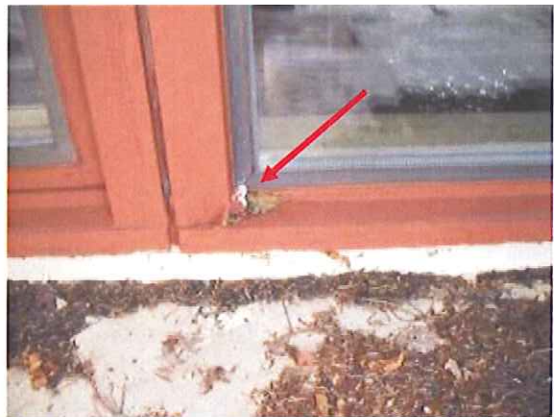
**Rubber roofing over front entry was properly installed allowing water to pond towards interior windows causing wood frames too rot.**

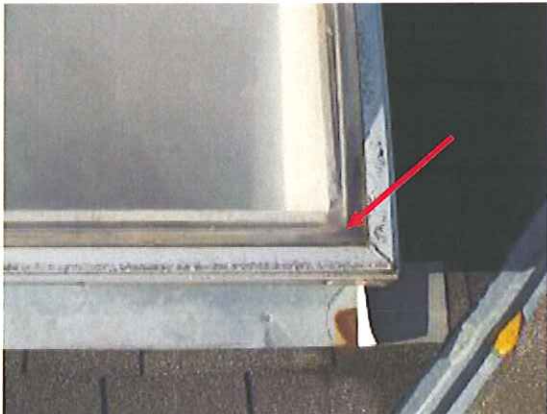
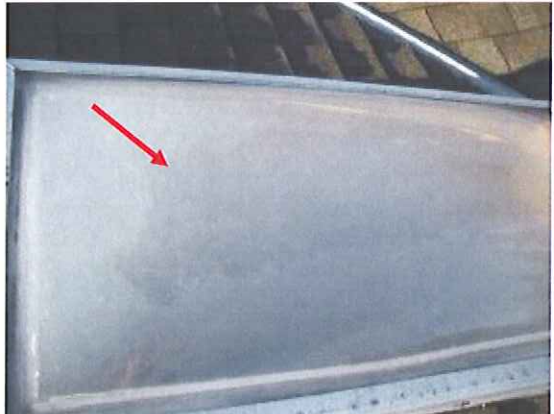
**Skylights (4) on roof have failing thermo pane seals and condensation around windows has leaked into attic causing wood rot to roof sheathing.**

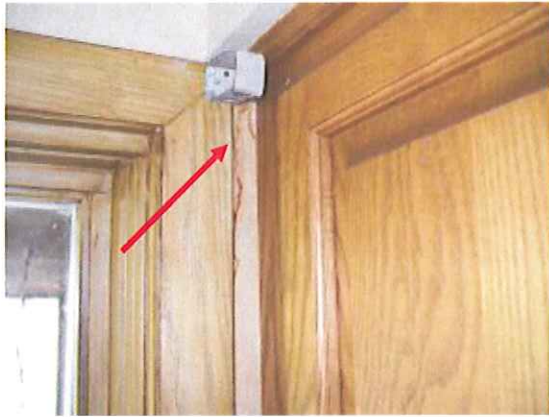
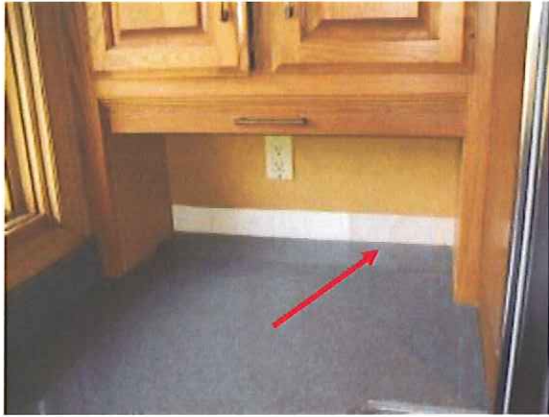
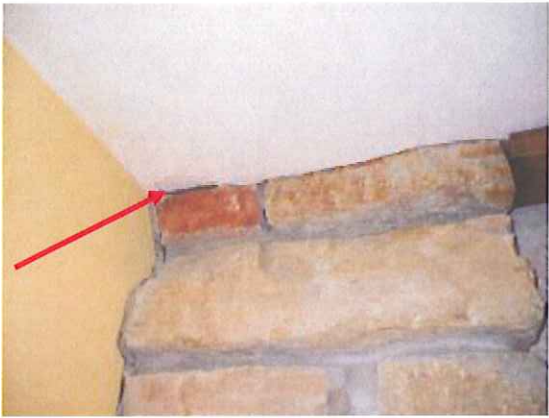
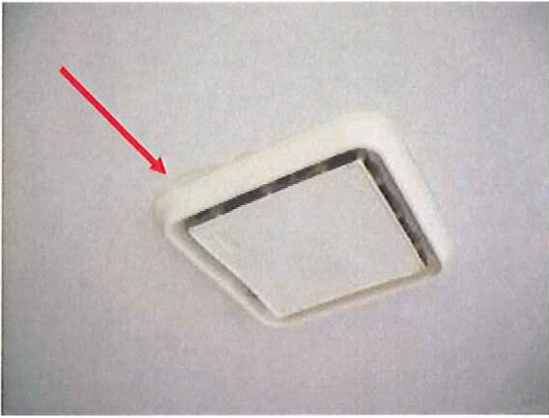
Moisture stains on kitchen walls, above family room fireplace and around bathroom vent show that roof has had leakage and many damaged areas have been covered with paint.

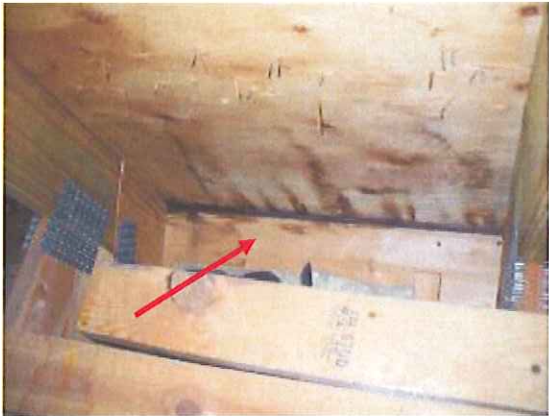
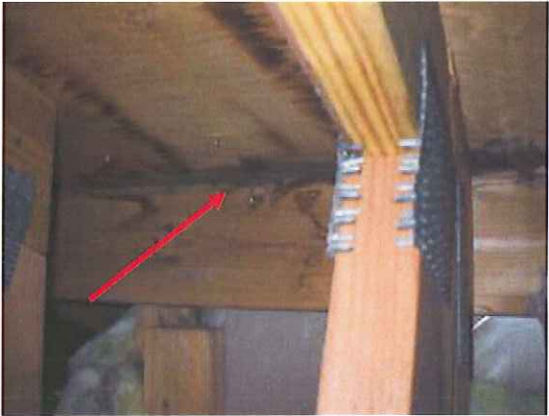
This confidential report is prepared exclusively for Hart DeNoble Builders  
© 2008 Haack Homestead Inspections, LLC.

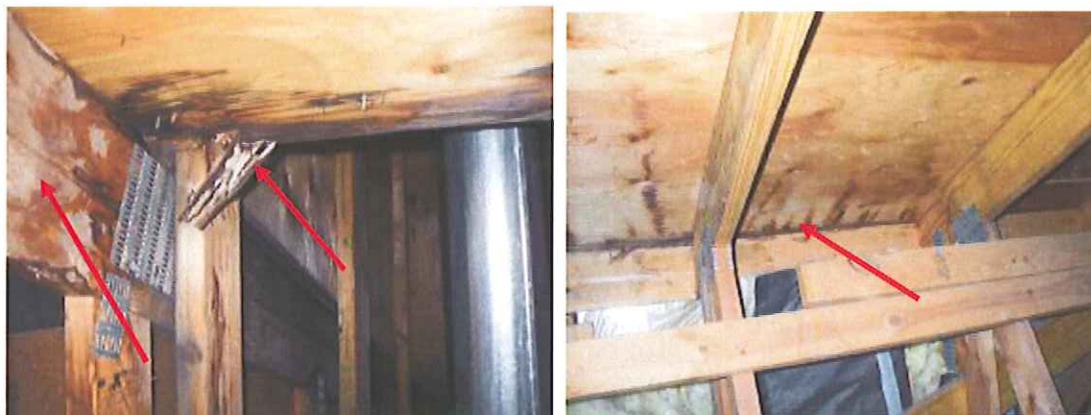
**Moisture damage to roof sheathing in attic and trusses around skylights. Possible mold like substance was noted in these areas.**

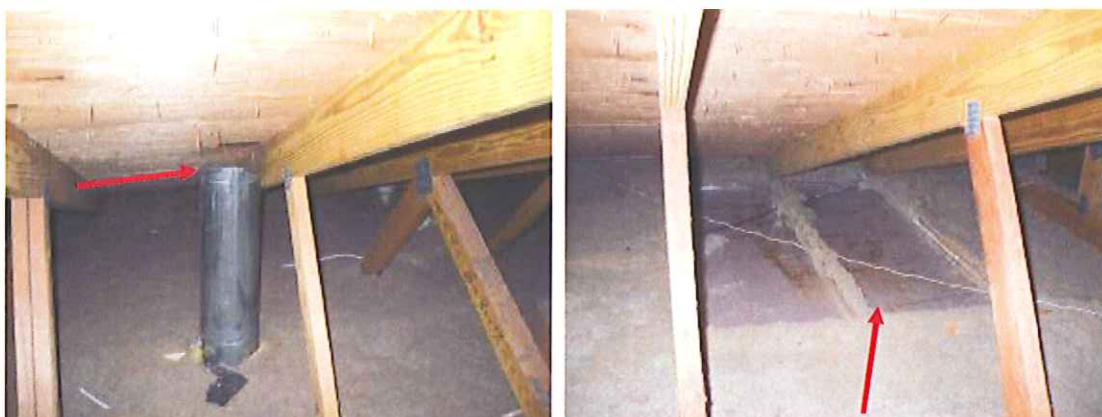
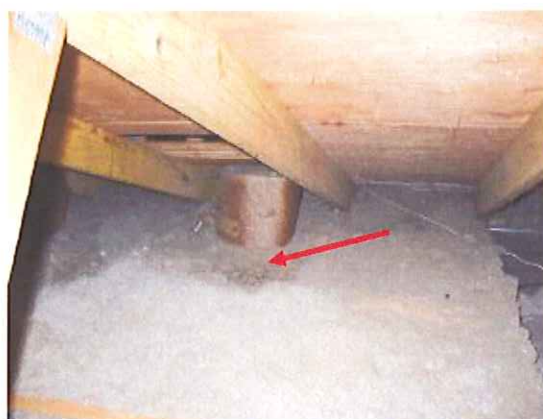
**Kitchen fan exhaust is not properly venting to the exterior of home. Insulation has been displaced and R-value is very low. Bottom picture shows where moisture has leaked onto insulation, this area is above moisture stains in kitchen.**

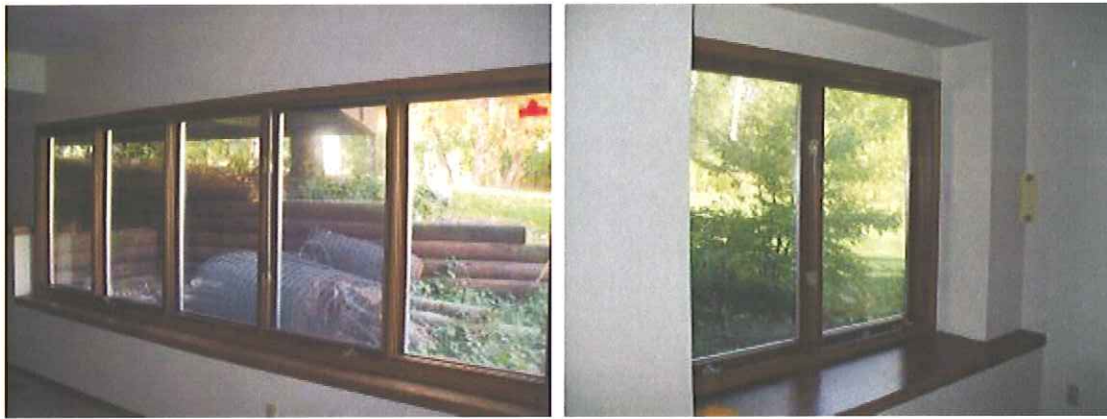
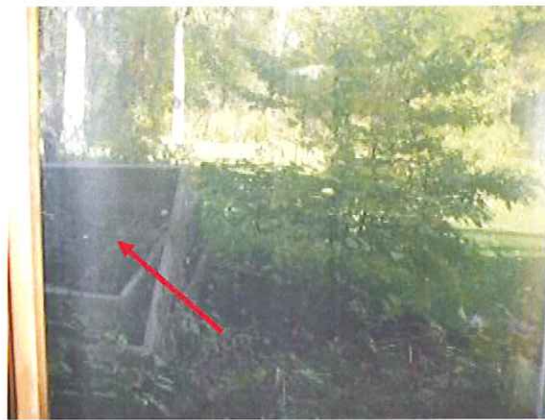
Windows on west wall in basement have failed thermo pane seals allowing moisture in between glass panels.

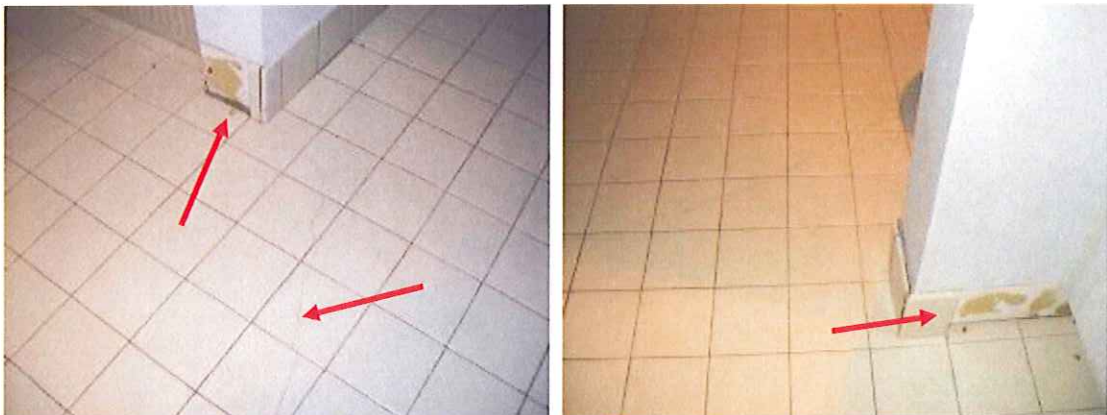
Missing wall tiles and cracked floor tiles in basement bathroom.

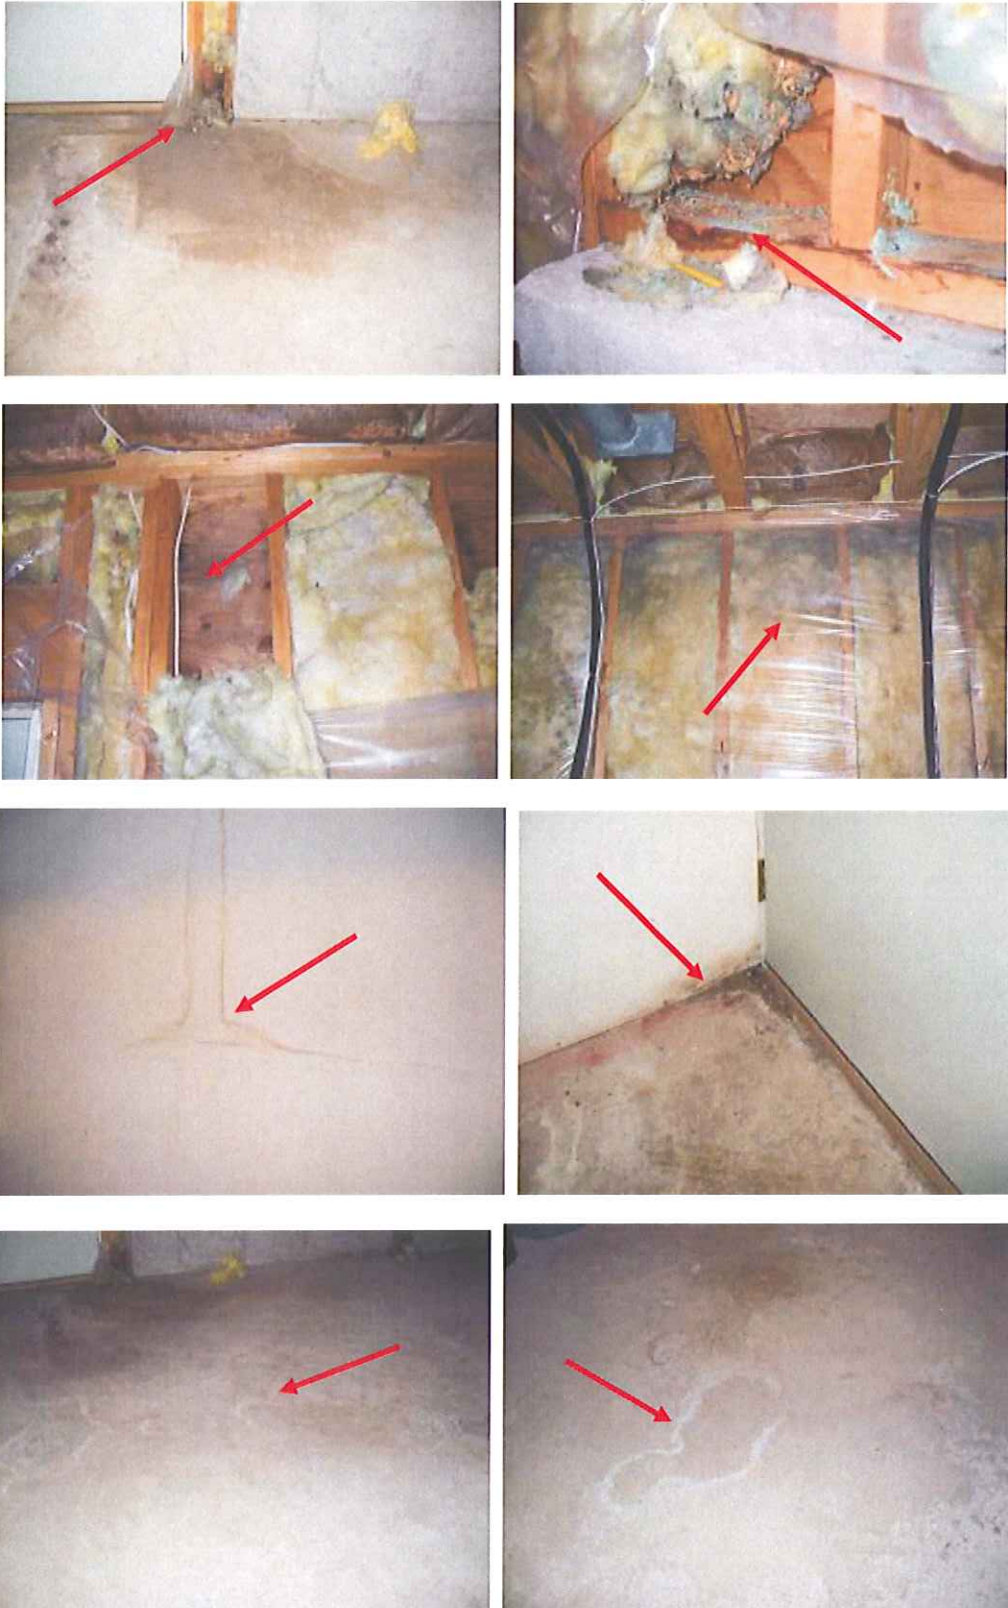
Areas of water seepage on floor, moisture damage and possible mold growth on insulation, walls and floor in furnace room.

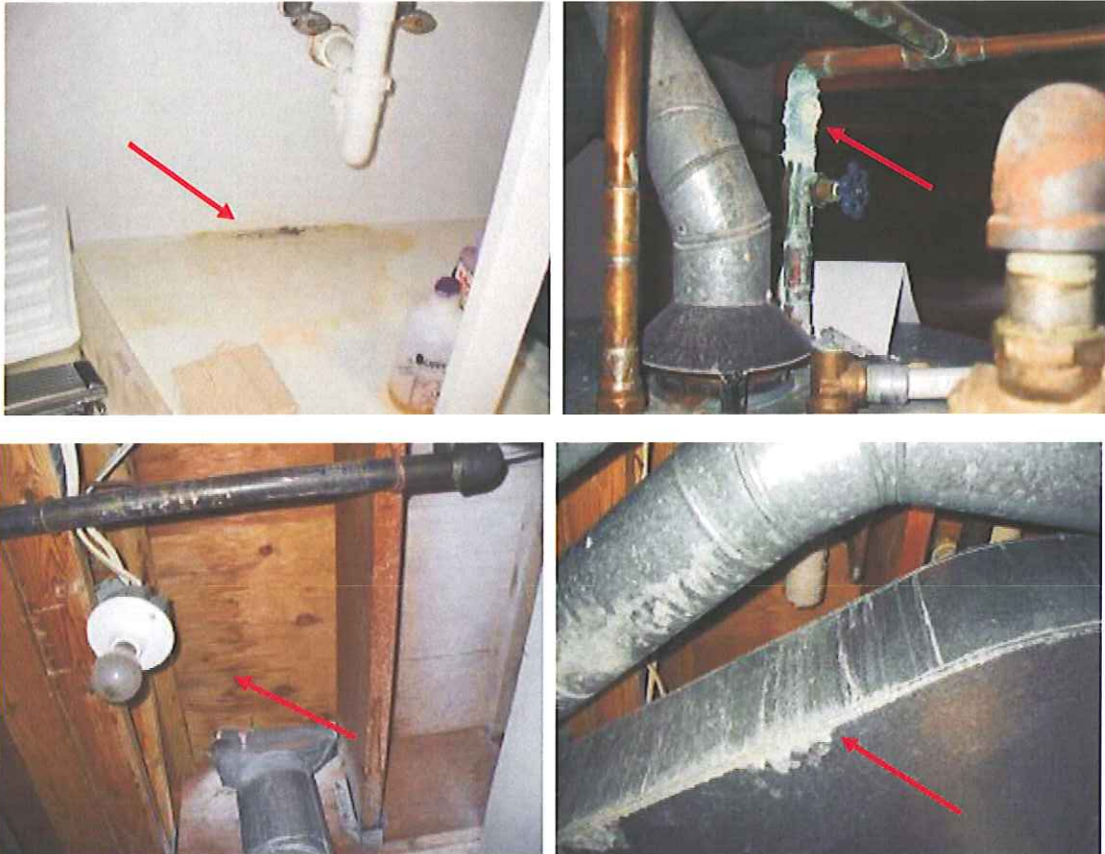
**Recommend plumber repair leaking drain pipe under sink in hallway bathroom, corroded and leaking water pipe on hot water heater and evaluate leakage stains on sub flooring and ductwork in furnace room.**

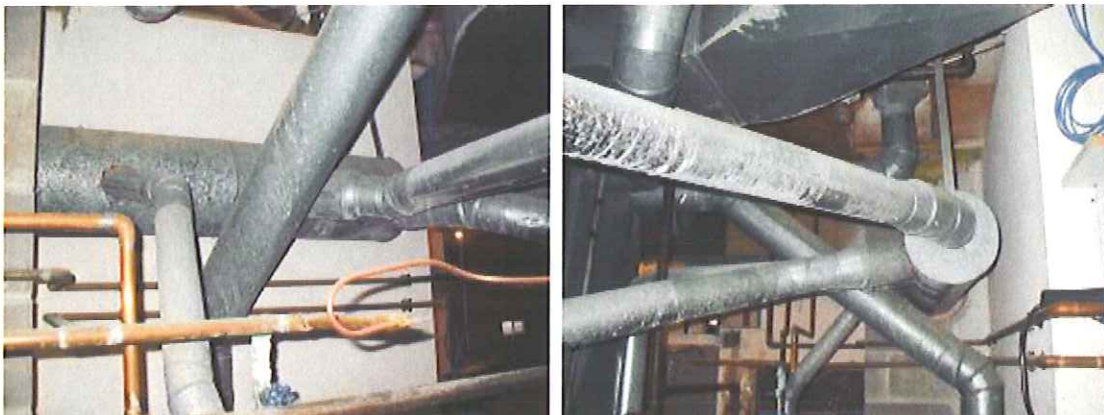
**All three furnaces and hot water heater vent into one flue pipe and chimney flue. Recommend having HVAC technician evaluate and bring exhaust piping up to code.**

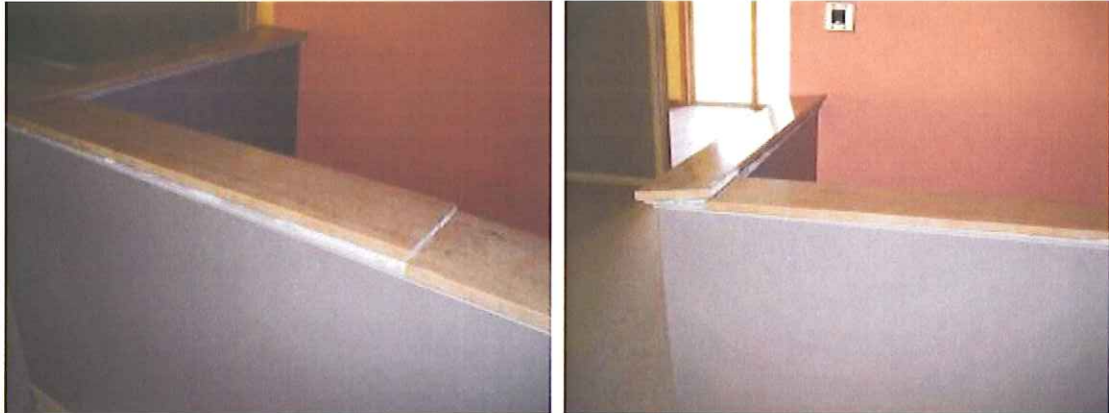
**Granite slabs on top of basement stairs are not properly secured down and could be possibly knocked off and down staircase.**
