March 18, 2013

**SUBJECT: 622 & 632 Howard Avenue Apartments  
Structural Assessment  
MP-Squared Project No: 1310034WI**

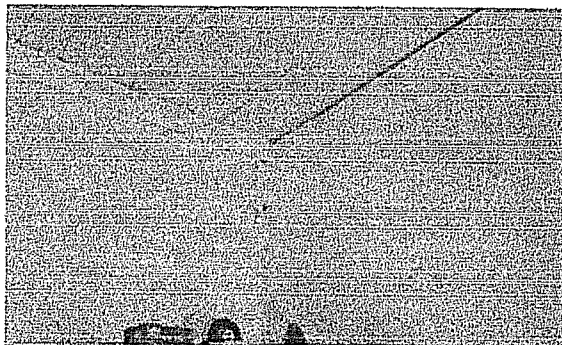
Nearly all the framing in the building is covered with wall/floor/ceiling sheathing; however, structural concerns are noticeable passively throughout the building. There are two "bump-outs" – one at the front of and one in the back of the building. Each bump-out appears to have once been an exterior, perhaps three season, porch that has been converted to livable space. There is a significant change in elevation between the main structure and the bump-out. Also, there appears to be differential movement between the bump-out and the main structure as seen by peeling paint at the intersection of the bump-out to the main building (see Photo 1); additionally, via conversations with the building

Photo 1: Peeling paint at joint between bump-out and main structure.

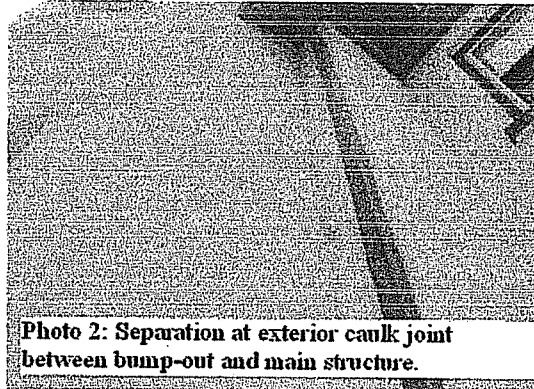
owner re caulking of exterior joint of the bump-out to the main structure, the caulking is replaced every one to two years because of visible separation (see Photo 2). The bump-out may not have a typical frost wall foundation which could be the cause of the relative movement.

Photo 2: Separation at exterior caulk joint between bump-out and main structure.

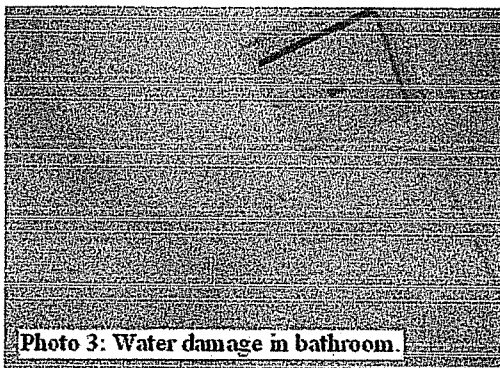
There are "soft" spots felt throughout the building. These may be due to localized water damage, undersized framing, or a combination of the two; however, without removing the sheathing and exposing the wall studs and/or floor framing it is not possible to determine how pervasive the damage is. Water damage of some degree can be assumed in nearly all bathrooms and kitchens (see Photo 3).

Photo 3: Water damage in bathroom.

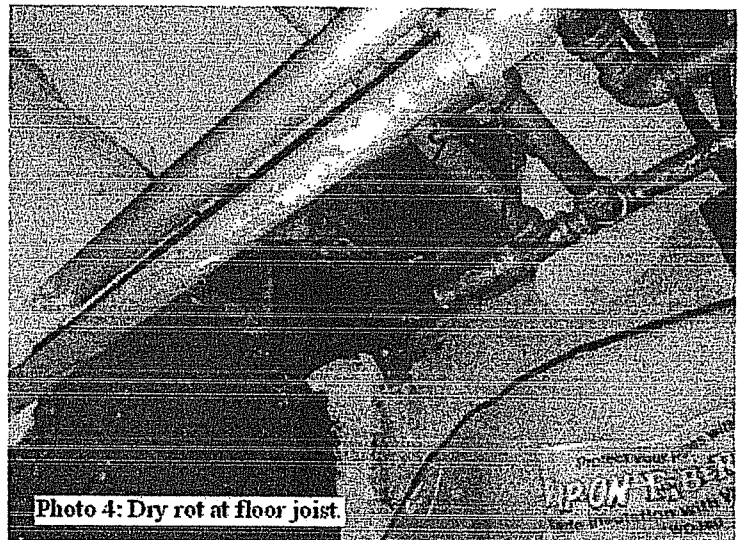
In the lower level some framing was exposed and dry rot was noted (see Photo 4). Again, without removing the sheathing and exposing the floor joists it is not possible to determine the extent of the rot.

Photo 4: Dry rot at floor joist.

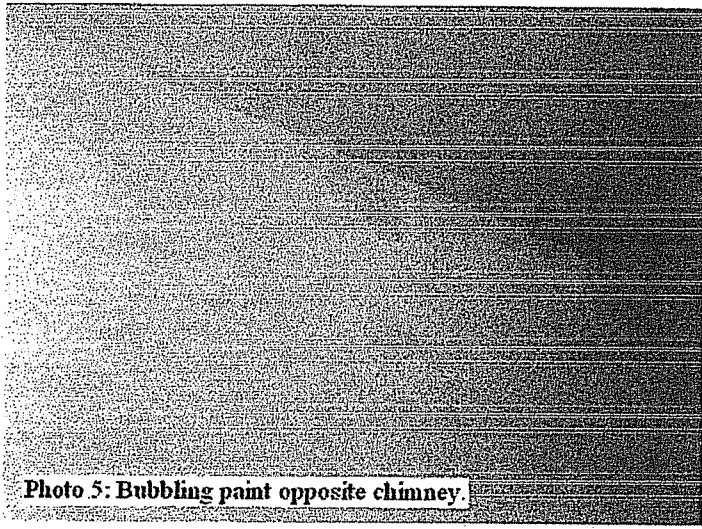
Paint in the stairwell opposite the chimney has bubbled (see Photo 5). Per the Owner the bubbling paint has been repaired numerous times and a new liner has been installed in the chimney. It is our understanding the bubbling continued after the liner was installed. This may not indicate a structural issue; however, it is concerning and may be indicative of high heat.

Photo 5: Bubbling paint opposite chimney.

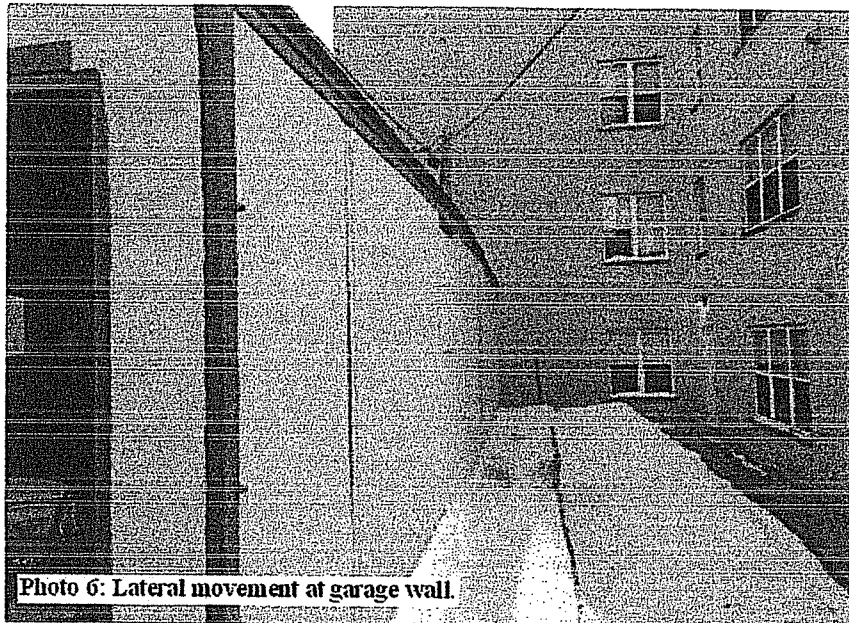
per typical structural engineering standards. The trusses have not been properly fastened to the top of the wall. Steel tie rods have been installed to prevent the walls from kicking out; however, the structure appears generally unstable and possibly in danger of imminent collapse. See Photo 6.

Photo 6: Lateral movement at garage wall.

The garage at 632 Howard should be considered in danger of imminent collapse and should be repaired, shored, or demolished.

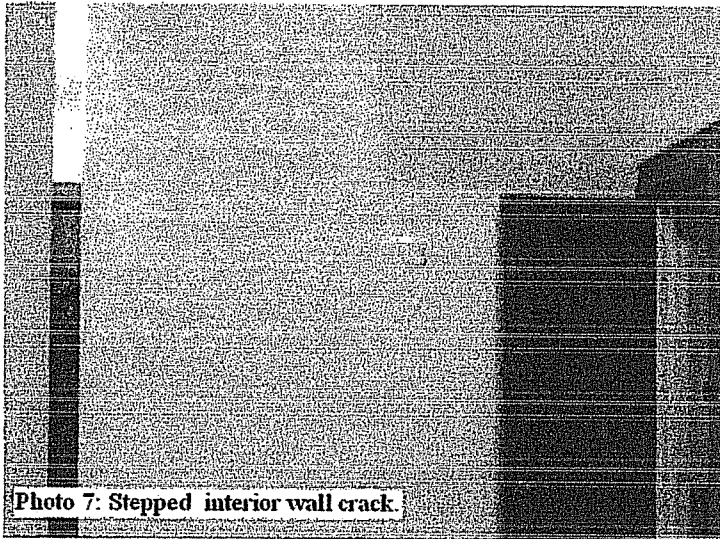
Photo 7: Stepped interior wall crack.

The most concerning structural behavior occurs approximately in-line with the ridge. The floor framing on the first and second floor significantly dips approximately 18'-0" from the front, exterior wall. On the second floor, there is a large, apparently active, stepped crack (see Photos 7 - 9). This is indicative of settlement. The exterior foundation and exterior wall framing show no signs of distress. A possible origin may be due to the removal of an interior load bearing member, or perhaps continued settlement of an interior load bearing column/wall.

The structural issues in 622 Howard Avenue appear less pervasive, but could be a larger life safety issue than what we are observing in 632. Tracking down the cause of the settlement will require a rigorous evaluation and exposure of the framing system. It may be necessary to retain to geotechnical engineer if the structural load path is found to be sufficient to transfer the loads to the foundation.

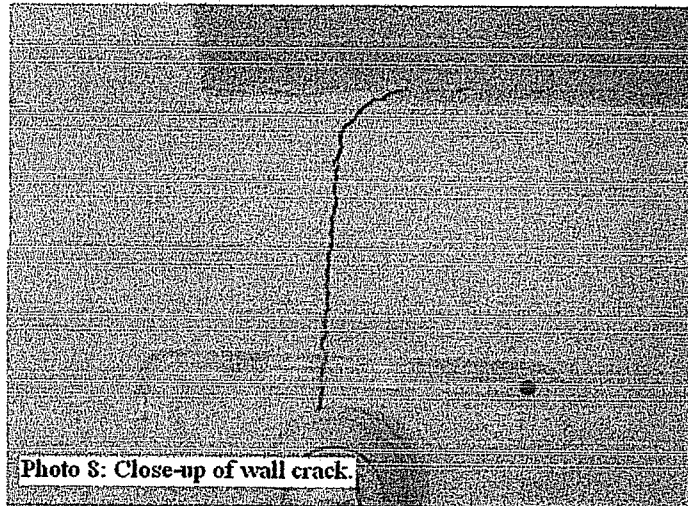
Photo 8: Close-up of wall crack.

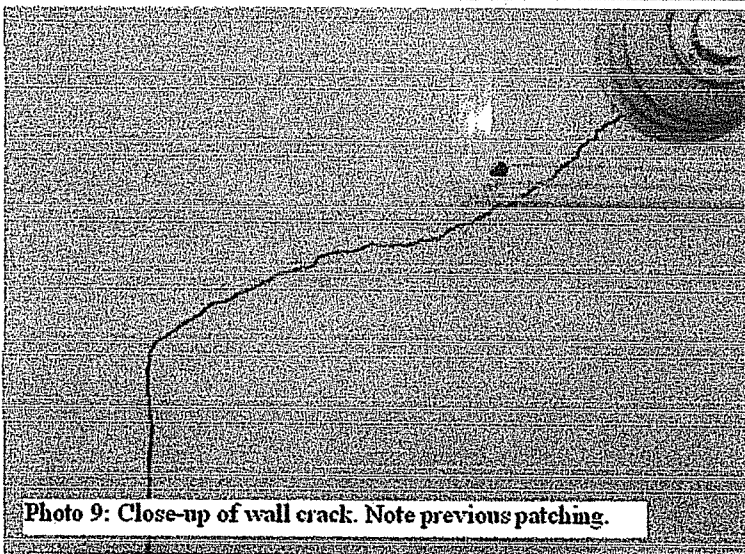
Photo 9: Close-up of wall crack. Note previous patching.
