**SURVEY OF CONDITIONS FOR
PROPOSED TODD DRIVE TAX INCREMENTAL
FINANCE DISTRICT (TIF) PROJECT**

Report on Blight Determination

**Prepared by:
Mid-America Planning Services, Inc.
621 N. Sherman Ave.
Madison, WI 53704
608-249-2514**

April 20, 2005

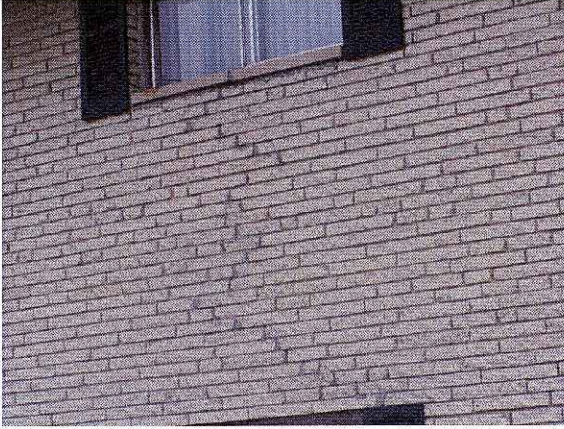
Cracked wall

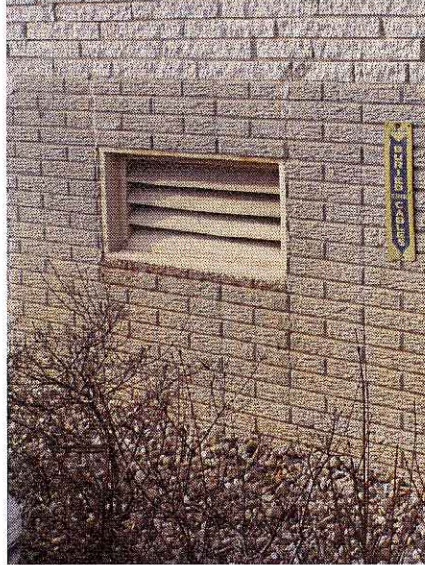
Cracked foundation

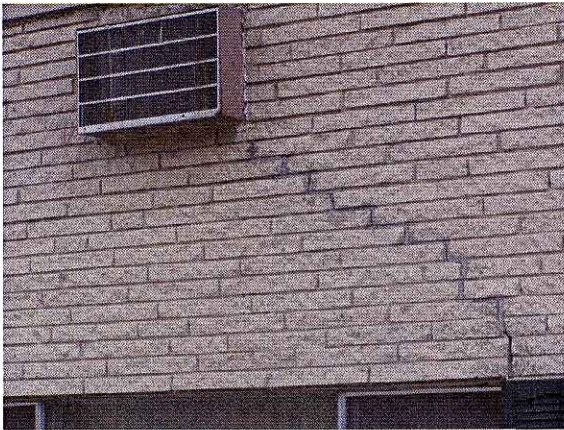
Cracked wall

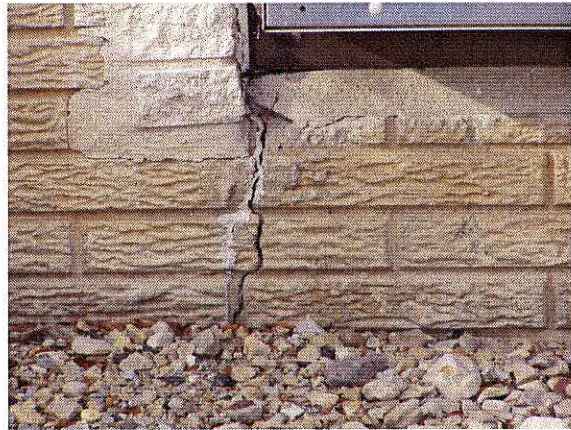
Cracked foundation

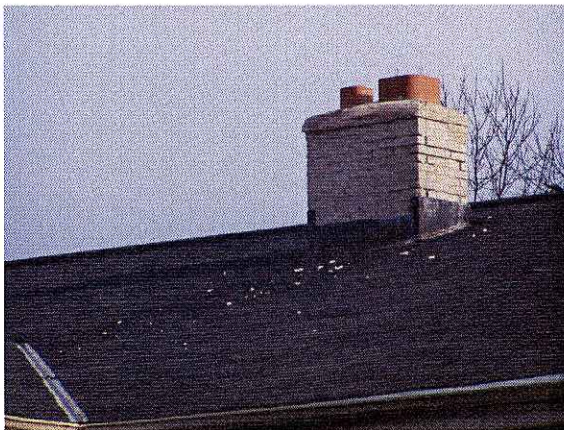
Deteriorating chimney

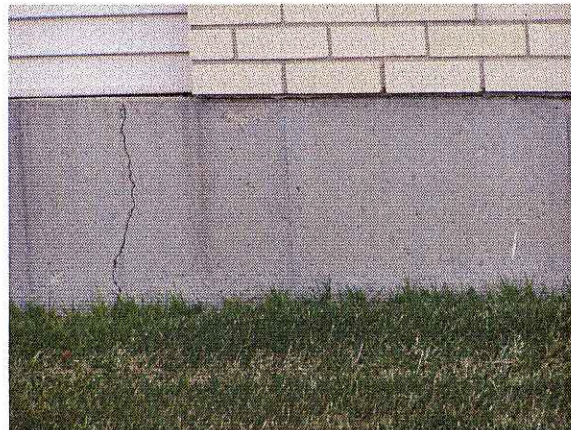
Foundation crack

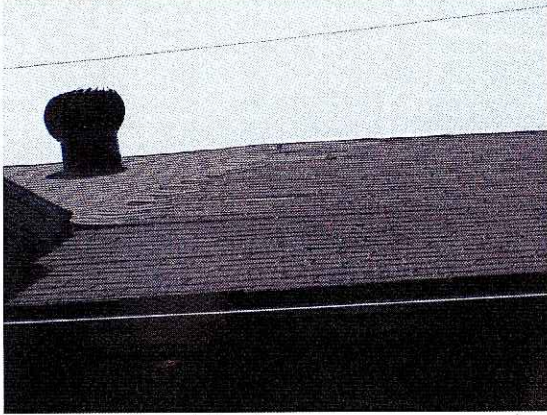
Deteriorating shingles

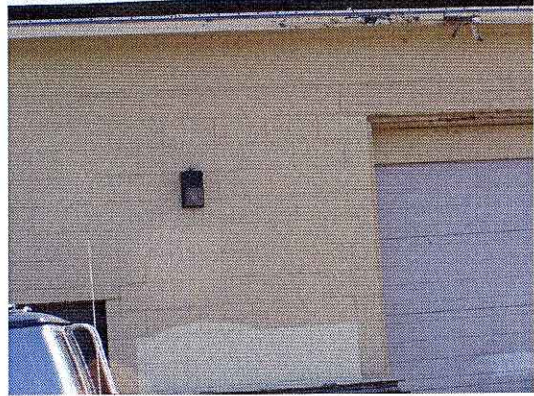
Cracked wall

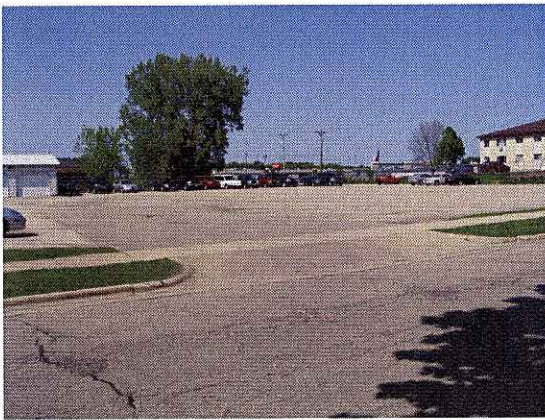
Blighted site, a sea of asphalt

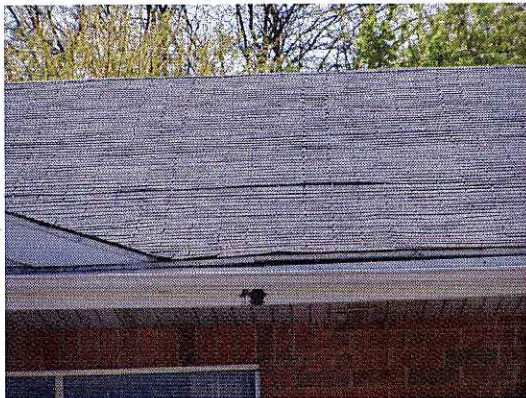
Deteriorating shingles
