1245 Spaight Street Madison W.I. 53703

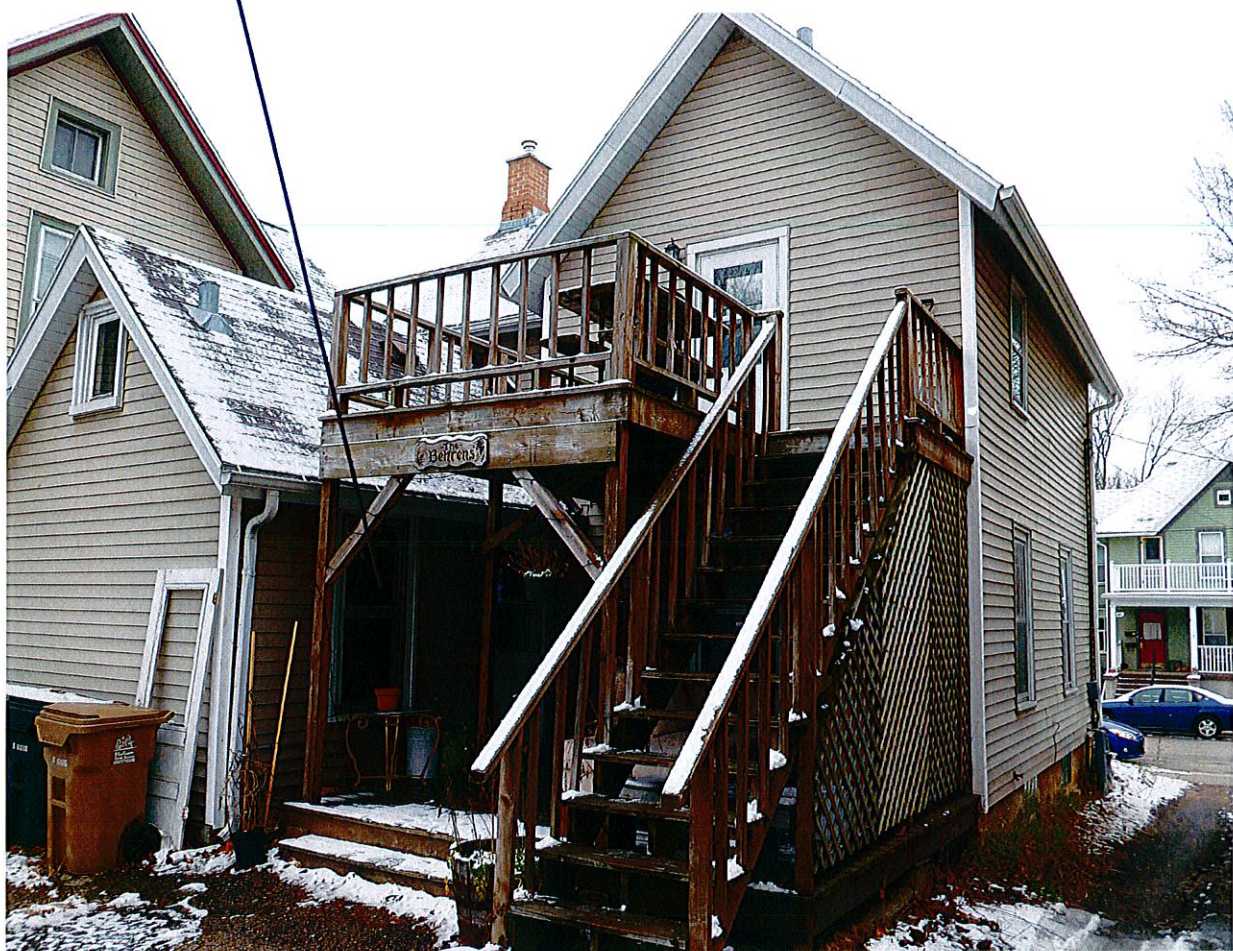
Window # 1

Window #1 lower back side (425-431 inside pictures)

Glazing is 50% bad, has been re-weather stripped, sash separation, 1/4" gap on inside stop, ropes are missing.

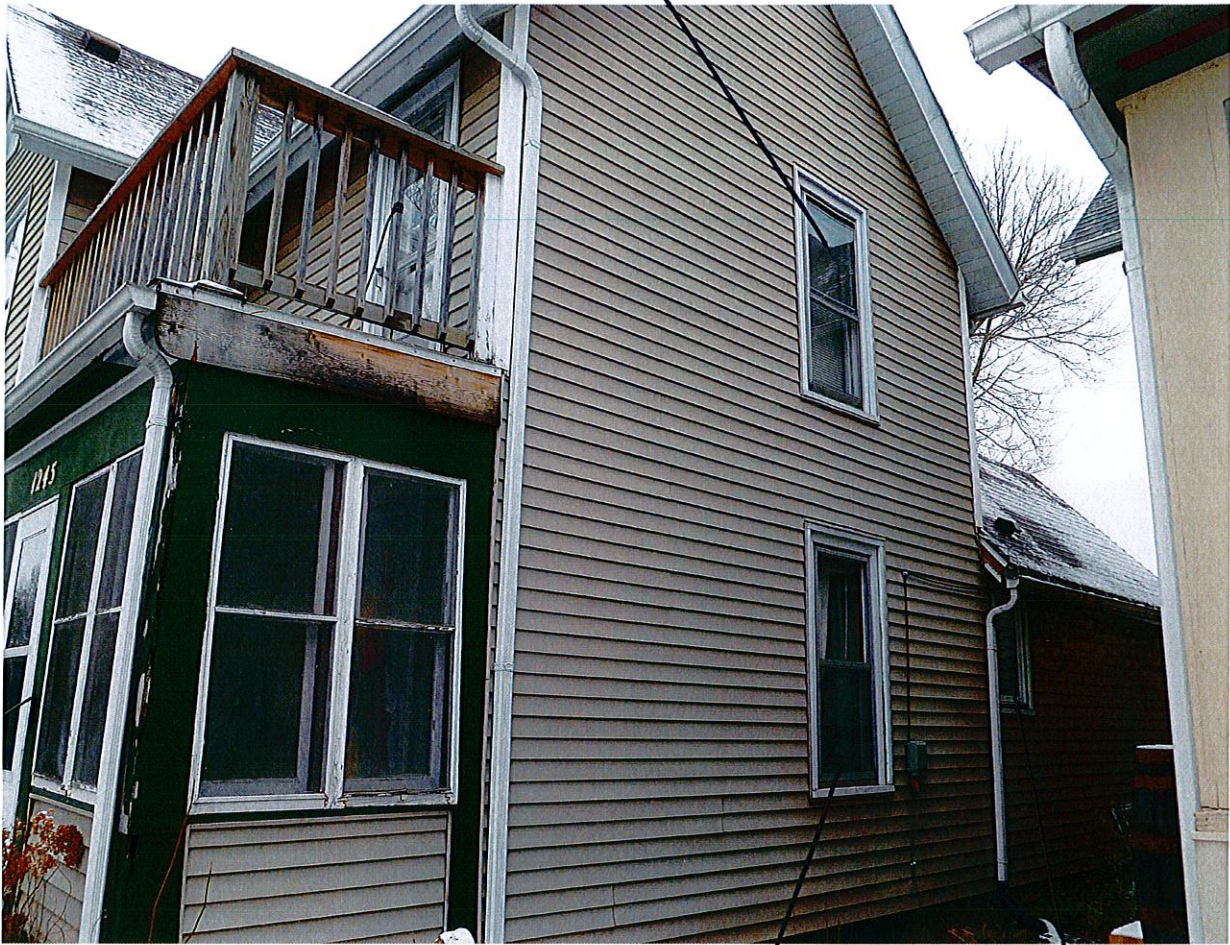
Window # 13

Window #2 lower west side (432-434 inside pictures)

1990's era casement window, manufactures name is Semco, wood interior and aluminum clad exterior, thermo pane.

Window #3 lower west side (435-440 inside pictures)

Glazing is 50% bad, has been re-weather stripped, top sash has been replaced, top of the bottom sash has sash separation, ropes are.

Window #13 west side (520-528 inside pictures)

Glazing is 70% bad, has been re-weather stripped, ropes broken, sash separation, mold and mildew on inside of storm windows, locks ripped out of sash.

Window # 3

Window # 2

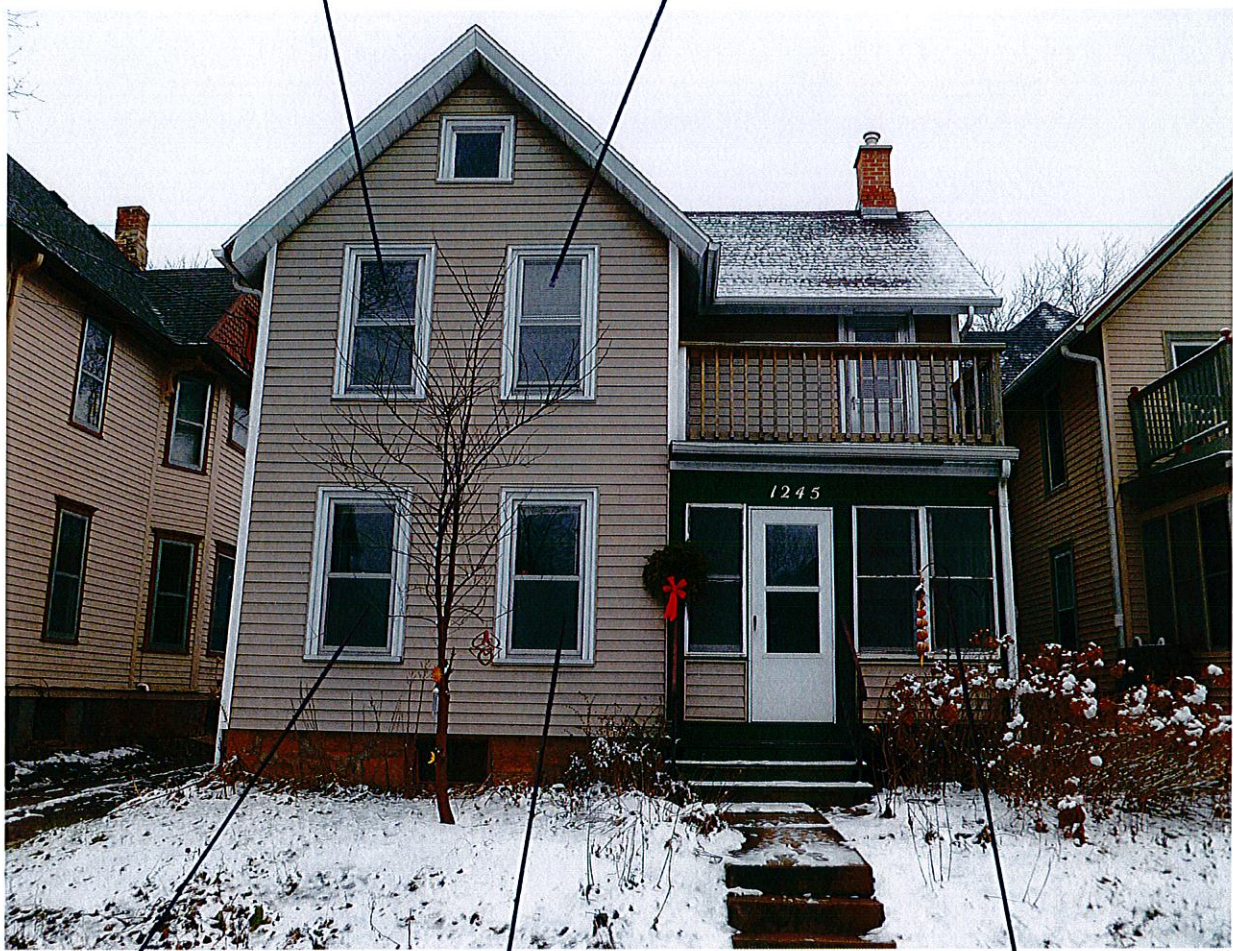
Front Side

Window #4 front side inside enclosed porch (441-448 inside pictures)

Glazing is 50% bad, has been re-weather stripped, bottom of sashes are rotten, ropes broken.

Window #5 front side (449-457 inside pictures)

Glazing is 40% bad, has been re-weather stripped, has new millwork around inside, weight boxes have been spray foamed, ropes broken, sashes have been replaced approximate date would be 1980's, sash separation, 3/8" gap at meeting rail.

Window #6 front side (458-468 inside pictures)

Glazing is 40% bad, has been re-weather stripped, ropes broken, has new millwork around inside, weight boxes have been spray foamed, sill has a crack and a hole, sashes have been replaced approximate date would be 1980's.

Window #11 front side (498-509 inside pictures)

Glazing is 80% bad, sill rotten and soft, broken ropes.

Window #12 front side (510-519 inside pictures)

Glazing is 90% bad, chunk of wood missing on sash, ropes broken, crack in bottom sash.

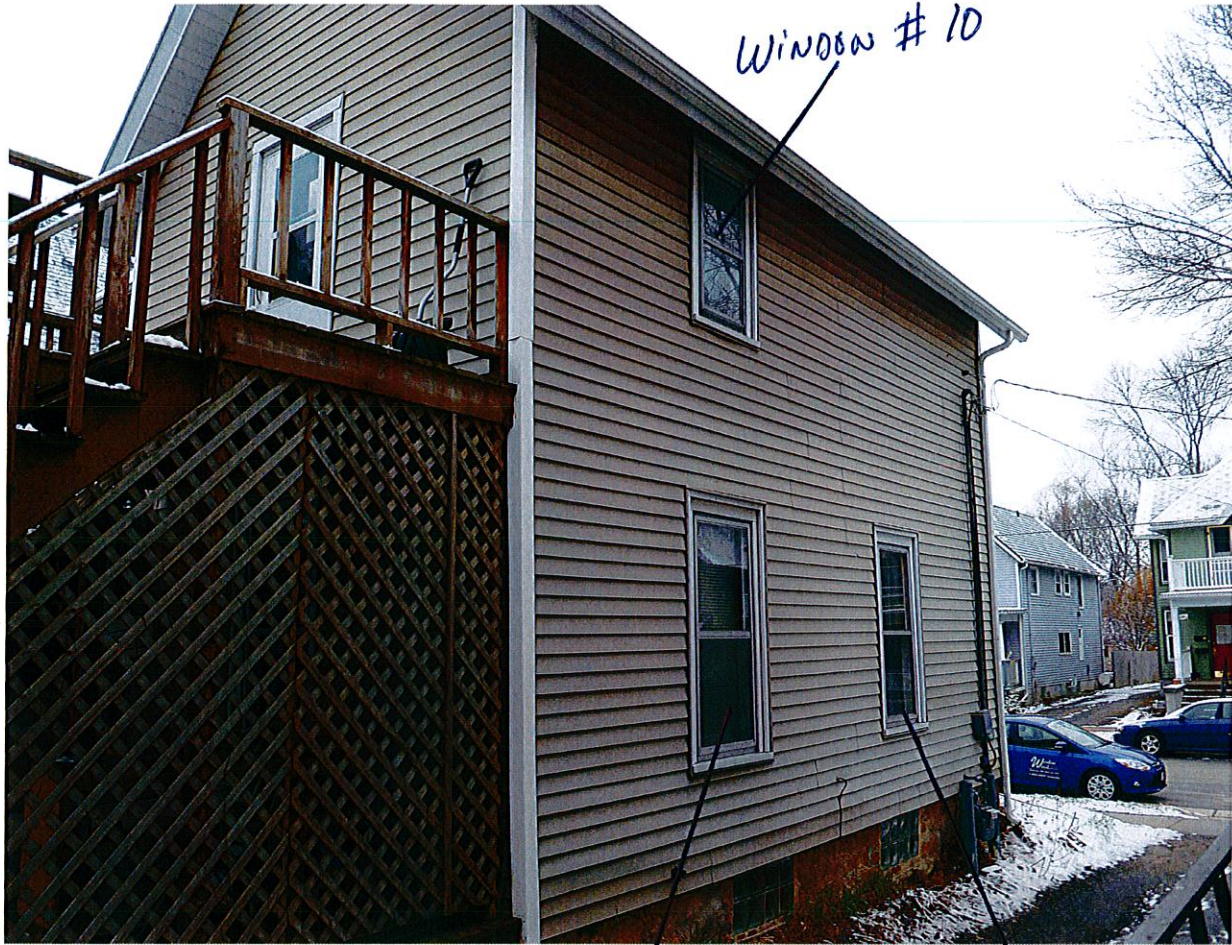
EAST SIDE

Window #7 east side (469-474 inside pictures)

Glazing is 20% bad, has been re-weather stripped, ropes broken, has new millwork around inside, weight boxes have been spray foamed, sash separation, sashes have been replaced approximate date would be 1980's.

Window #8 east side (475-479 inside pictures)

Glazing is 30% bad, has been re-weather stripped, ropes broken, sashes have been replaced approximate date would be 1980', sash separation, top sash has chip out at meeting rail, bottom sash rot.

Window #10 upper east side (490-497 inside pictures)

Glazing is 20% bad, has been re-weather stripped, ropes broken, mold and mildew on window sills and sashes, inside stops missing, sash separation.

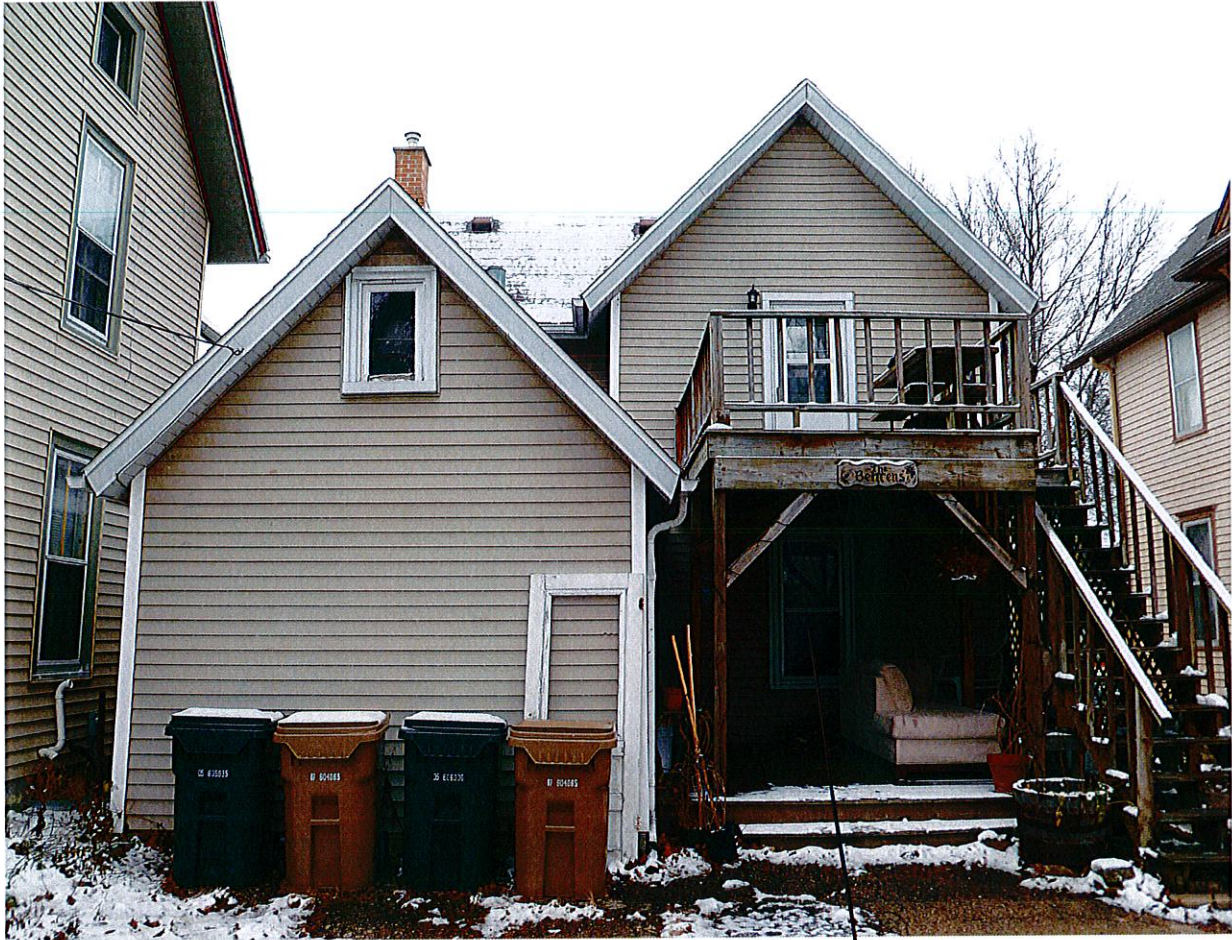
Window # 9

Window #9 back side (480-489 inside pictures)

Glazing is 40% bad, has been re-weather stripped, ropes broken, chunk missing on top of the bottom sash, sash separation, sashes replaced approximate date would be 1980's, torn screen on storm window.
