D3. Demolition Context Images

901 E. Washington Ave Hotel - 2016.36.01

July 25, 2017

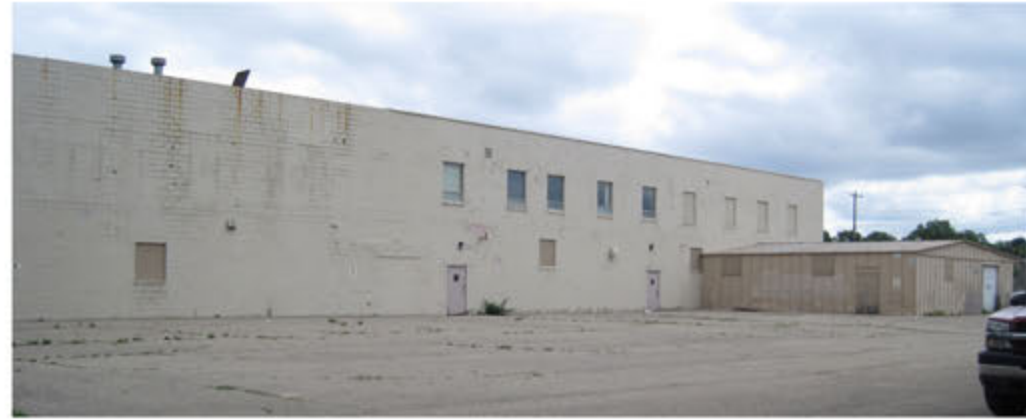
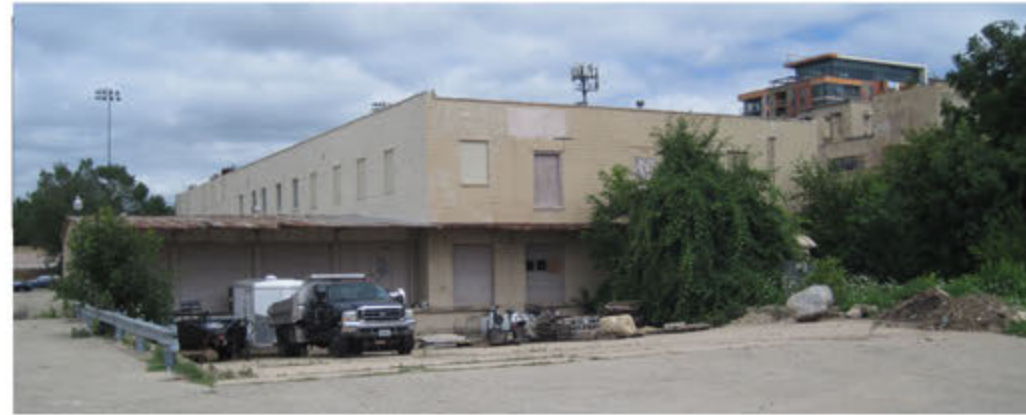
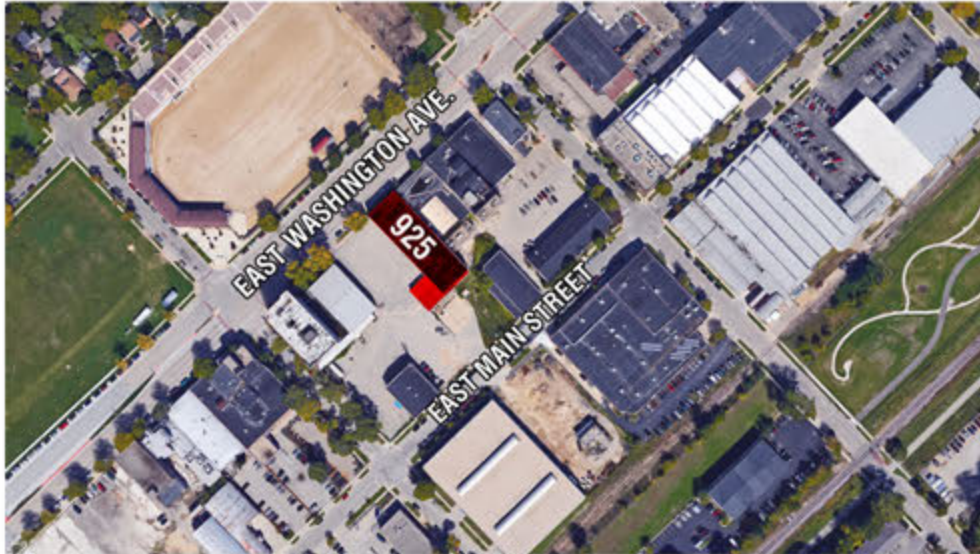
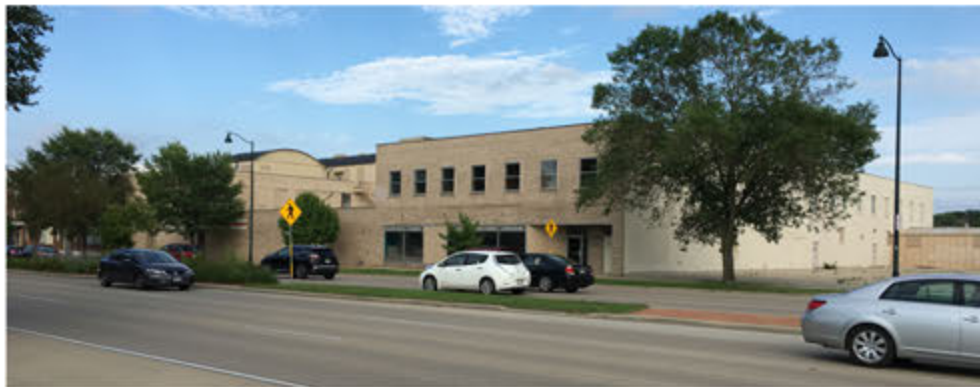
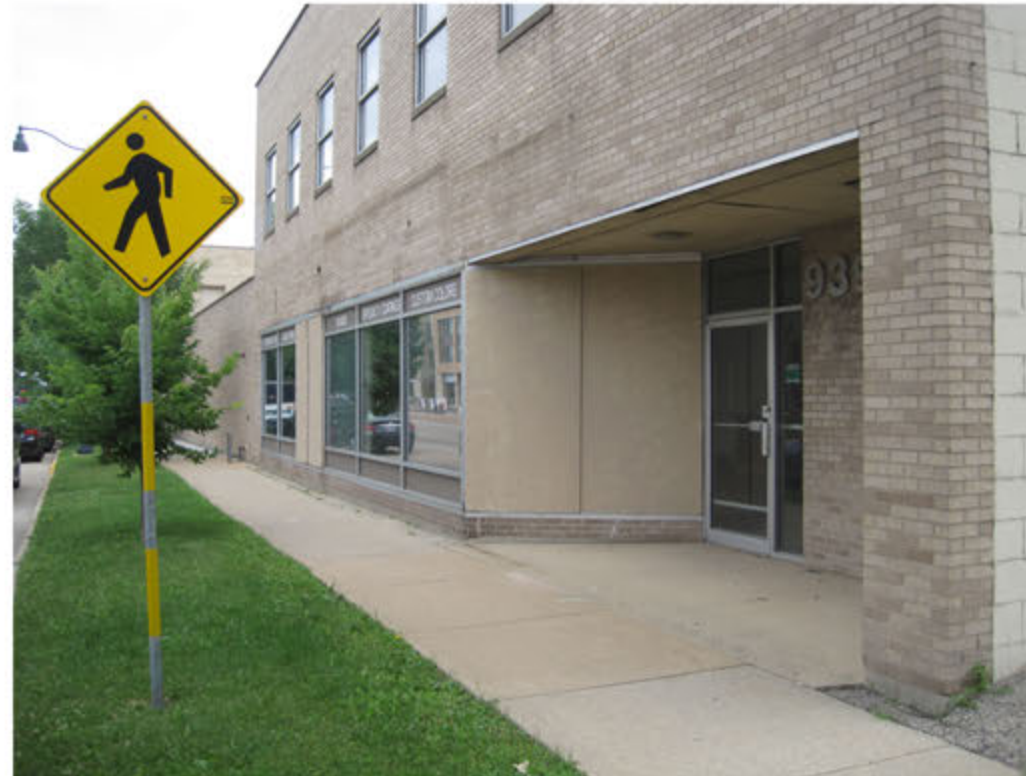
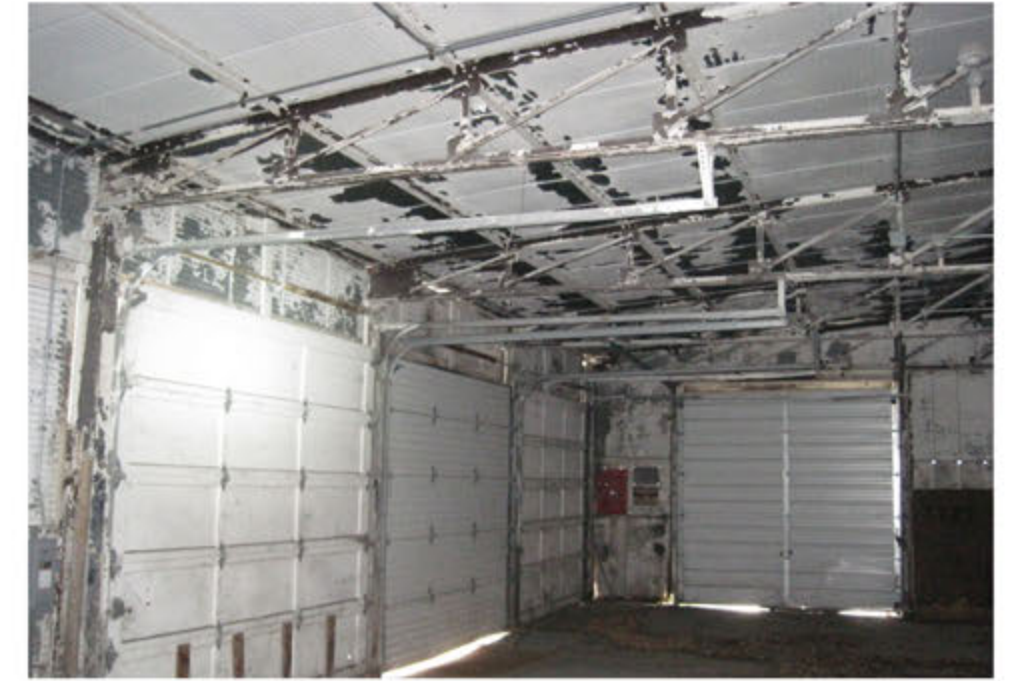
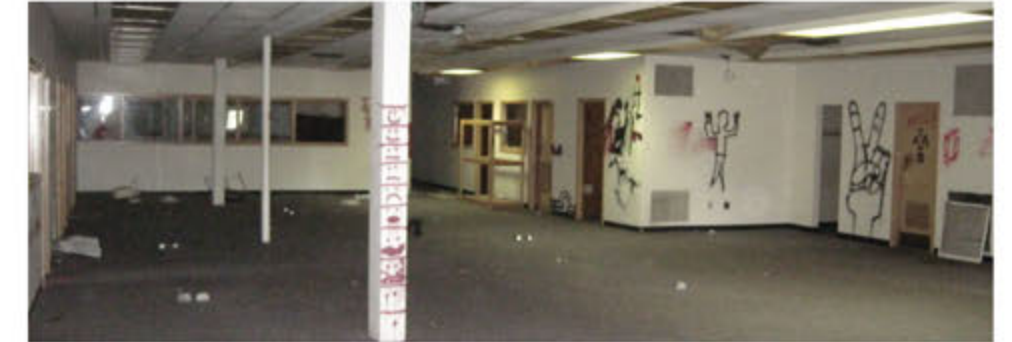
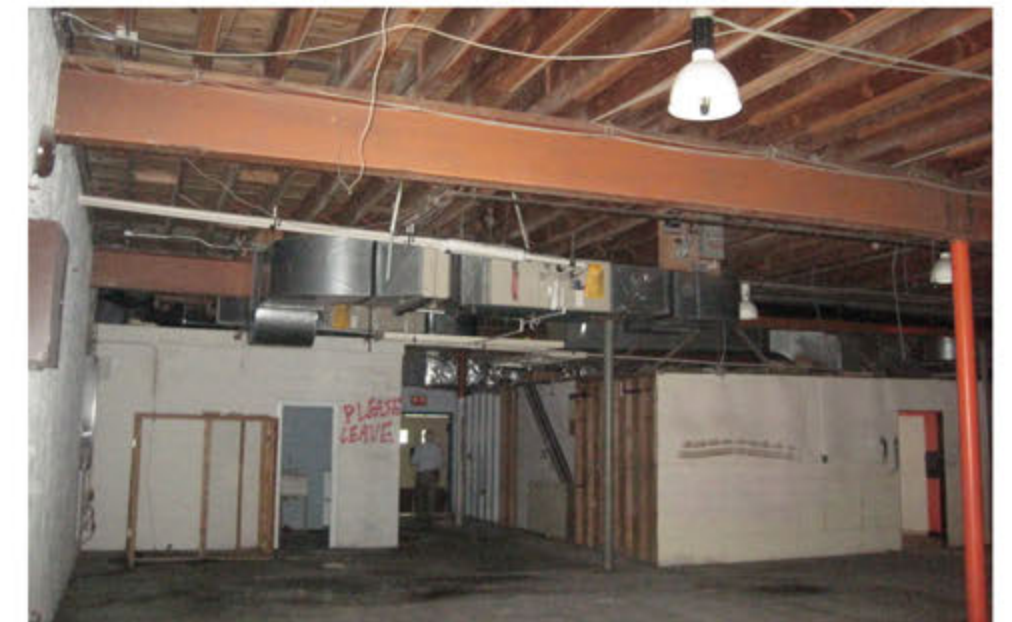
925 East Washington Ave.

Façade: Brick façade along East Washington. Concrete masonry units along the other three sides. The loading addition is clad in metal panel. The paint finish on the concrete masonry units is peeling off. Minor signs of settlement can be seen in the concrete masonry units.

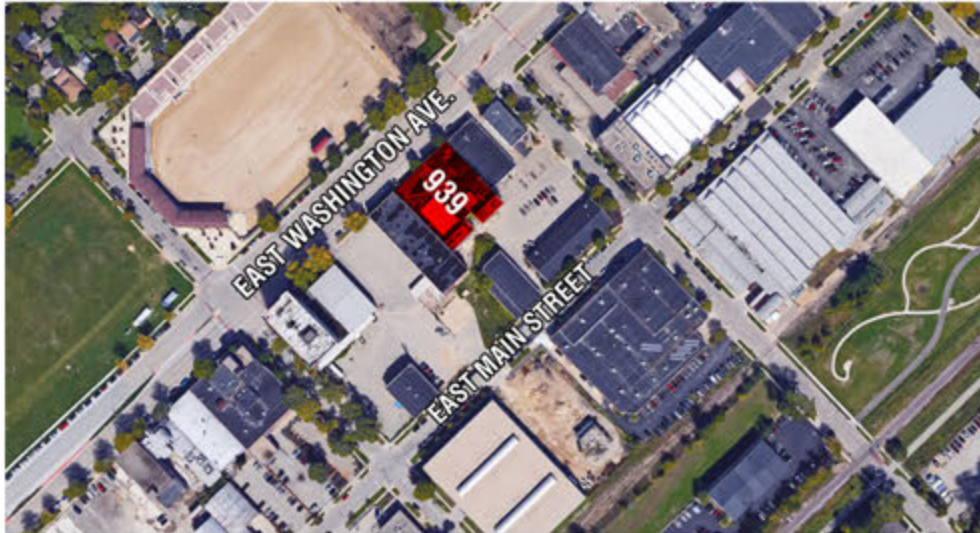
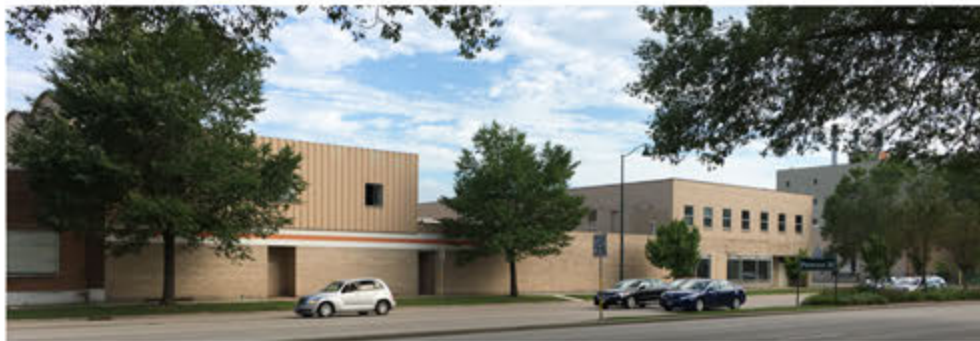
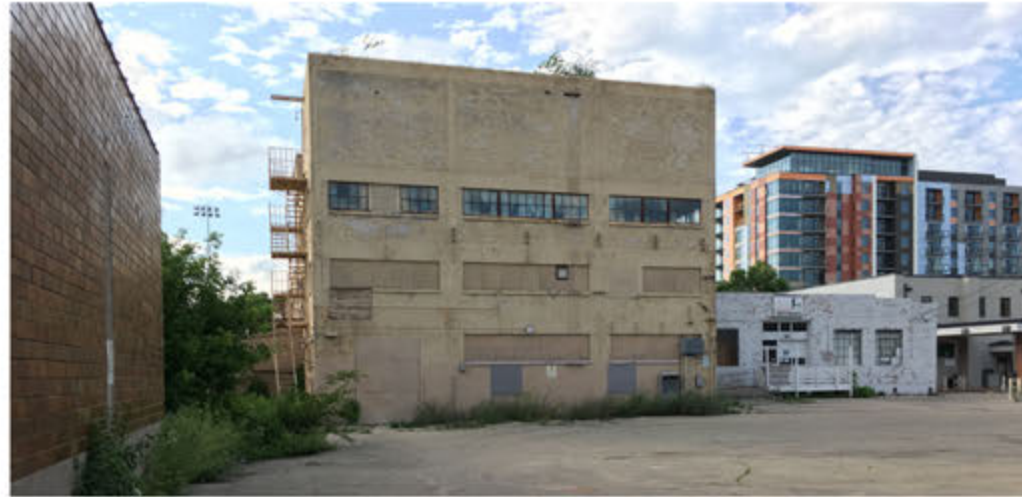
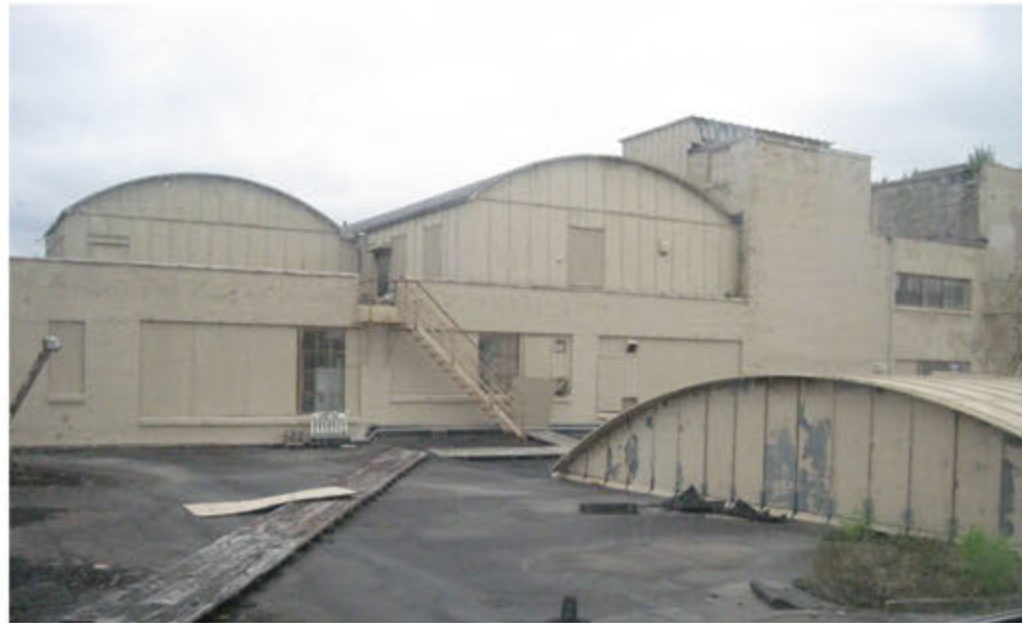
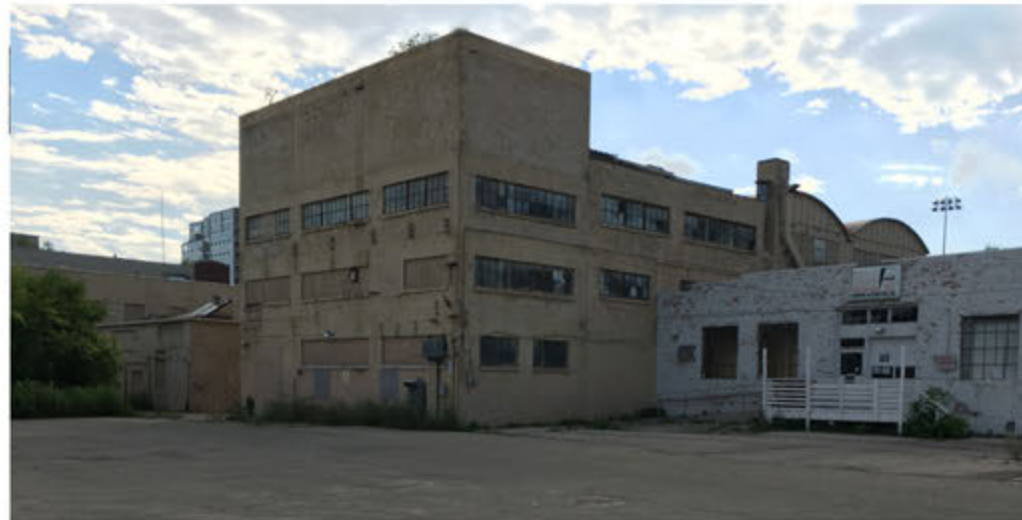
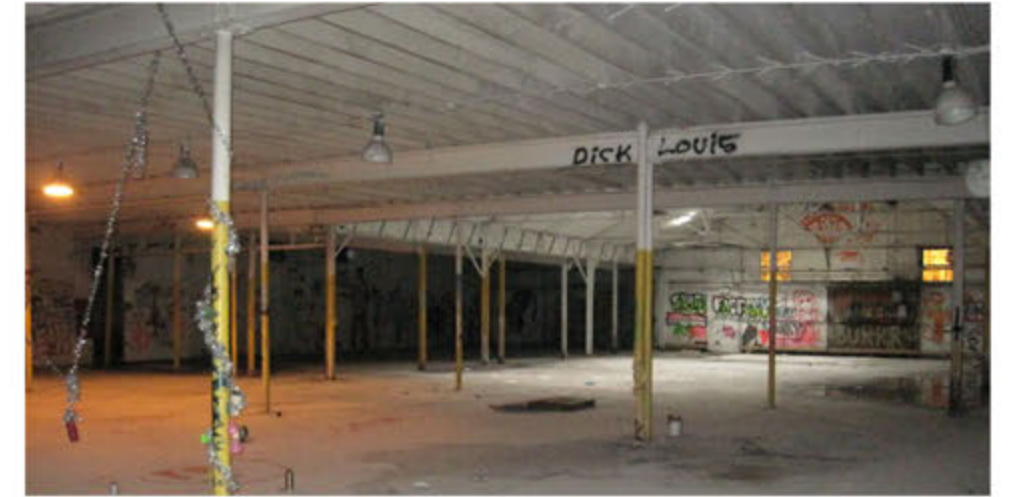
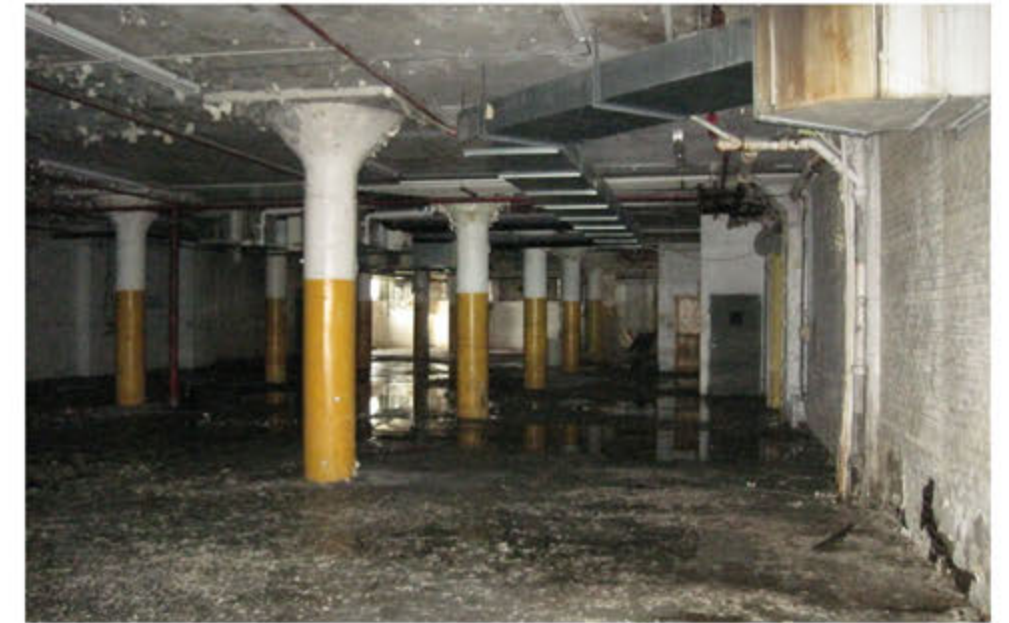
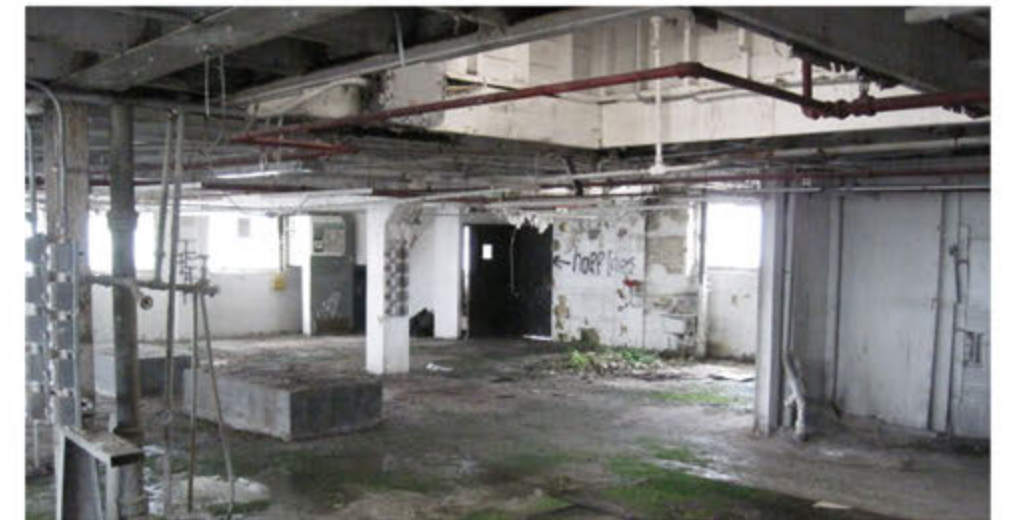
939 East Washington Ave.

Roof: Flat and curved roofs composing of rubber roofing membranes and metal panels. Foliage has started to grow on the roof

Façade: Brick and corrugated metal paneling occur along East Washington. The main building has an exposed concrete frame with a brick infill. Along the back sides of the building there are concrete masonry walls, clay block walls and brick facades. Roof top penthouses are composed of metal panels or a concrete frame with a brick infill. The painted finish on the façade is peeling off, signs of brick spalling is present.

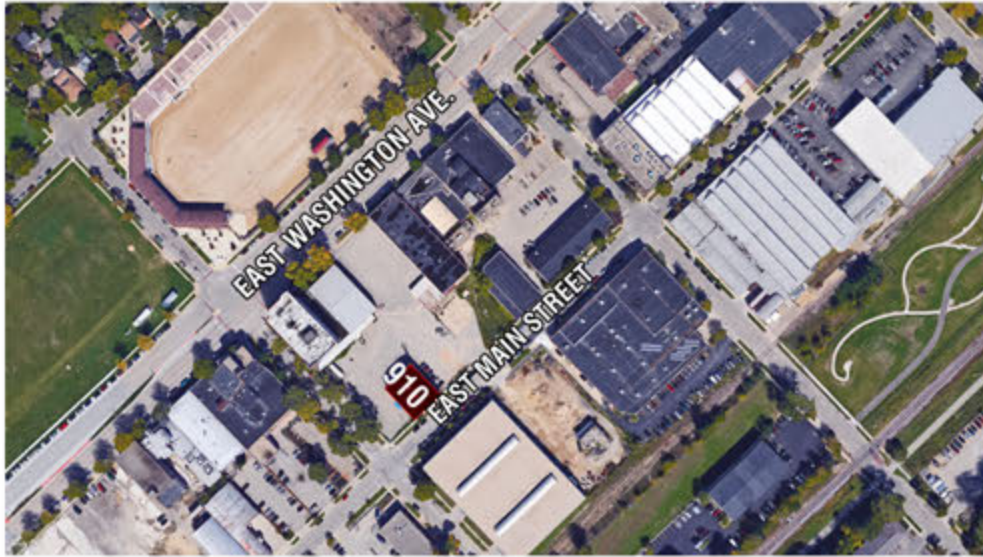
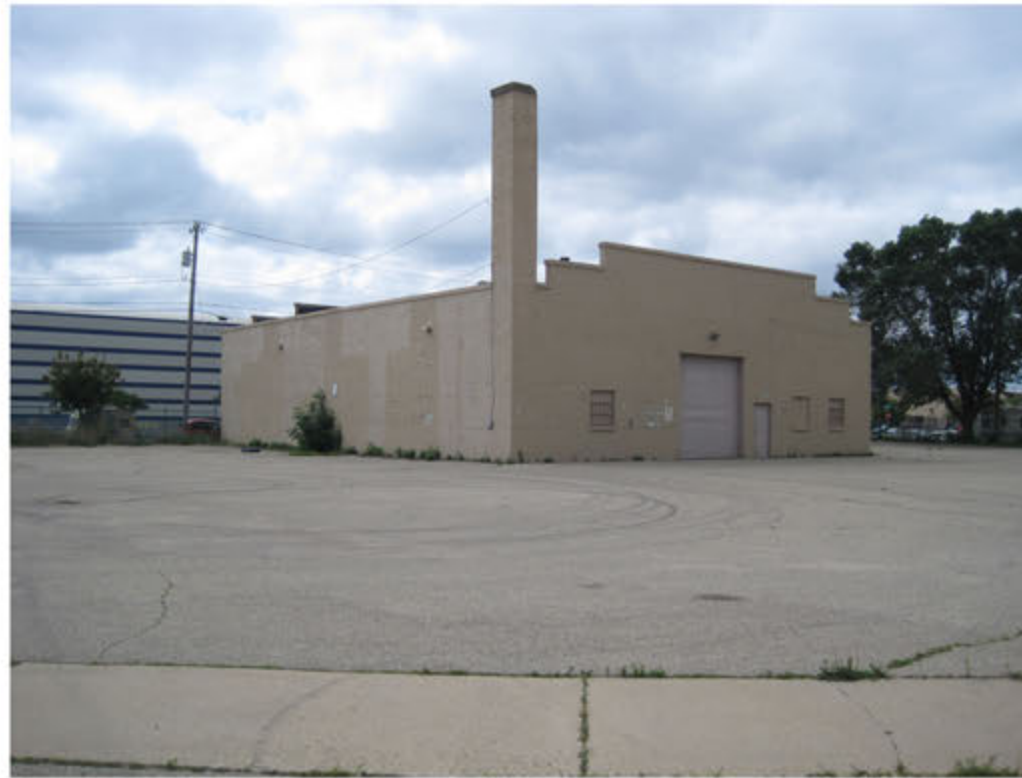
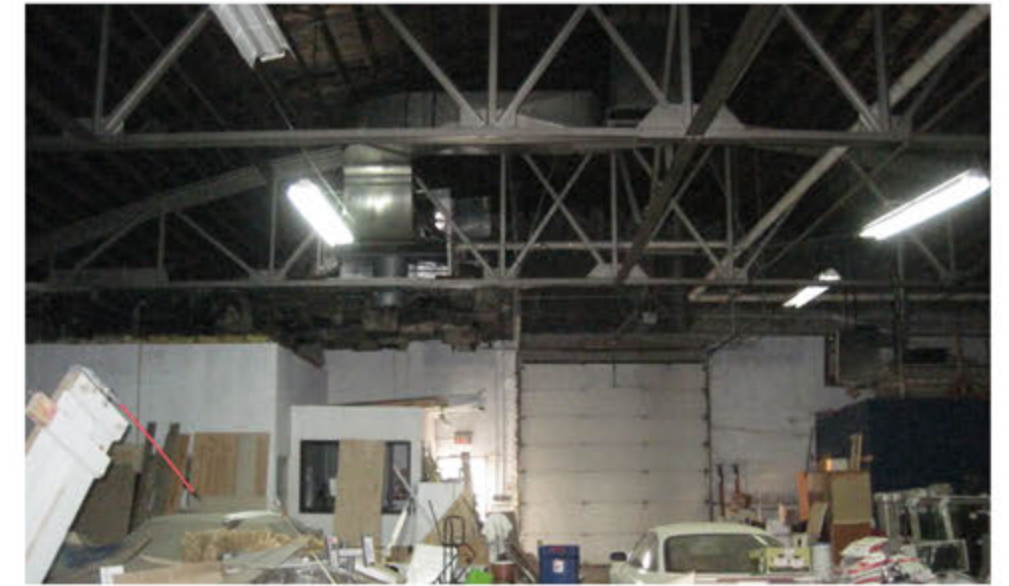
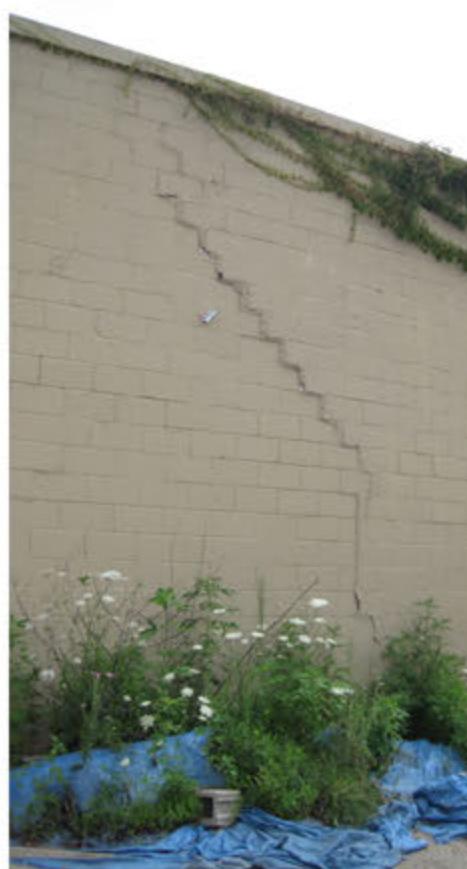
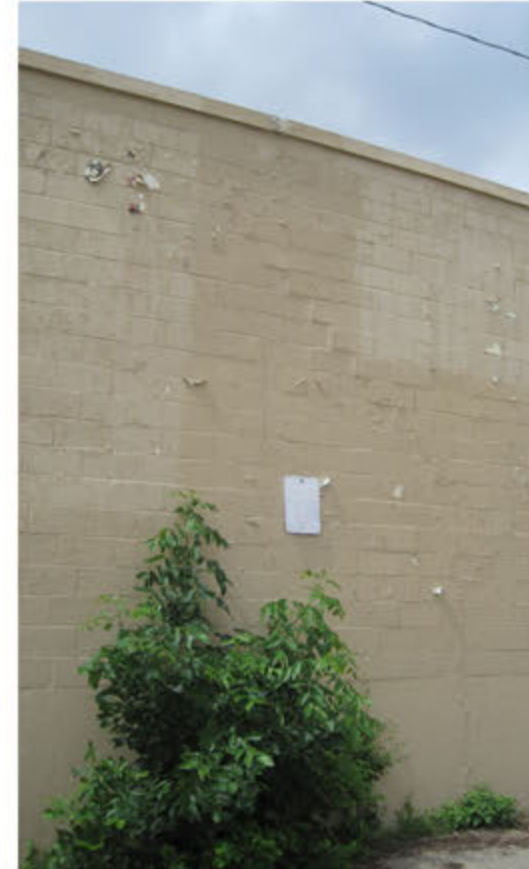
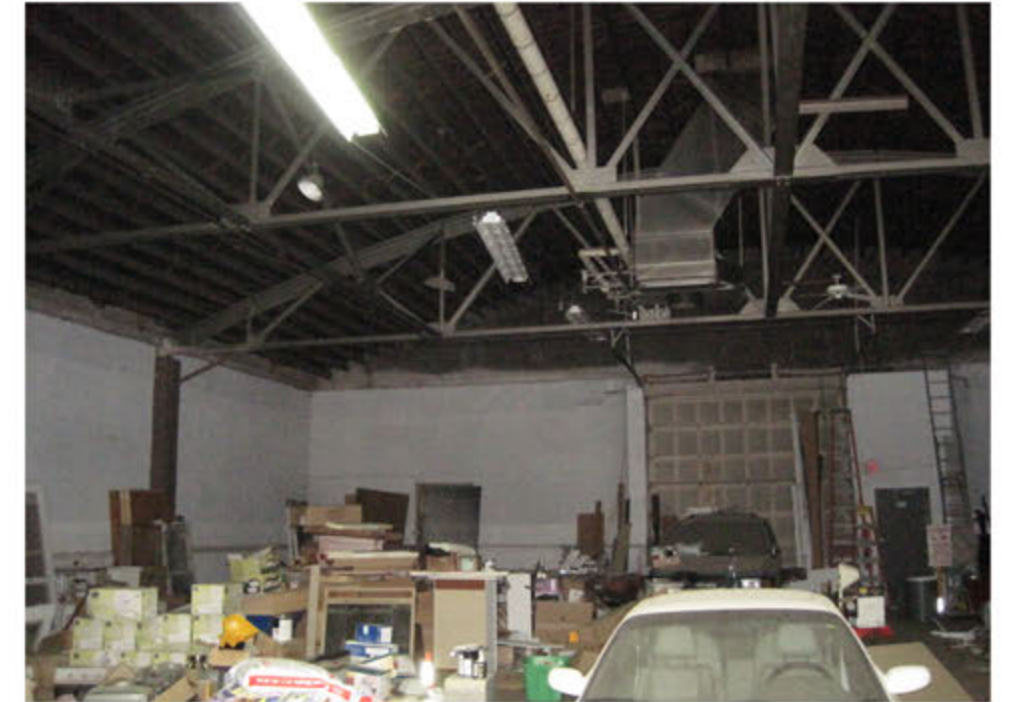
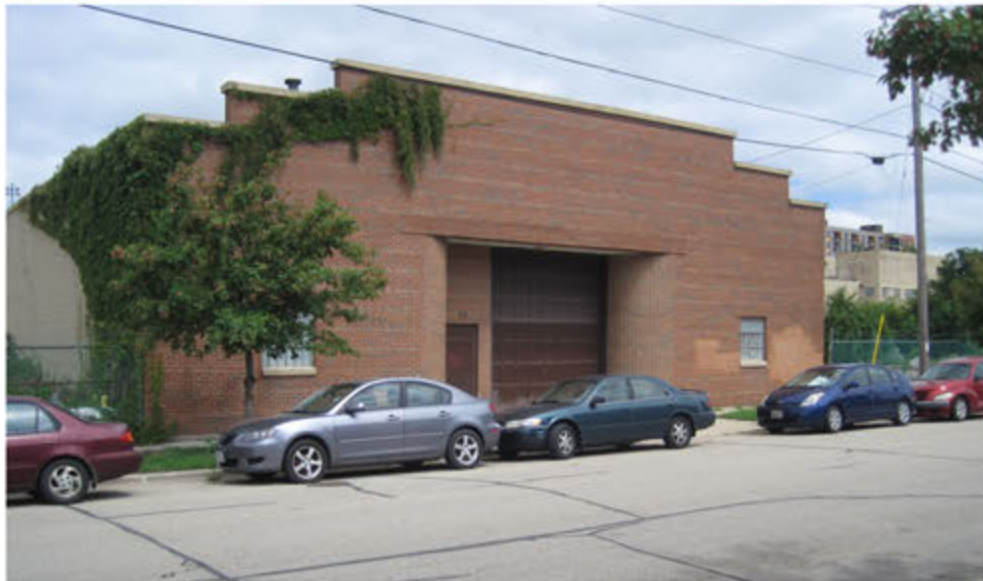
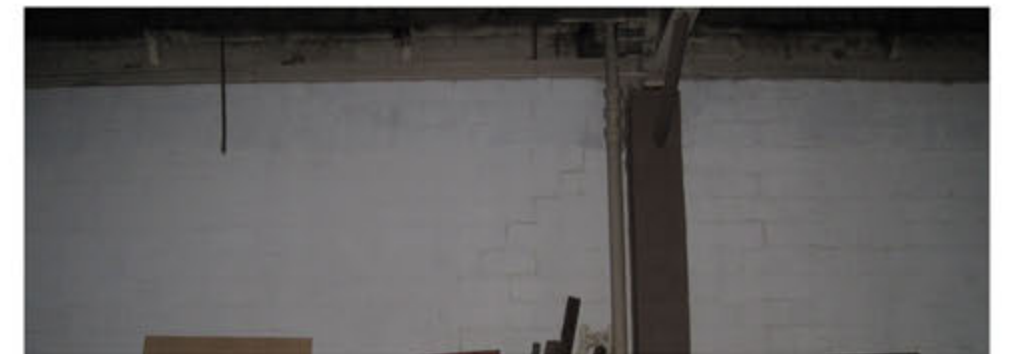
910 East Main St.

Structure: Concrete masonry unit bearing walls and piers with a steel barrel vault roof truss. The bearing walls have bowed out and cracked at the center of the building on both sides.
