## 2240 Keyes Avenue, Madison, WI – Condition Assessment 10/21/2020

Prepared by Melissa Destree, AIA

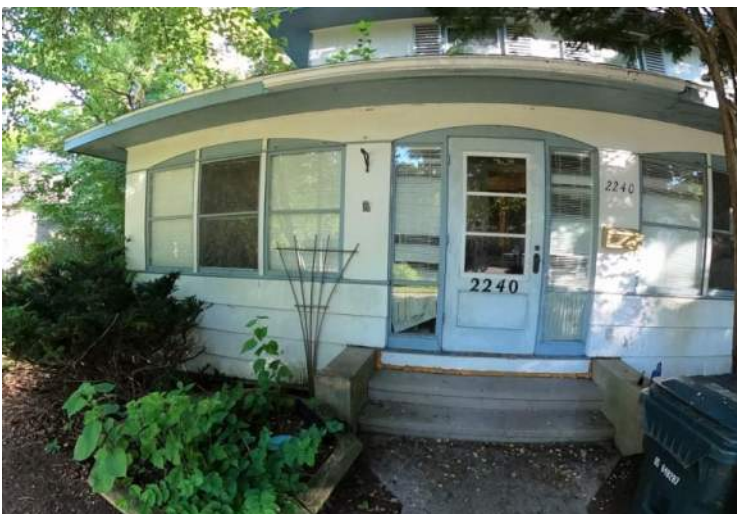
**Detached Garage** – There is a two car detached garage in the rear of the lot that is in acceptable condition. Roof requires replacement, garage door damaged and siding needs maintenance. Reuse may be a possibility.

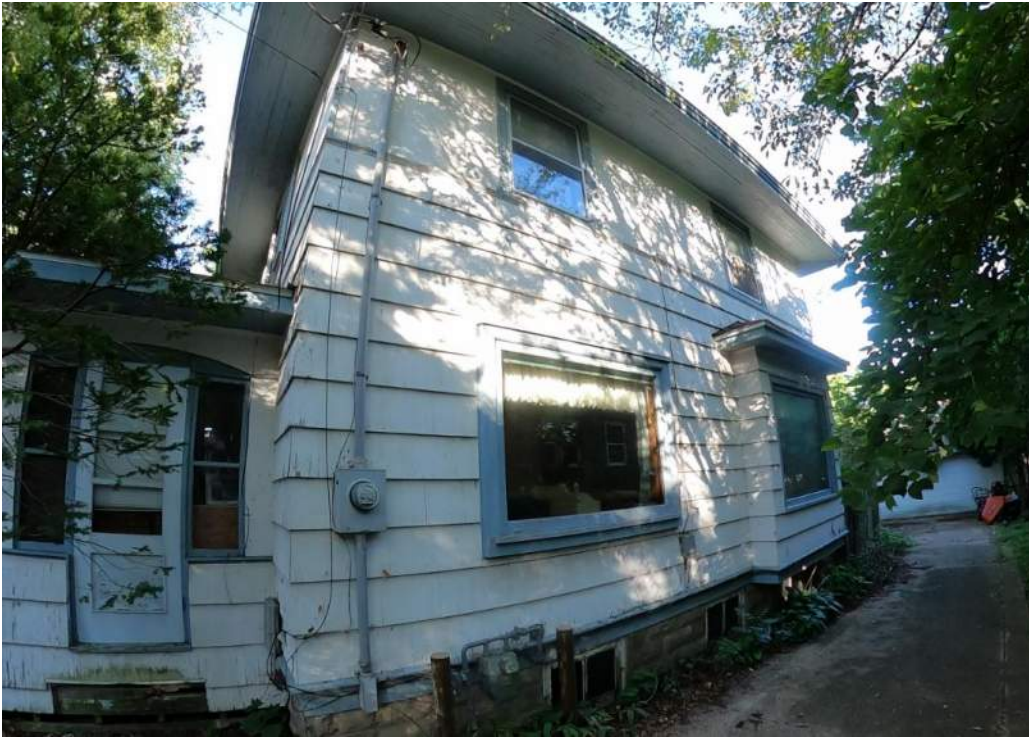
**Side of House - Garage Side (north)** – The windows are deteriorated and rotten, cedar is in a tired state and is not reusable, foundation is in an acceptable condition, however moisture migrates into basement during rain events, Basement ceiling is low. Overhead Electrical Line. Location of Gas meter.

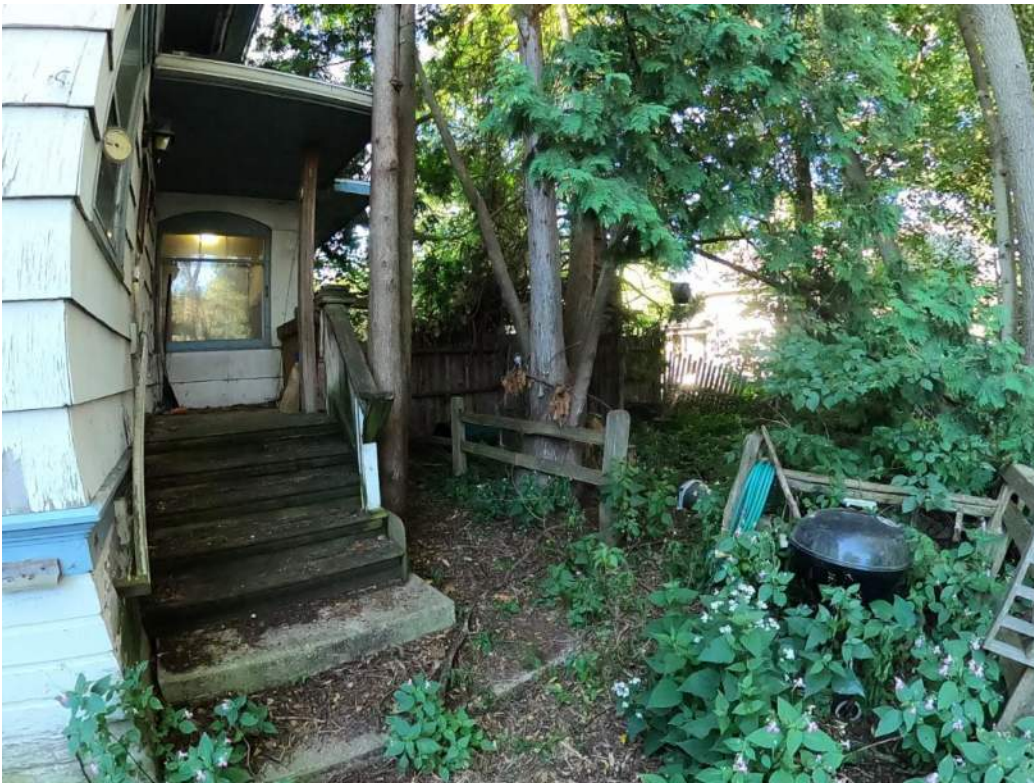
**Side Porch** – evidence of moisture intrusion at the roof, deteriorated stairs and railing. The side porch walls and roof are undersized structurally and roof is leaking.

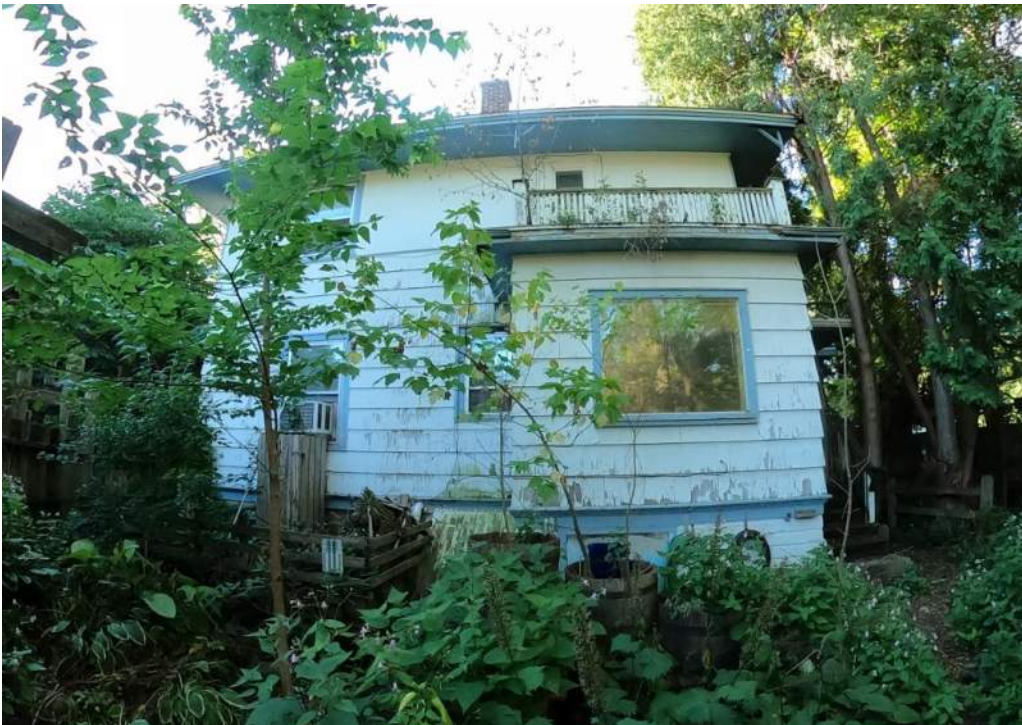
**Exterior Rear Elevation** – Exterior is cedar , evidence of significant water infiltration and lack of maintenance. The area with the picture window is the kitchen. Failing moisture barriers at the upper porch floor/roof has caused significant water damage and mold on the addition and existing exterior wall.

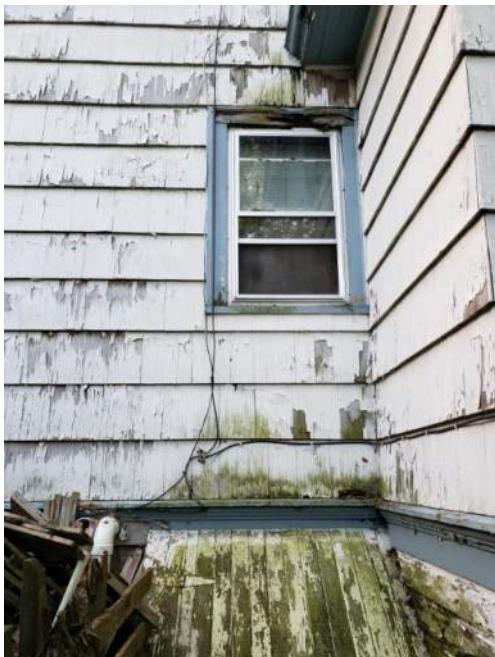
**Exterior at Main Level Kitchen** – wood rot

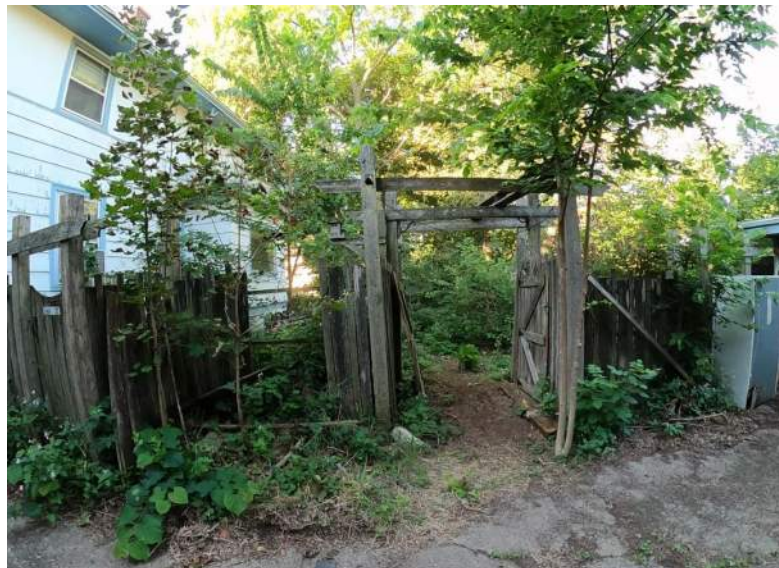
**Rear yard** – fence structure is deteriorated, needs removal

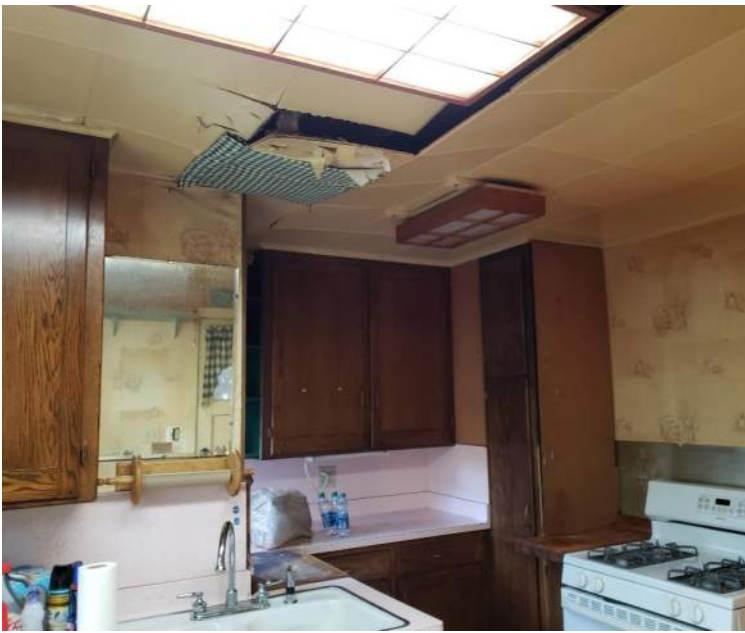
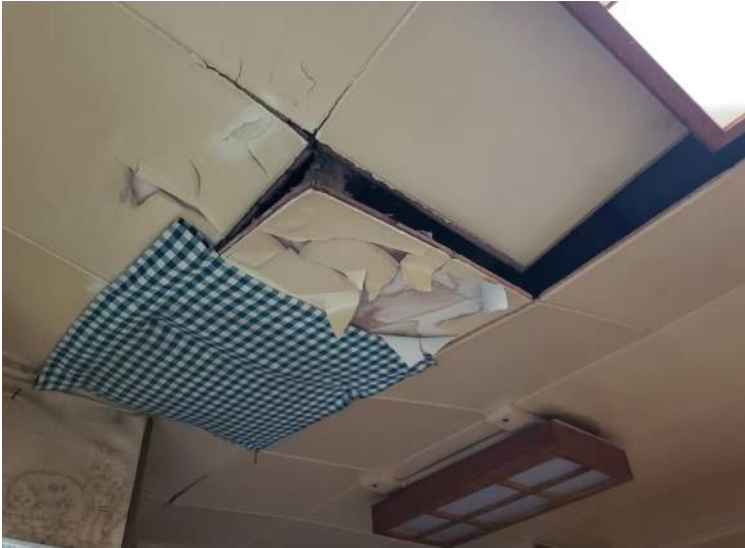
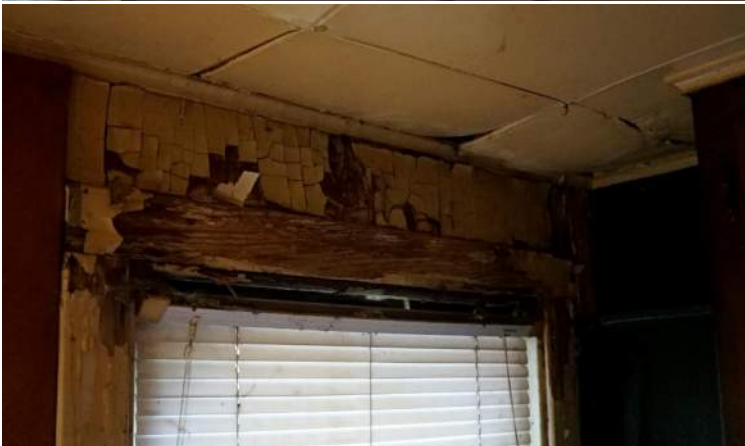
**Main Level Kitchen** – evidence of moisture intrusion causing falling ceiling, rotted window head and mold. See attached images of porch causing water damage. The kitchen addition requires complete removal.

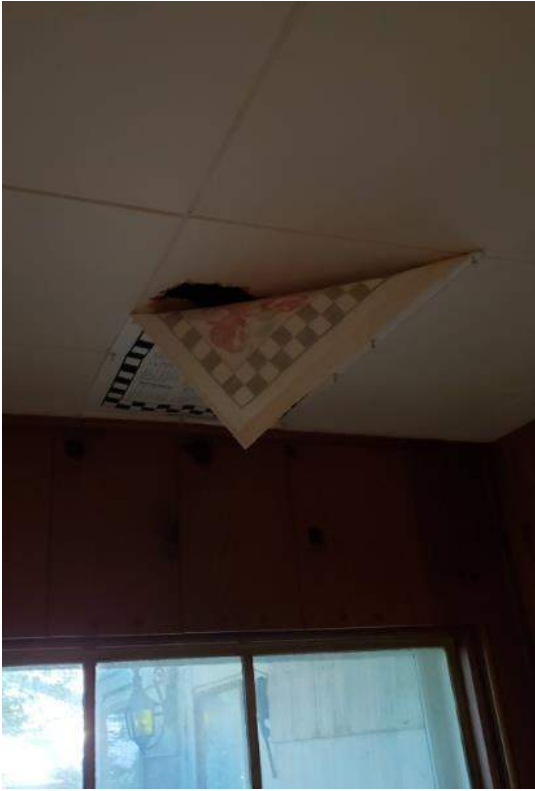
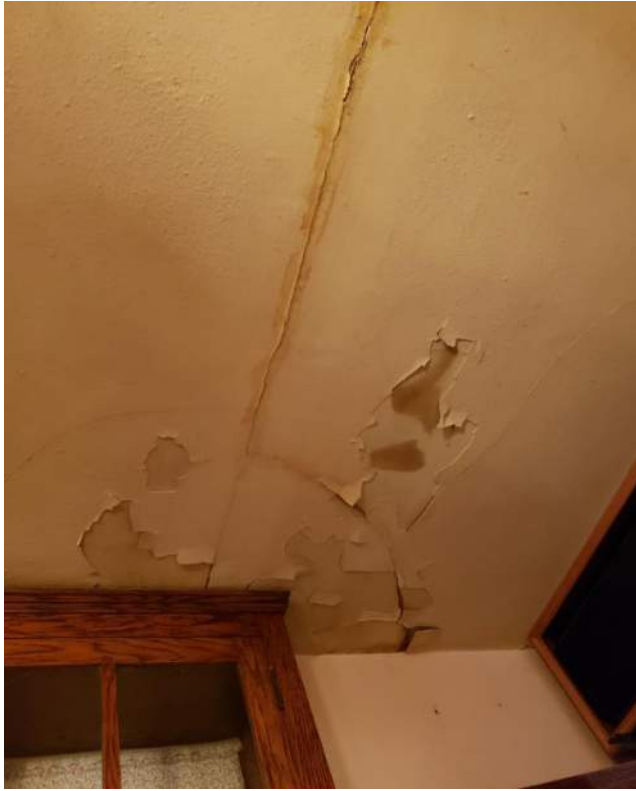
**Main Level** – evidence of moisture intrusion causing failing paint and holes in side porch ceiling and dining room. The side porch is completely damaged due to water infiltration and needs to be removed.

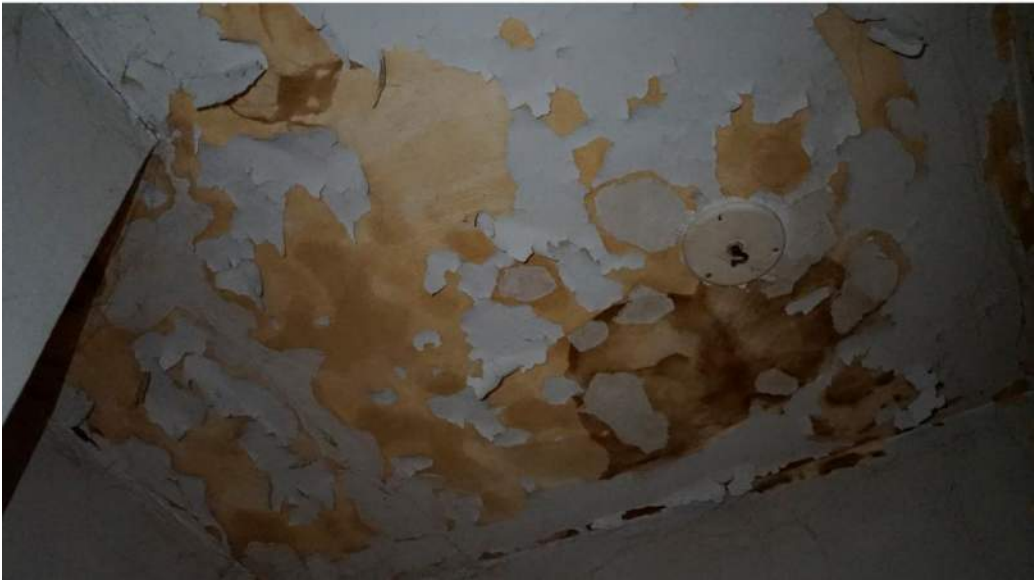
**Upper Bedroom** – evidence of moisture intrusion causing failing paint and plaster

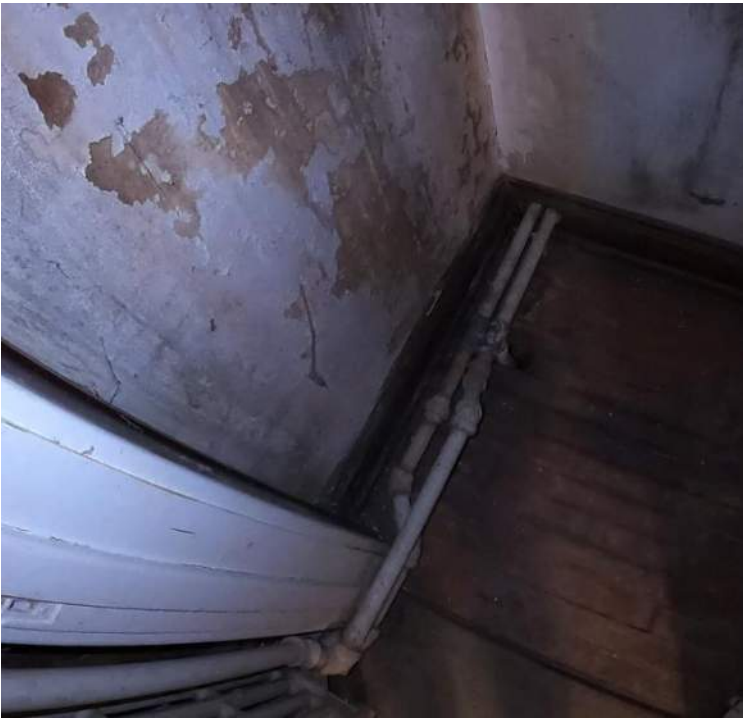
**Upper Floor** – wood floors are damaged and past their life, exposed pipes through-out.

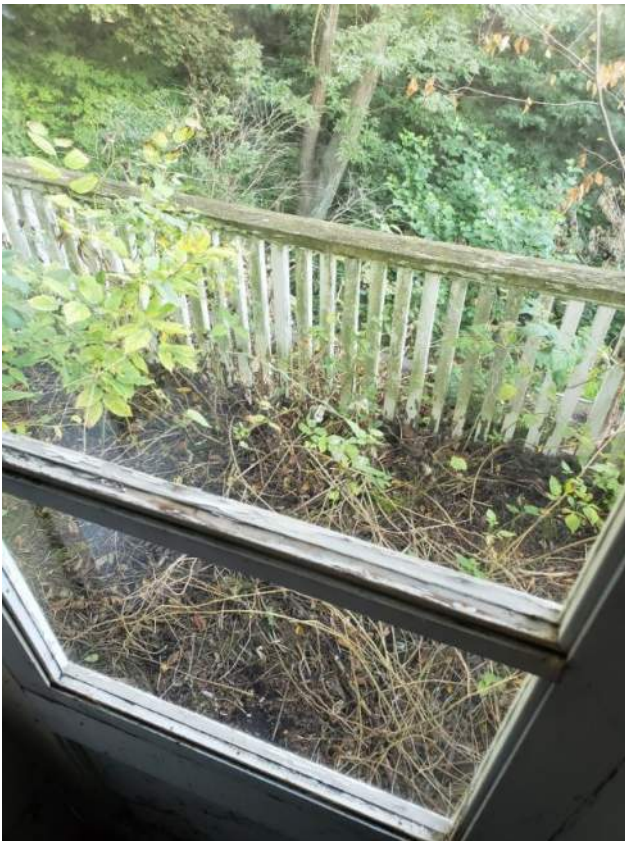
**Upper Porch (above Kitchen)** – excessive lack of maintenance has caused vegetative growth producing significant water damage to Kitchen below.

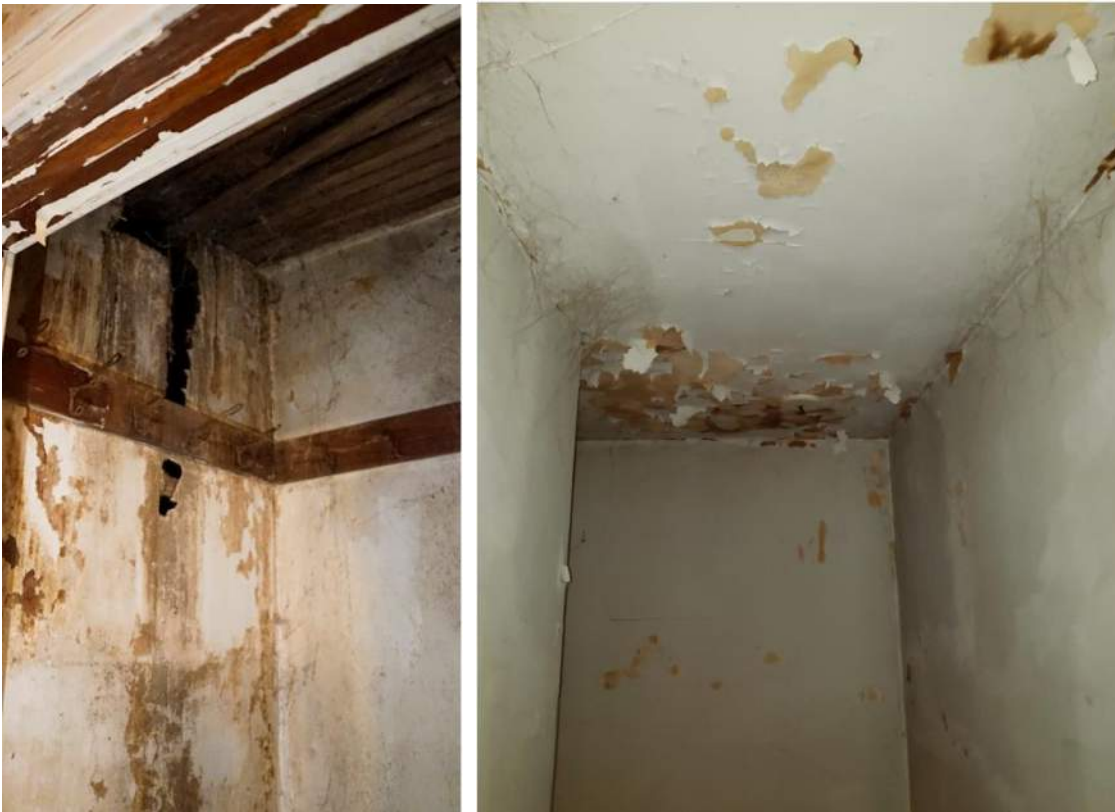
**Upper Bedroom & Hall** – evidence of moisture intrusion causing failing paint and palaster

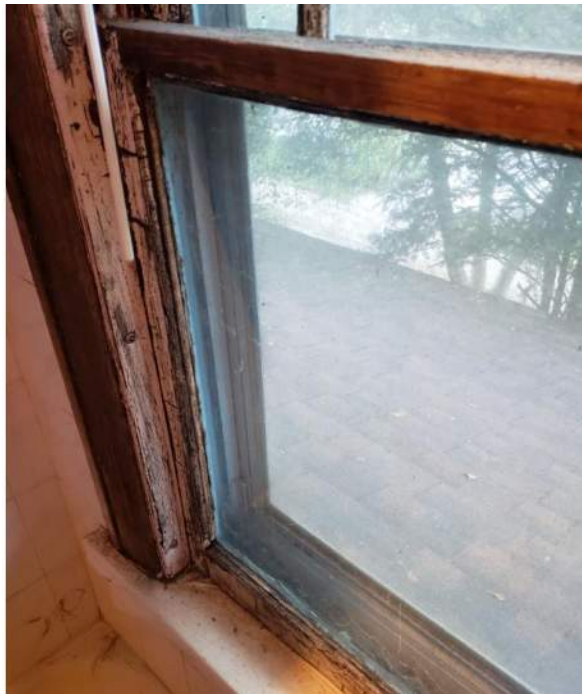
**Windows** – all the windows of the house are single paned and dry rotted.

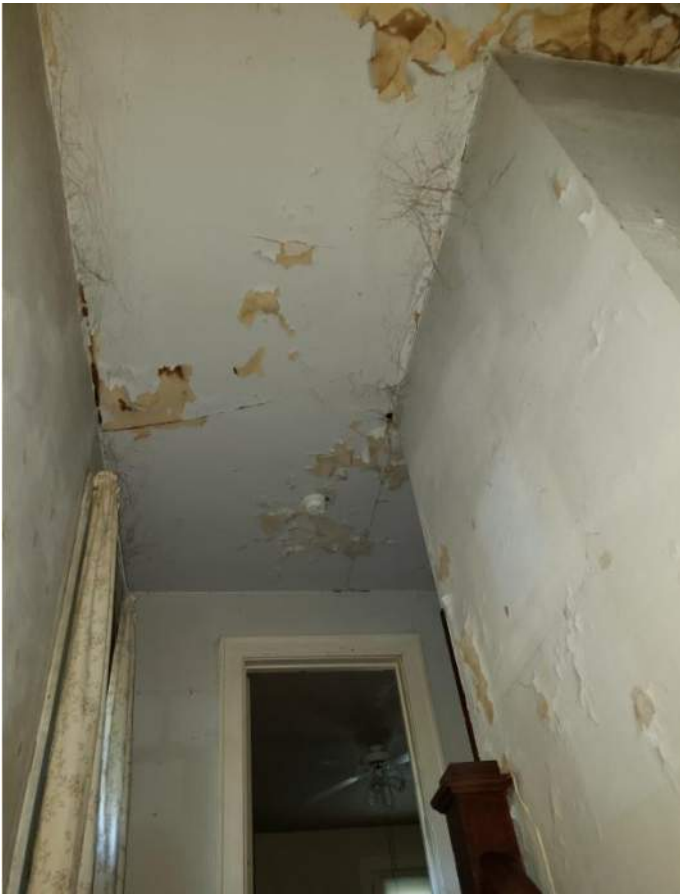
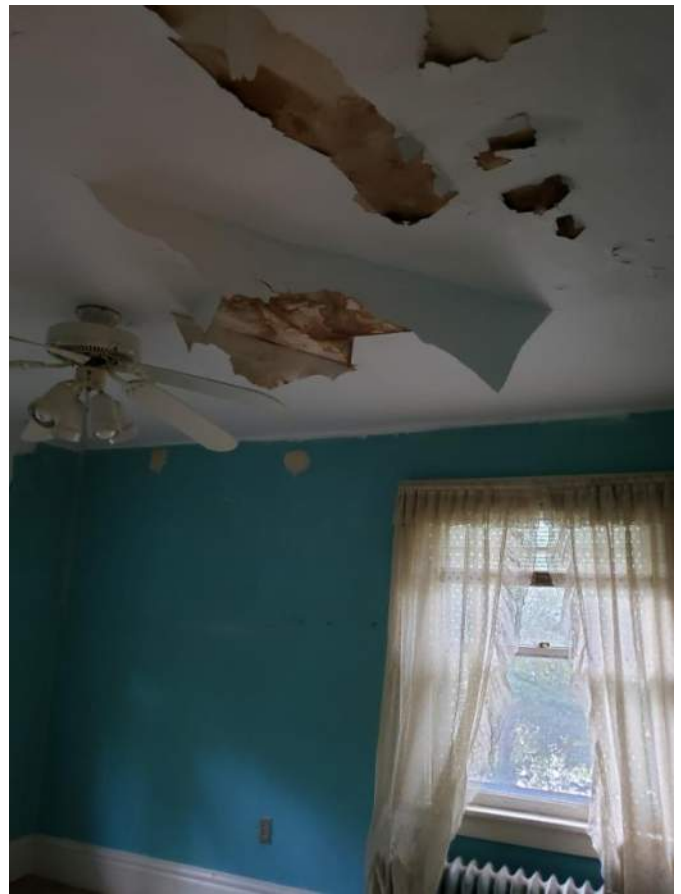
**Upper Stair & Upper Bedroom** – evidence of moisture intrusion causing failing and peeling paint

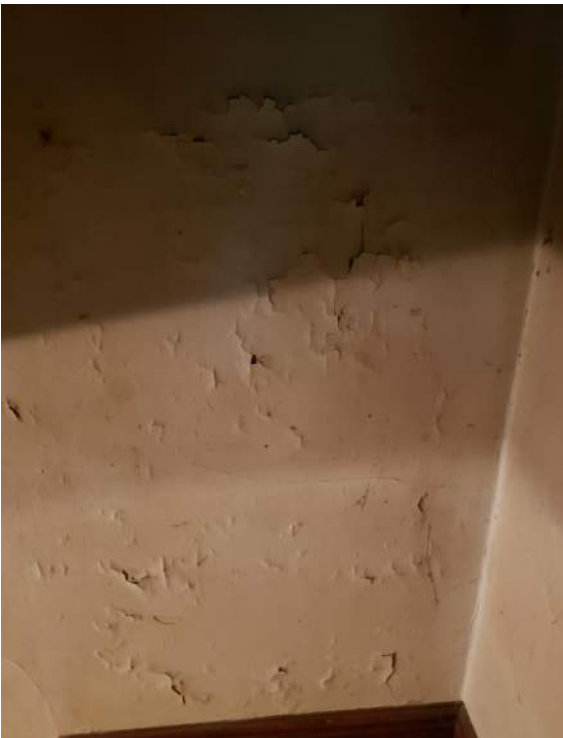
**Exterior wall at stair** – moisture penetrating through wall due to inadequate flashing

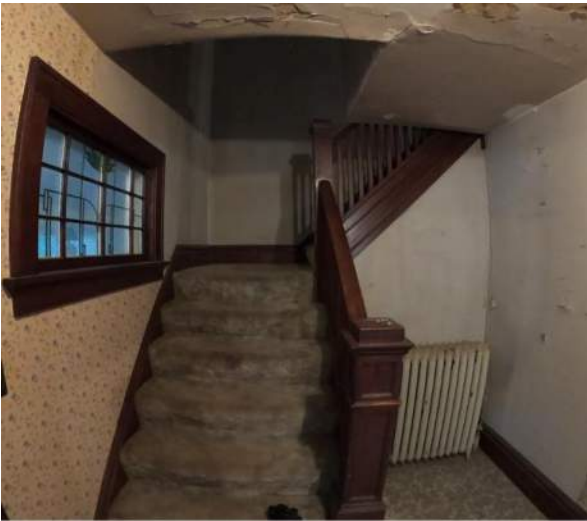
**Existing Stair** – limited 72” head clearance
