EXISTING BUILDING REVIEW

125 State Street

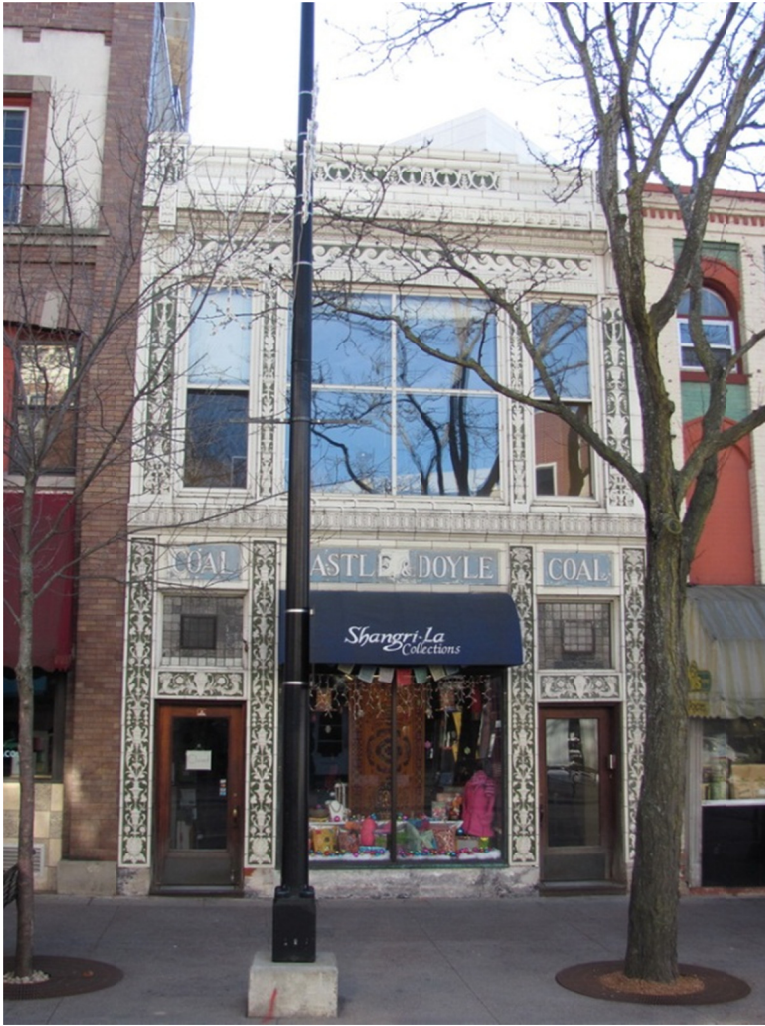
Figure 1. Overall view of the State Street facade.

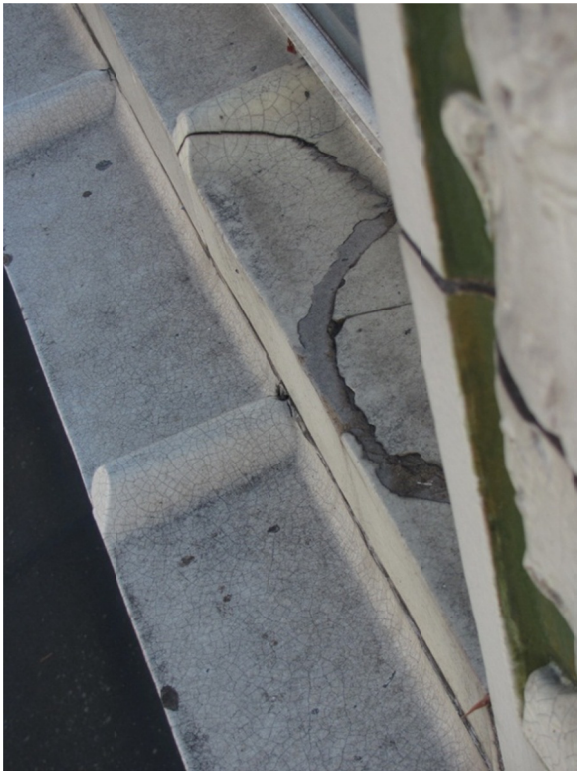
Figure 3. One cracked terra cotta window sill.

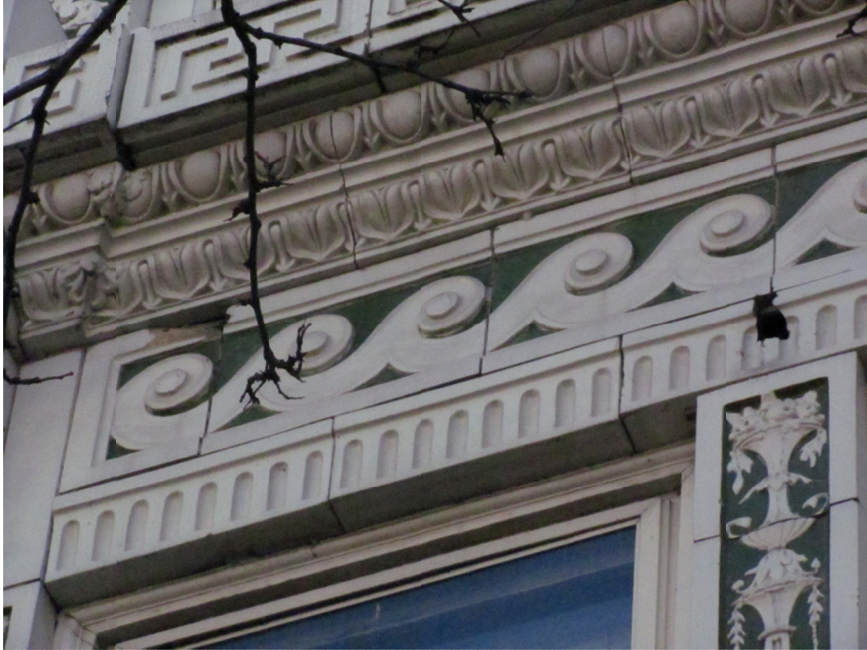
Figure 4. One unit with a hole and one spalled unit.

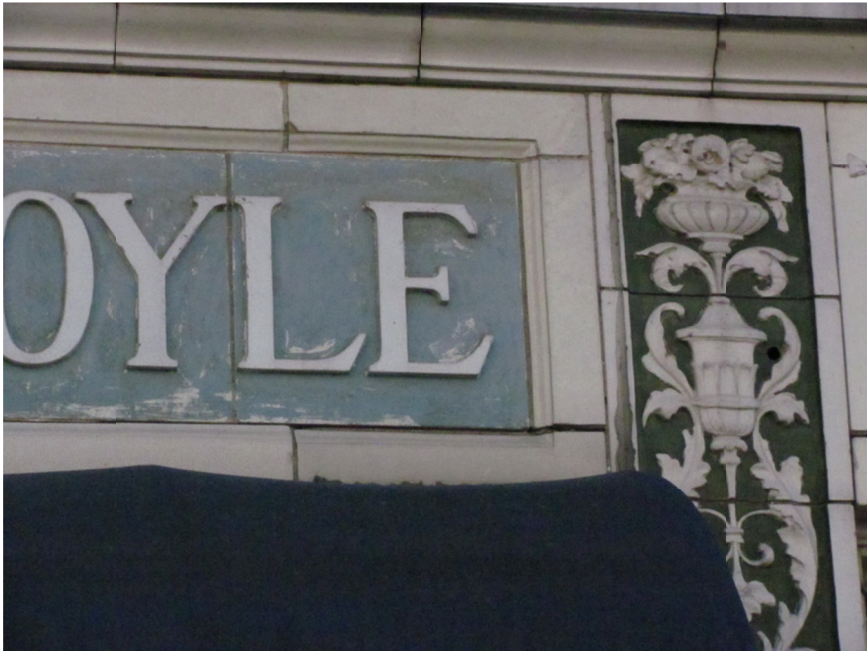
Figure 5. One displaced unit above the first floor storefront.

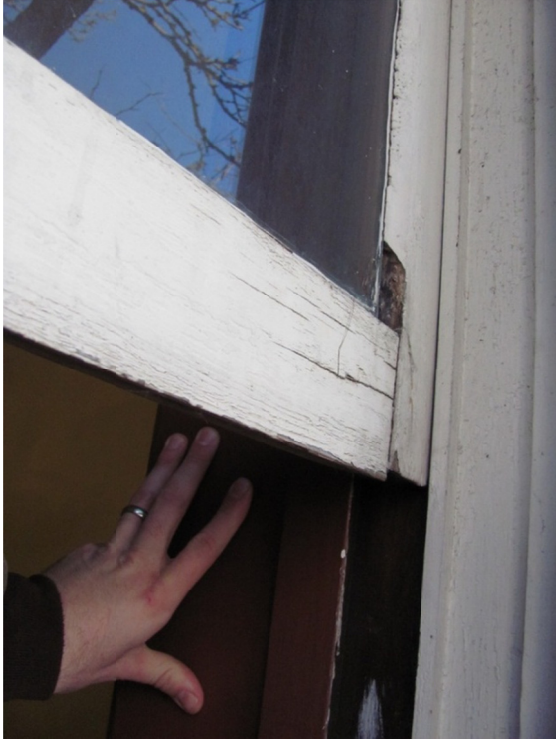
Figure 8. The wood windows are in fair condition, with some wood decay and displacement of window sash joinery.

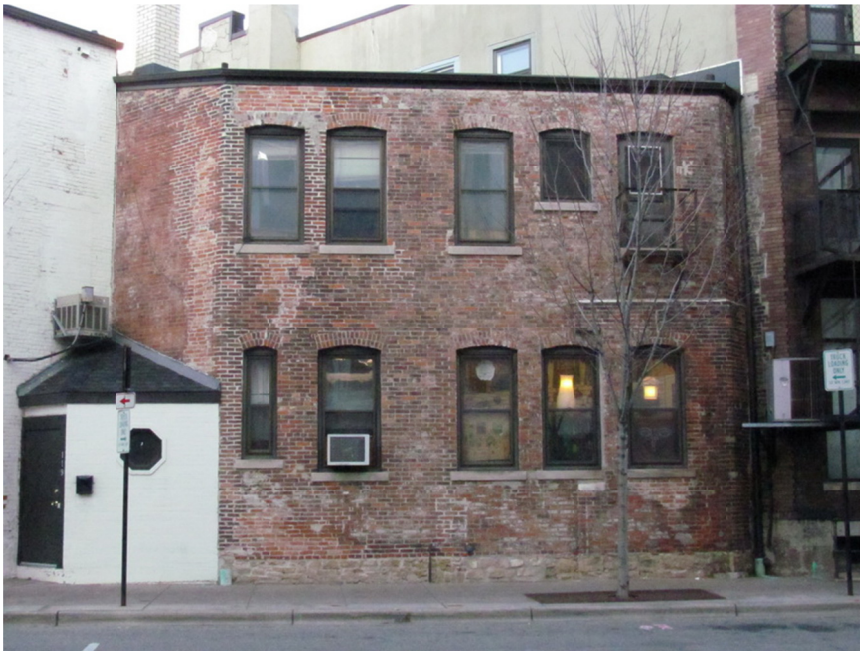
Figure 9. The Fairchild Street facade.

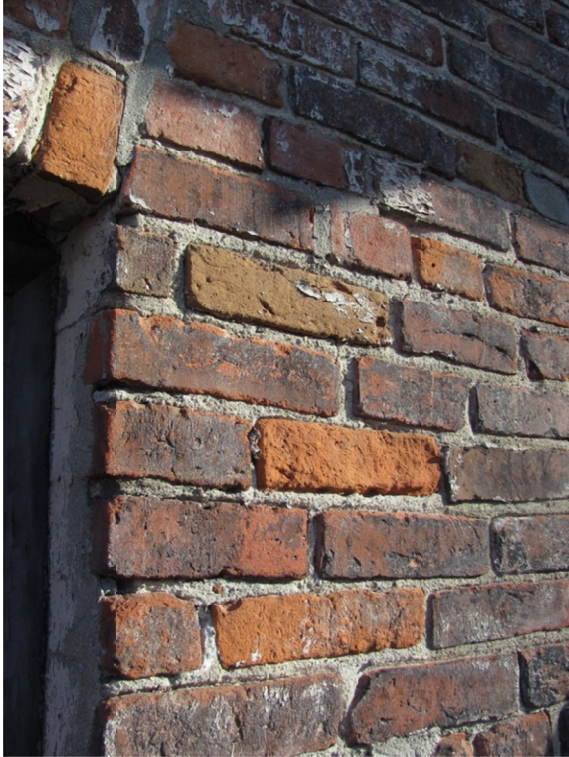
Figure 10. Left: Individual brick units were observed to have erosion or spalling of the face.

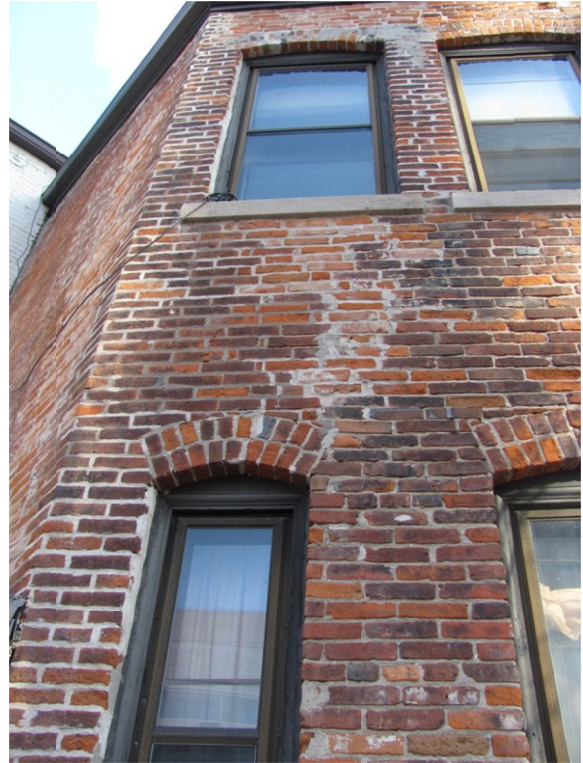
Figure 11. Right: Cracks and spalls that have been previously filled with mortar were observed.

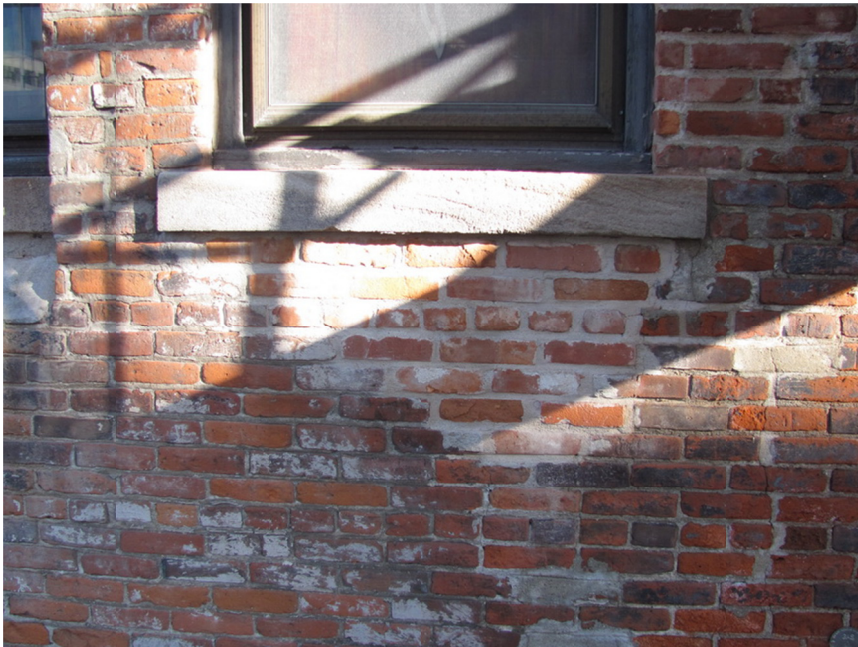
Figure 12. Localized areas of brick masonry appear to have been rebuilt previously.

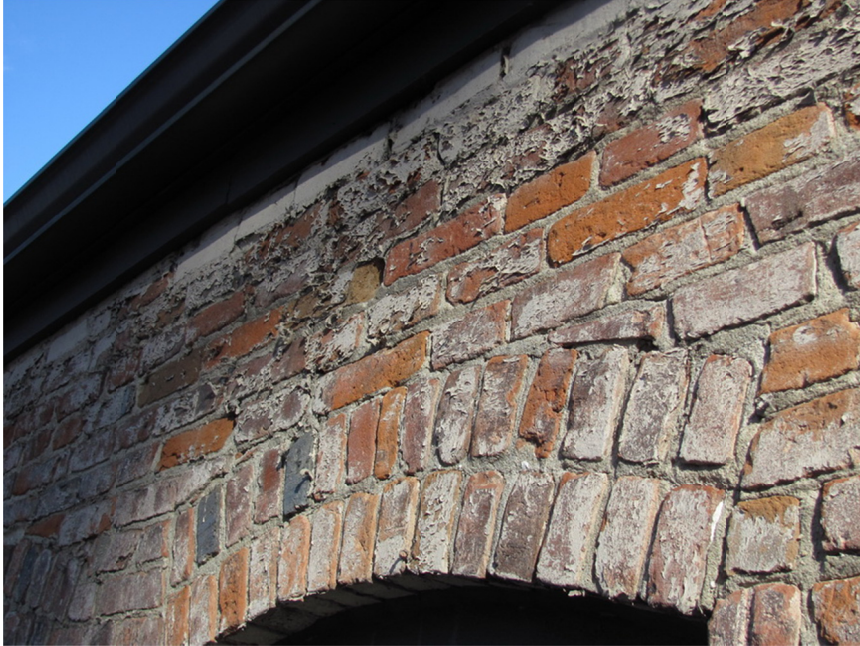
Figure 13. Remnants of a previous coating on the masonry were observed.

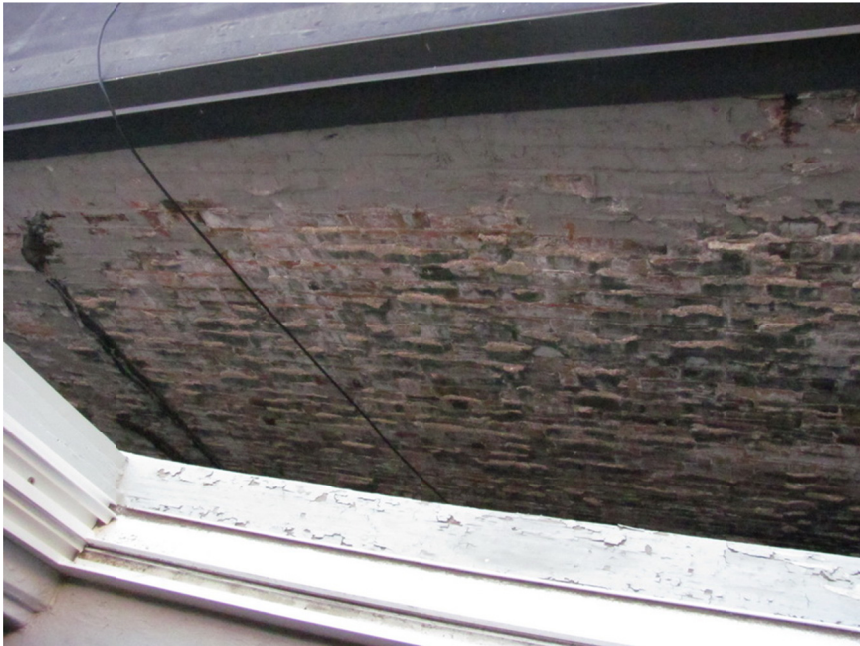
Figure 14. The masonry party wall as viewed from the adjacent building appeared to be in fair condition.

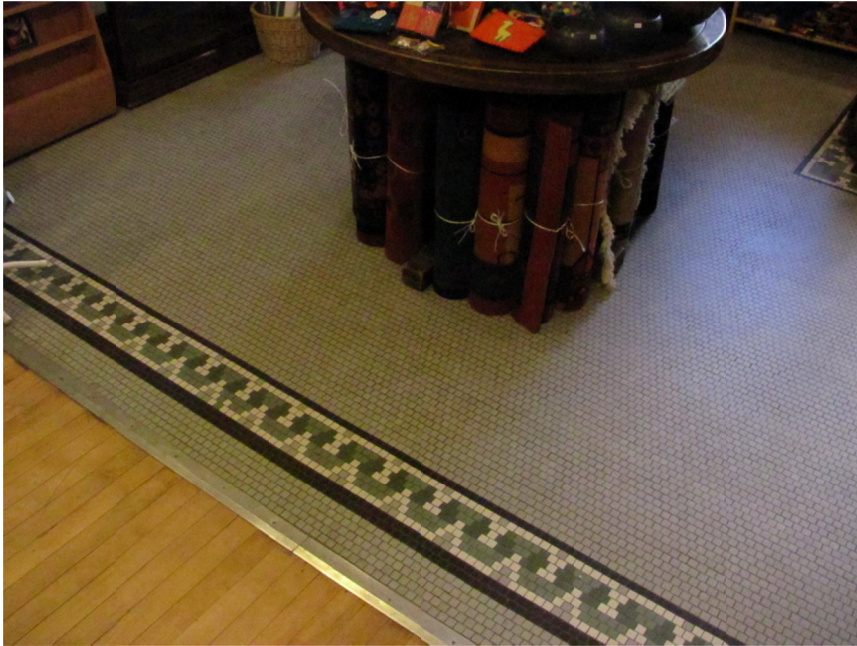
Figure 15. Hardwood and mosaic ceramic tile flooring in the first floor retail space.

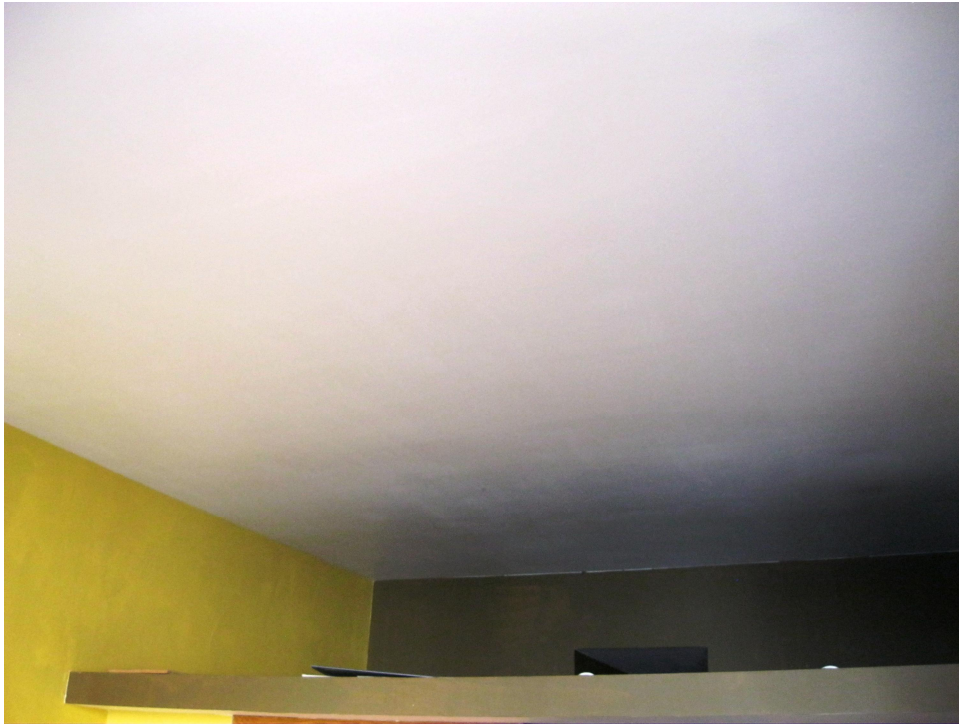
Photo 8 – 2nd floor apartment ceiling

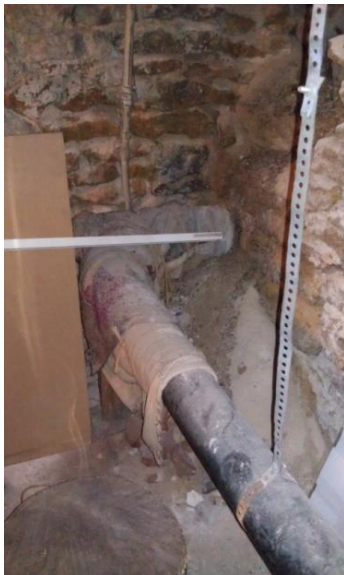
The heating system consists of a gas-fired atmospheric hot water boiler located in the basement. A gas-fired domestic water heater is next to the boiler. The retail space has an air conditioning unit but the apartments not air conditioned. There is a single gas meter and single water meter for this building, which serves only this building. The roof drains into a gutter along N. Fairchild St. and into an exterior downspout .

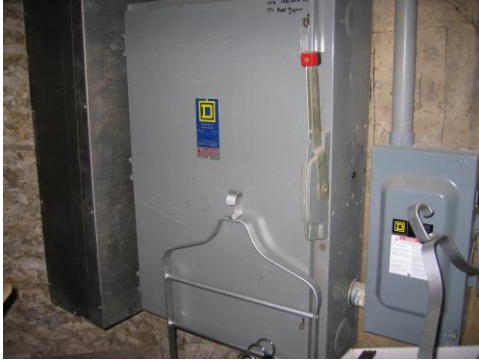
Building main disconnect.
