EXISTING CONDITIONS:

EXISTING CONDITIONS: Interior of Existing House

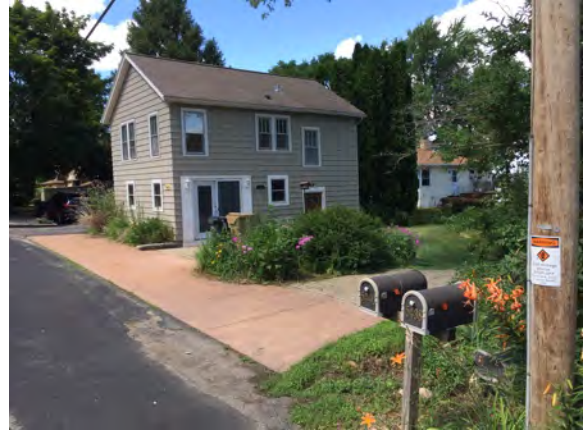
Existing concrete walk and driveway

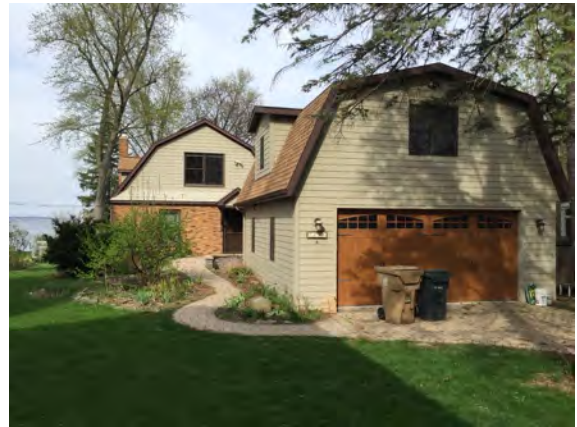
Existing house and garage

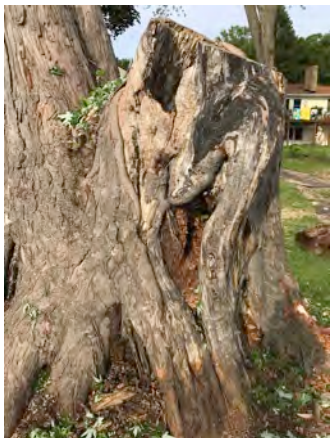
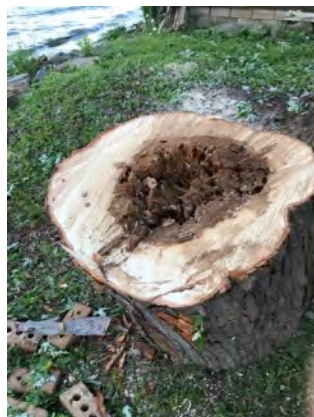
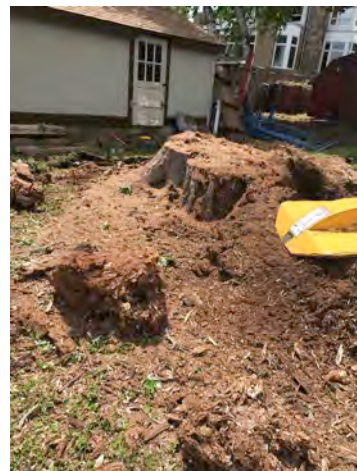
Diseased Silver Maple Removed:

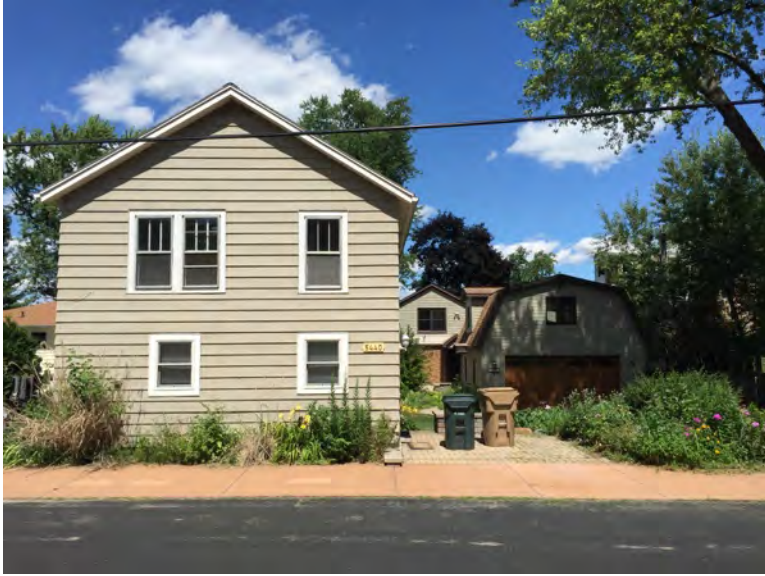
Accessory Building : To be converted to compliant ADU

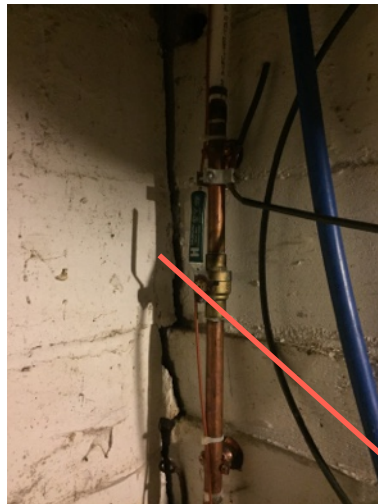
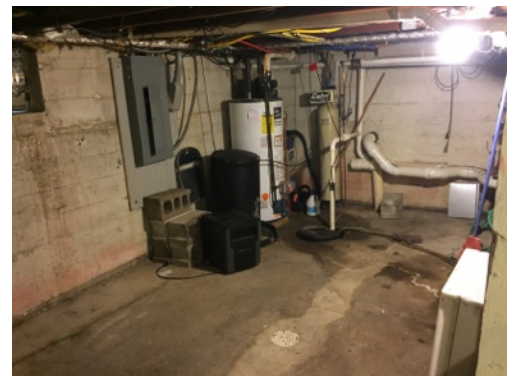
Foundation crack
