EXISTING BUILDING REVIEW

117-119 State Street

Name: Haswell Furniture Co.

117–119 State Street – Architectural Review

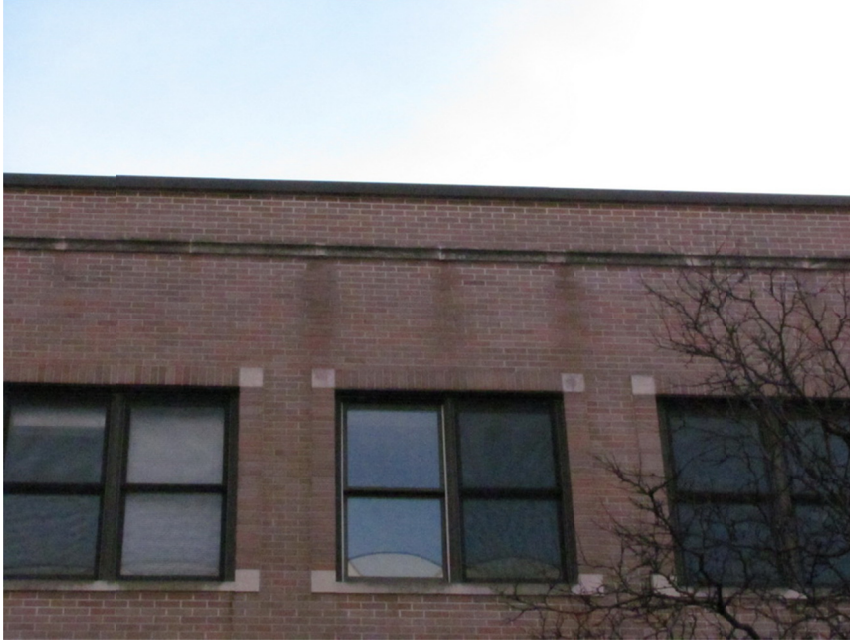
The State Street facade consists of manufactured polished stone panels and brick and cast stone masonry (Figure 1). Except for a limestone belt course and balustrade at the third floor (Figure 2), this facade was completely reconstructed in the 1990s. The only visible distress observed on this facade is localized water rundown staining below the stringcourse at the parapet wall (Figure 3).

Figure 3. Water rundown staining below the stringcourse at the parapet wall.

Based on this limited survey, the State Street facade does not require any significant repairs at this time. The building roof should be surveyed and any maintenance needs addressed.

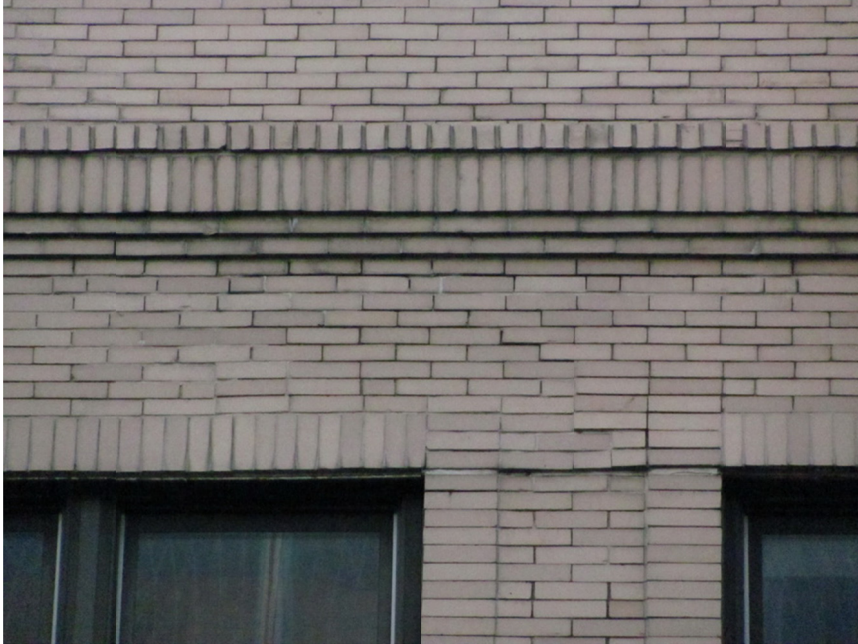
The Fairchild Street facade primarily consists of the original brick masonry facade, although the areas around the entrance doors were apparently altered as part of the 1990s renovation (Figure 4). Limestone is used for window sills at this facade. Cracking and displacement of brick masonry above window heads was observed, likely related to corrosion of embedded window lintels (Figure 5).

Figure 5. Cracking and displacement of brick masonry above window heads.

Masonry repairs are required at the party walls and the Fairchild Street facade. Areas of cracked masonry should be rebuilt, and areas of open or eroded mortar joints should be repointed. At the obtuse corners of the party walls, installation of backer rod and sealant in the continuous vertical crack may be appropriate to accommodate movement and provide a weather tight joint. Repairs are required at bearing locations of window lintels on the Fairchild Street facade; additional investigation is needed to evaluate the condition of the steel lintels and determine the scope and extent of the required repair.

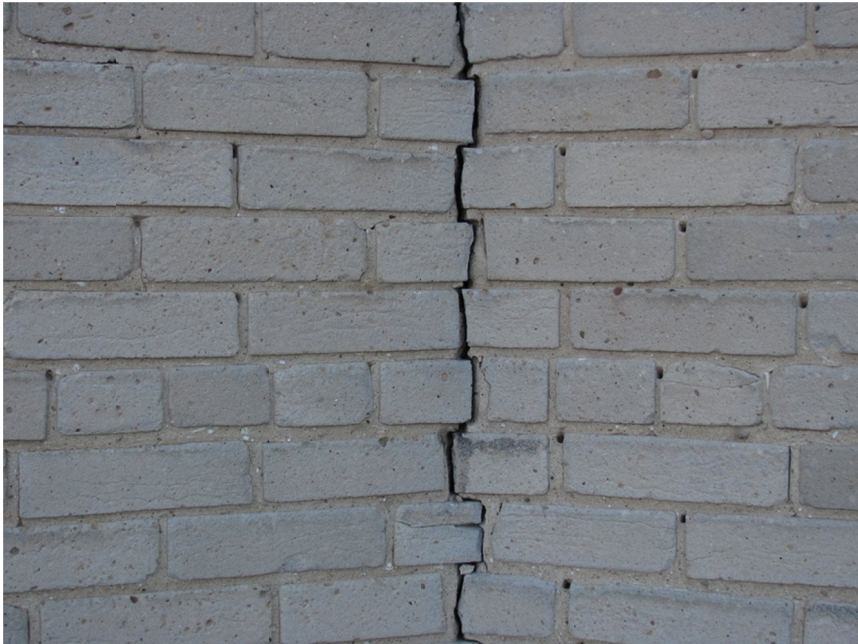
The brick masonry party walls at the sides of the building were reviewed from lower roofs of adjacent buildings, where these walls extend and are exposed above the adjacent roof levels. Vertical cracking was observed at multiple locations in both party walls, especially at obtuse angle changes in the plane of the wall (Figure 6 and Figure 7). Also, some areas of poorly matched repairs and areas overclad with an EPDM rubber roof membrane were observed (Figure 8). Erosion of mortar joints and water rundown staining was also observed at the party walls.

Figure 6. Vertical cracking at an obtuse corner in the brick party wall.

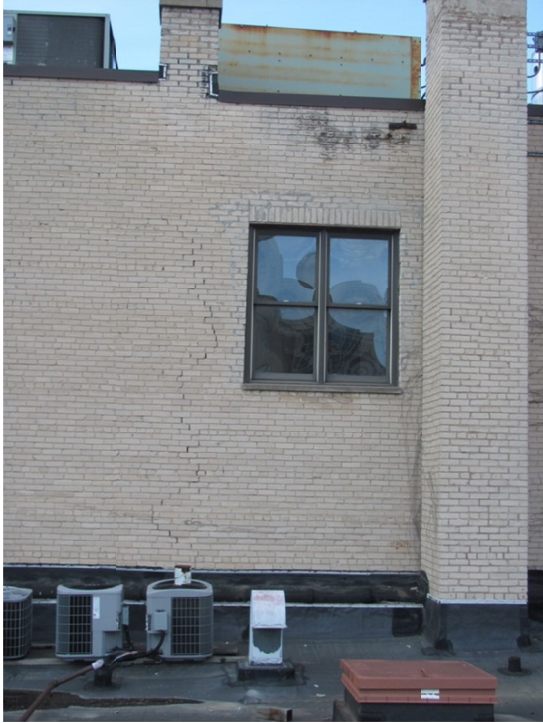
Figure 7. Left. Vertical cracking and localized damage in the brick masonry party wall, which is visible where it extends above the roofs of the adjacent buildings.

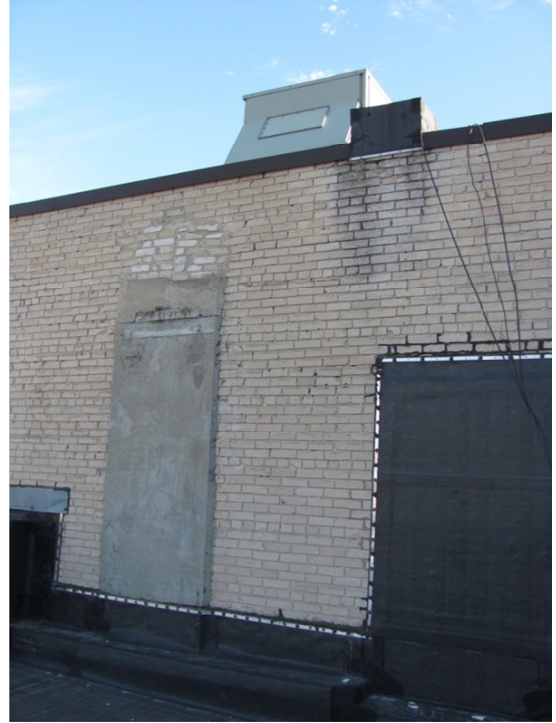
Figure 8. Right. Some areas of poorly matched repairs and areas overlaid with an EPDM rubber roof membrane were observed at the party walls. Also note rundown staining and open mortar joints.

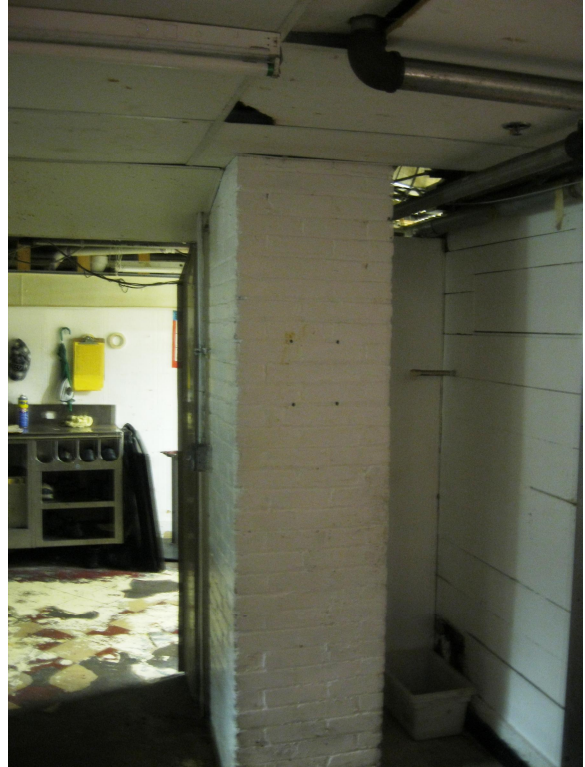
The floor is wood framed. The floor joists span perpendicular to State Street. They are supported on a wood beam of built up 2x members in turn being supported on 2' square brick piers. The floor live load capacity based on the joists is 85 psf. Floor load capacity based on the built up beams is less than 50 psf. The present day live load requirement is 100 psf for retail occupancy.

Photo 5 – Basement level brick pier

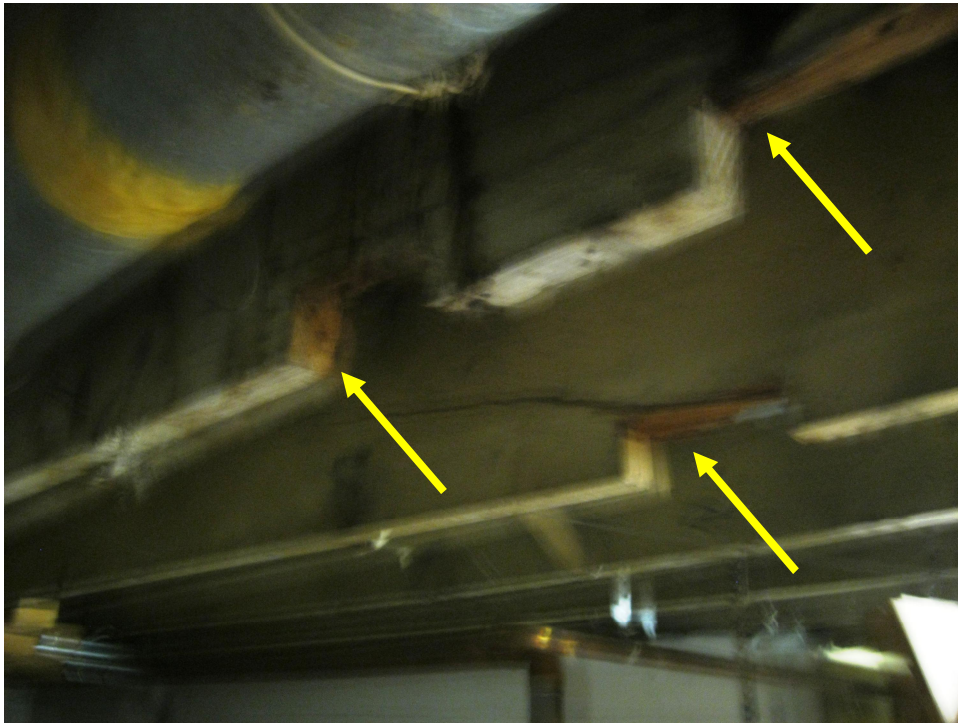
3. Areas of Compromised Structure
 - a. Numerous structural revisions have been made which are outlined in the body of the report.
 - b. Floor joists in the basement for the first floor framing have been cut and notched over the years for the passage of piping. Shores have been placed to prop some of these areas up. These areas are outlined in the body of the report.

Photo 6 – Notched 1st floor joists

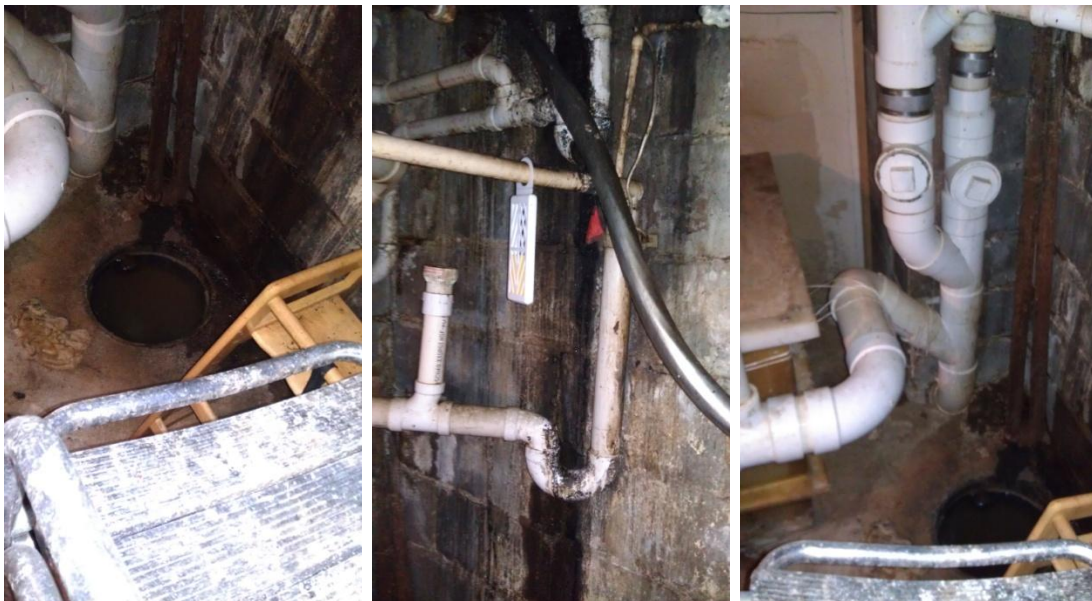
Poor condition of sanitary piping

The basement water heater appears less than 10 years old and is in good condition. Domestic hot and cold water piping is a mix of new and old in the basement due to renovations/remodeling over the years but it is expected that much of the piping on the upper floors is original or very old. Similarly, the sanitary piping from the kitchen in the basement is PVC due to recent modifications, but ties into original cast iron mains and under floor laterals. The domestic water heater on the upper floor appears to be fairly new, probably less than 5 years old.

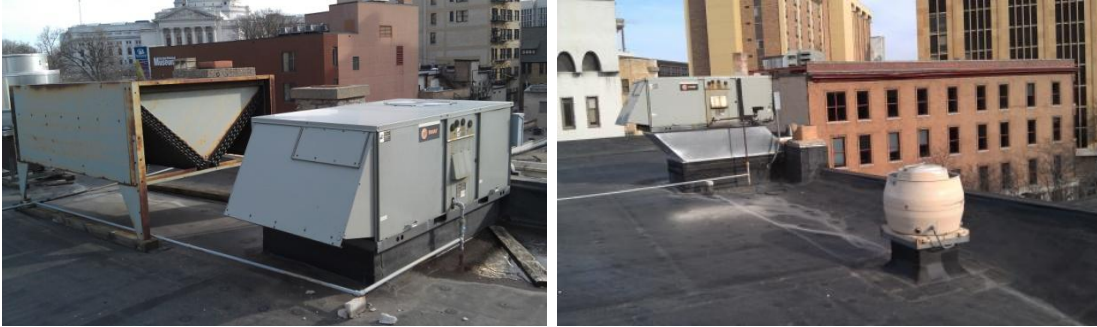
Existing rooftop equipment

The rooftop air handling units are estimated to be about 20-25 years old. That is past the typical average useful life for this type of equipment. The kitchen hood exhaust fan is newer, probably around 5 years old or less.

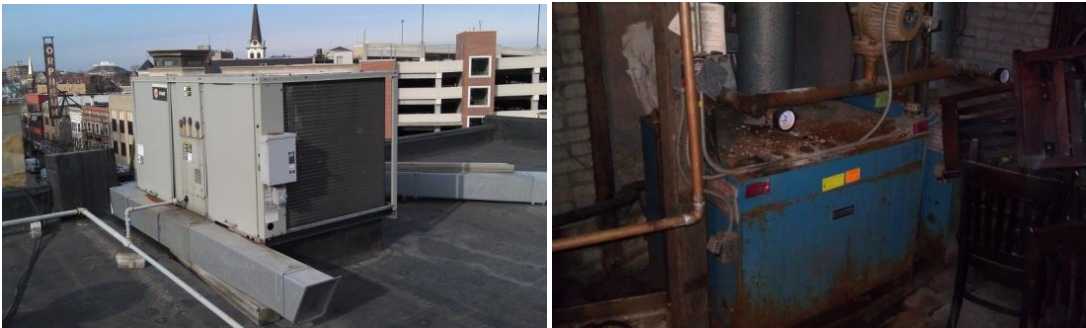
Basement Boilers

The boilers are estimated to be 25-30 years old and are in poor condition. Some of the hot water piping is new but it is expected that most is original. Some may contain asbestos insulation. It appears that piping that was replaced was due to repairs and/or equipment replacements.

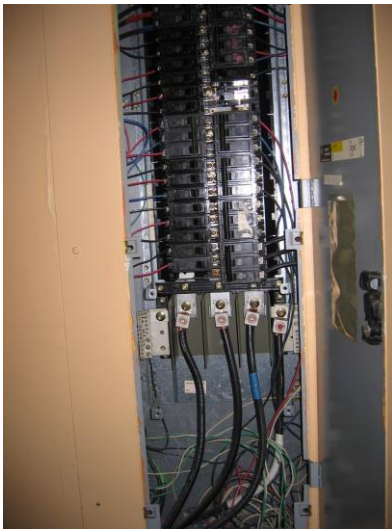
The branch panel on the 2nd floor was missing the interior trim cover, resulting in exposed wiring terminations when the panel front was opened. Since the current condition is a potential safety hazard the building manager brought this deficiency to the attention of the restaurant manager to replace the trim cover that was removed.

Electrical panel on 2nd floor restaurant missing interior trim cover.
