Architectural Engineering Consulting

Garver Feed Mill Building Repairs

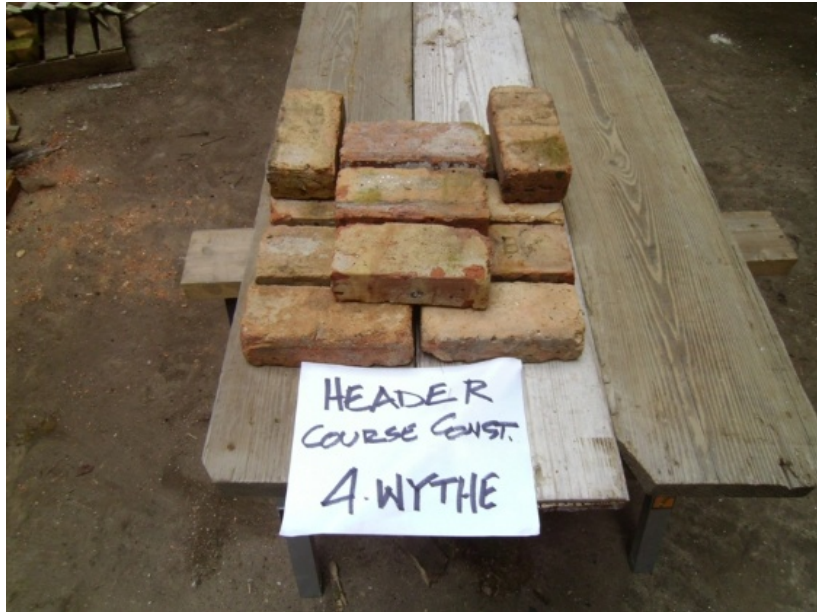
Image showing header course construction of four wythe wall.

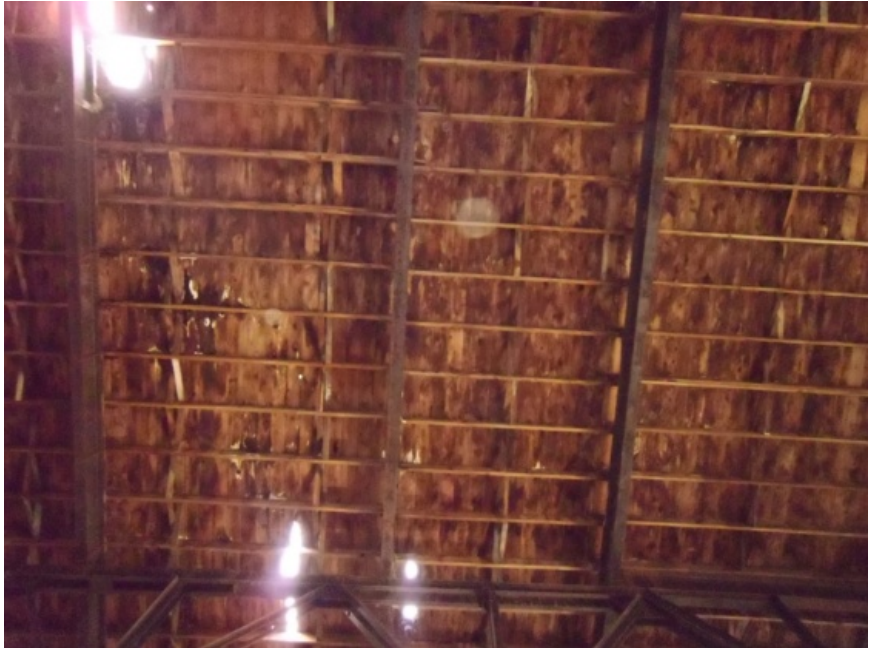
Image showing a view of the underside of the deteriorated wood roof framing at Module A.

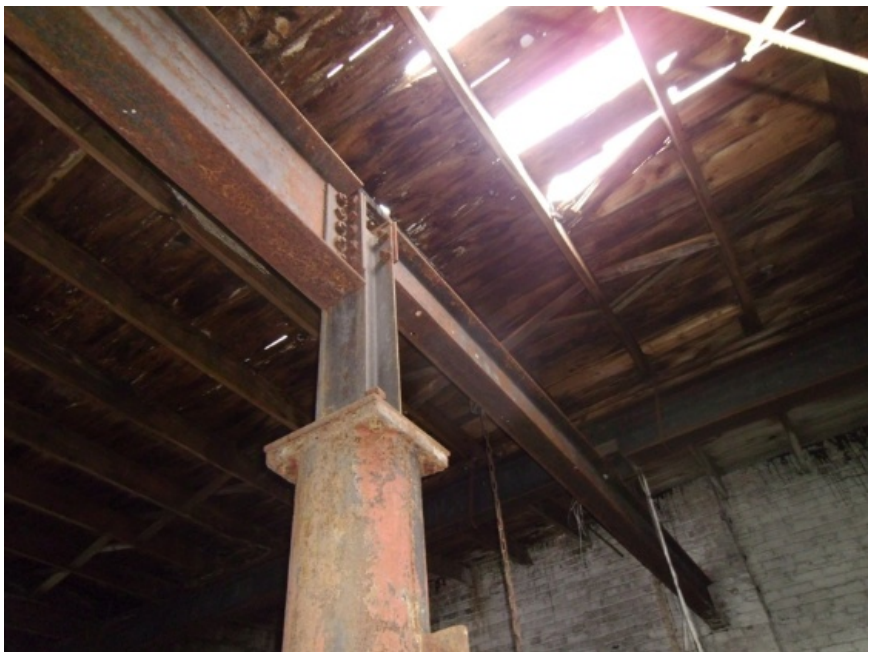
Image showing the original 1905 columns of the buildings being adapted to support the 1929 roof beams.

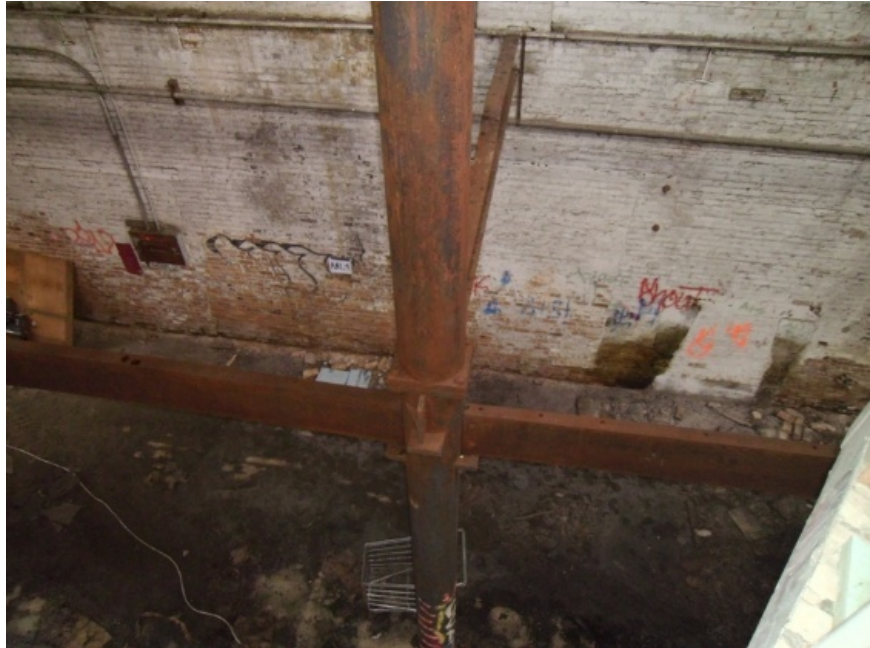
Image showing that the joints in the 1905 columns currently used to support roof structure are braced into the masonry walls.

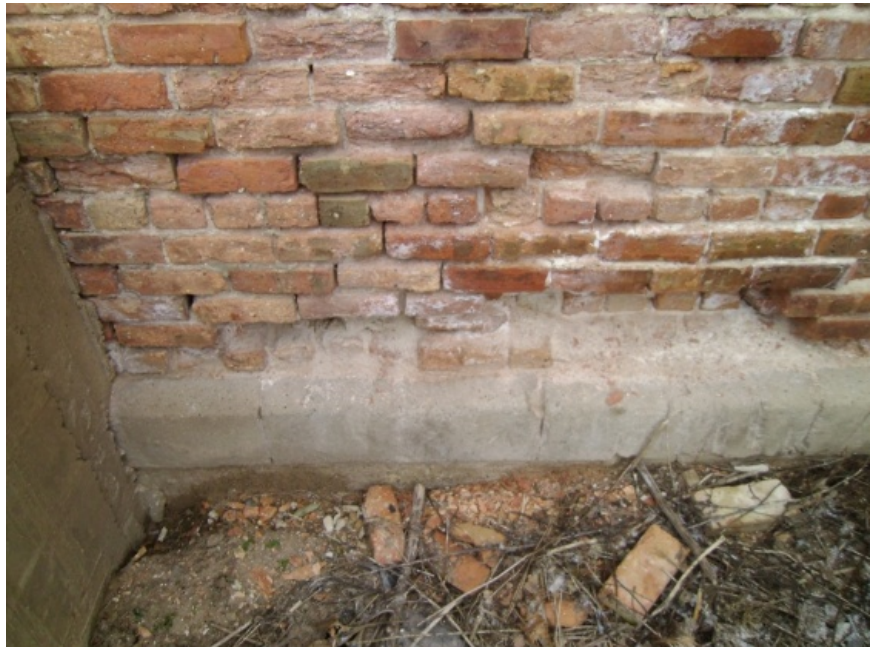
Image showing wall deterioration along its base at Module A.

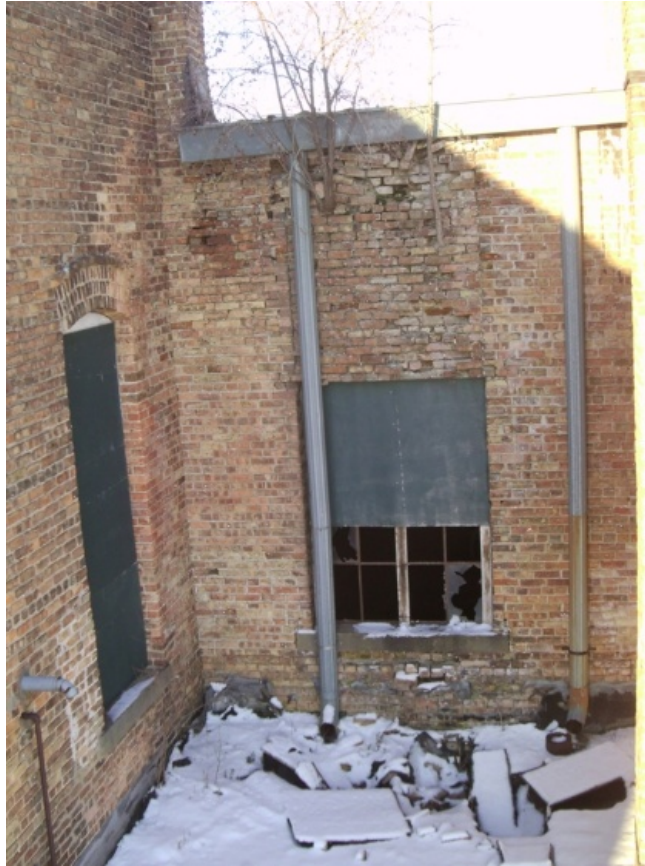
Image showing the nonfunctional downspout at the northeast wall at Module A. Note the vegetation at the wall.

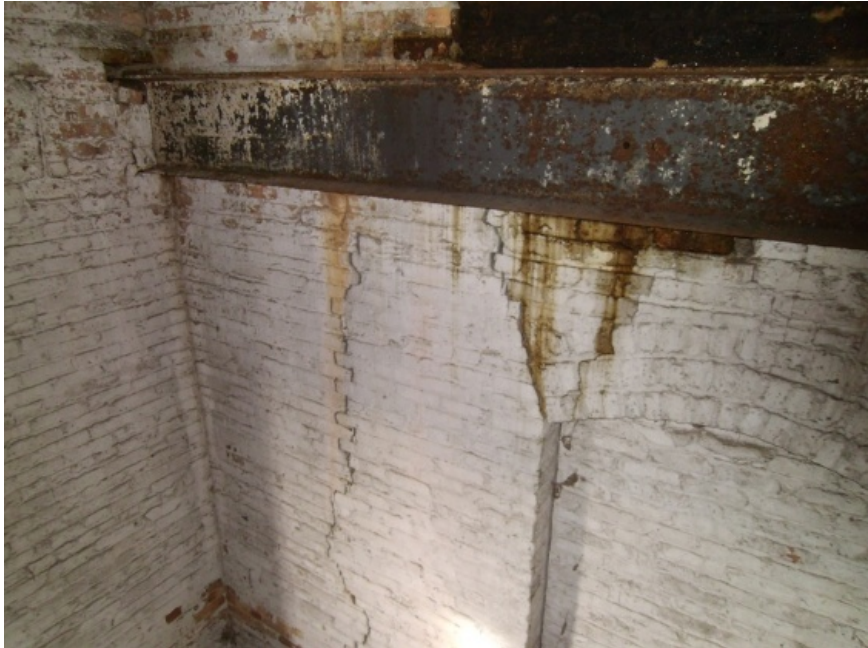
Image showing the large cracks in the walls at the southwest corner of Module A.

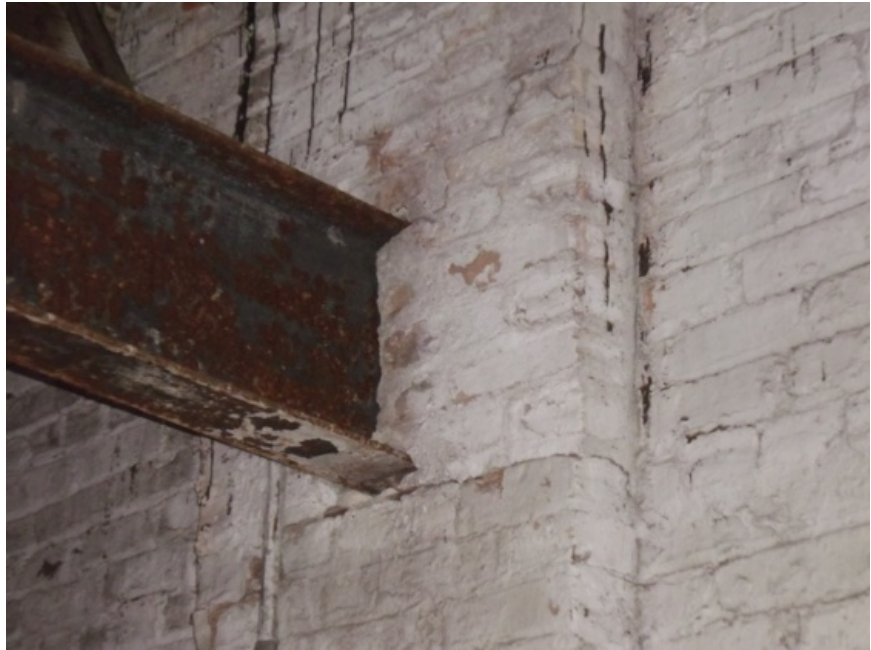
Image of a beam bearing into the masonry wall of Module A. Notice the horizontal crack below the beam and the diagonal step crack above the beam to the right.

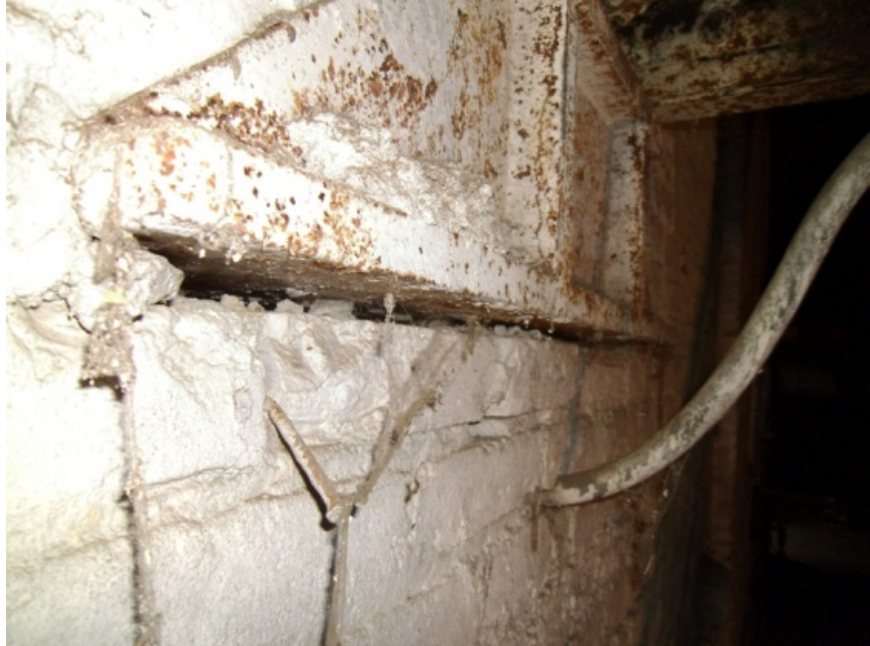
Image showing the gap between the masonry wall and the truss bearing casting.

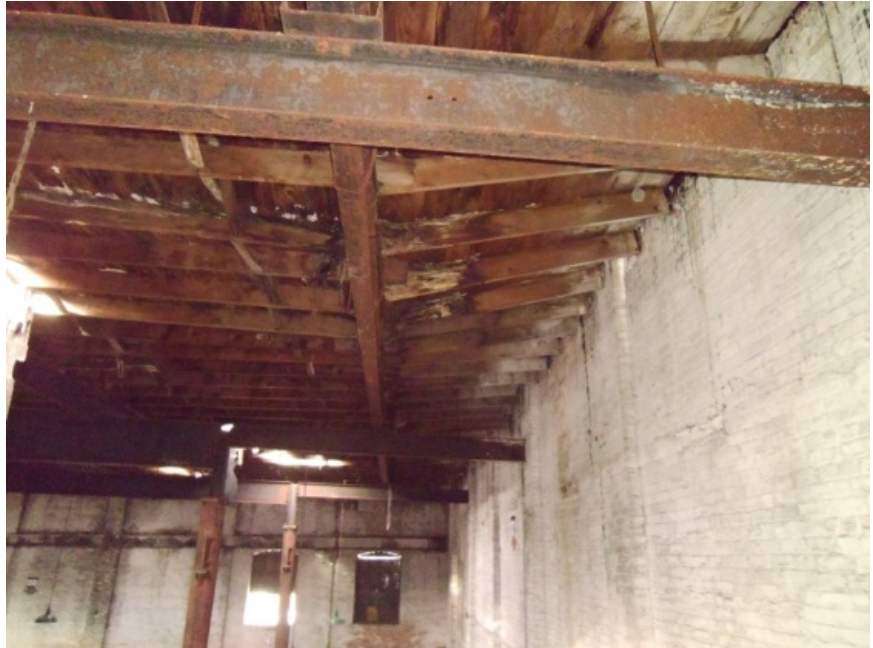
Image showing deterioration in the wood roof framing.

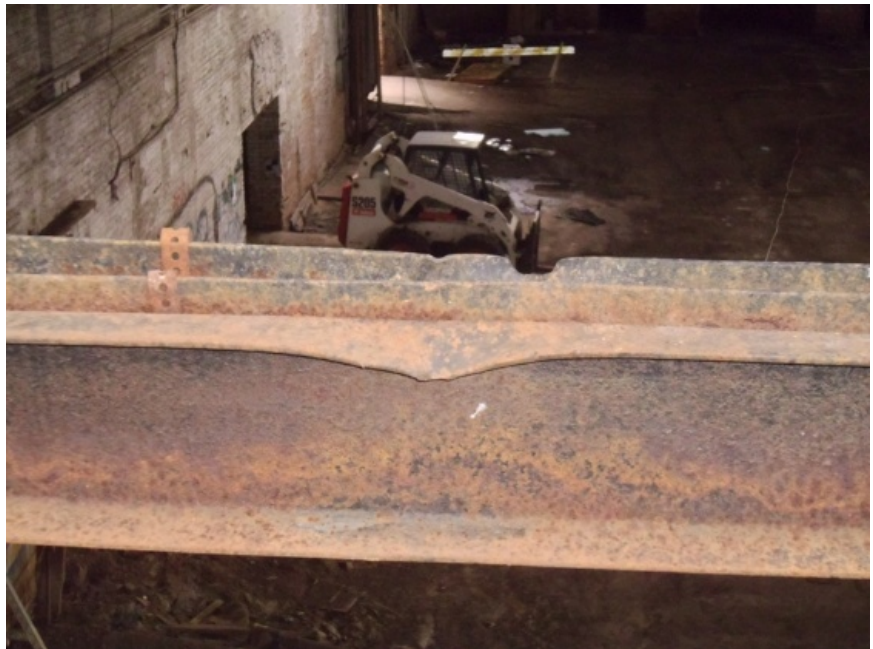
Image of a bottom chord that has been damaged by falling objects.

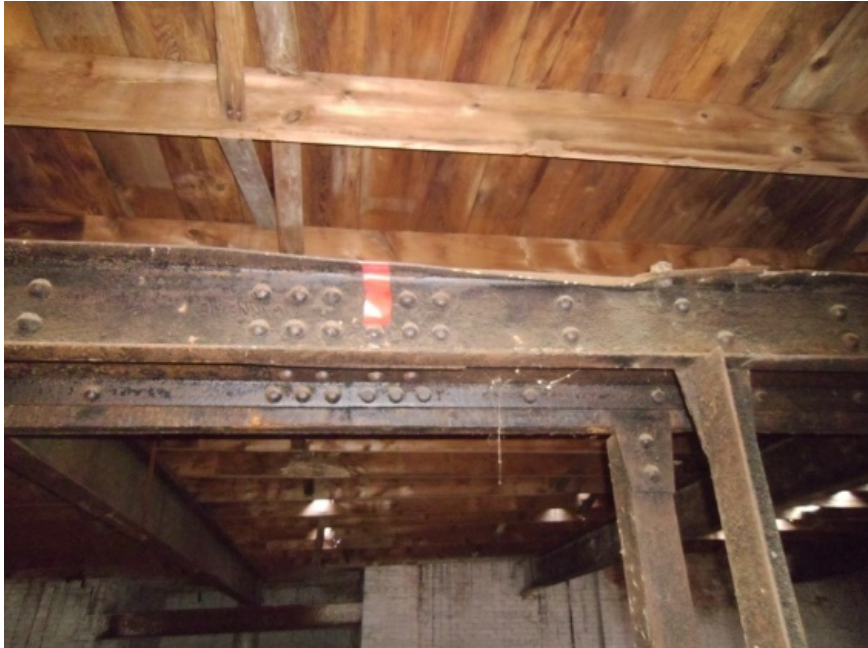
Image of a top chord that has been damaged by falling objects.

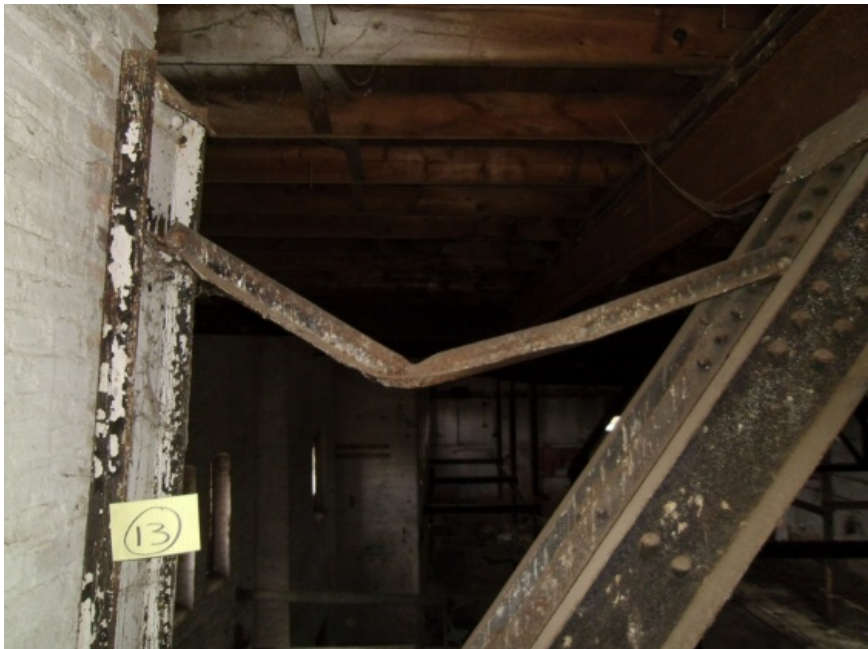
Image showing the bent stabilizer from the truss to the masonry wall.

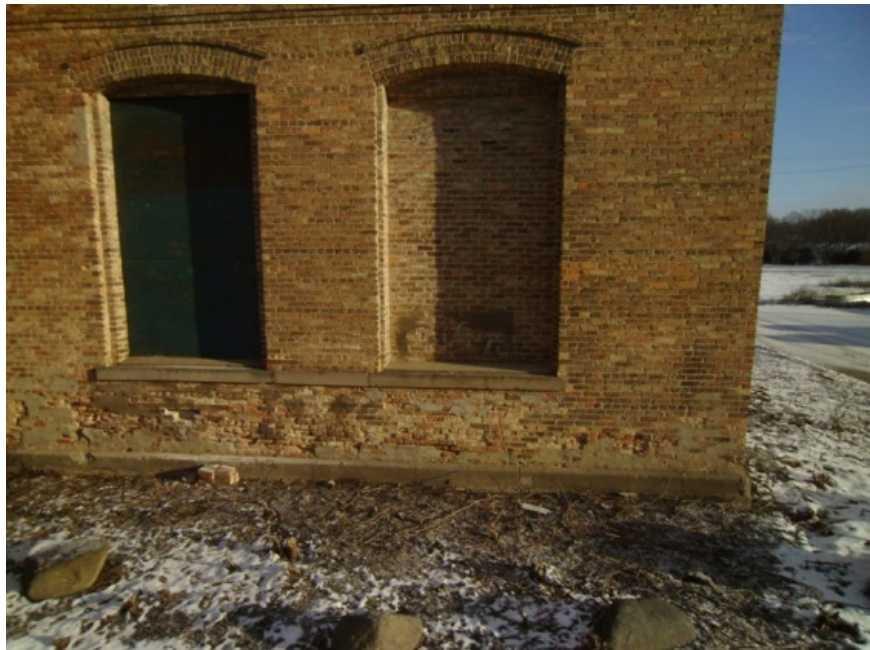
Image showing poorly performed patches at ongoing deterioration issues at the wall base.

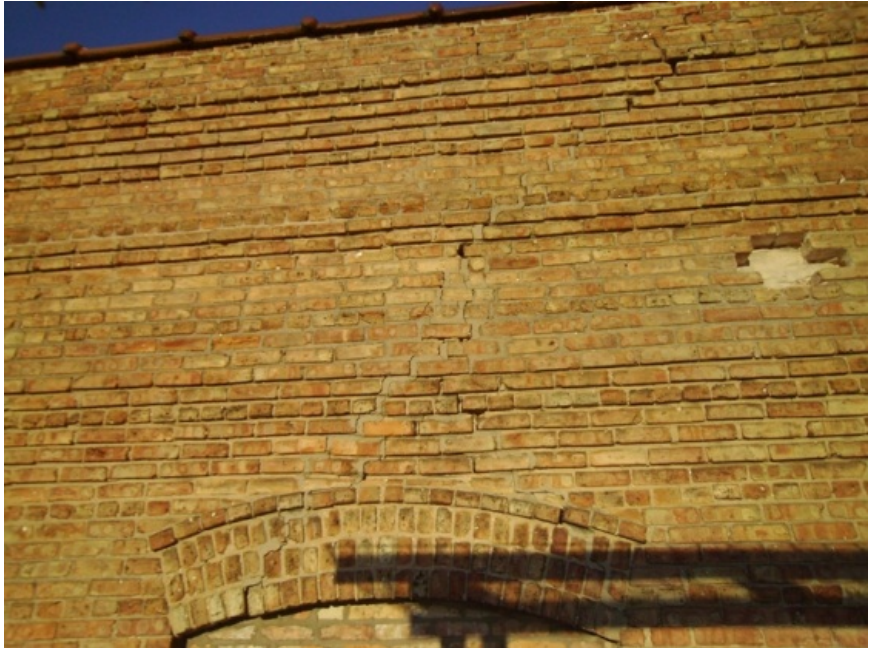
Image showing a stepped structural crack from a second level lintel to the roof.

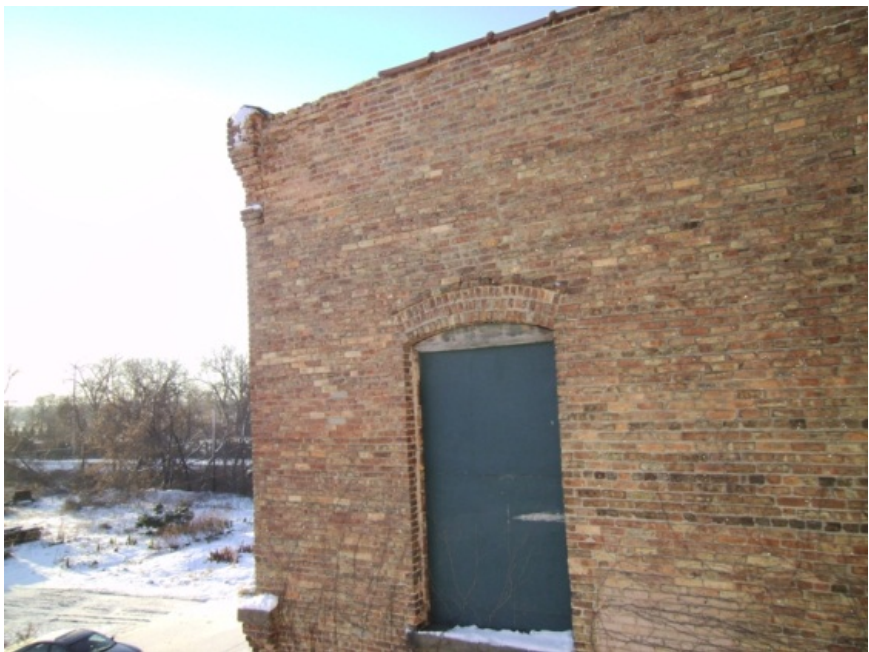
Image from the north at the second floor northeast corner of Module B. A section of parapet has lost its cap and allowed moisture to migrate into the corner of the building.

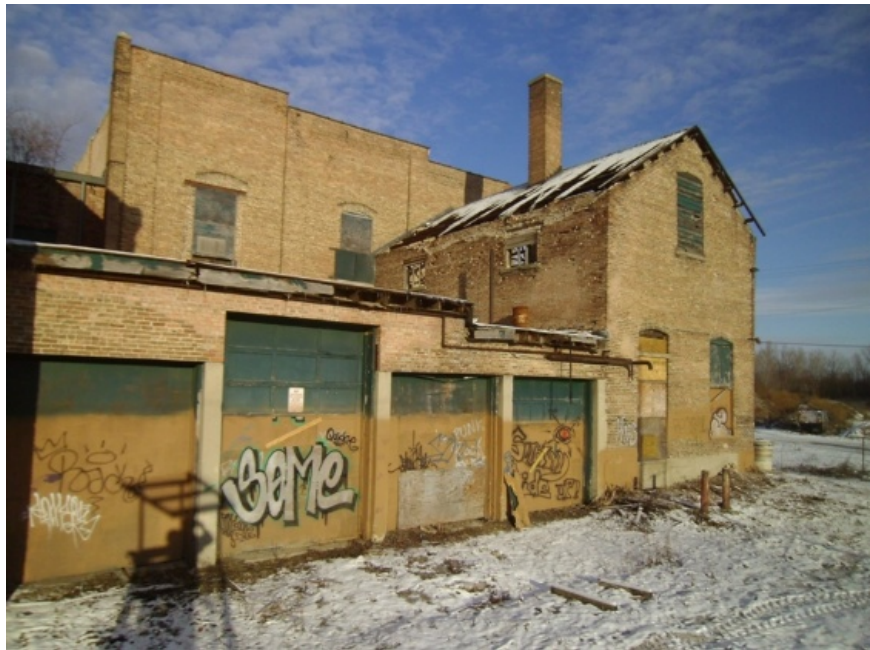
Image showing the east elevation of module C & D.

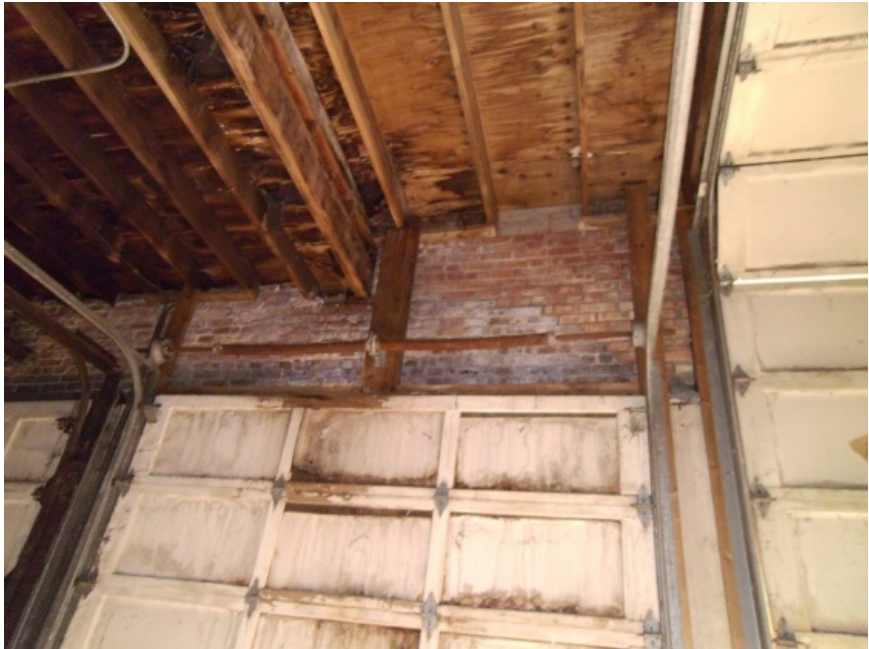
Image showing the interior surfaces of the east wall. Note the heavy efflorescence and damage to the garage door. The heads of the doors appear to be level and lintels appear to be performing as intended.

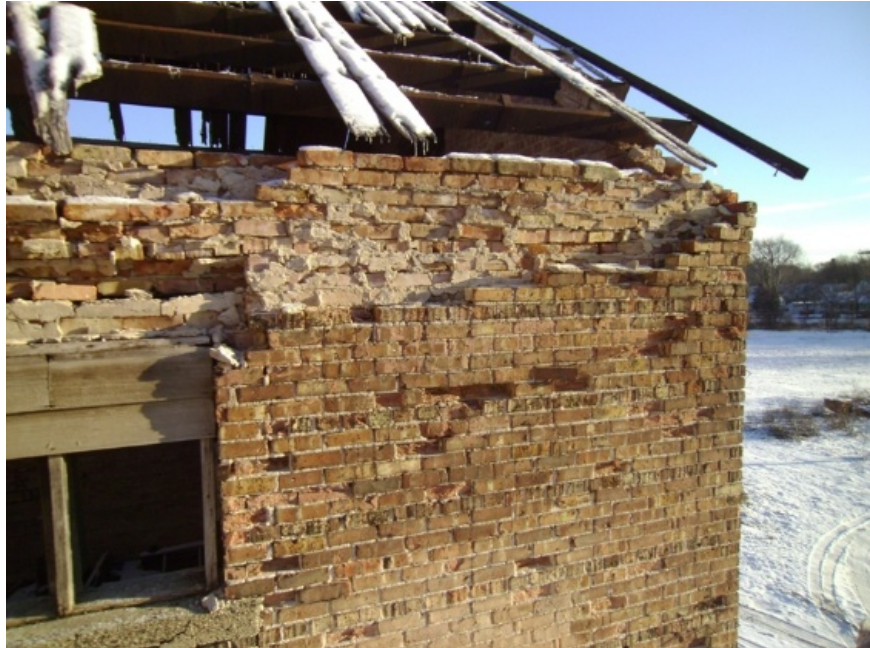
Image showing a section of the south wall. The extensive masonry deterioration extends at least to the underside of the window openings. Note the missing lintel section at the window opening.

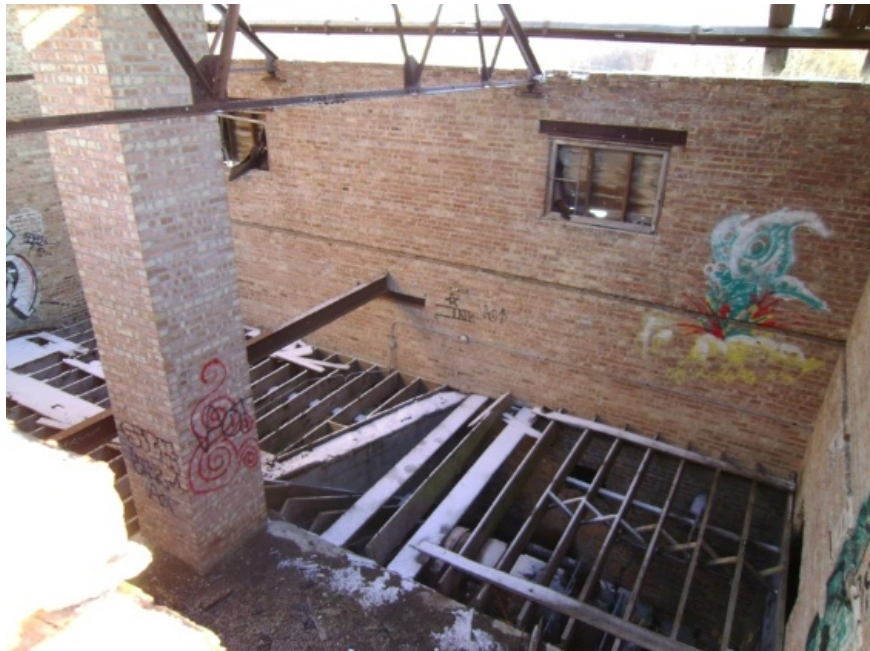
Image showing the north wall, interior side. Note the dark line below the windows. This is the change in wall thickness change from 12" to 8", back to 12"

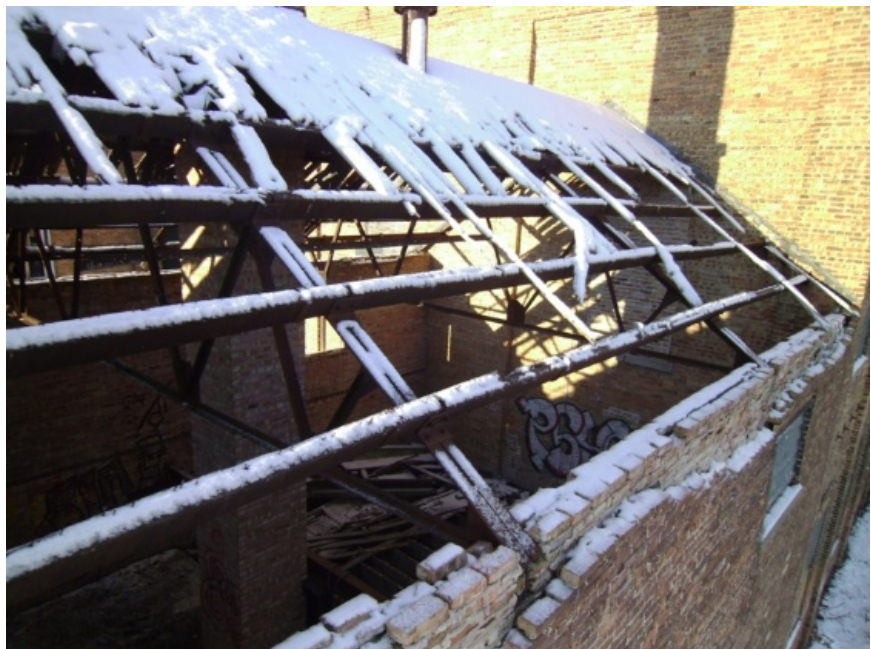
Image showing the deteriorated wood sheathing over the blocking nested in the channel purlins, and the fabricated trusses below. The truss bearing ends can be seen exposed in the damaged masonry.

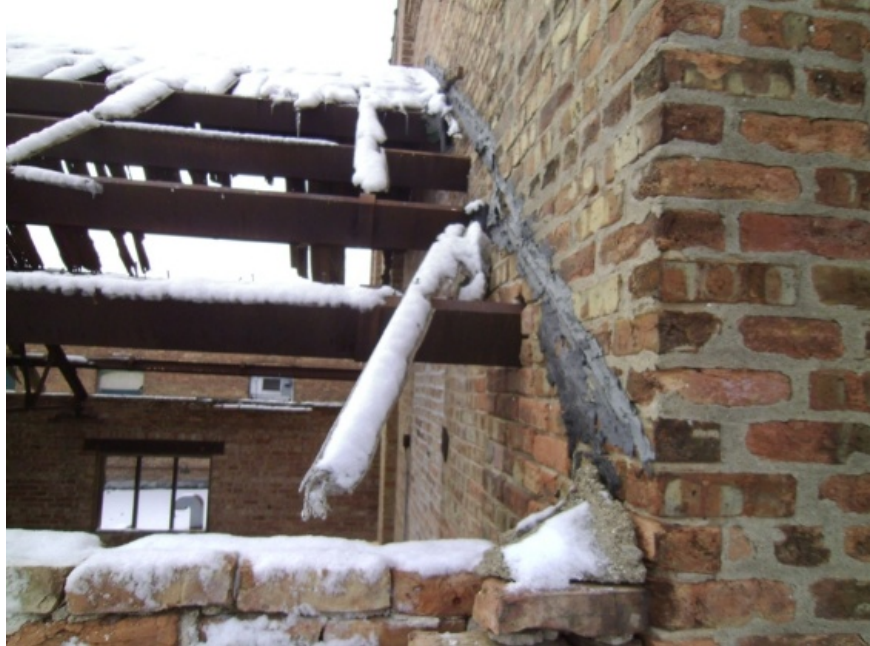
Image showing the bearing ends of Module D's steel channels into the wall of Module E

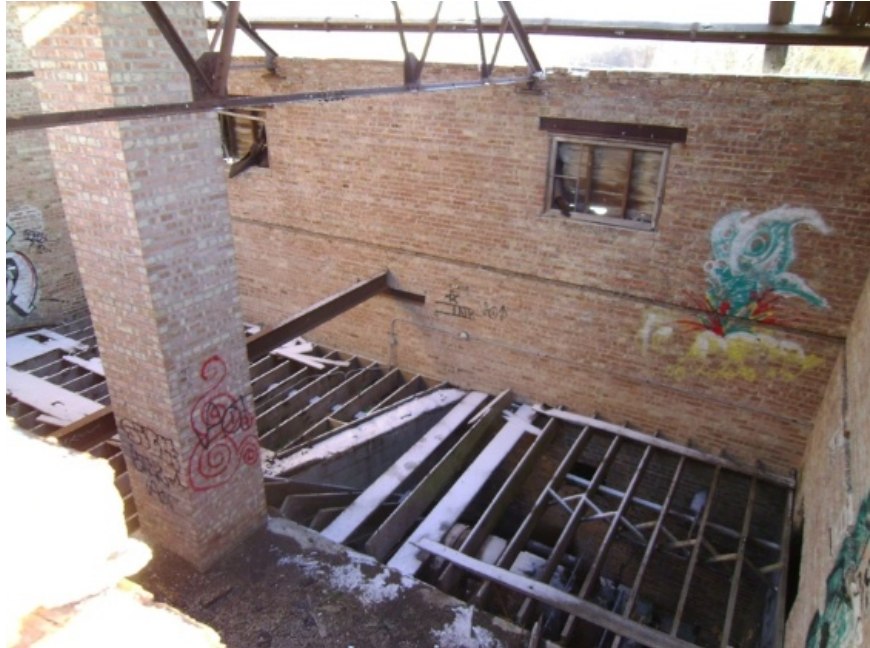
Image showing the remaining wood joists of the second floor. No structural diaphragm exists due to the lack of decking. A concrete covered vault is visible at the bottom of the image next to the chimney.

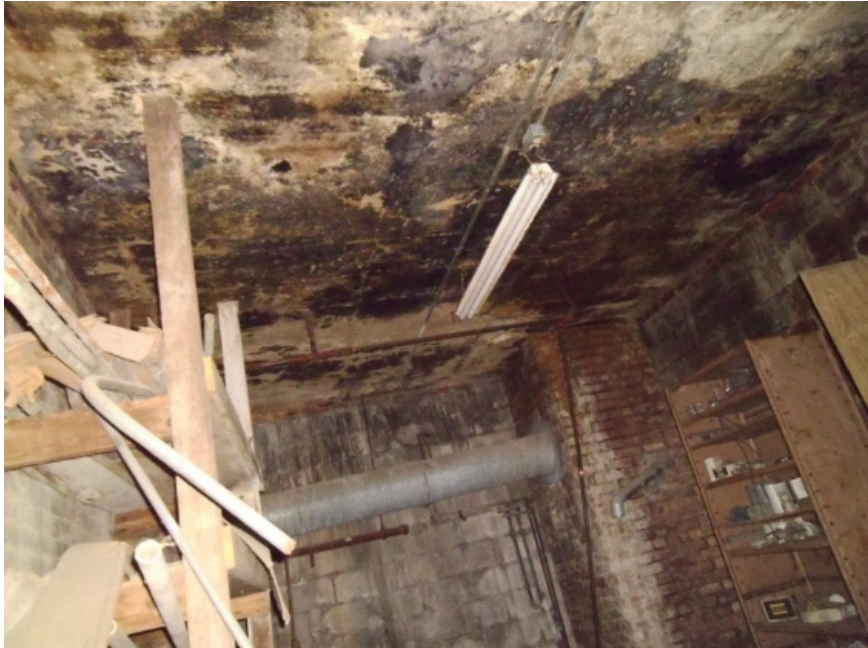
Image showing the underside of the concrete slab over the CMU vault. The stained areas are areas of water saturation and deterioration. The brick masonry at the lower right side is the bottom of the same chimney in the image above.

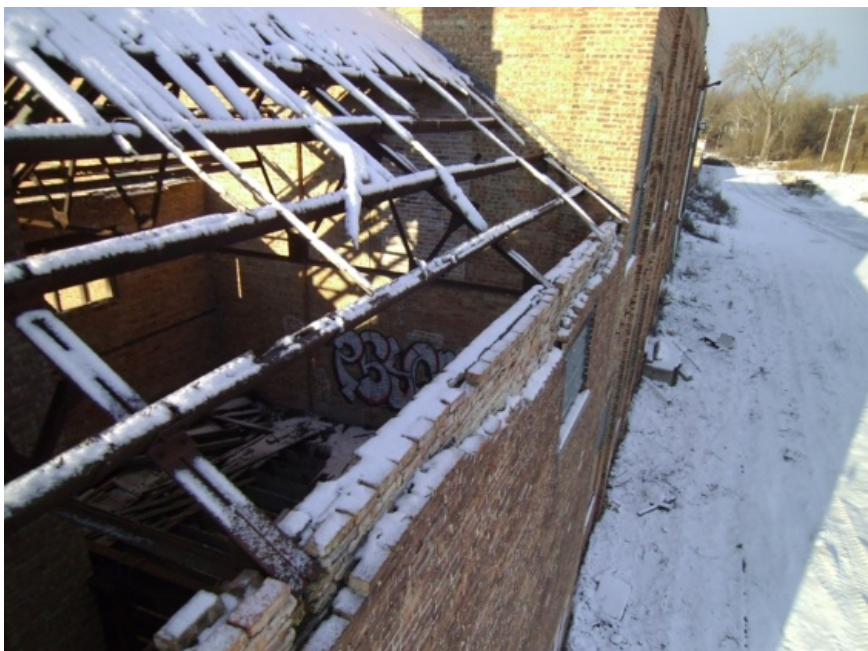
Image showing the top of the north wall. The deterioration appears to be slightly less significant than on the south wall.

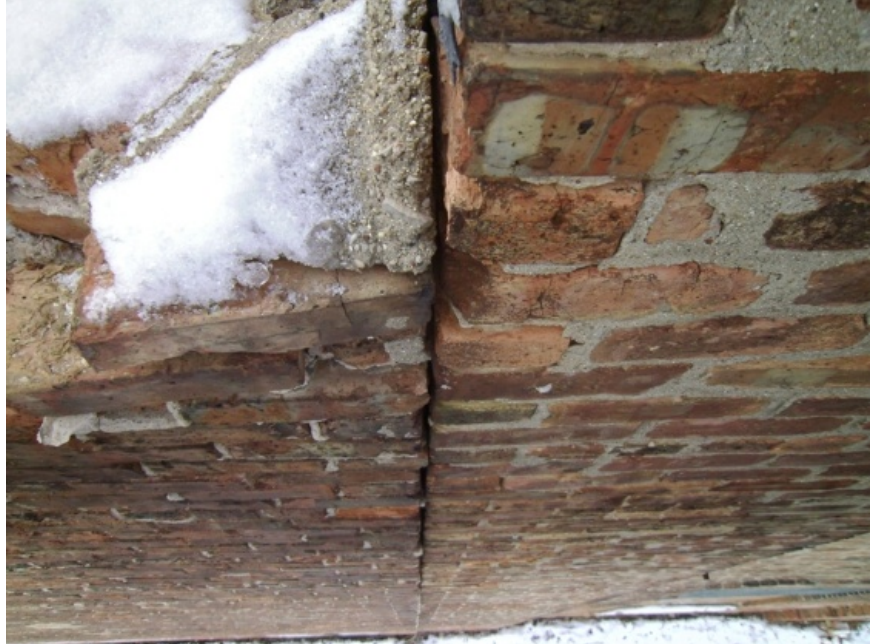
Image showing the joint on the north wall between Module D and Module E. The joint is open; the wall of Module D is allowed to move freely from Module E. Unfortunately, the roof of Module D is tied to the side wall of Module E. This type of arrangement can lead to damage in the connections of the roof framing or in the wall masonry. At mid-height of the wall this joint reveals the 1" to 2" bulge in the wall of Module D.

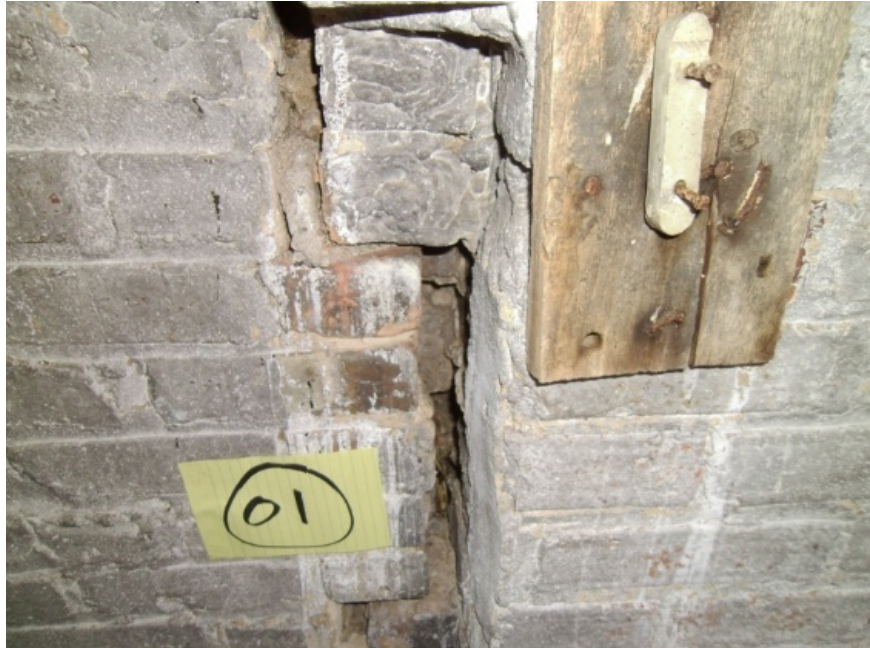
Image showing the poorly toothed joint at the south wall.

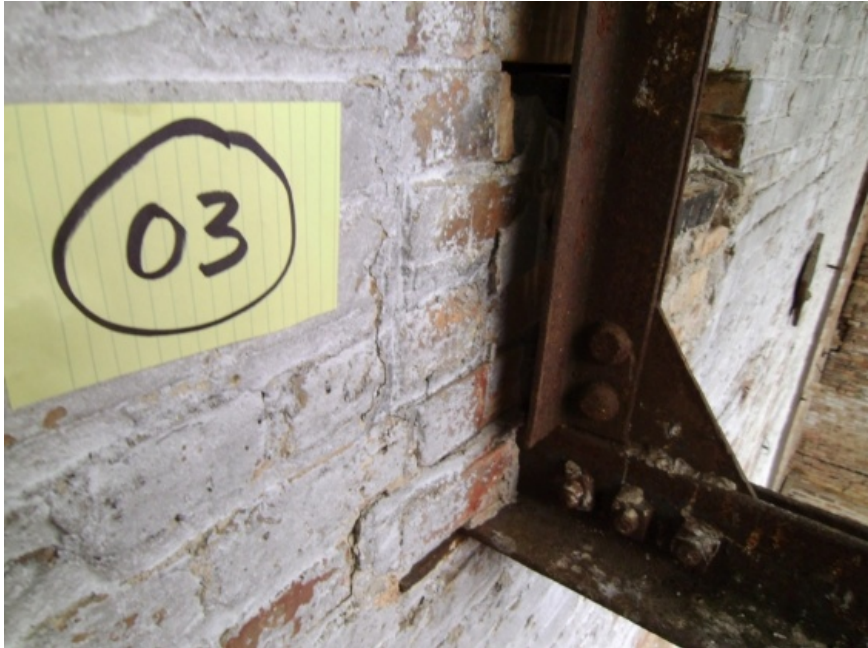
Image showing a truss bearing at the south wall. Note the cracks in the masonry suggesting that the truss is being tugged out of the masonry.

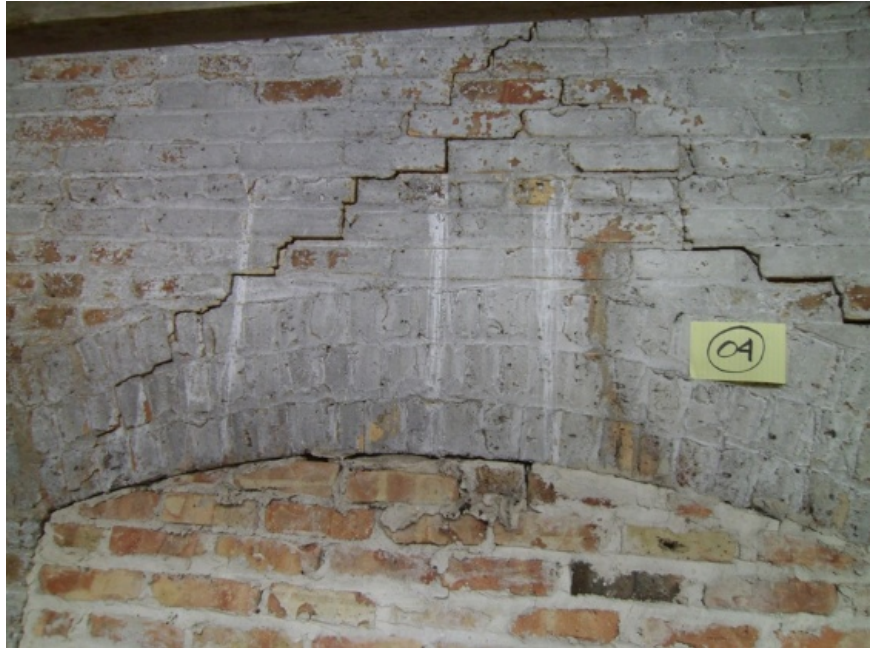
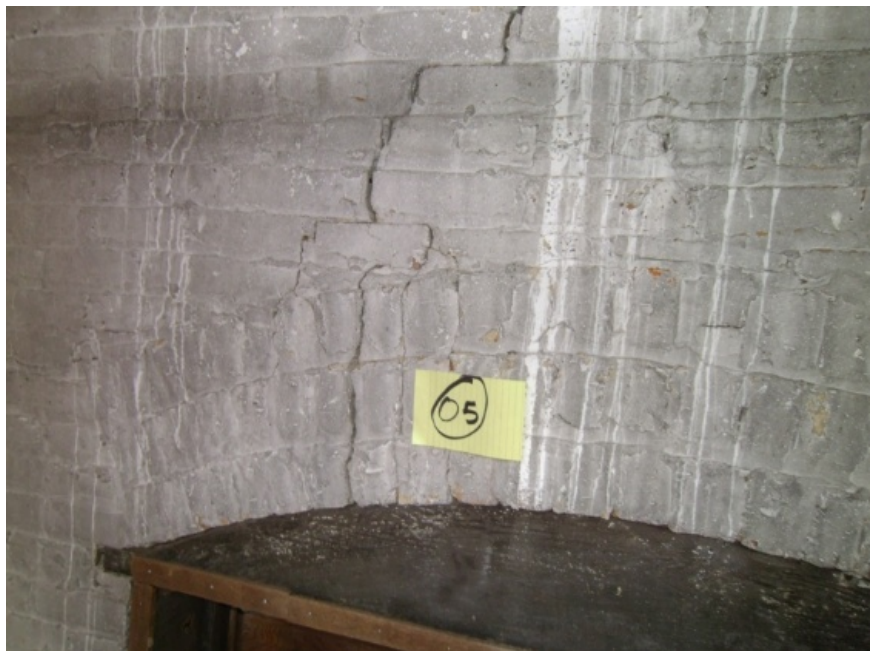
Images showing failed brick arches at a masonry walls, cracking at embedded steel beam ends and eroded masonry at an arched brick lintel.

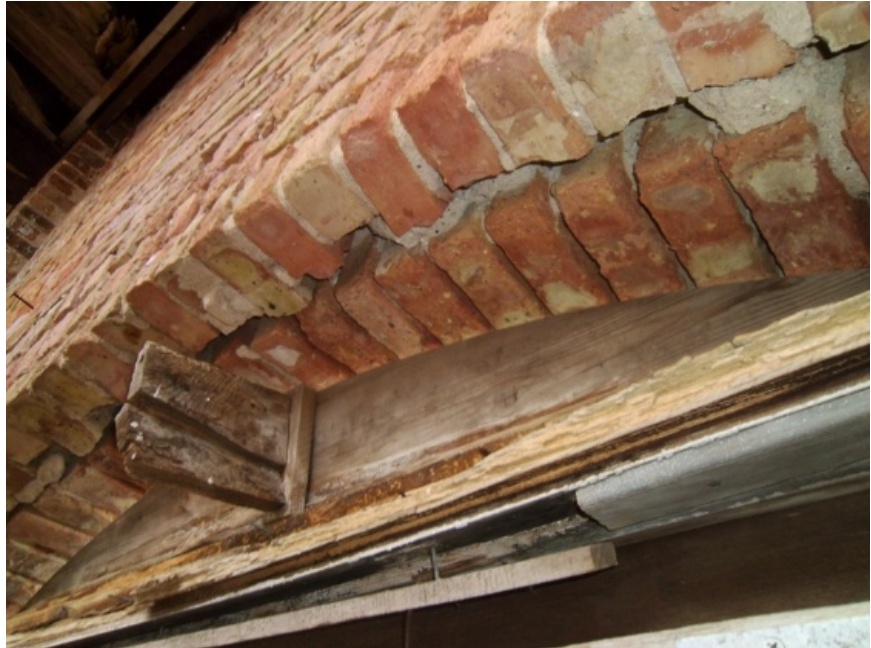
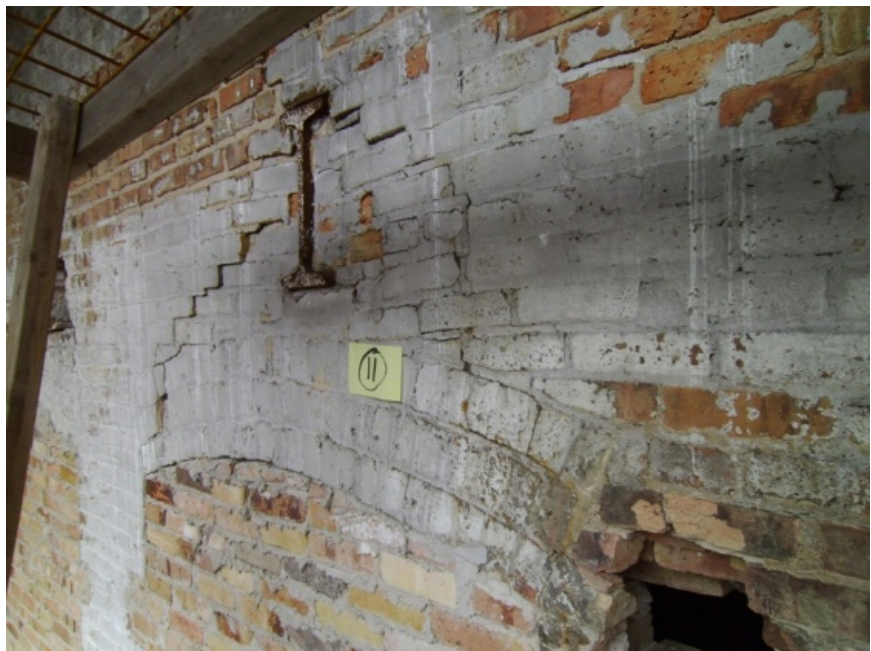
Images showing failed brick arches at a masonry walls, cracking at embedded steel beam ends and eroded masonry at an arched brick lintel.

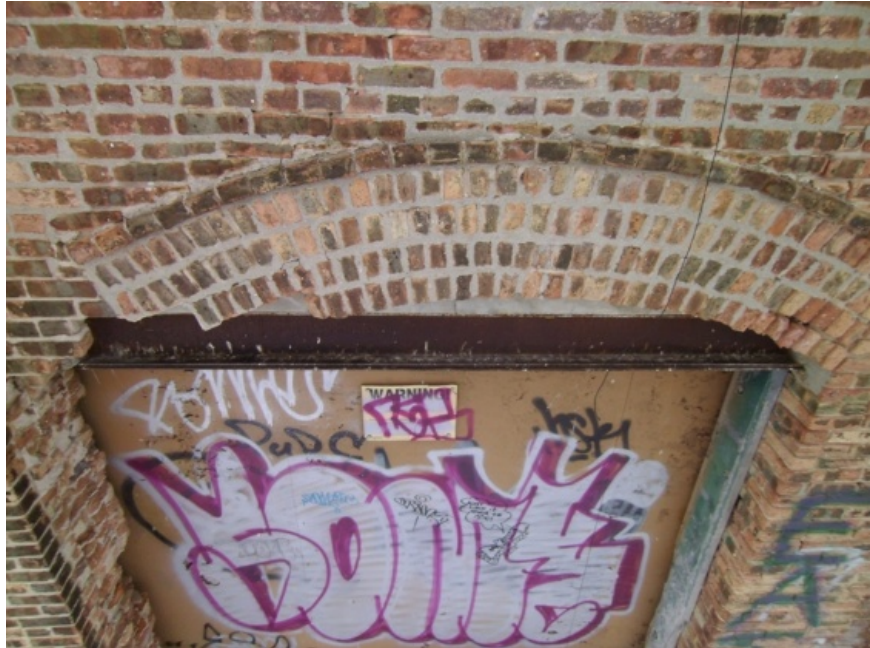
Image showing the poorly constructed lintel at the north wall. The steel supporting the masonry only supports a portion of the wall width. The bearing shown at the left is damaged.

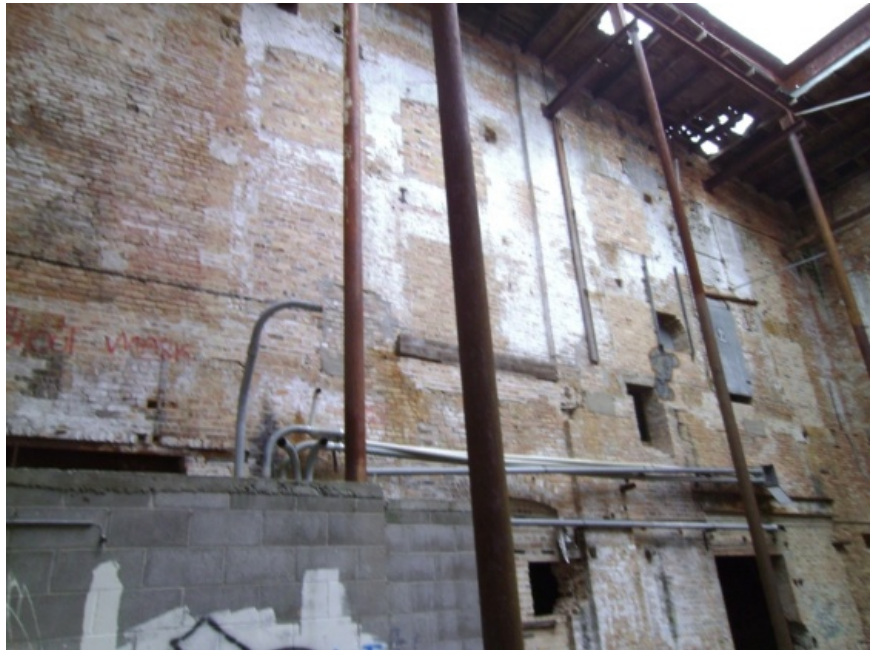
Image showing tall unstable columns to cobbled roof framing. Note the holes present in the wood sheathing.

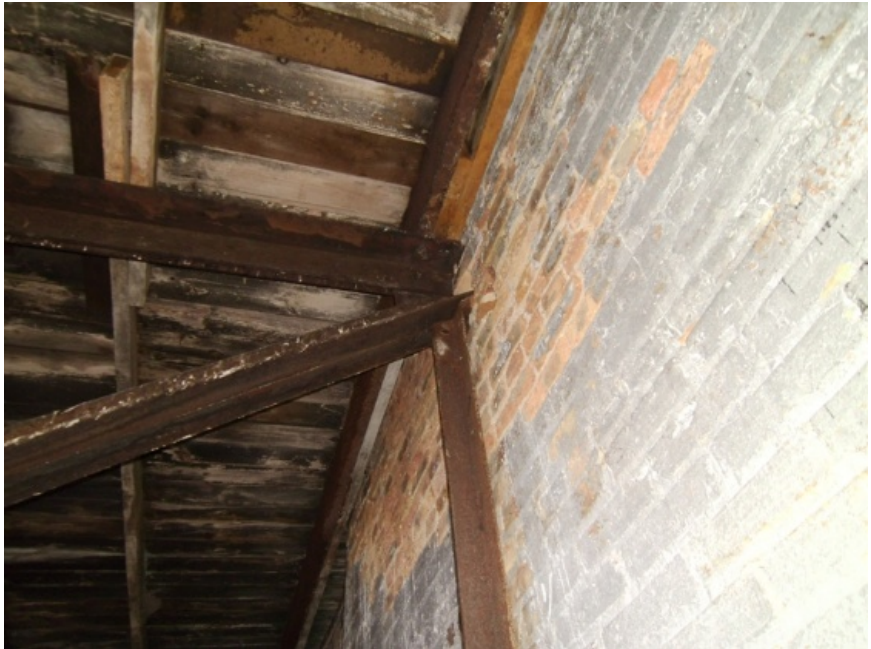
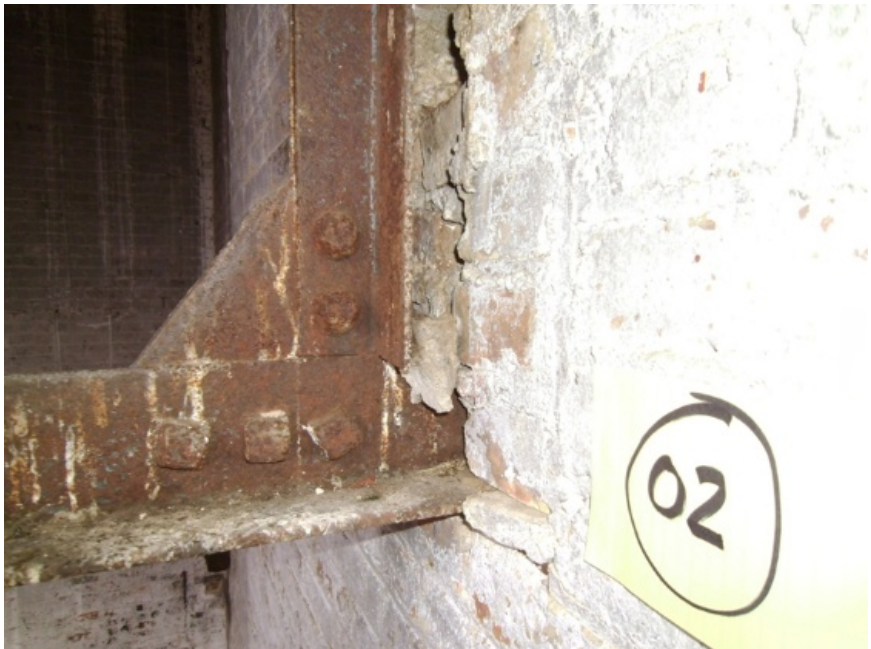
Image showing one of the truss (top) bearing locations. The bottom embedment into the wall appears to be a stabilization point. The rust appears to be only superficial.

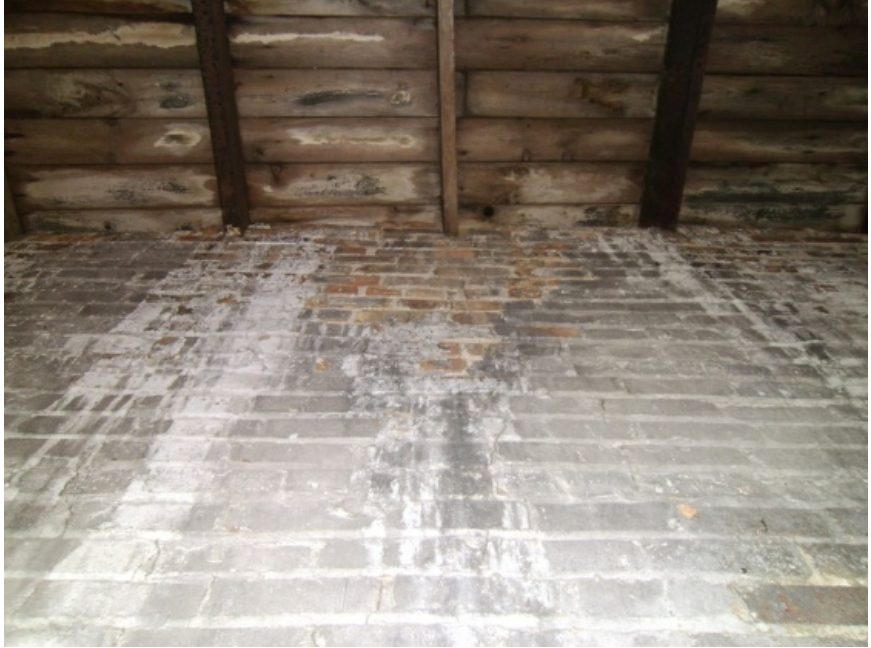
Image showing the damaged wood and steel framing bearing into the masonry walls.

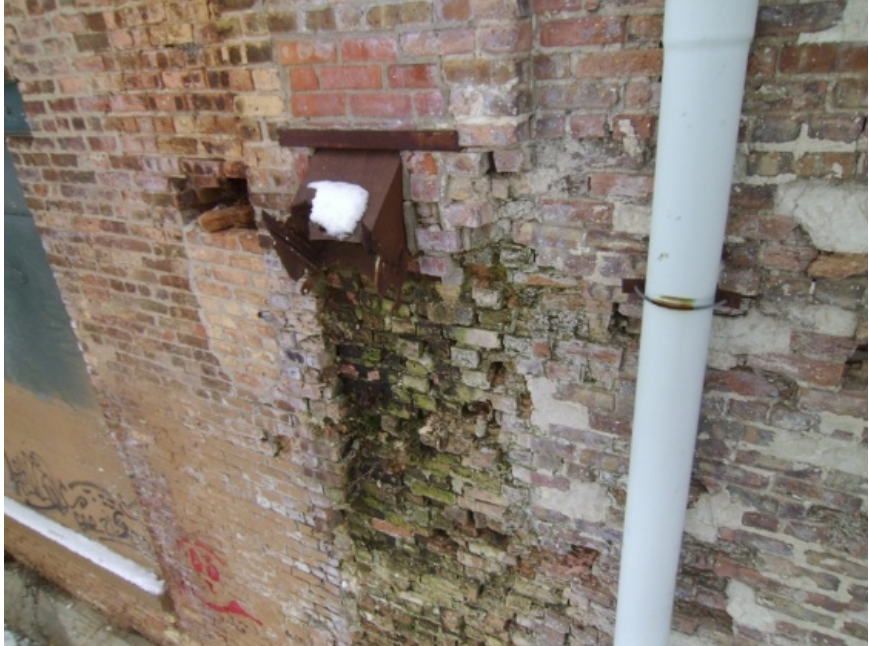
Image showing the exterior face of the north wall. This image was taken at the second floor level. A beam end behind this masonry is dislodged from its supporting masonry.

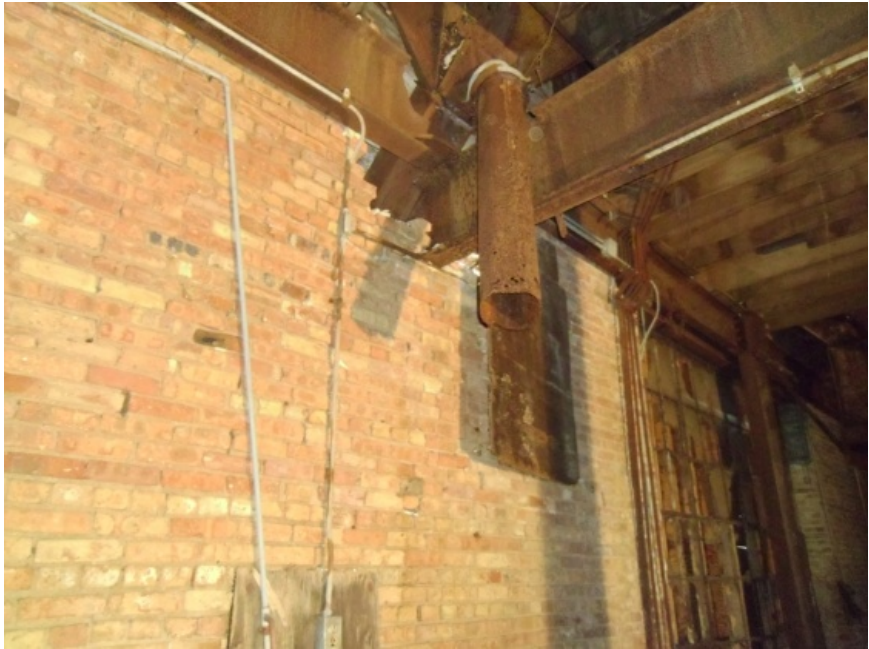
Image showing the dislodged beam end at the damaged masonry.
