Architectural Engineering Consulting

Garver Feed Mill Building Repairs

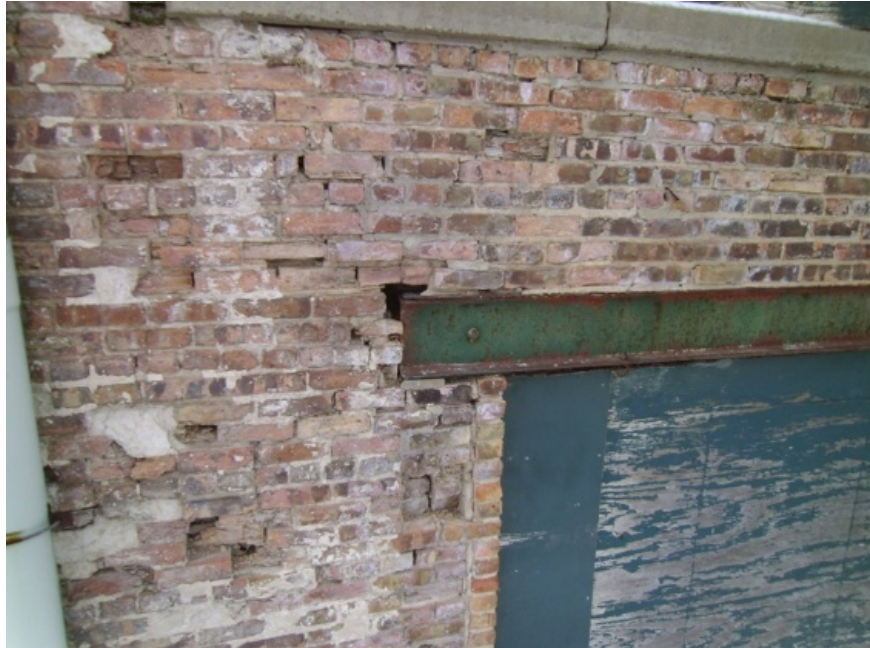
Image showing how deterioration and erosion in the masonry have undermined the integrity of a lintel's bearing.

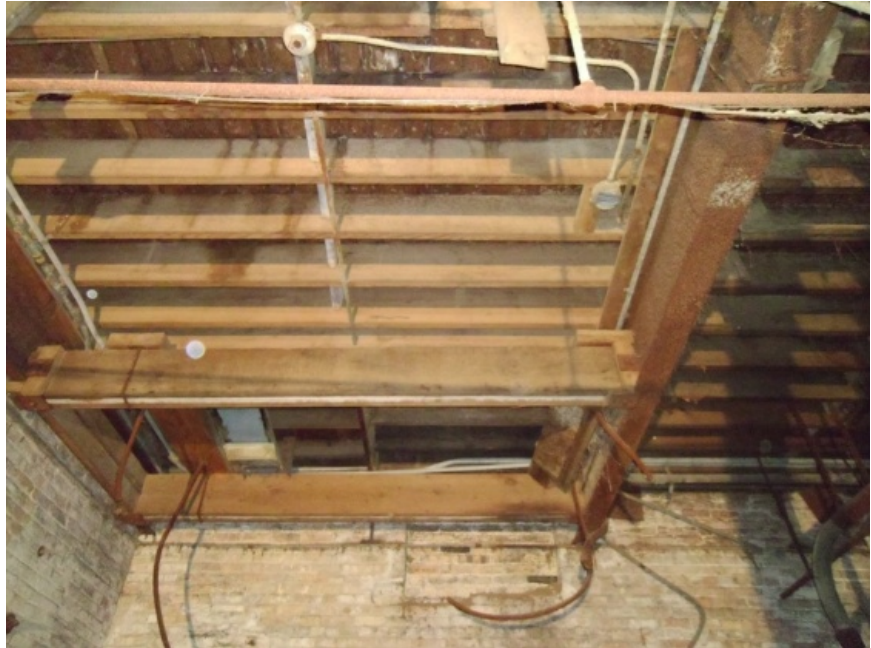
Image showing the floor construction of the second floor. The construction is similar at the third floor. Note the white mold on the floor decking near the top of the image. Other than some water staining, a significant quantity of the joists can likely be salvaged.

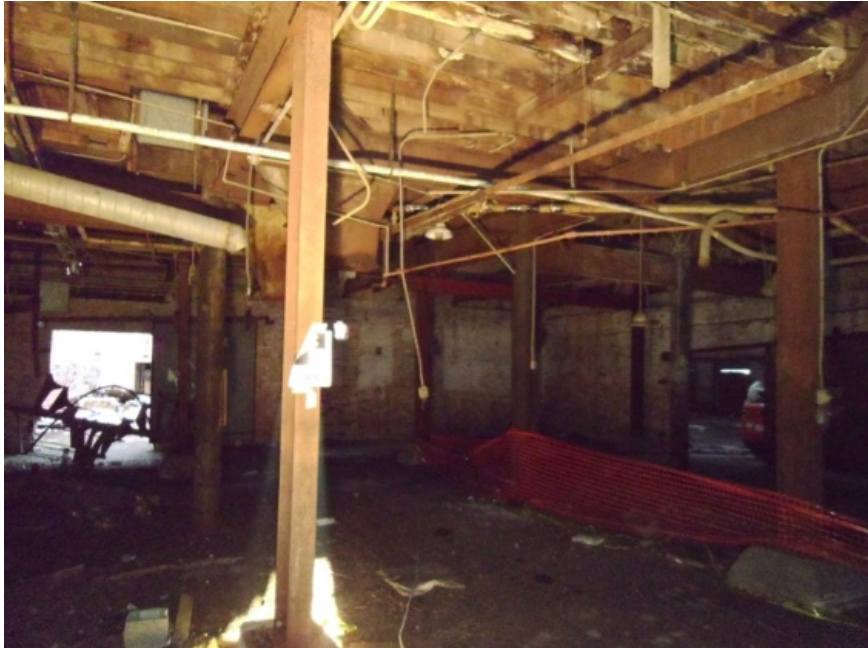
Image showing the column, beam and joist framing of Module F. Note white mold-covered joists present near the top of the image.

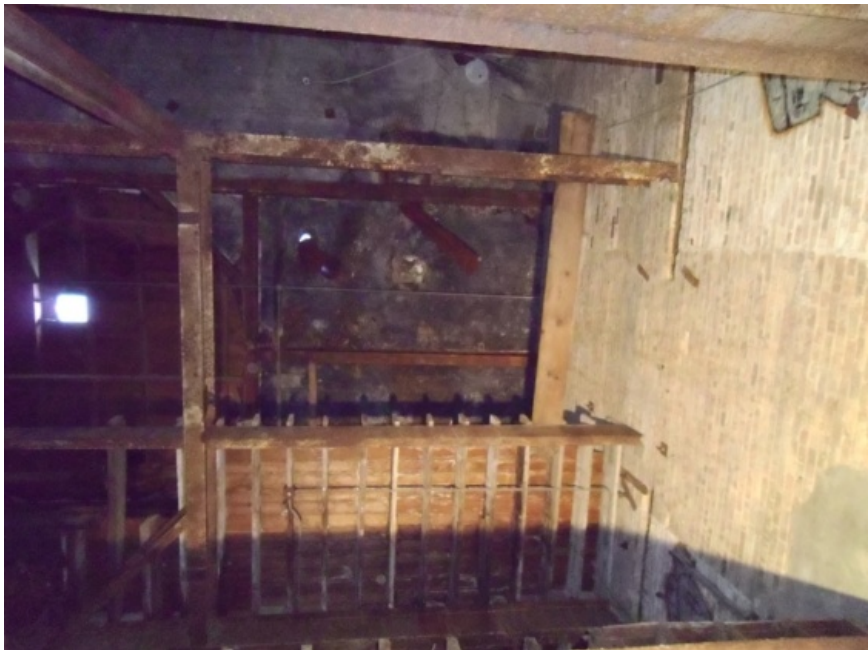
Image looking upwards at the roof framing. The wood framing at the bottom of the image is the third floor. Steel beams and columns support the wood framing.

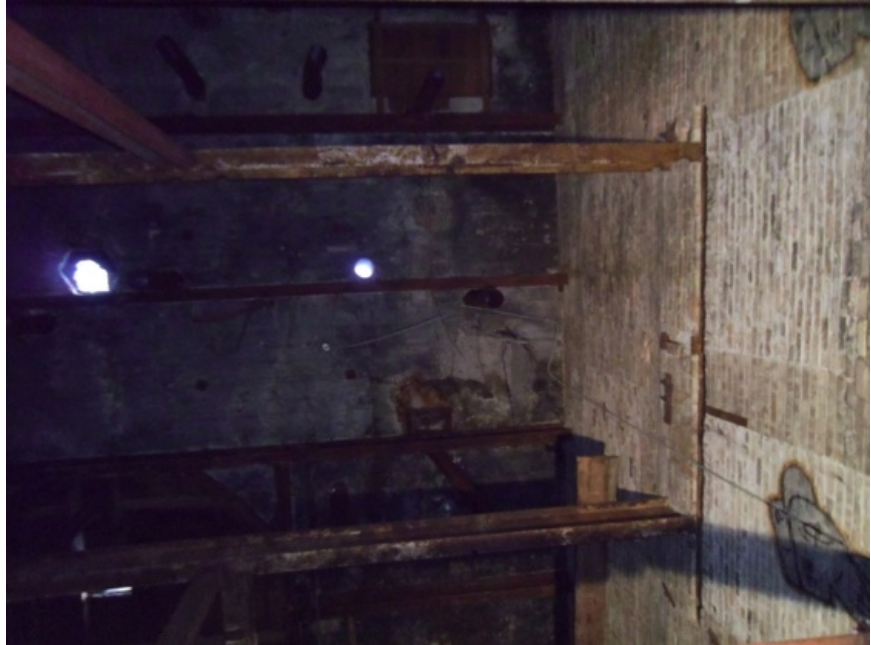
Image showing the underside of the concrete roof from the ground. Obtaining suitable images of issues was difficult due to poor access. A part of the spalled section can be seen as a rusted circular shape between the two roof beams. Note daylight from holes in the roof left from past removal of equipment.

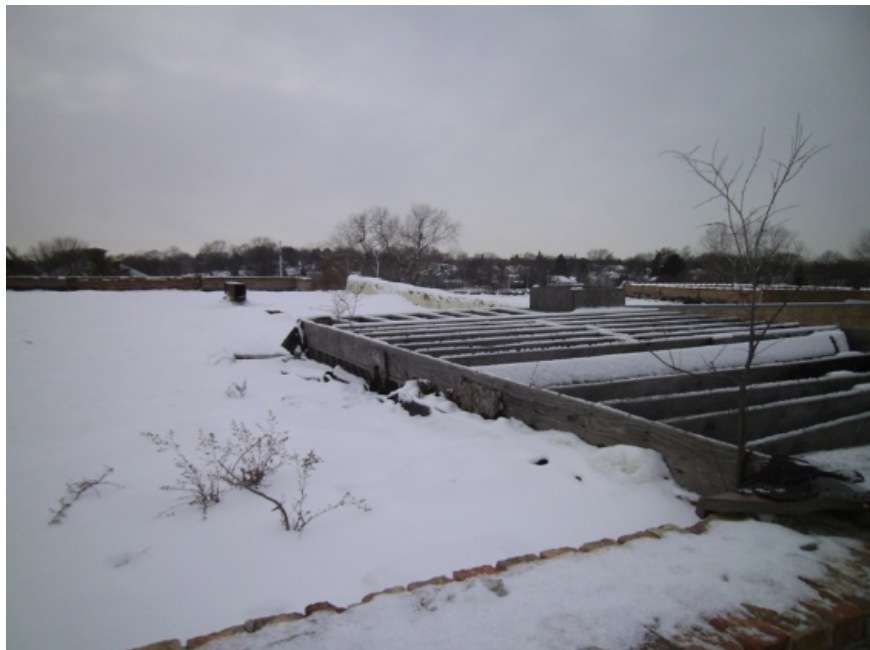
Image showing the topside of the roof at Module G. The north half of the roof appears to be partially framed with wood.

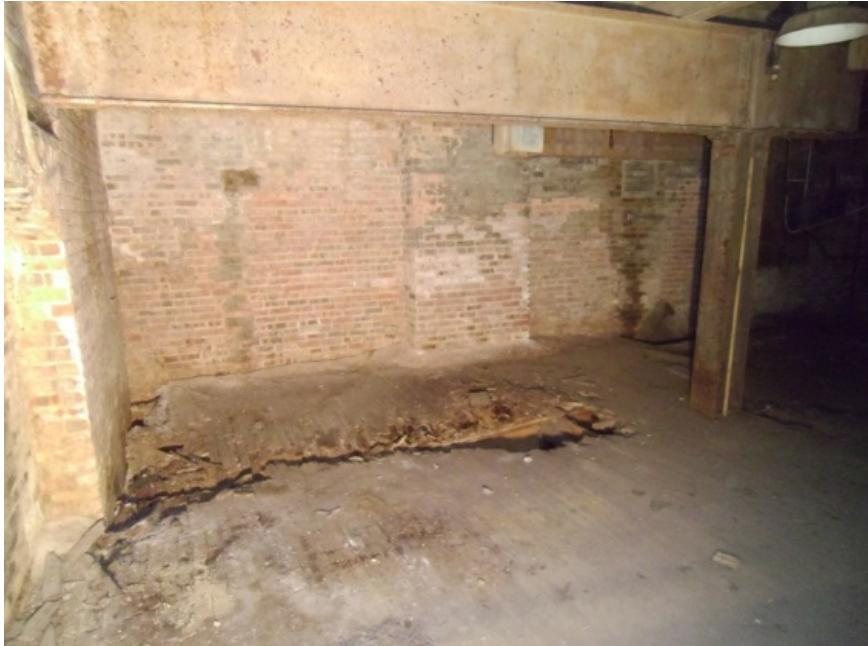
Image showing an area of the first floor collapse. Internal access to this room was not permitted.

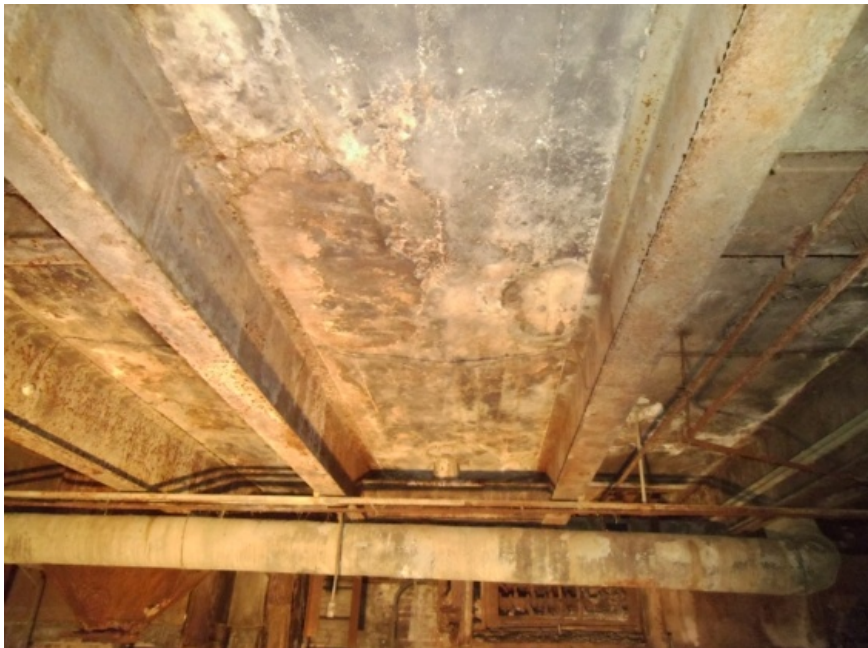
Image showing a portion of the floor construction of the second floor.

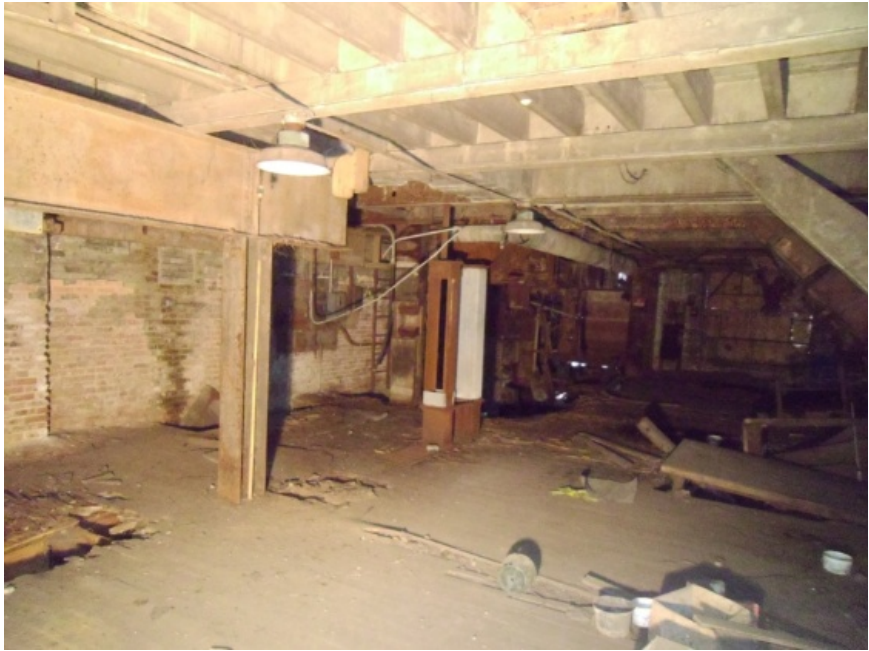
Image showing another region of Module G. This floor system is wood joist covered with a concrete slab. The framing appears to be in good condition.

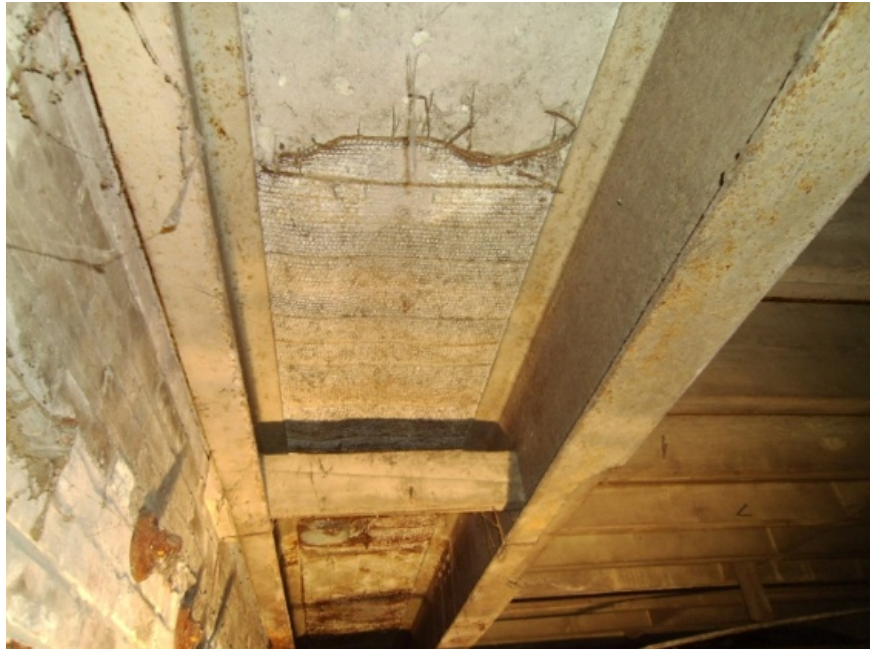
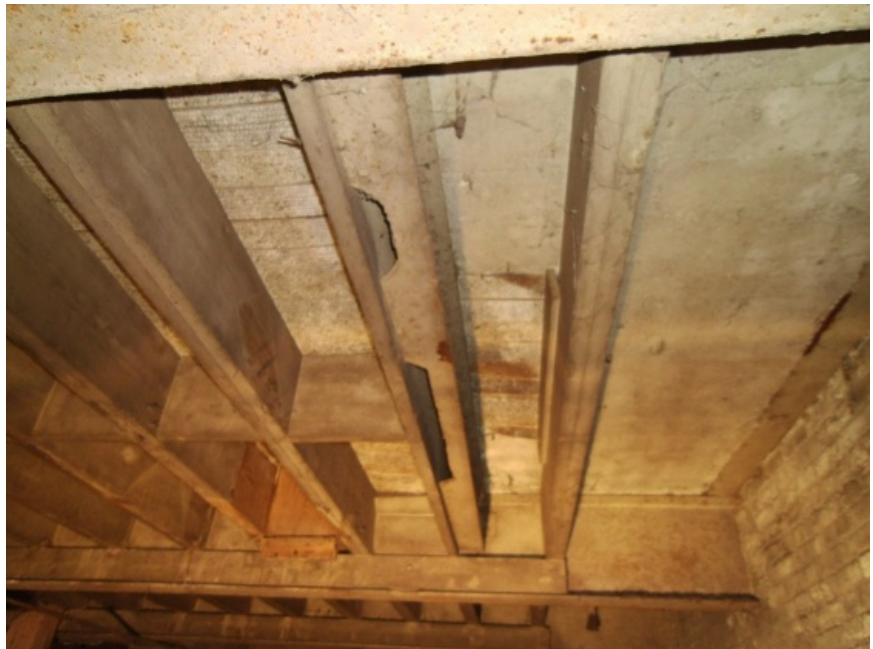
Images showing a transition from wood joist supporting concrete to reinforced concrete along the walls. The protective cover on the reinforcing mesh has fallen away in some areas exposing the mesh.

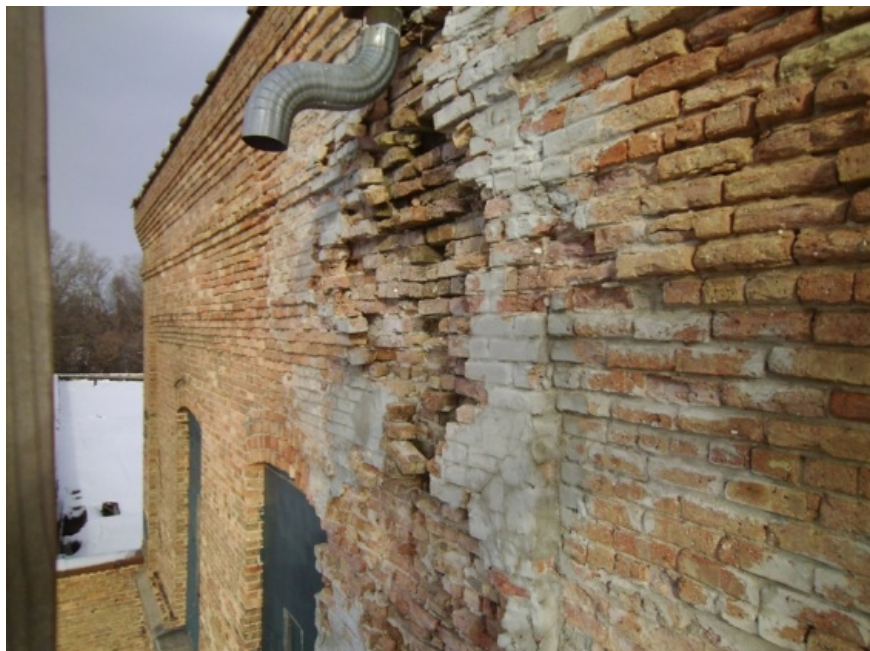
Image showing the upper section of brick deterioration from water infiltration. Large areas of missing brick and mortar can be seen. The

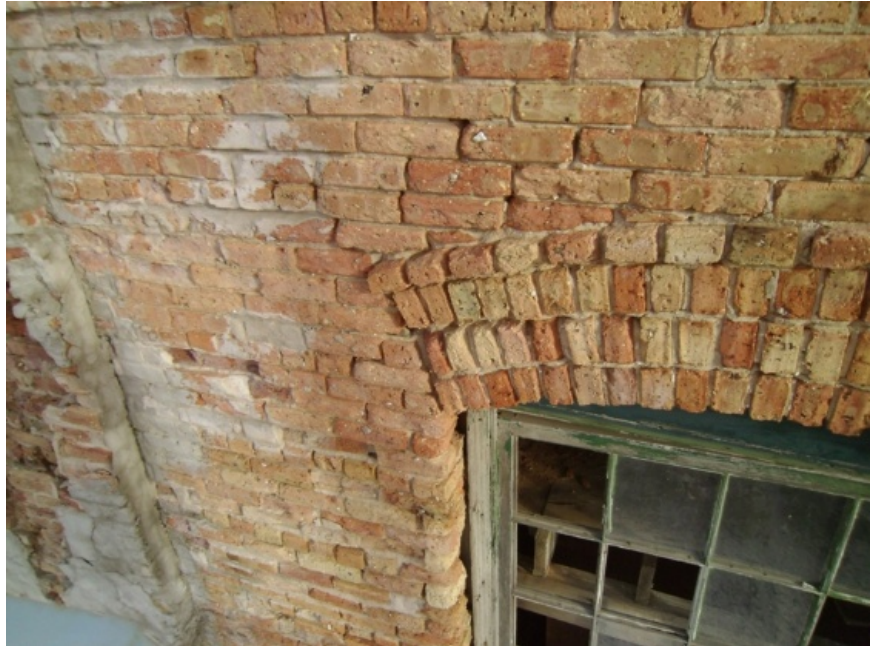
Image showing the water damage at the arched brick lintel.

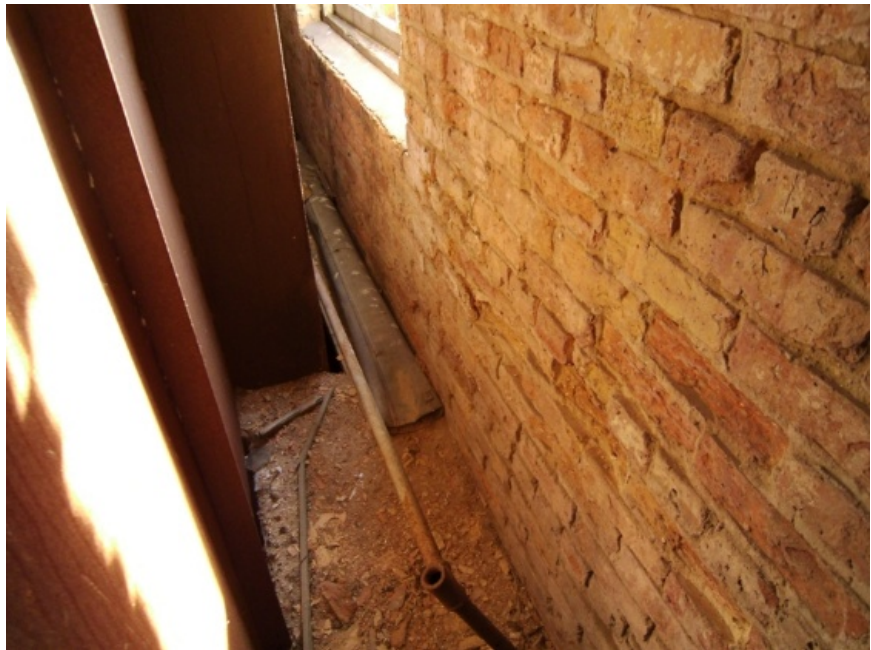
Image showing the interior mortar erosion and brick damage.

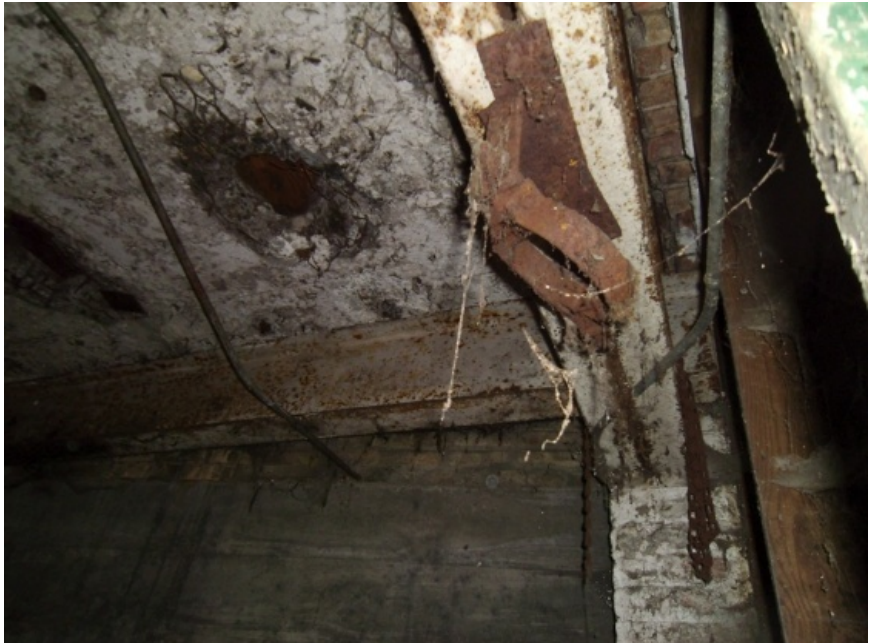
Images showing the construction of first floor. The rusted loop is an old mechanical hanger. The structural slab can be seen as well as a support beam at the left side of the image. Above the hanger loop is the lintel supporting the brickwork above.

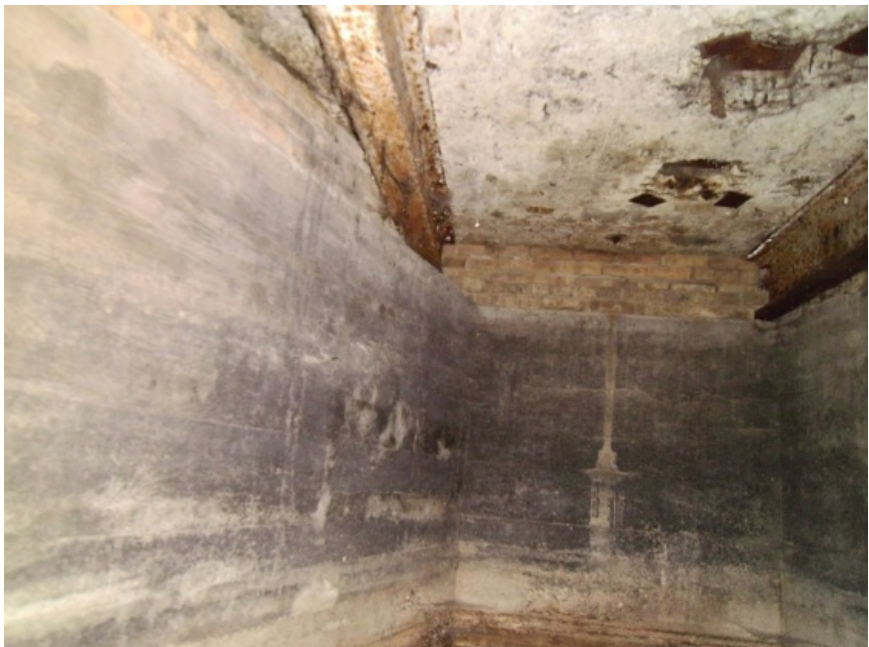
The space is a concrete confined pit with skewed walls. The space appears to have been covered in 1929 with steel beams and a reinforced concrete slab. The beams and slabs in this module appear to be in fair condition. Note the brickwork infill around the beams. The bottom of this pit is filled with stagnant water.

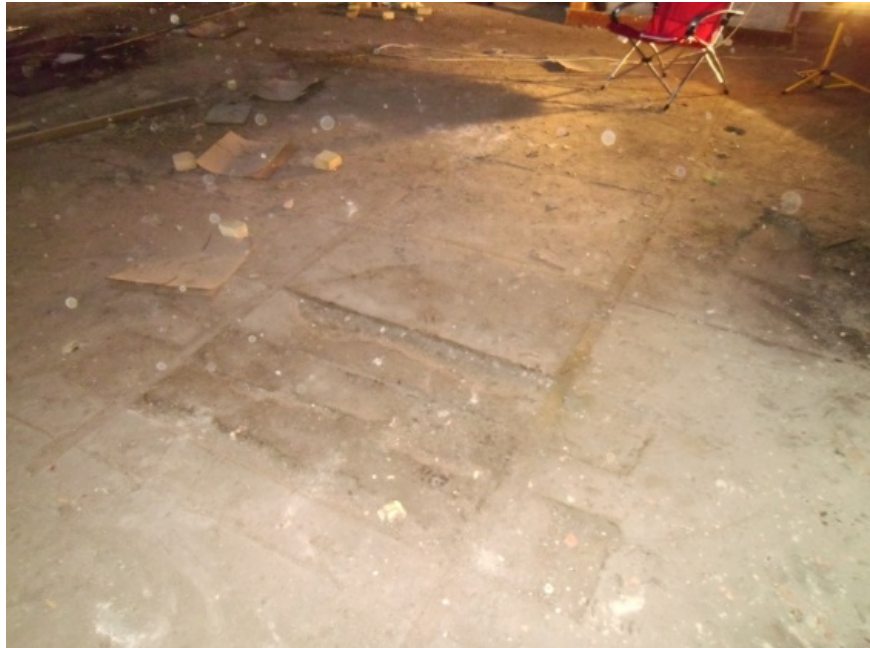
Image showing the topside of the second floor. Steel rails exist embedded into the concrete, possibly acting as reinforcement in the slab. The rails orient diagonally from bottom left to top right in the image. Some of the concrete between these rails was not flush with adjacent concrete. The darker colored area of concrete in this image is just such an instance. This may suggest some damage has occurred, leading to slippage. These regions were not as obvious from the underside.

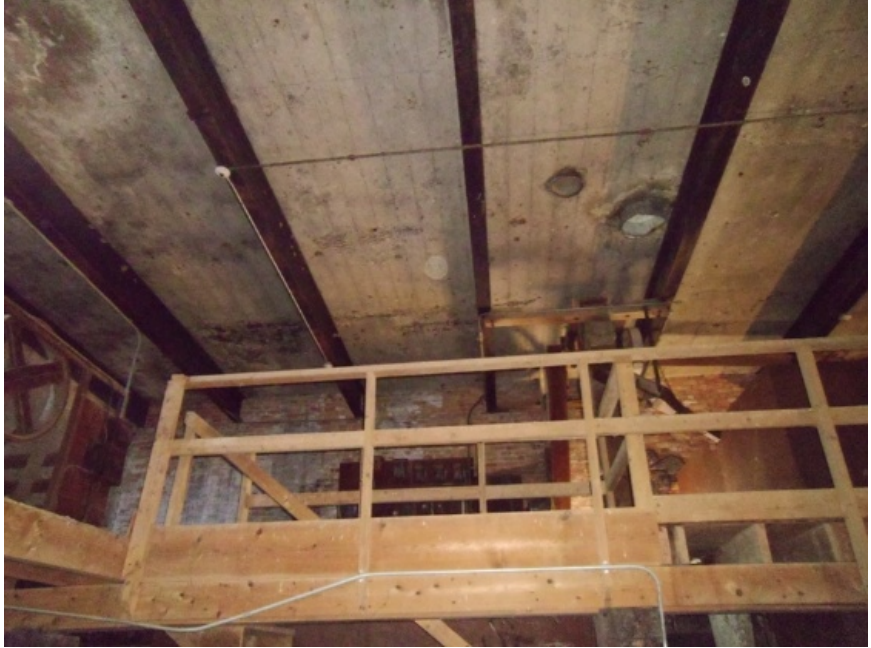
Image showing the wire mesh-reinforced concrete slab over steel beam roof structure.

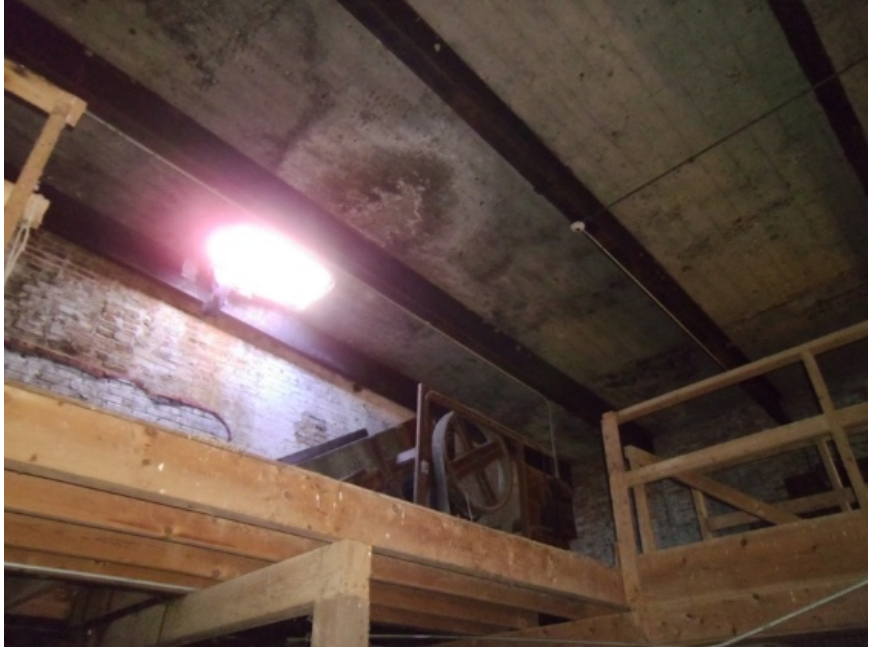
Image showing the damaged roof slab at the east end.

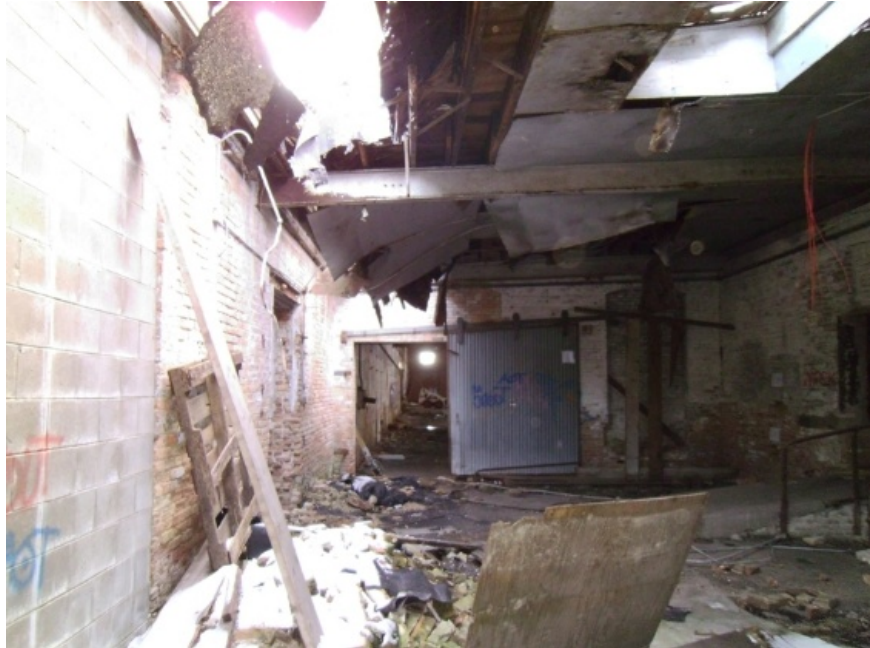
Image looking east through the building. Note the CMU section of wall.

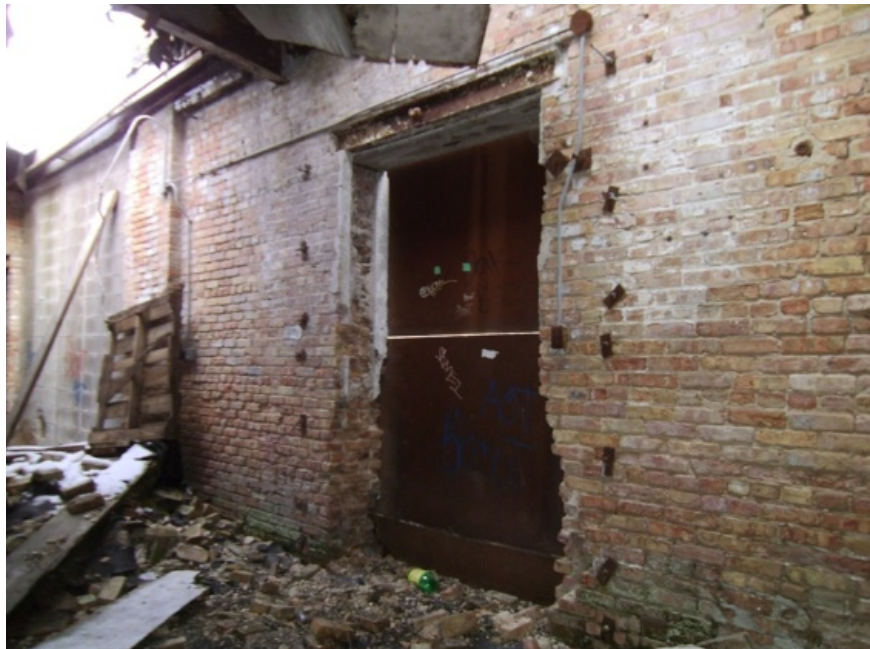
Image showing the north wall of brick unit masonry. Note the poor condition at the lower section of wall and the relatively good sections of brick near the top of the wall.

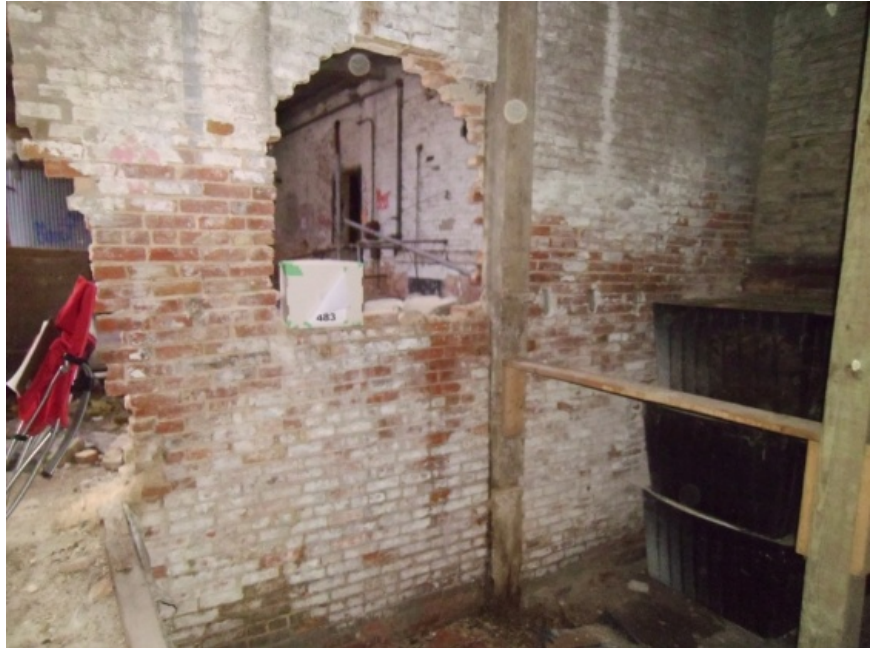
Image showing structural damage to the existing interior bearing wall. Besides missing significant sections of masonry, the red areas midway up and the green portions at the bottom are areas found to contain water damage.

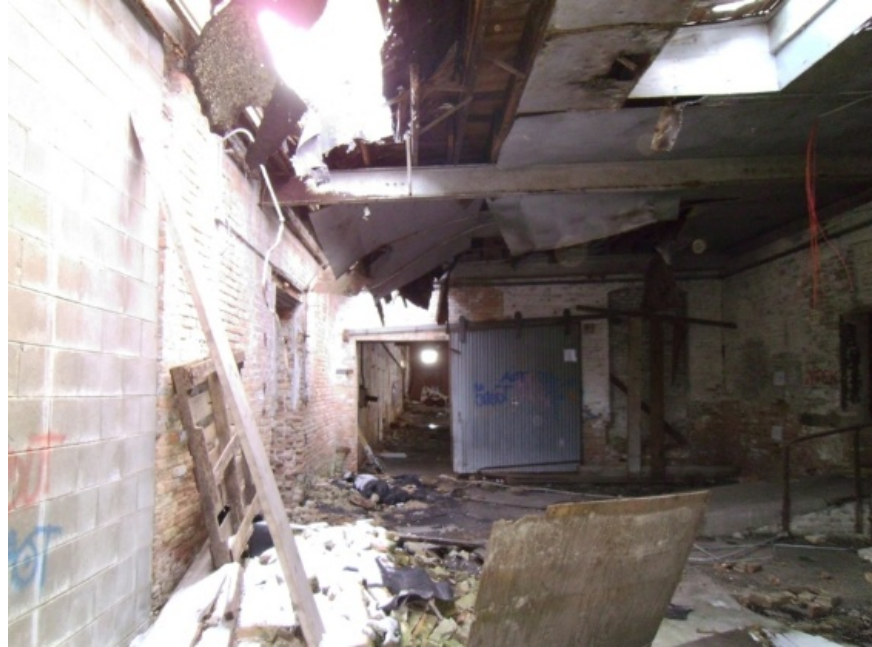
Image showing the damaged roof sections in the north end of the module. Substantial damage was noted in this region of the module.

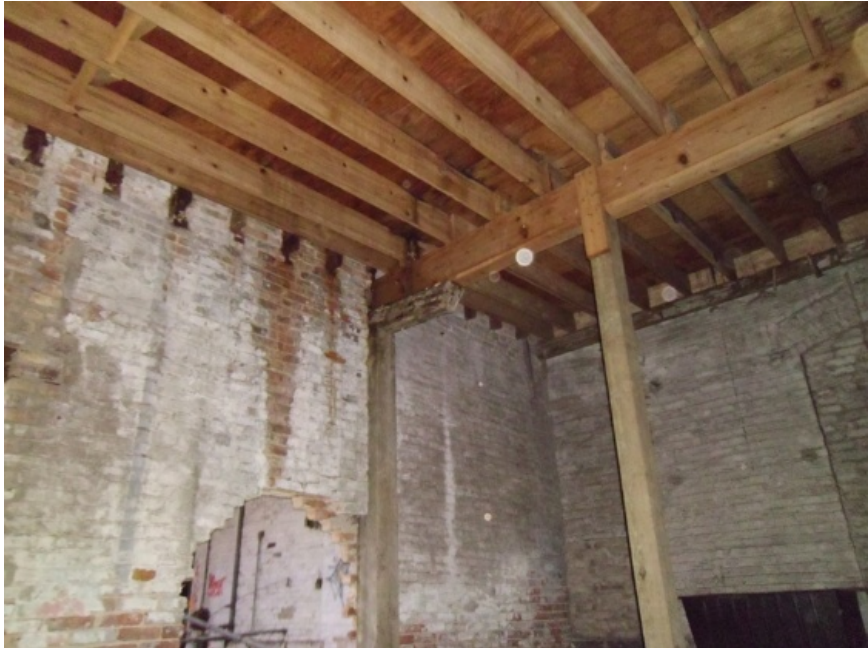
Image showing the framing at the west end. This framing is relatively new replacement framing for a section previously removed.

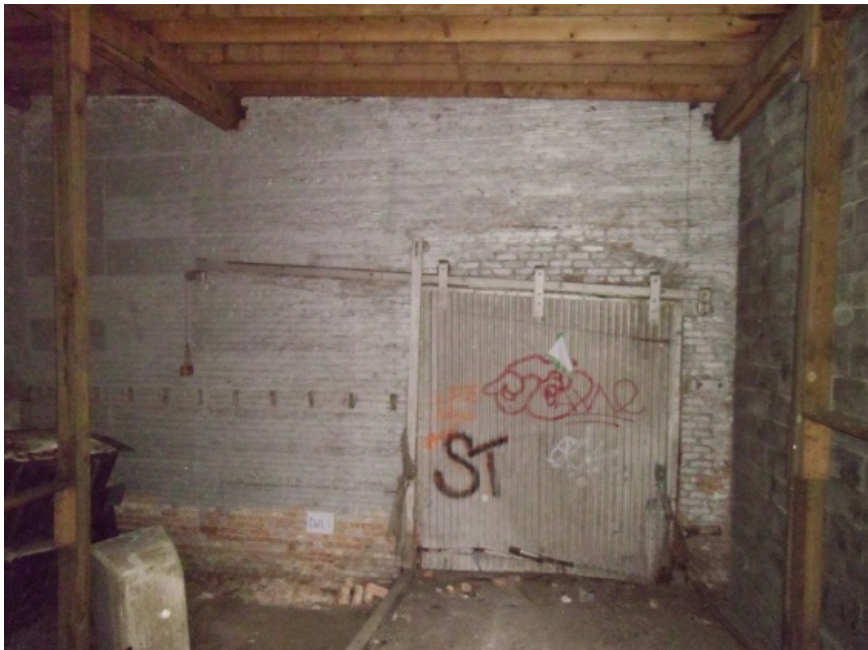
Image showing the west end of the module. Note the two beam lines supported by columns. The sliding door leads to Module J.

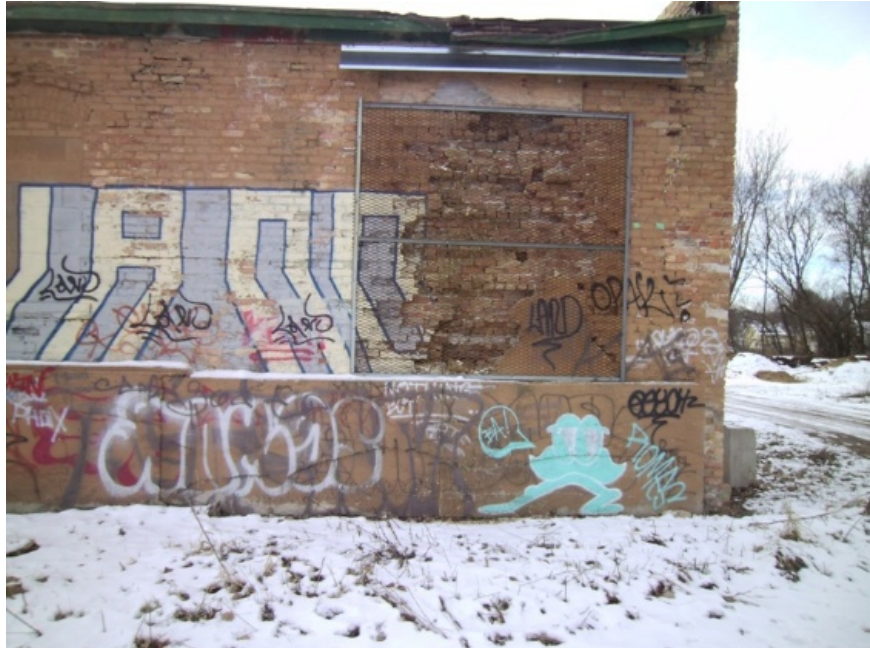
Image showing the region of wall exhibiting absent brick and eroded mortar.

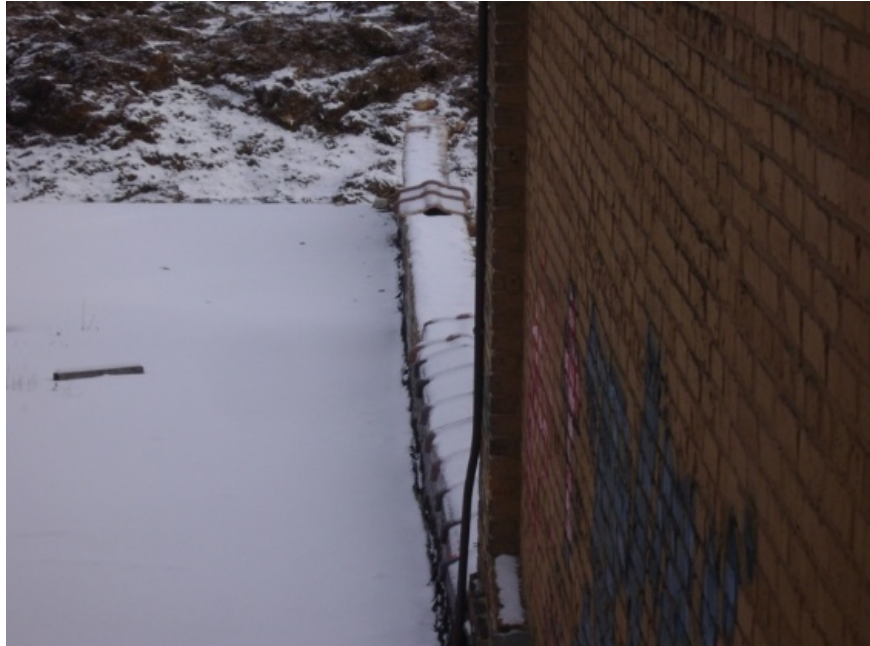
Image showing the sweeping curvature of the east wall. The sweep appears to be confined to the single story section of the building.

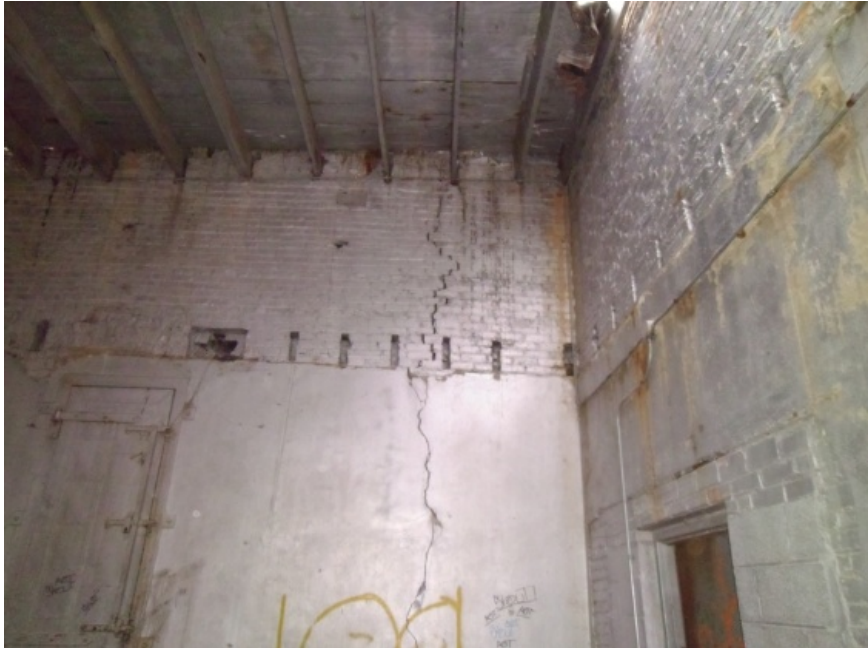
Image showing the vertical crack in the east wall at the southeast corner.

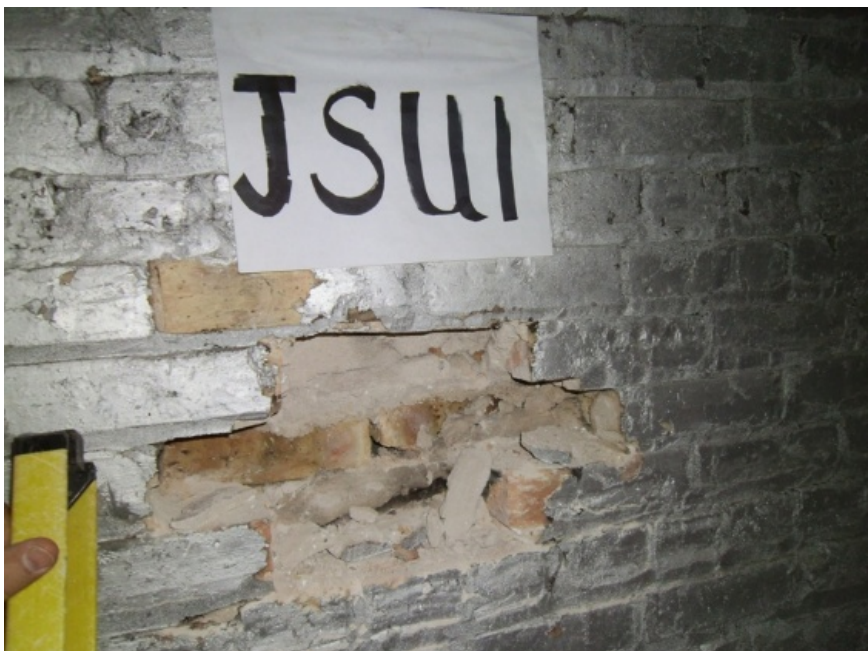
Image showing one of the access points taken during the survey. The impervious coating can be seen in silver.

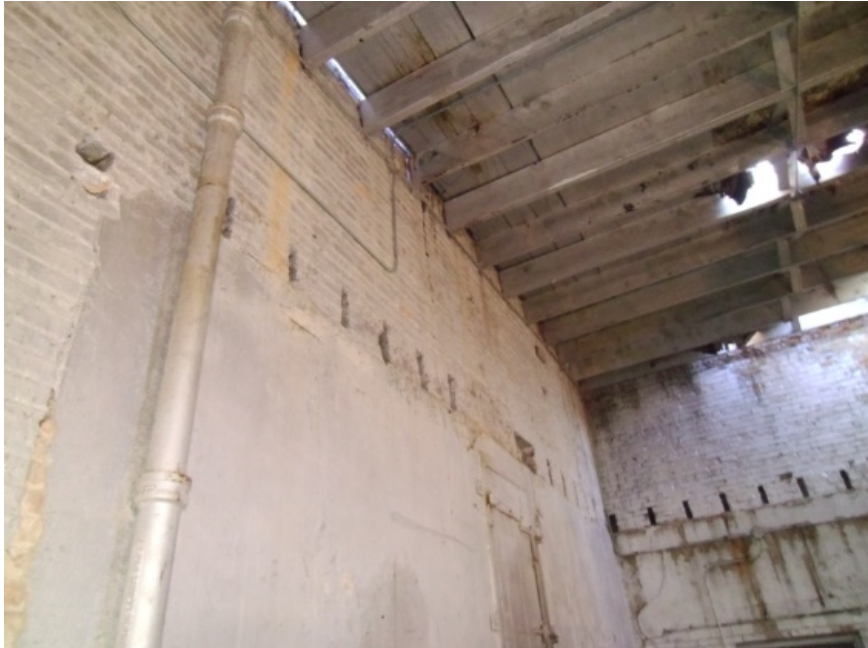
Image showing a damaged section of roof. Daylight shines through a void in the roof, along the wall: the region that had experienced fire damage.

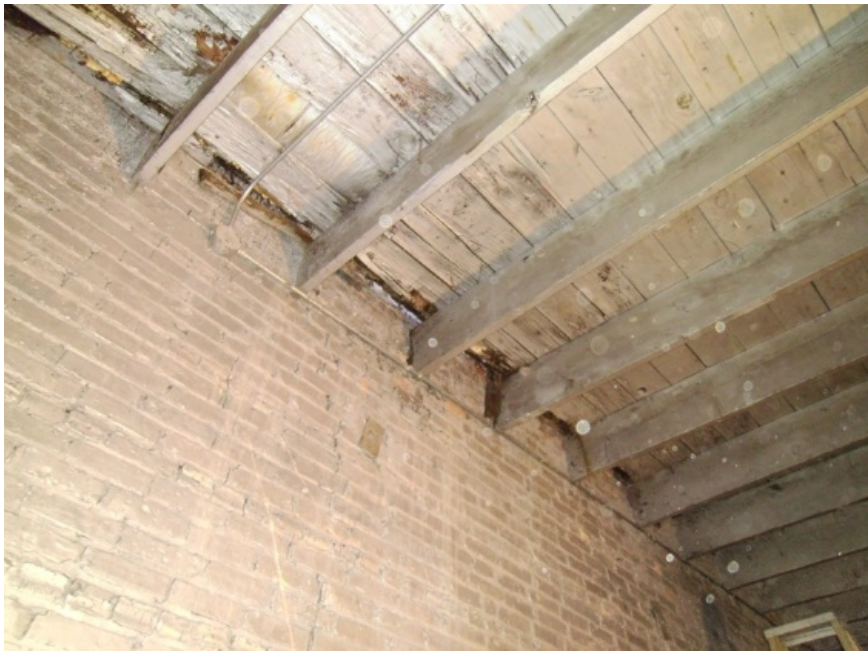
Image showing damaged roof decking along the west wall. The decking directly in contact with the wall is deteriorated. Adjacent discolored regions in the decking show the deterioration for a significant distance away from the wall. Many of the joist ends bearing in the wall have decay damage. The concealed topside surface of the decking will likely reveal significantly more damage that what can be seen in images.

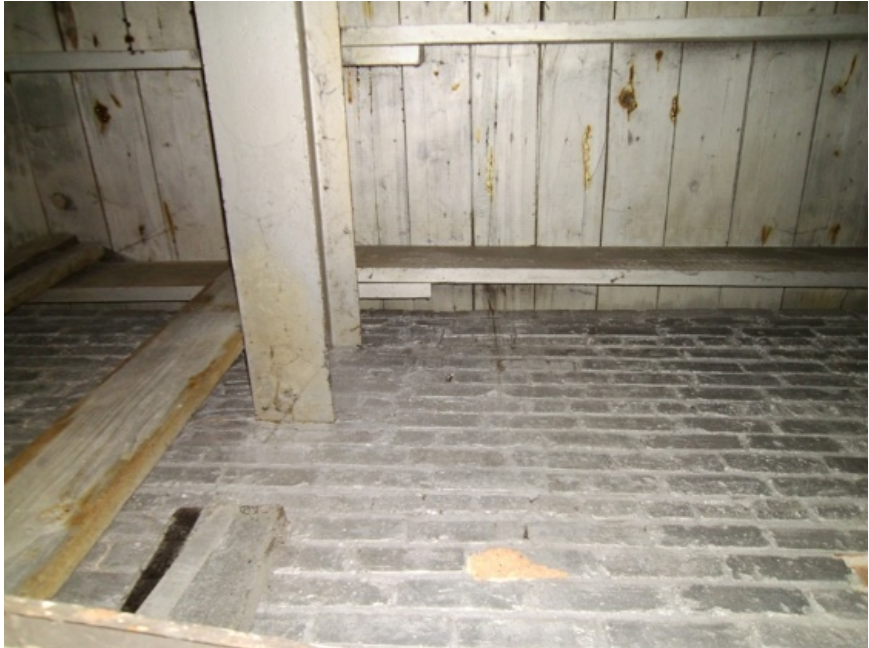
Image showing the lapped condition of joists and bearing of a steel beam in the masonry wall.

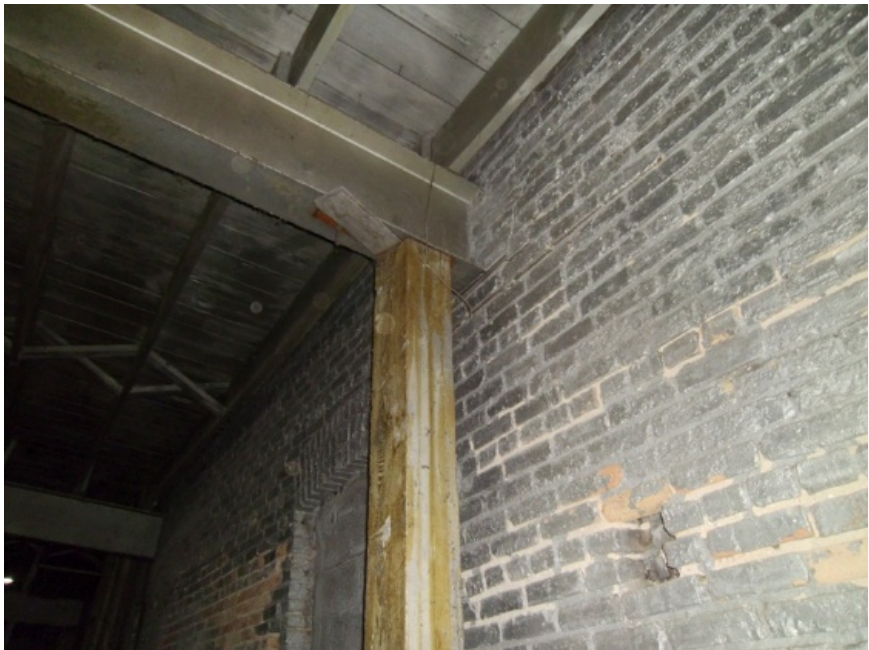
Image showing the shored end of a steel beam. Perhaps the shore has been added as a precaution in the event of a partial wall collapse.

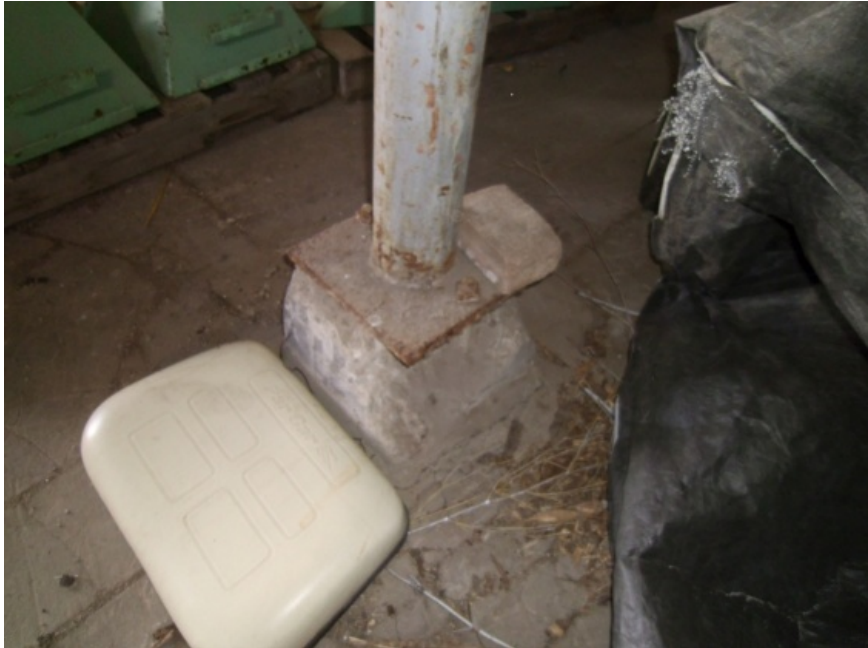
Image showing the column support at a damaged concrete pier. A portion of the bearing plate is unsupported.

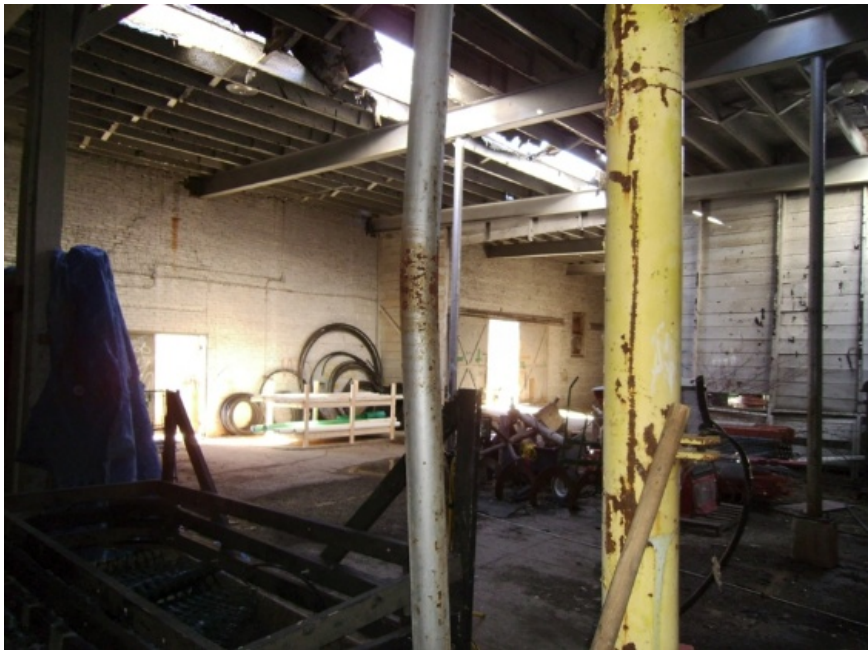
Image showing a damaged roof column. The bend has reduced the load carrying capacity of this column.

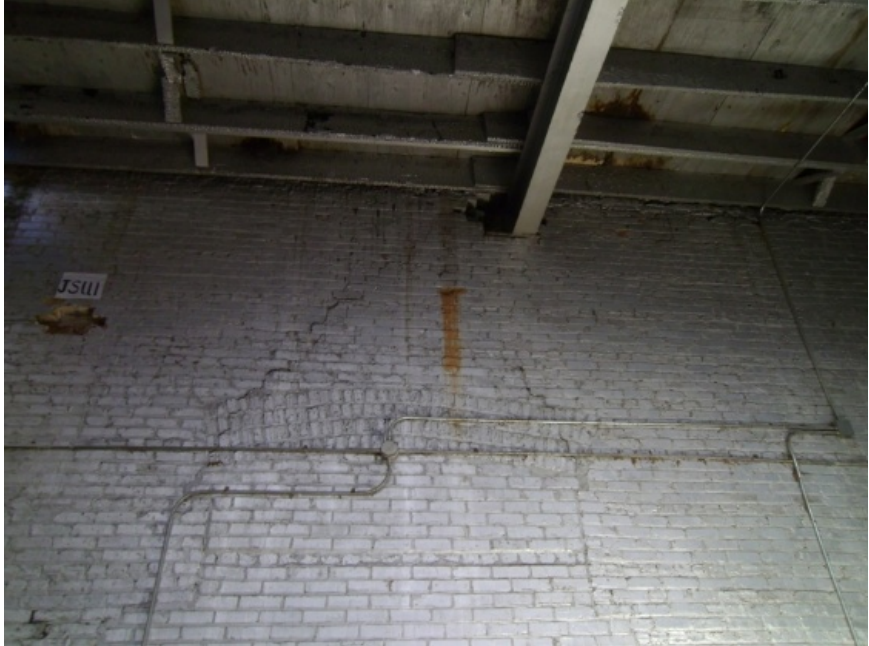
Image showing the crack at the beam to the foundation.

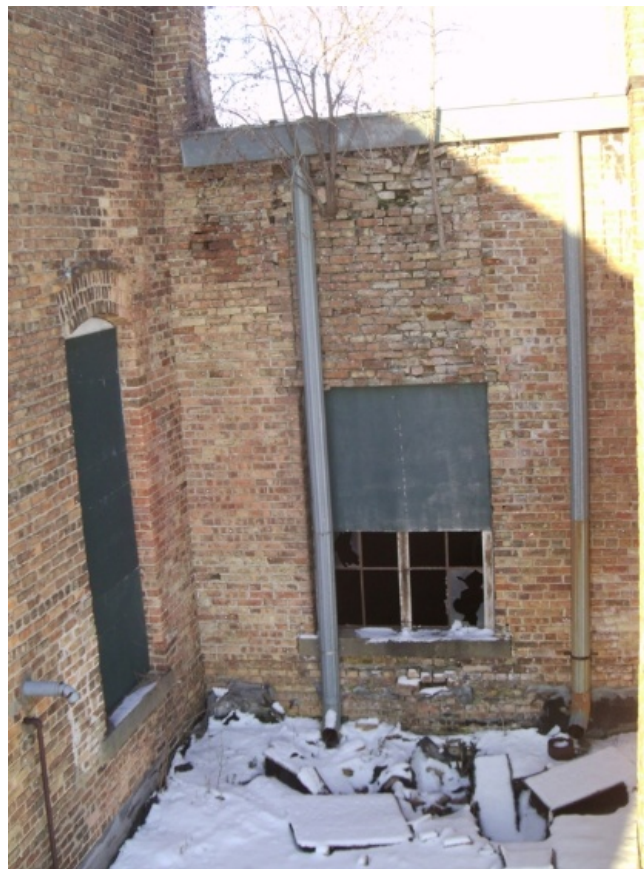
Image showing the exterior of the east wall in the region of the damage.

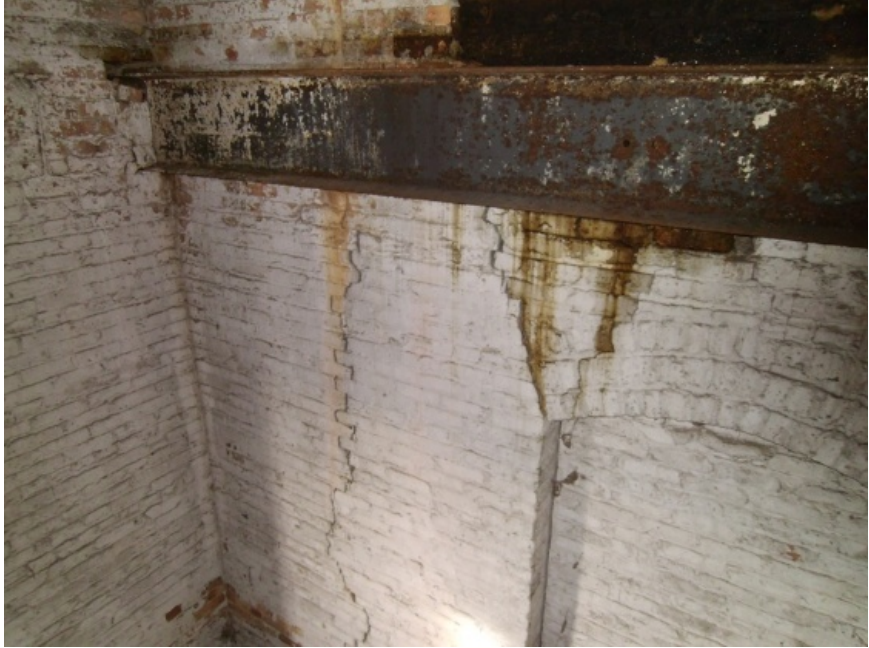
Image showing the large cracks in the walls at the southwest corner A. The steel channel will be left in place.
