Architectural Engineering Consulting

Garver Feed Mill Building Repairs

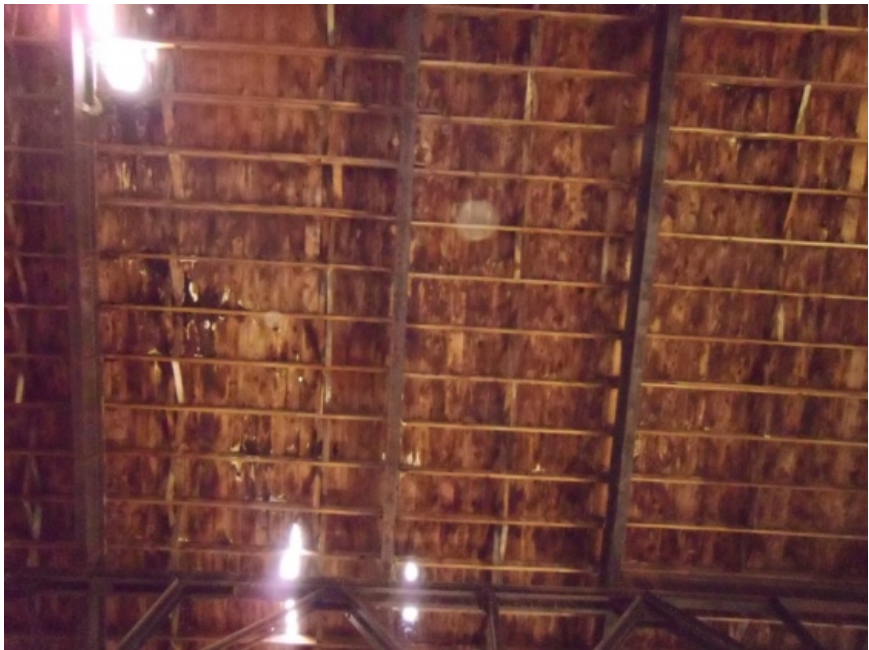
Image showing the construction of the existing wood and steel framing.

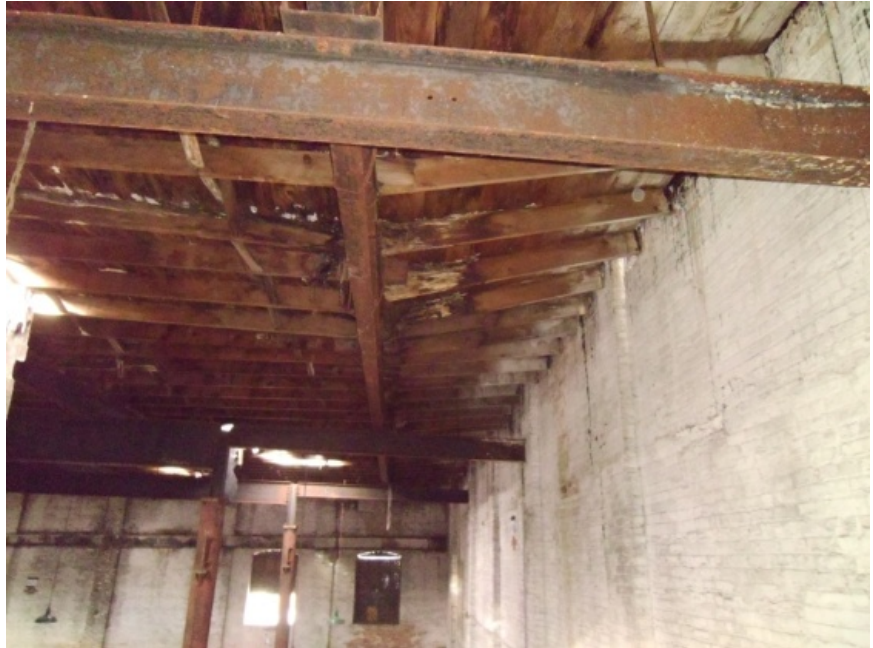
Image showing deterioration in the wood roof framing.

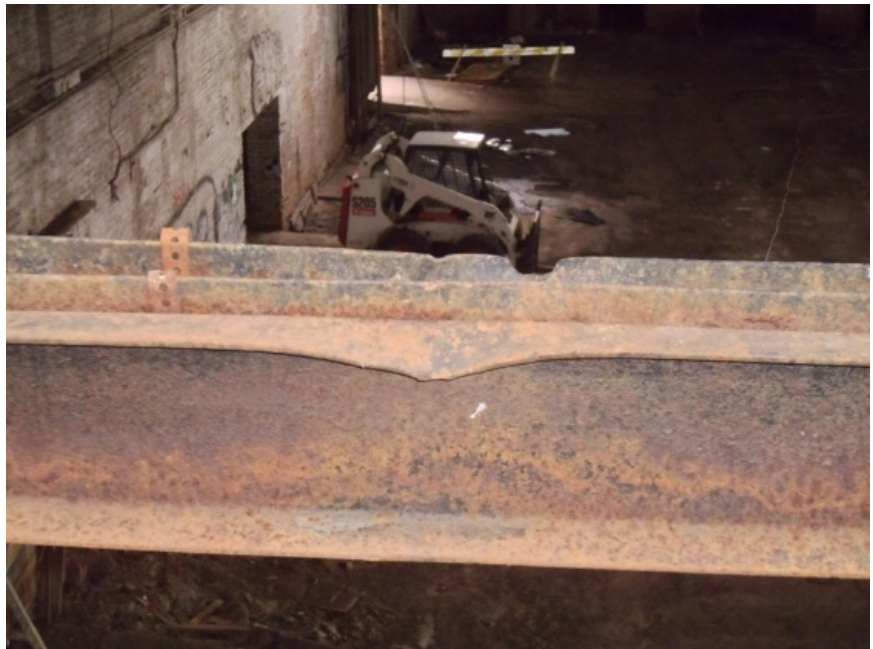
Image of the damaged bottom truss chord.

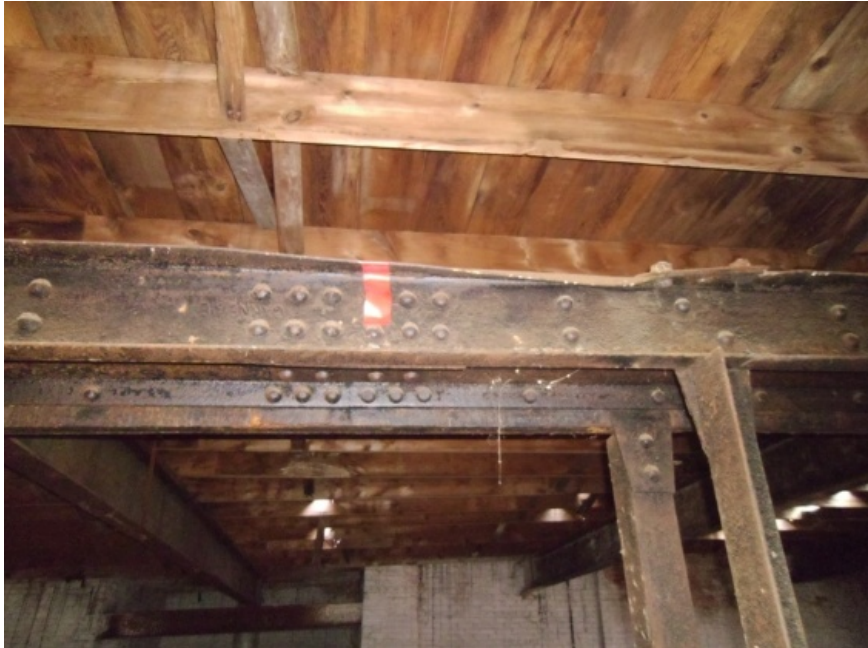
Image of the damaged top truss chord.

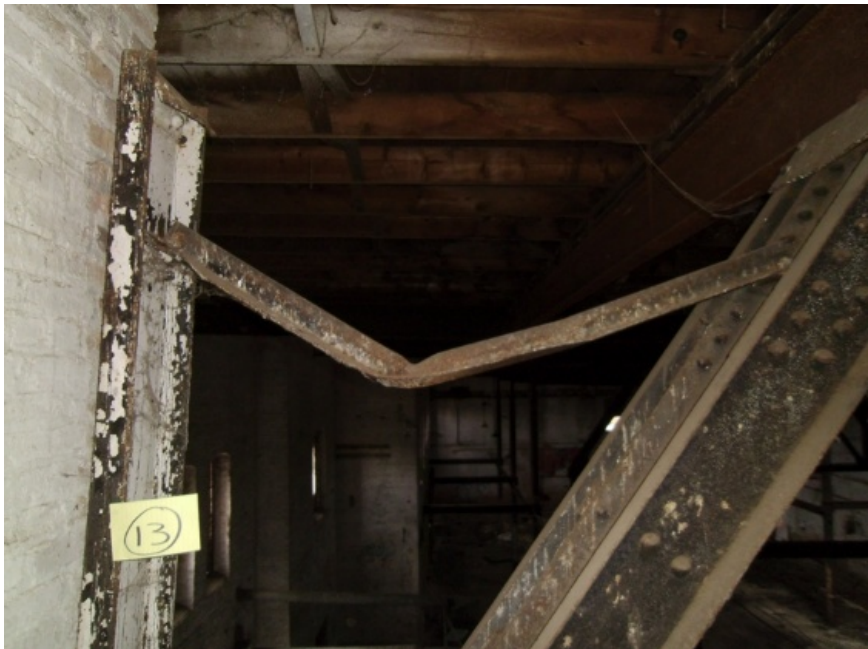
Image showing the bent angle at the stabilizer from the truss.

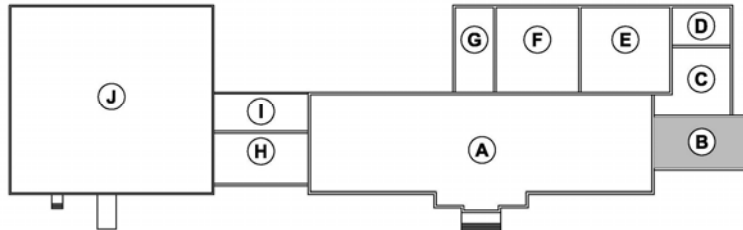
Masonry Recommendations

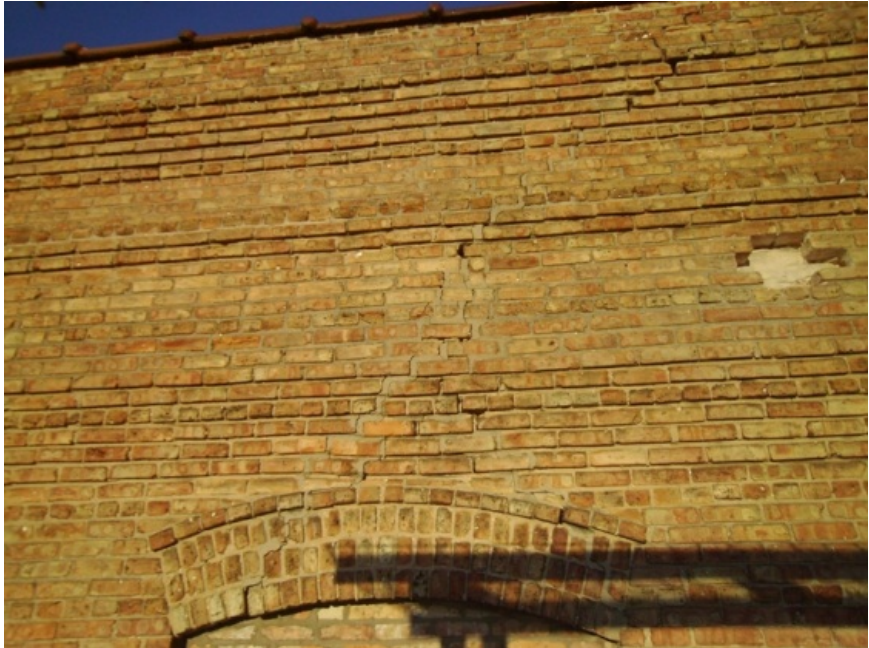
Image showing the stepped structural crack from a second level lintel to the roof.

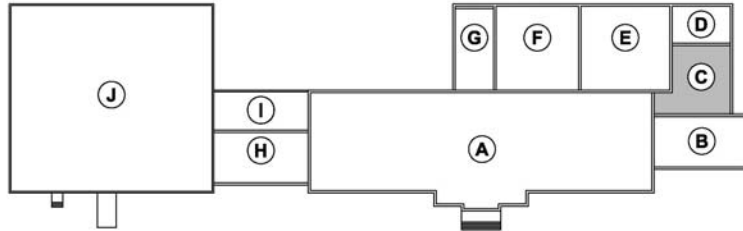
Masonry Recommendations

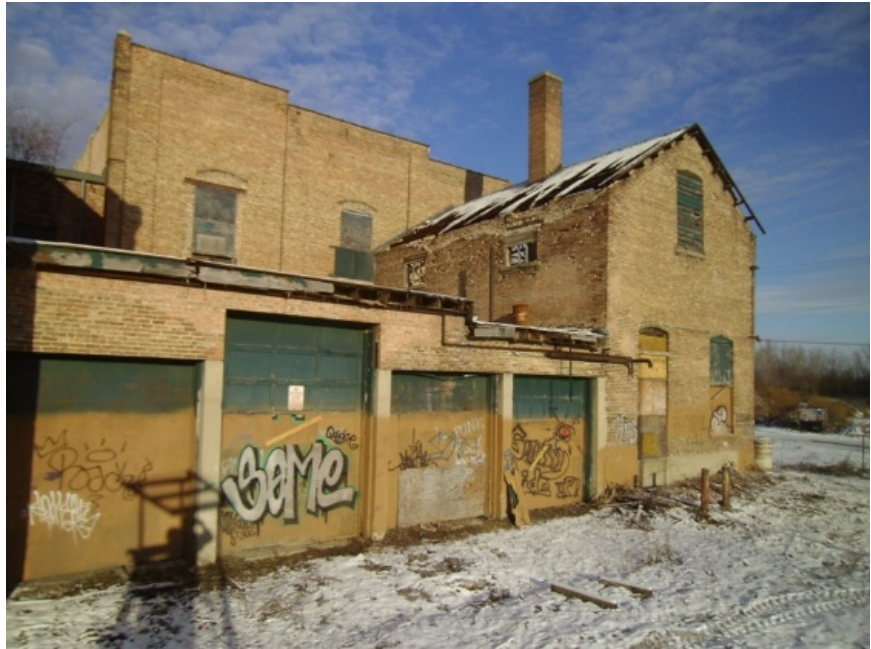
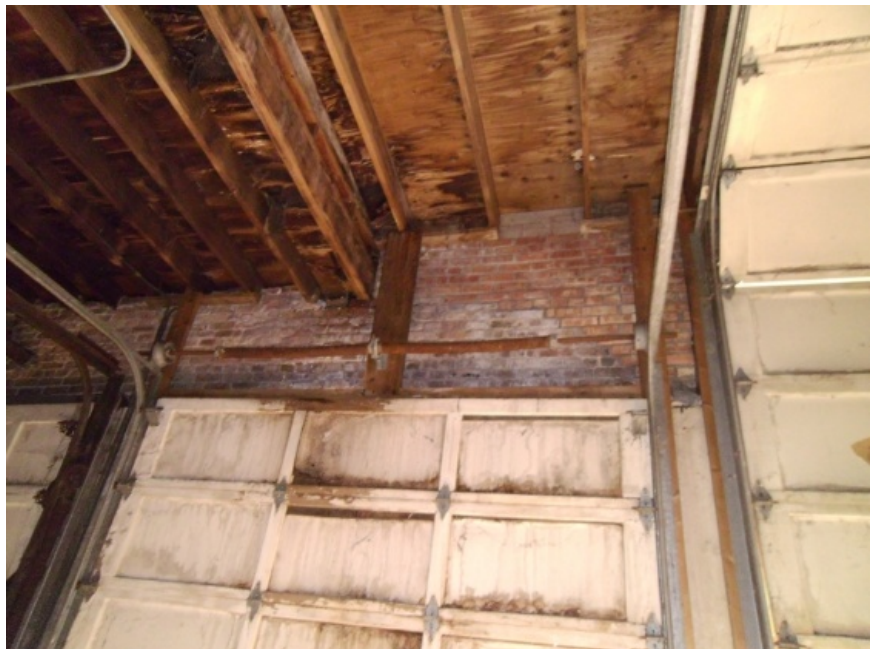
Images showing the interior and exterior surfaces of the east wall.

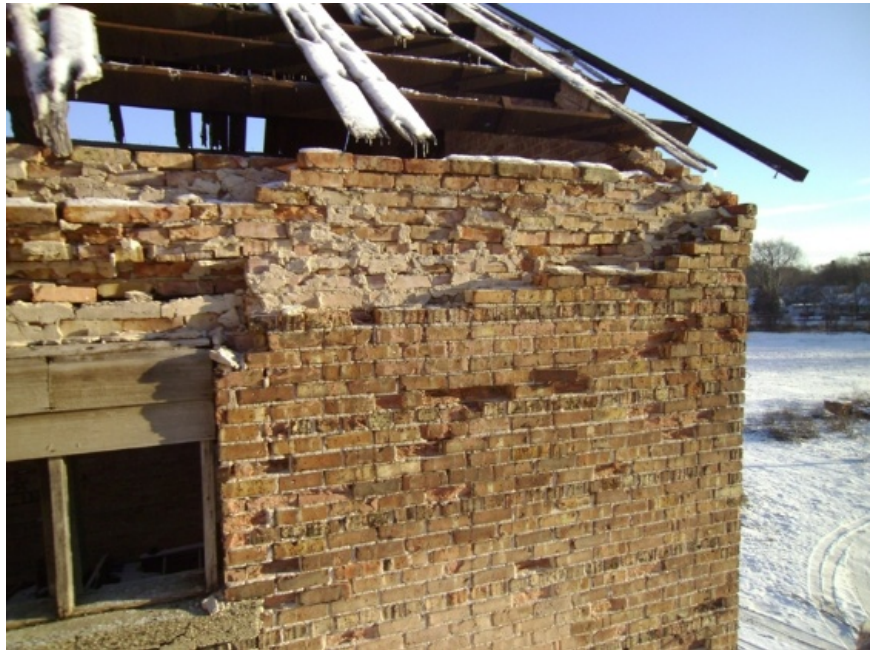
Image showing a section of the south wall.

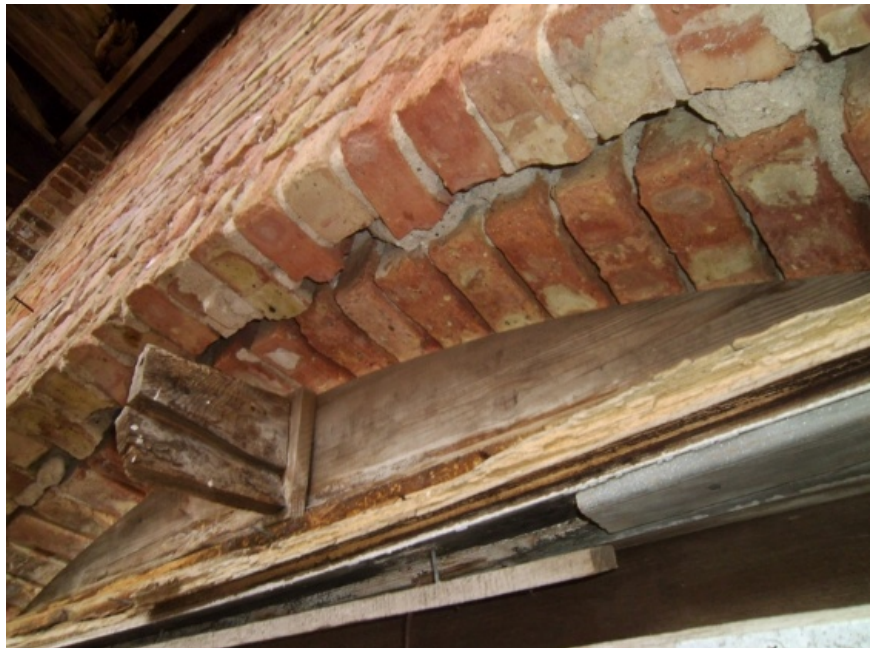
The arched lintels of brick unit masonry shall be repaired by downstacking with subsequent re-build.

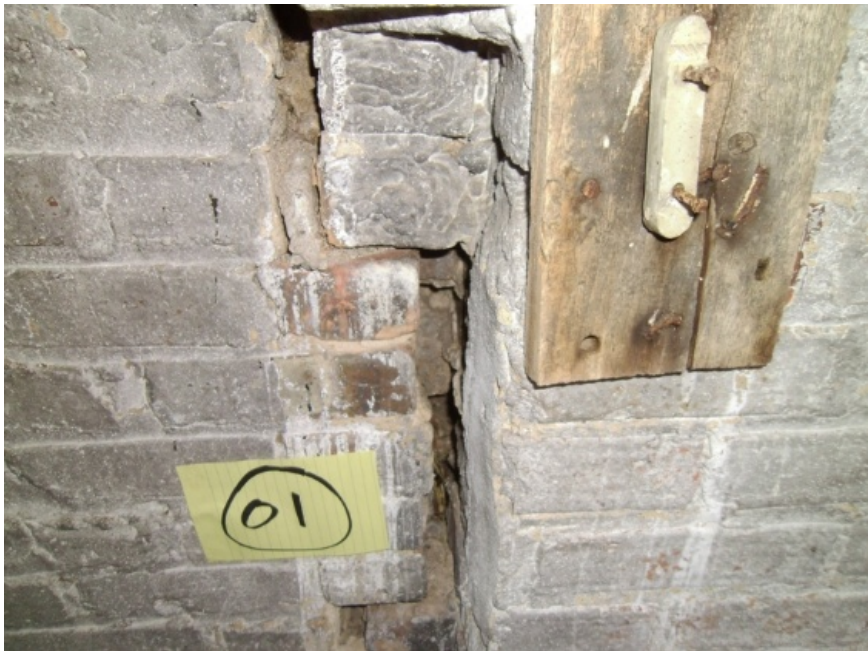
Image showing the poorly toothed interface at the south wall.

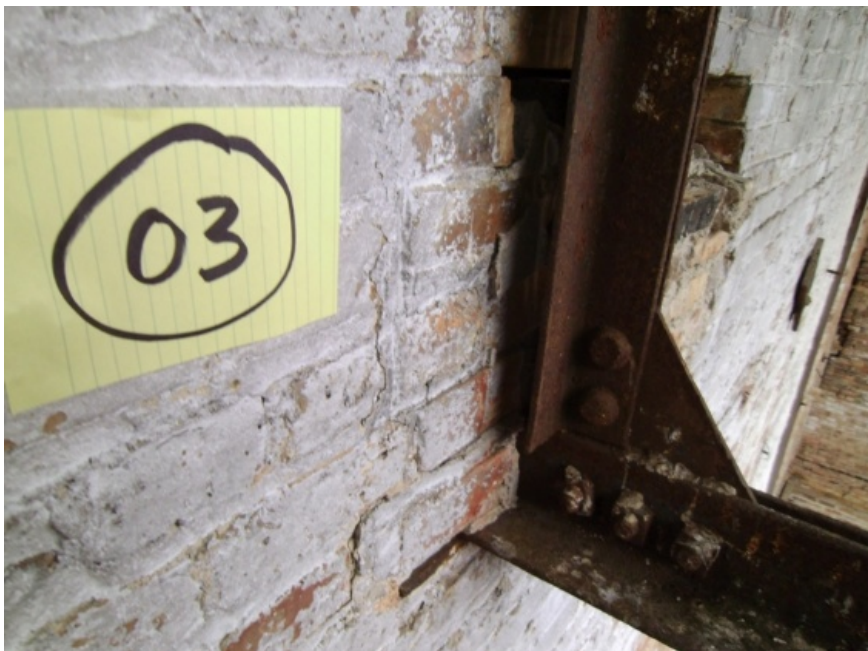
Image showing a truss bearing at the south wall. Note the cracks in the masonry suggesting that the truss is dislodged from the masonry.

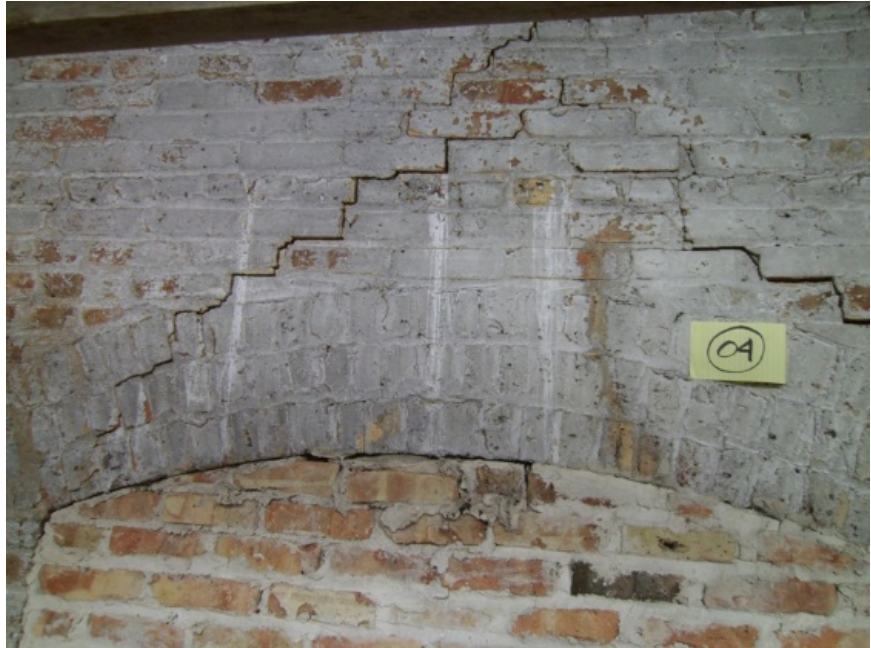
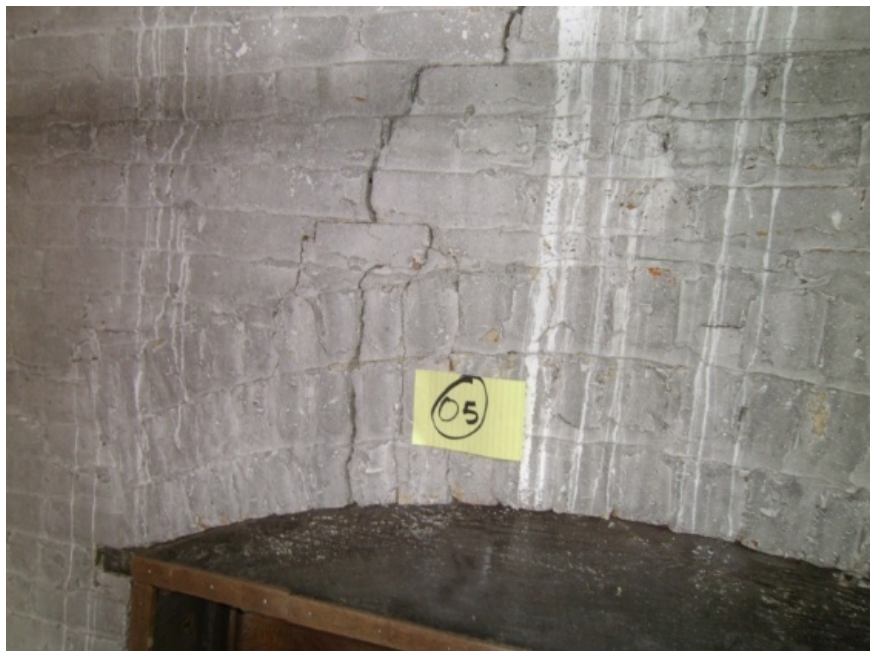
Images showing failed arched lintels of brick unit masonry, cracking at embedded steel, and brick and mortar erosion

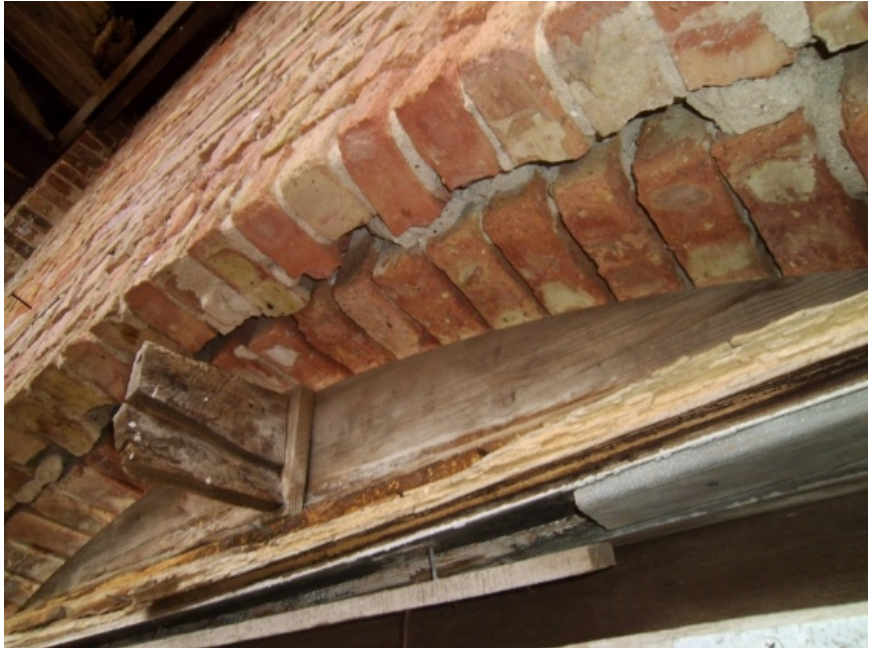
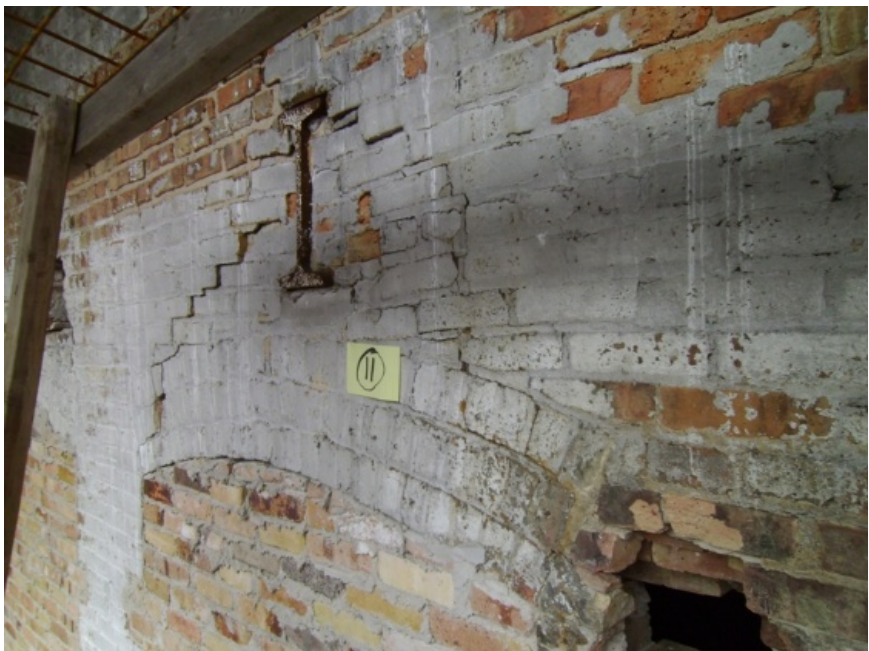
Images showing failed arched lintels of brick unit masonry, cracking at embedded steel, and brick and mortar erosion.

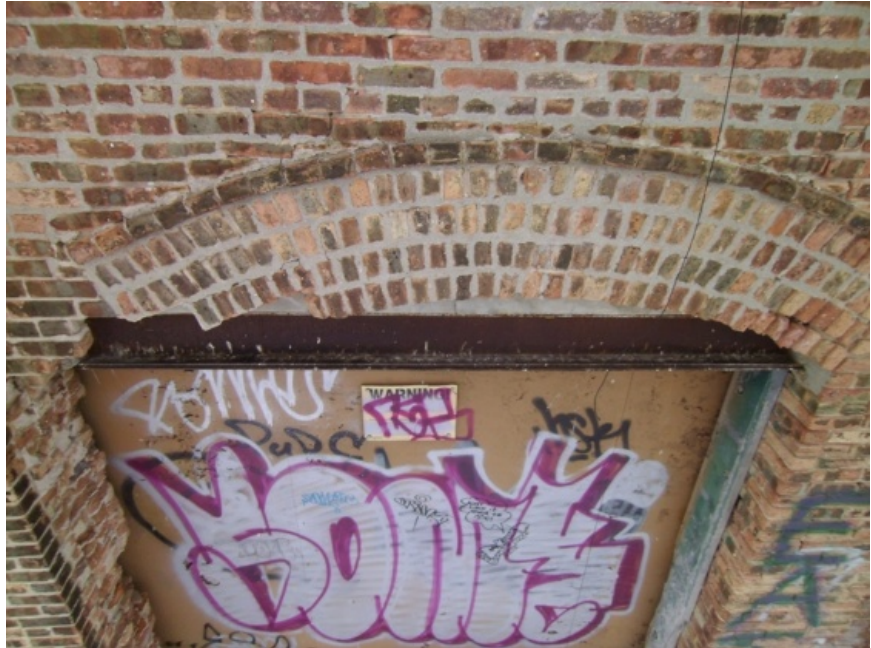
Image showing the poorly constructed steel lintel at the north wall. The steel supporting the masonry only supports a portion of the wall width. The left bearing is compromised.

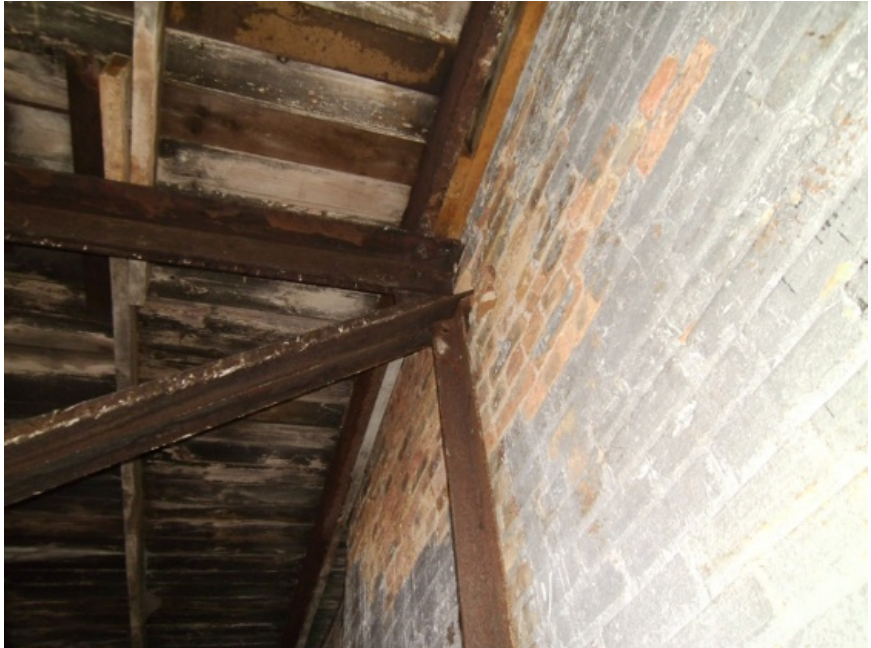
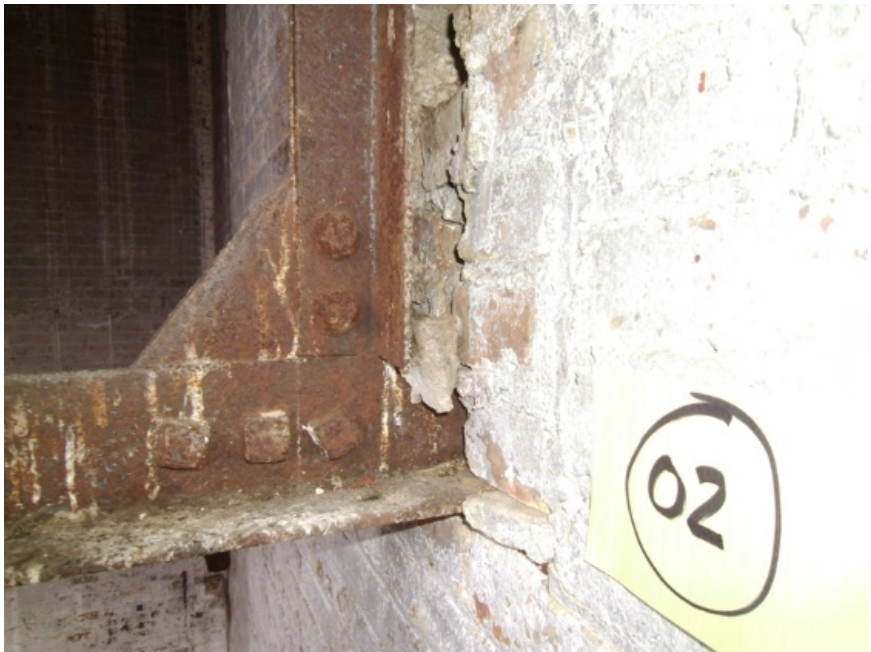
Image showing one truss (top) bearing. The bottom bearing embedment appears to be a stabilization point. The rust present appears to be superficial.

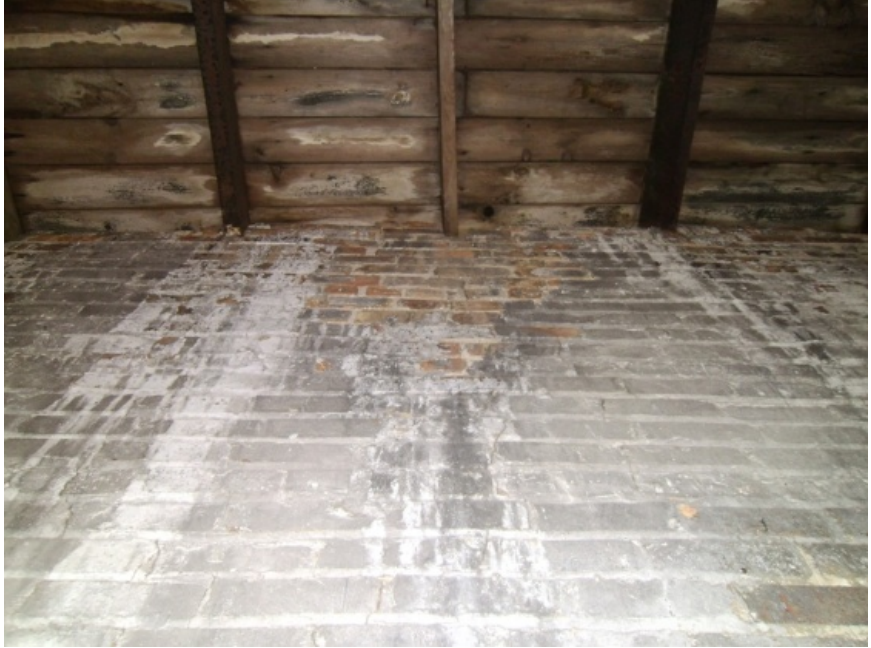
Image showing the damaged wood and steel framing bearing into the masonry walls.

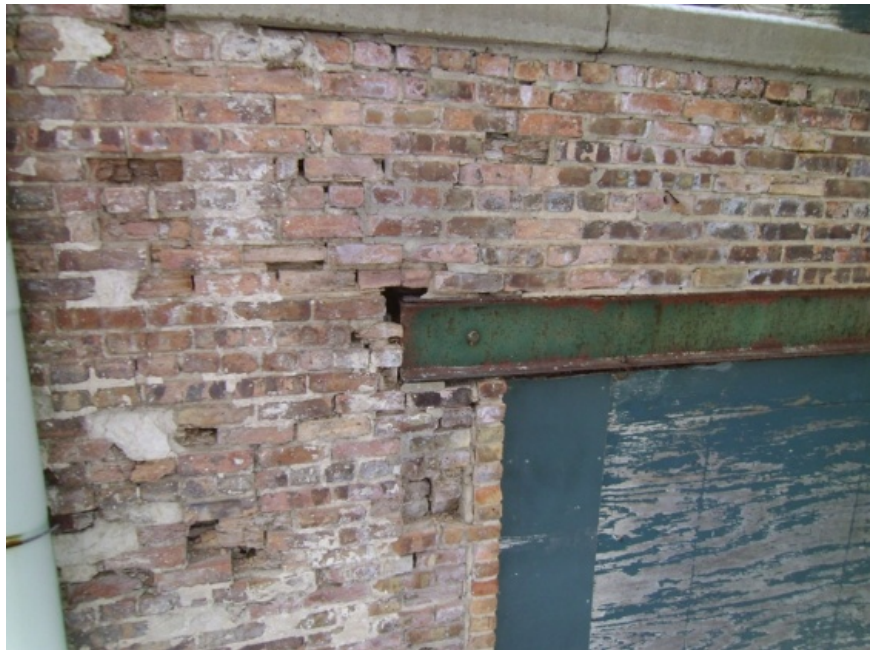
Image showing how deterioration and erosion in the masonry joints have undermined the integrity of a lintel bearing.

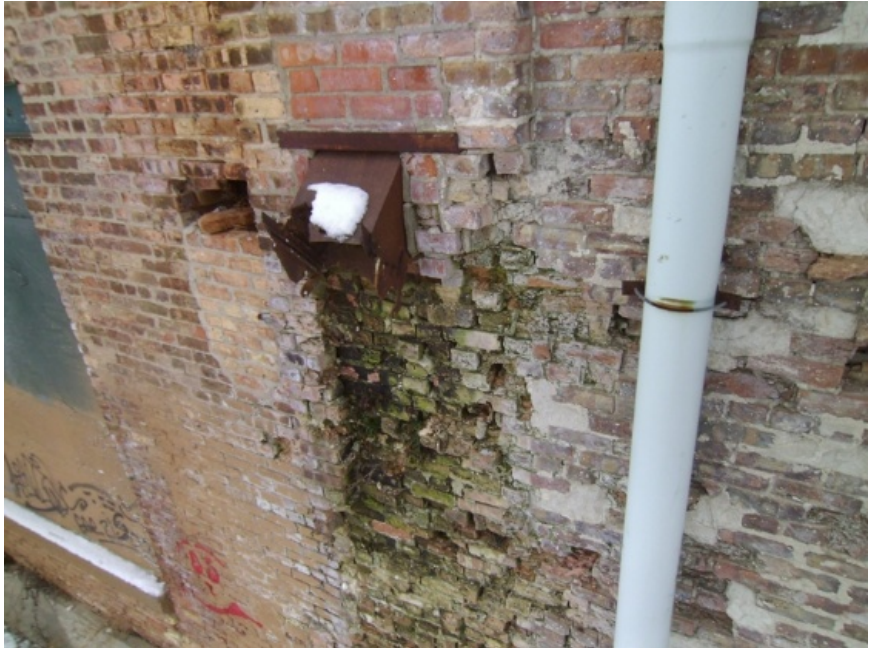
Image showing the exterior face of the north wall. This image was taken at the second floor level. The second floor beam end behind this masonry has dislodged from its supporting masonry.

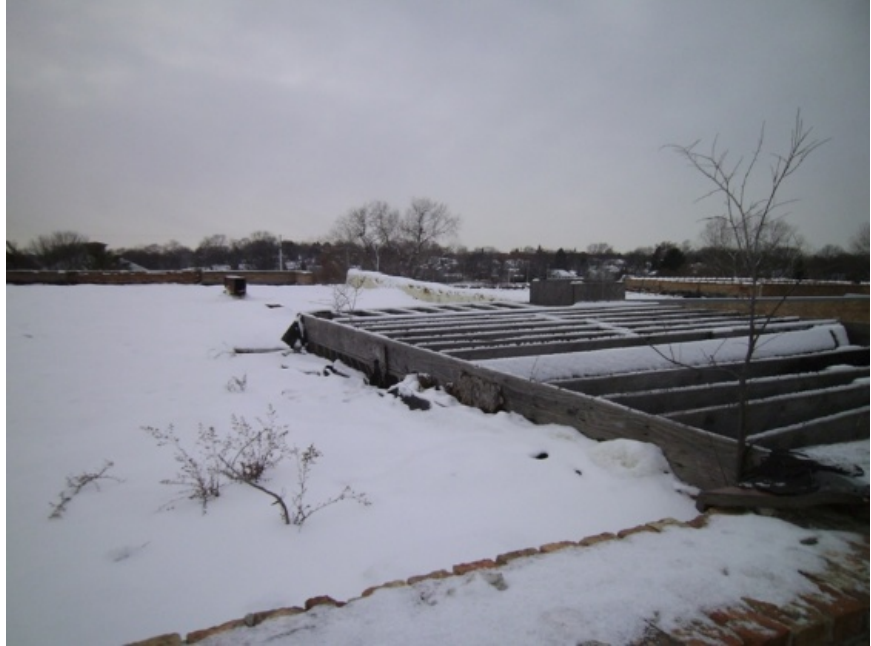
Image showing the topside of the roof. The north half of the roof appears to be partially framed with wood.

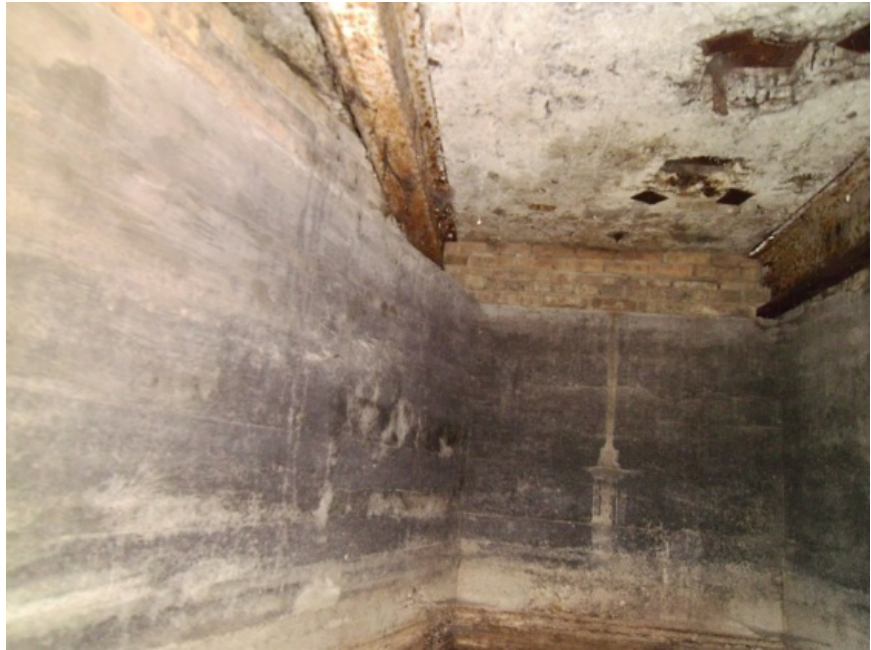
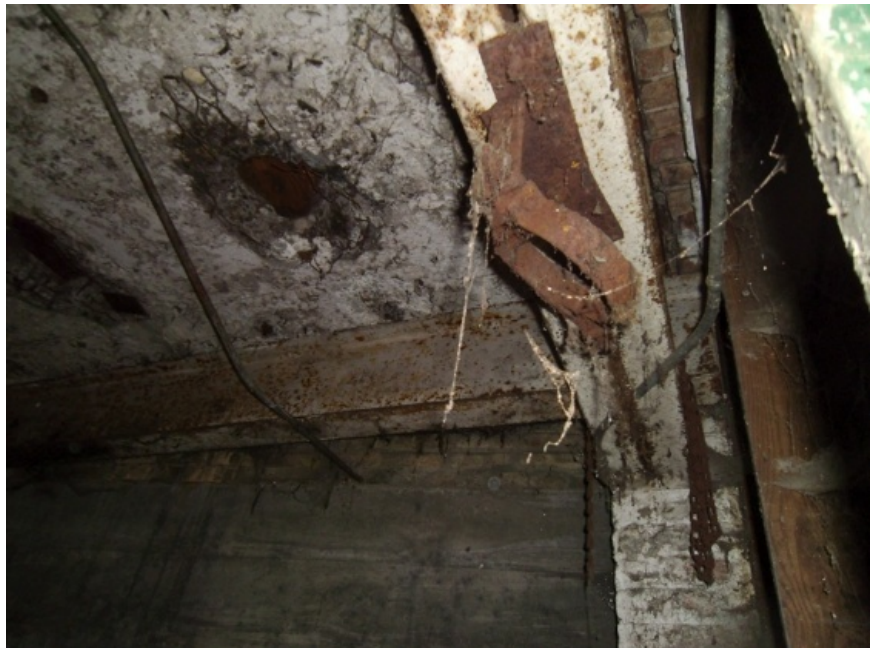
Images showing the pits/vaults below the first floor.

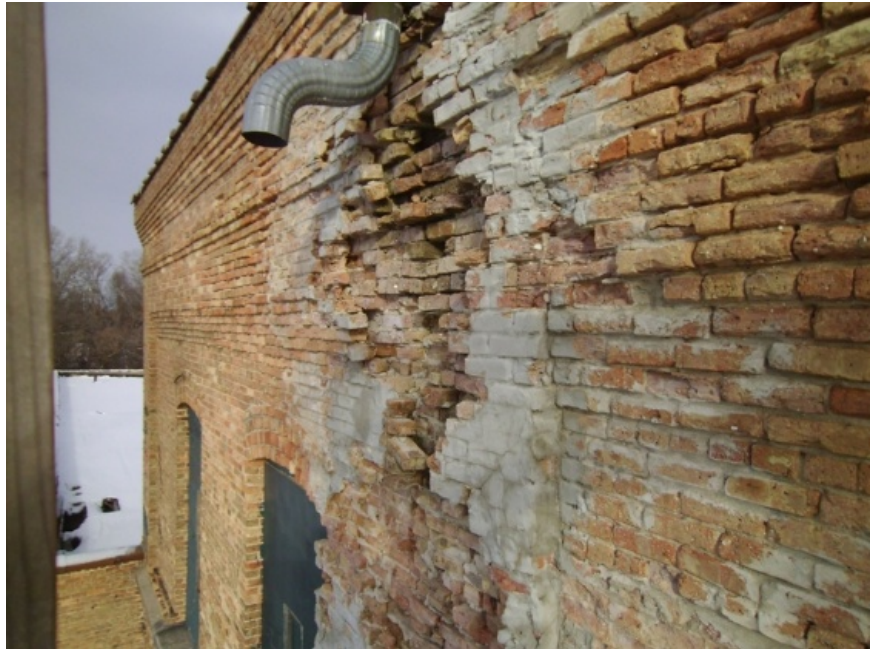
Image showing the upper section of brick deterioration from water infiltration.

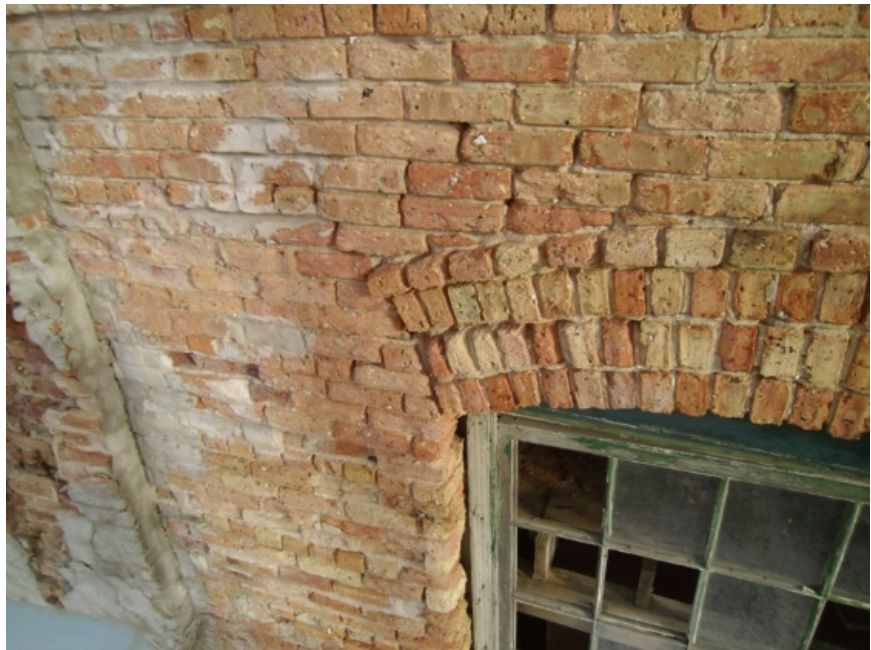
Image showing the mortar and brick erosion, exterior.

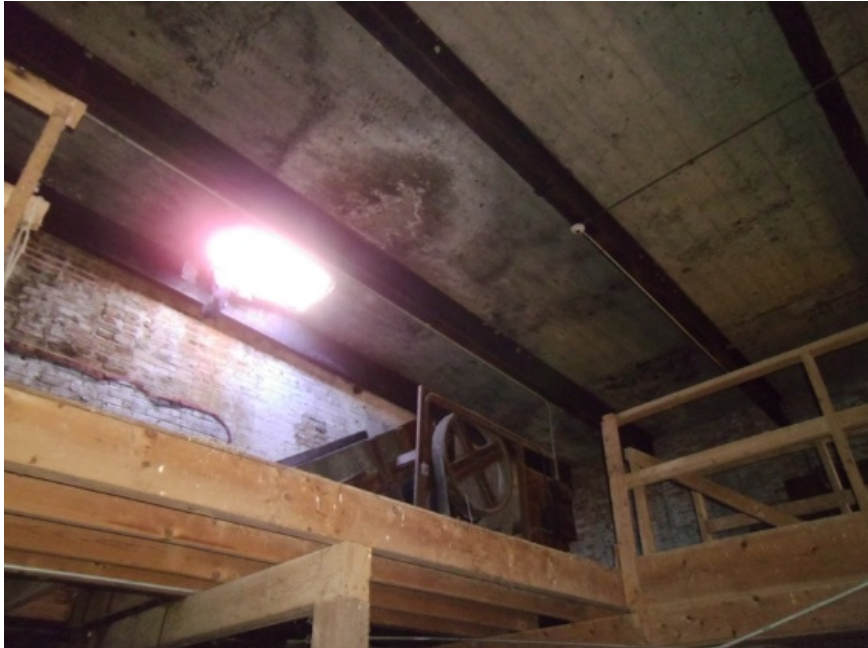
Image showing the location of the 5'x10' roof replacement area.

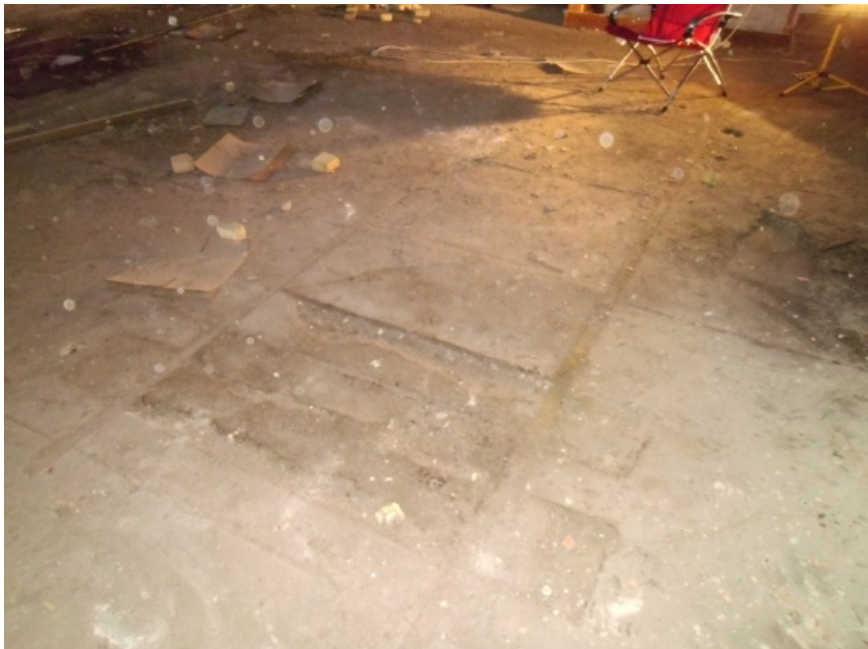
Image showing a suspected area of poorly placed concrete from the topside of the second floor.

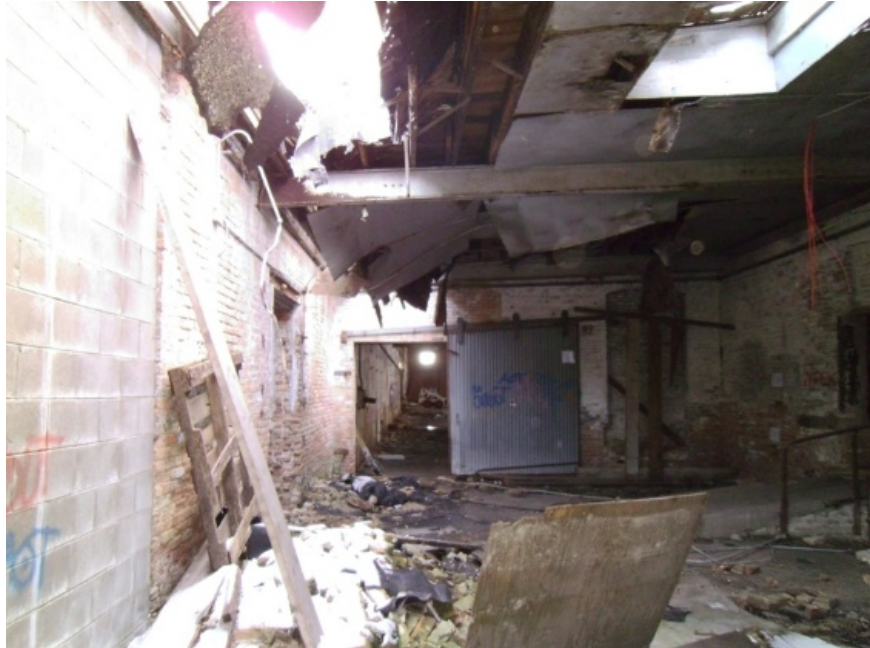
Image of the interior surface of the north wall of the module facing east.

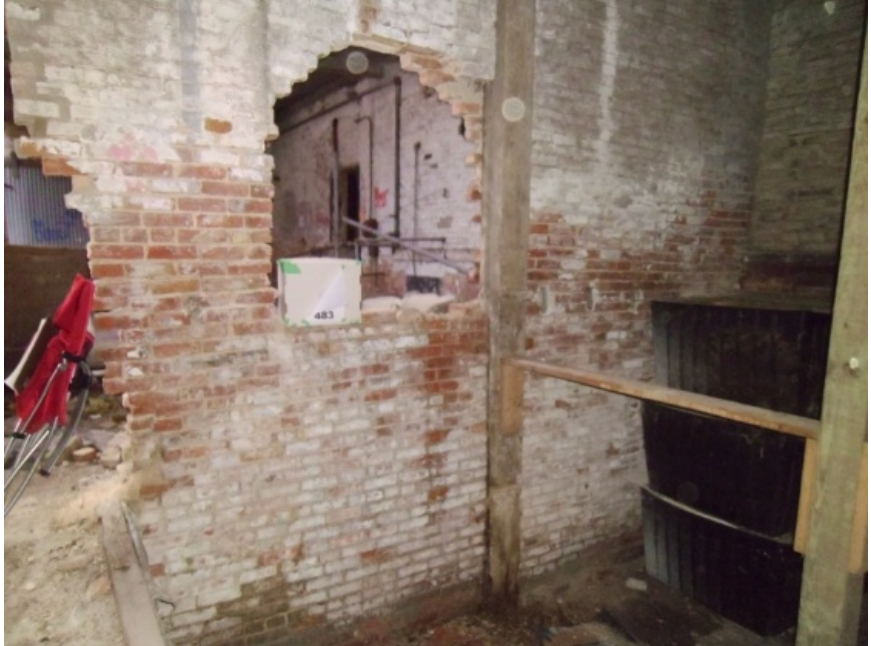
Image showing structural damage to the existing interior bearing wall.

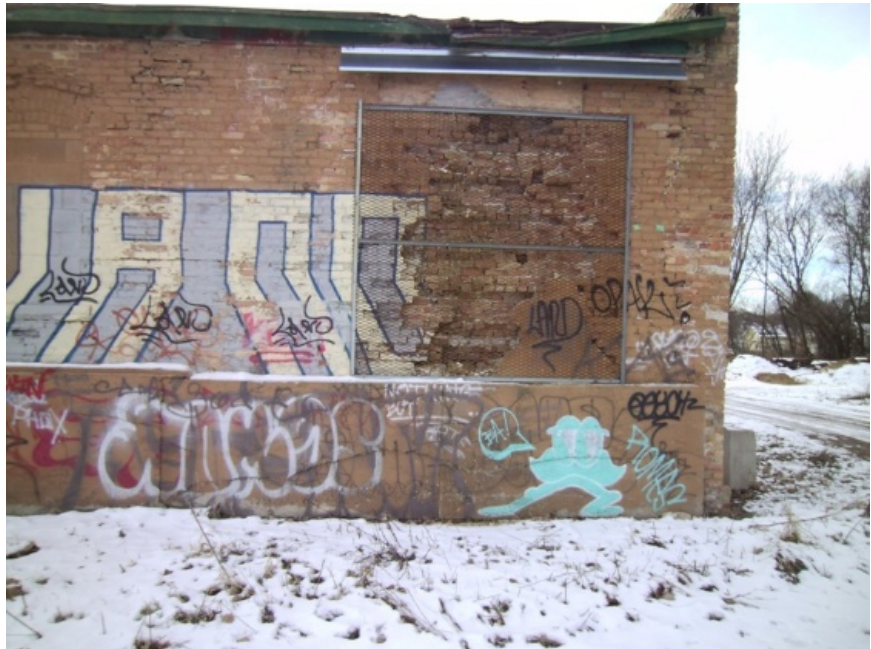
Image showing the west end of the north wall.

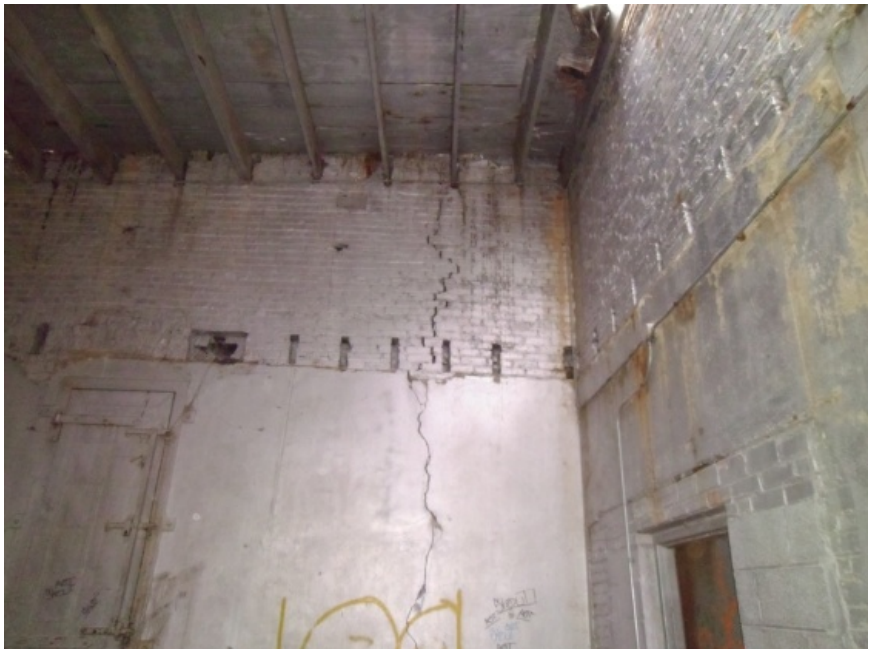
Image showing the vertical crack in the east wall at the southeast corner.

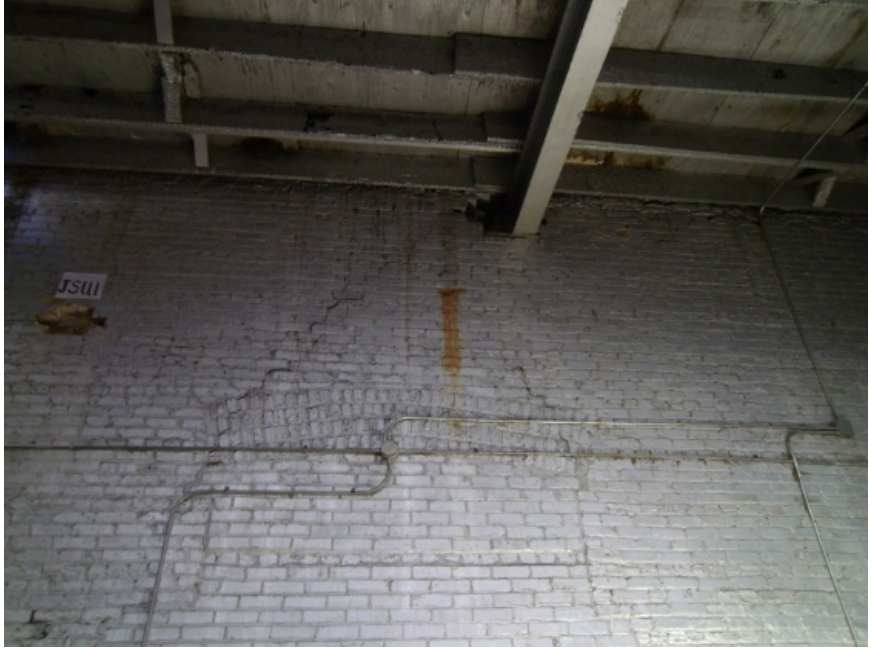
Image showing a through wall crack at a south wall beam.

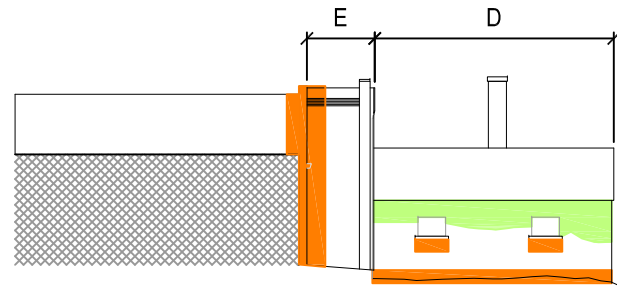
4 SOUTH ELEV. EXTERIOR
Scale: 1/32"=1'-0" SOUTH ELEVATION @D & E

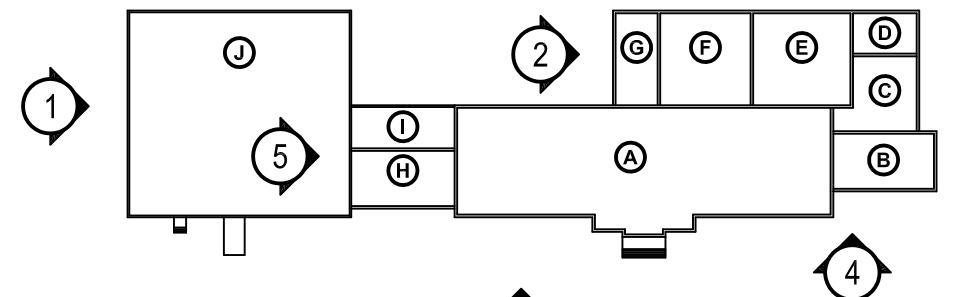
KEY PLAN
Scale: NONE

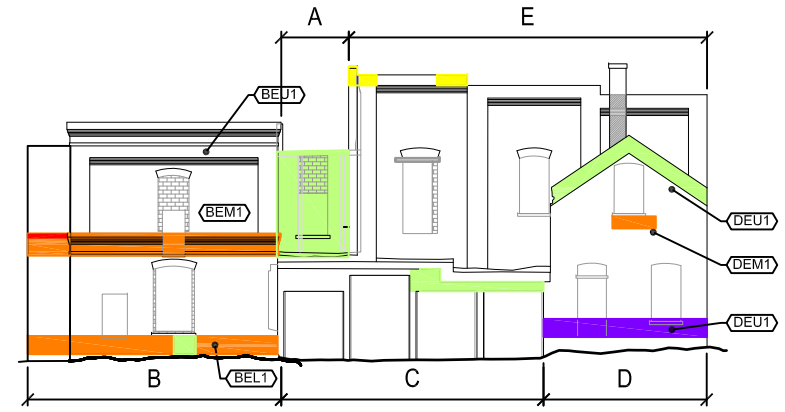
8 EAST ELEV. EXTERIOR
Scale: 1/32"=1'-0"

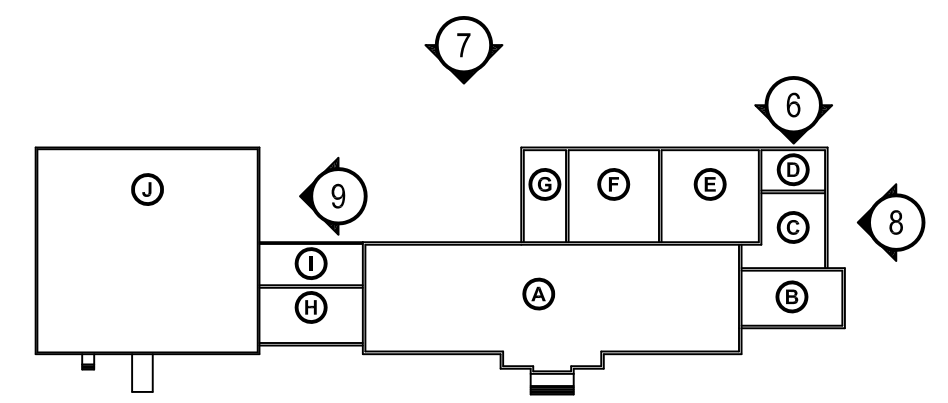
KEY PLAN
Scale: NONE

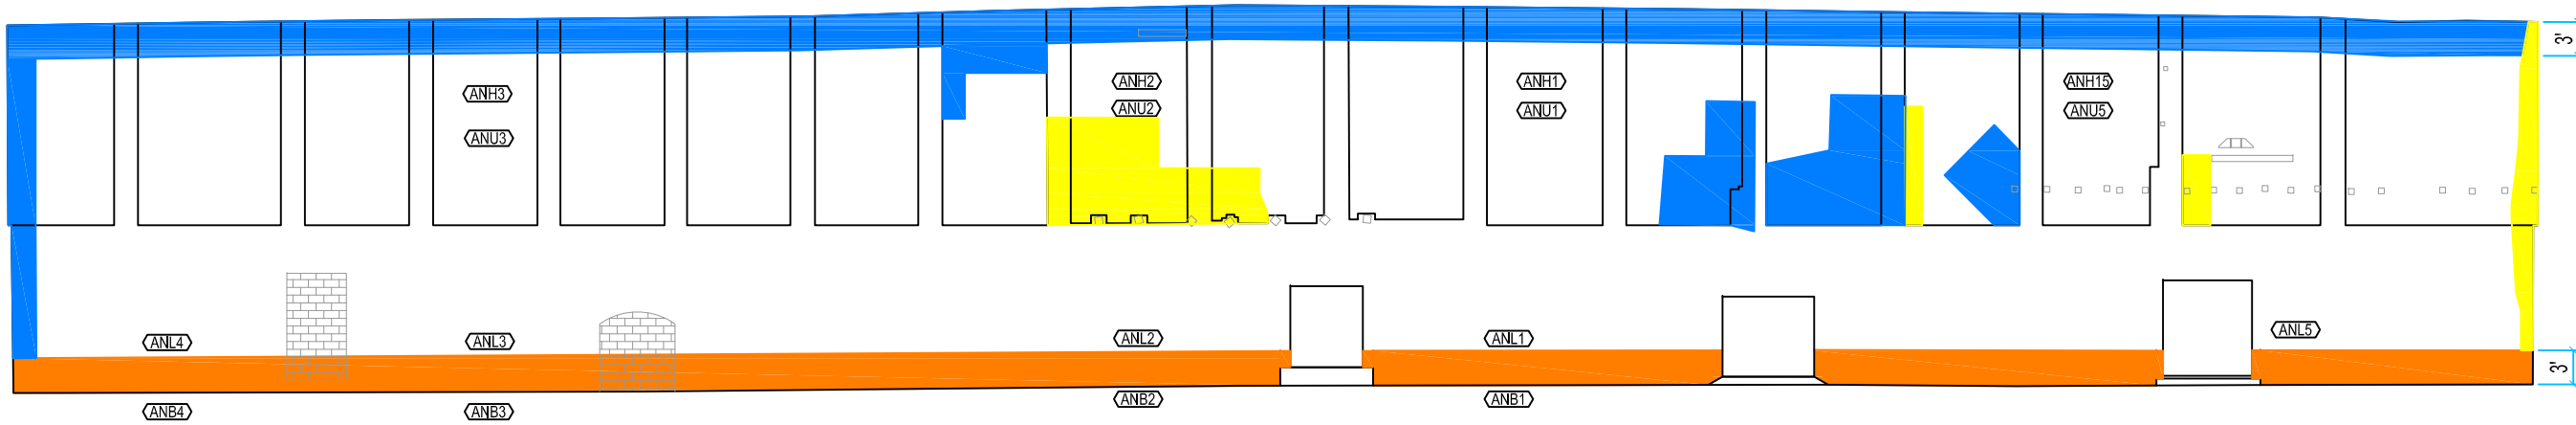
4 NORTH ELEV. MODULE A
Scale: 1/16"=1'-0"

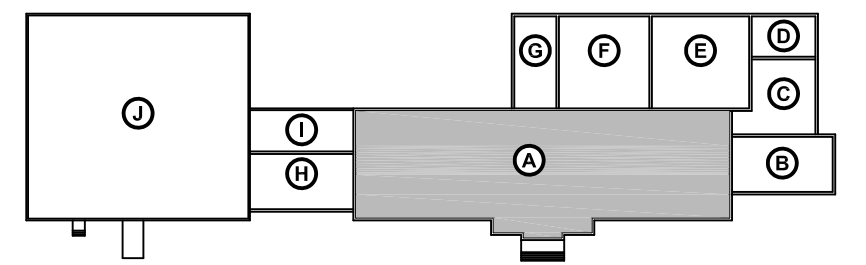
KEY PLAN
Scale: NONE

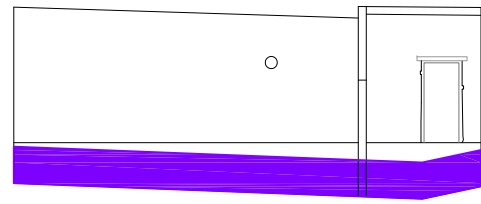
6 NORTH ELEV. MODULE C
Scale: 1/16"=1'-0"

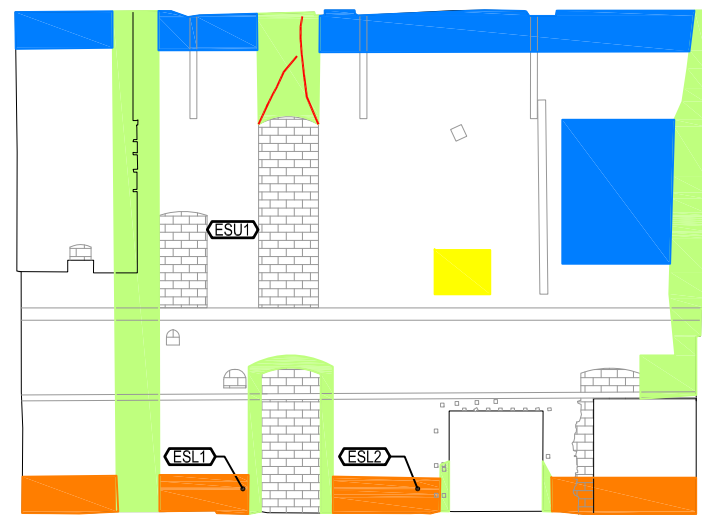
3 SOUTH ELEV. MODULE E
Scale: 1/16"=1'-0"
