Architectural Engineering Consulting

Garver Feed Mill Building Repairs

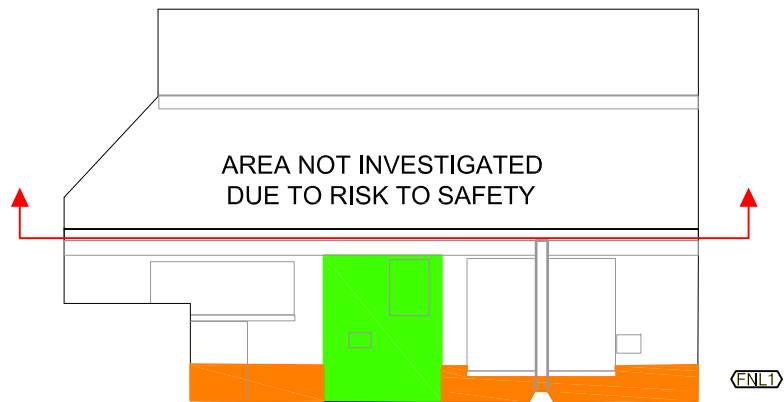
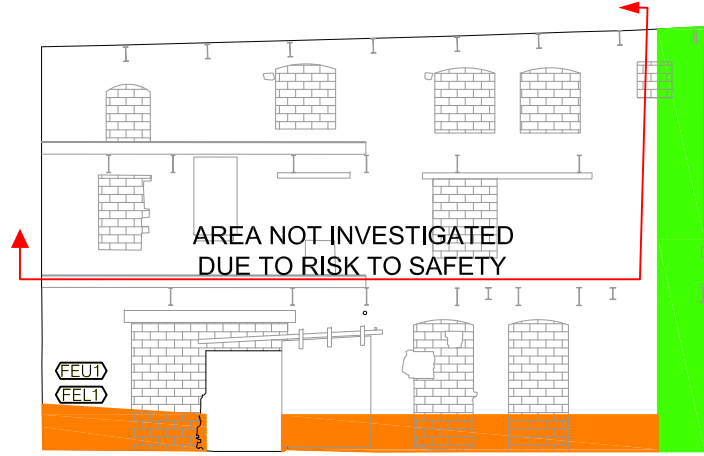
4 NORTH ELEV. MODULE F
Scale: 1/16"=1'-0"

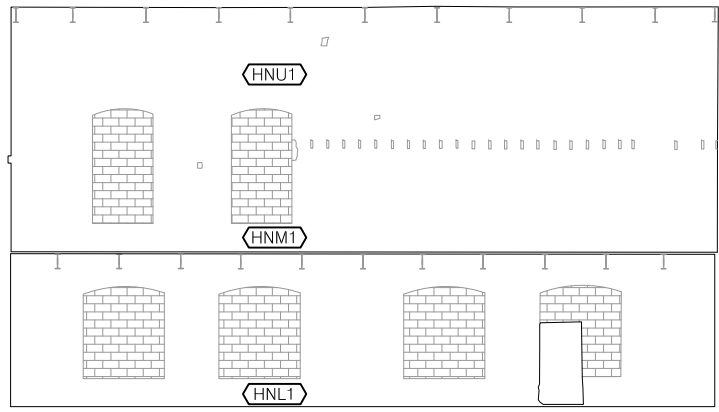
3 NORTH ELEV. MODULE H
Scale: 1/16"=1'-0"

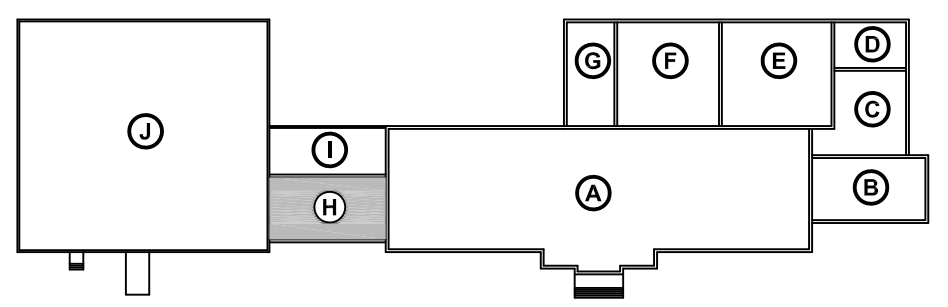
KEY PLAN
Scale: NONE

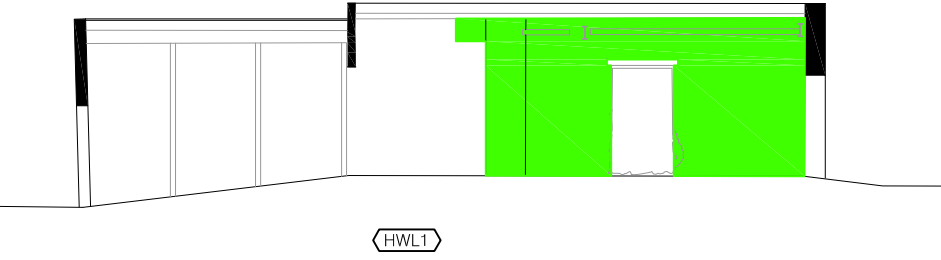
5 NORTH ELEV. MODULE I
Scale: 1/16"=1'-0"

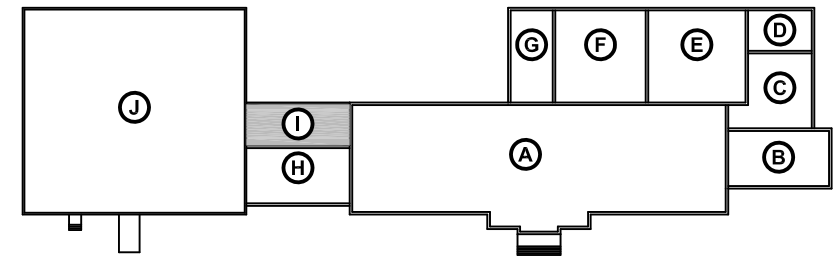
KEY PLAN
Scale: NONE

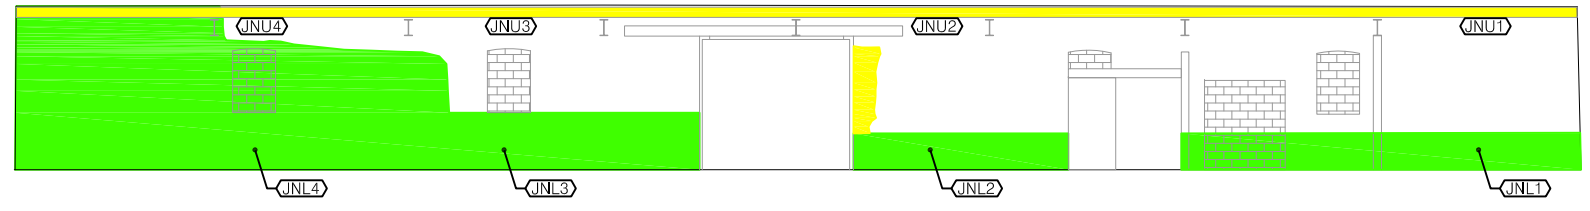
4 NORTH ELEV. MODULE J
Scale: 1/16"=1'-0"

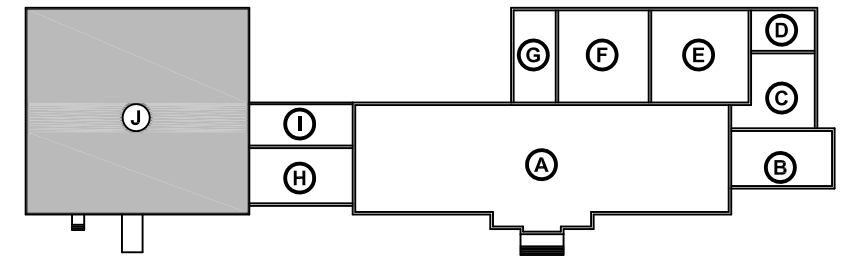
KEY PLAN
Scale: NONE

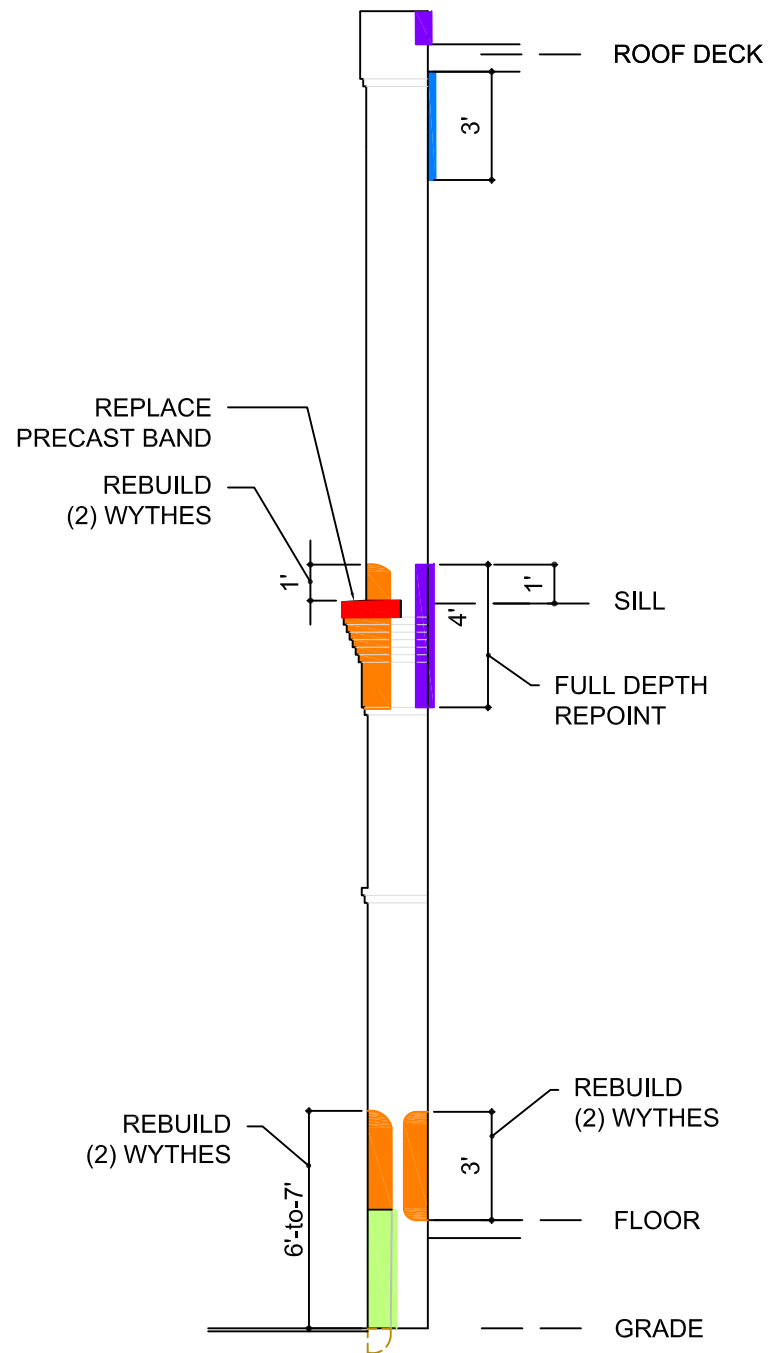
1 SECTION
Scale: NONE
