January 27, 2014

Re: Evaluation of Concrete Cores and Soils from Tree Openings between 329 and 528 State Street, Madison, Wisconsin (STS Job. No. 13068)

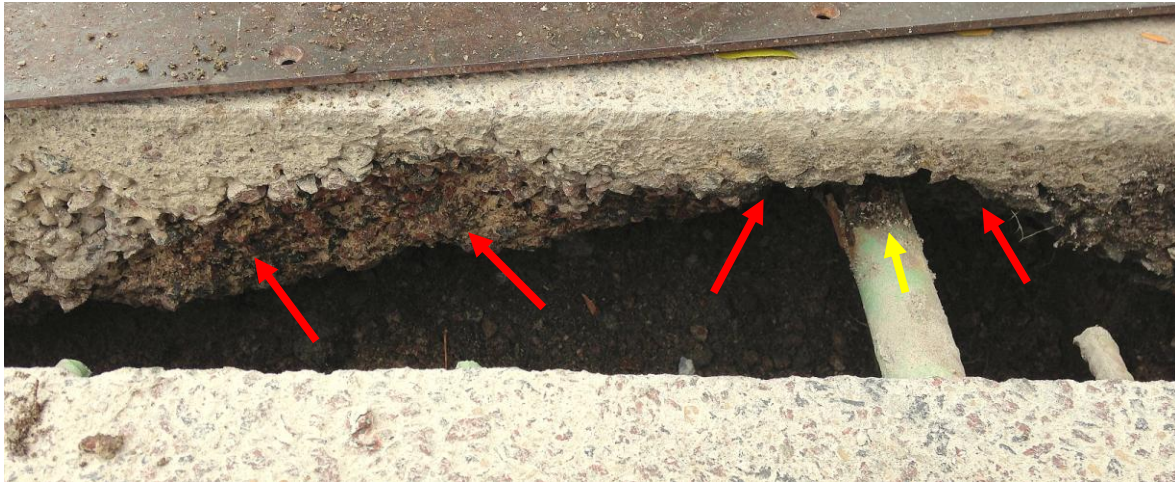
Sometime this past Fall, it was determined that along joints the slabs were deteriorating from the bottom upward (Figure 2). The deterioration is in the form of bottom of the slab cracking and spalling (Figure 2) and joint surface cracking and spalling (Figure 3). The City of Madison contracted CGC, Inc. to take cores of various slabs for testing to determine the cause(s) and extent of the deterioration.

Figure 2. Oblique view of the slab showing deterioration of the slab bottom (red arrows) and corrosion of a dowel bar (yellow arrow).

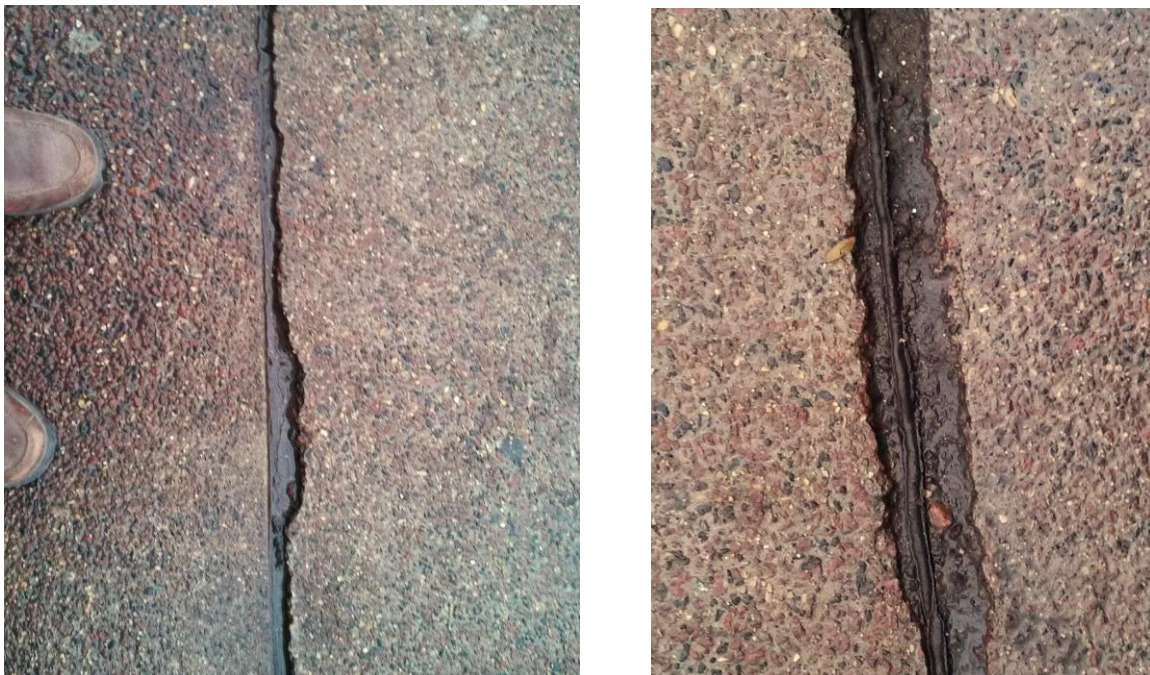
Figure 3. Cracking, spalling and raveling along joints
