APPLICATION FOR DEMOLITION OF PRINCIPAL BUILDINGS

The existing buildings are unsafe and uninhabitable due to severe structural deterioration. Rehabilitation would cost upwards of \$40,000 per property and would not result in usable or safe living or working space. In their current condition, these properties present ongoing safety risks.

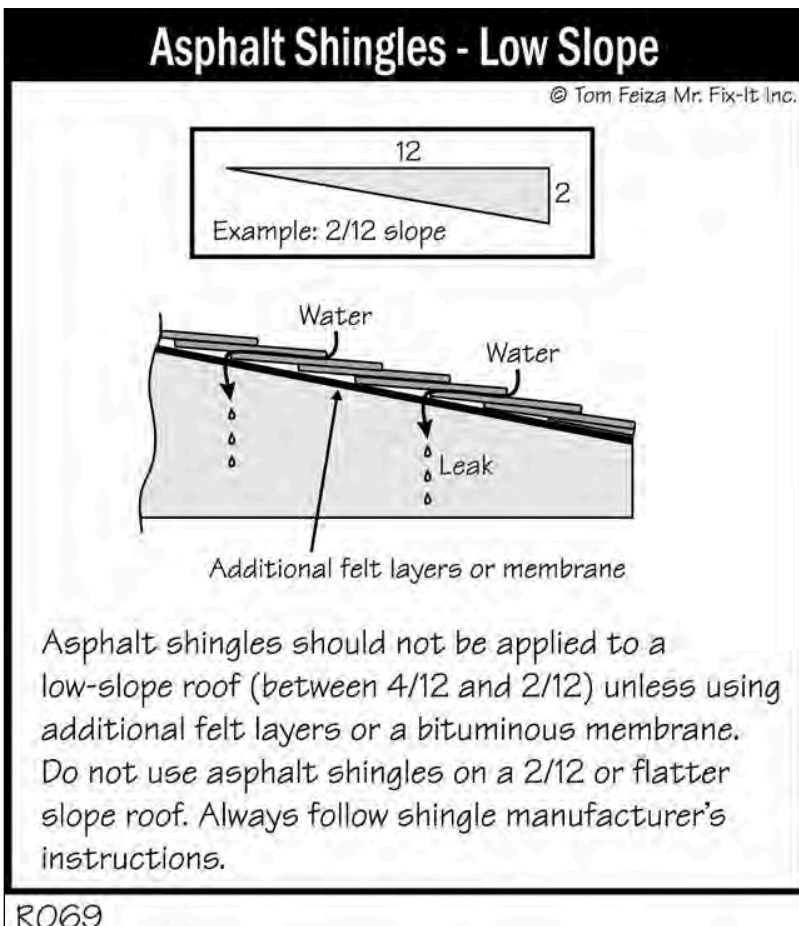
1.0 (2) Defect: The low slope roof at the on the front porch had asphalt composite shingles installed. It should have either selvage, roll roofing, rubber membrane or an approved covering for a flat roof. The roof may leak in heavy rain or ice may dam in winter causing a leak.

Recommend further evaluation of the roof coverings and repair/replace as necessary by qualified roofing contractor.

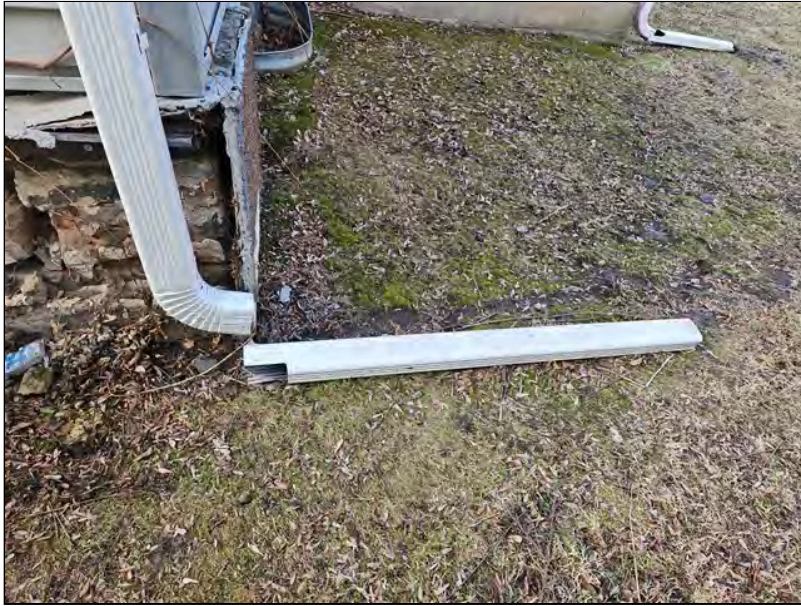
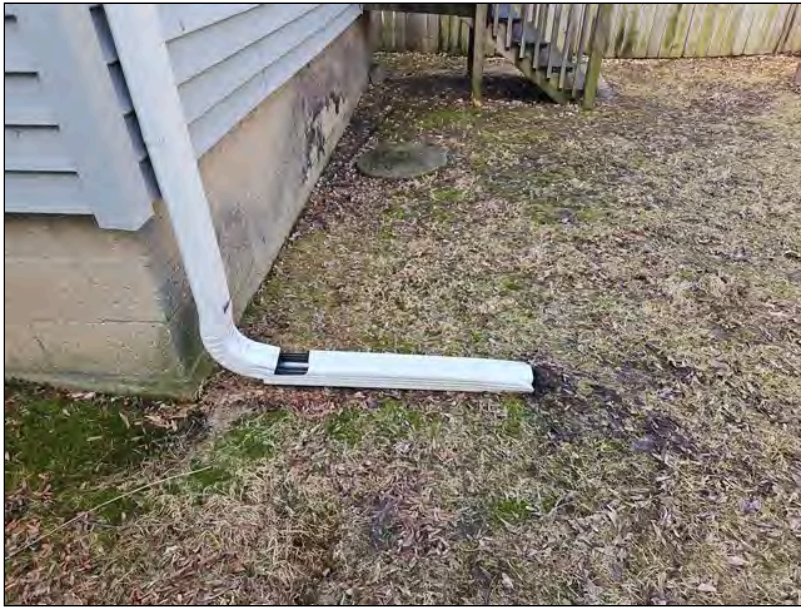
1.1 Repair: Downspouts discharged roof drainage next to the foundation. This condition can result in excessively high moisture levels in the soil at the foundation and can cause damage to the foundation and moisture intrusion into the basement.

Recommend installation of downspout extensions to discharge roof drainage a minimum of (6) feet from the foundation.

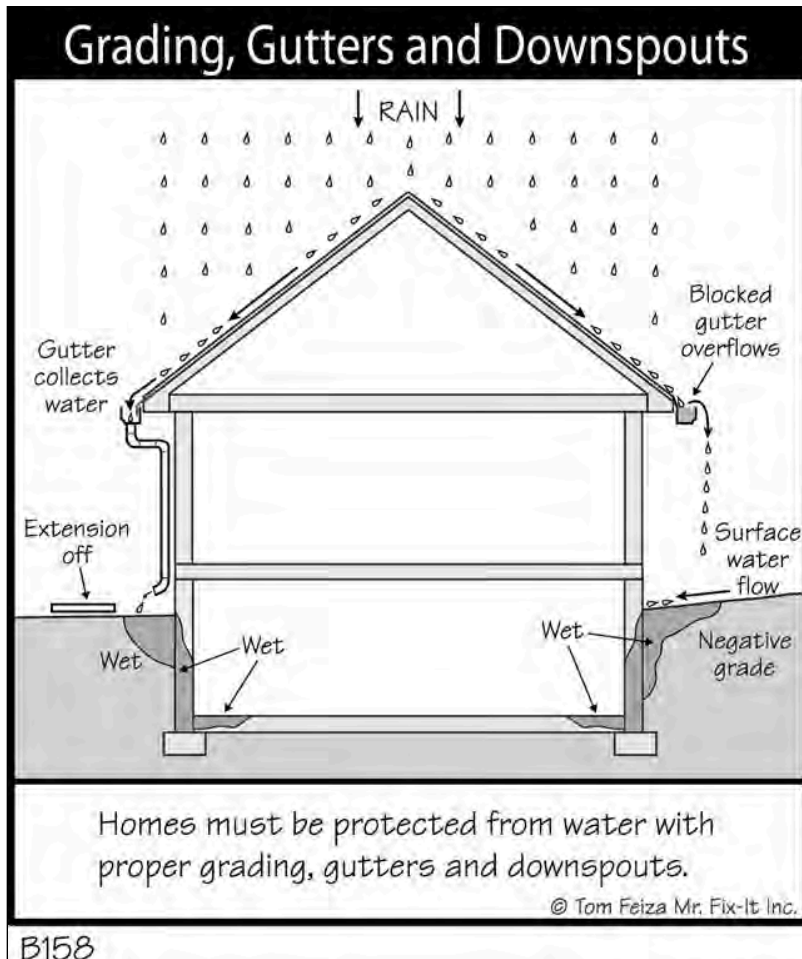
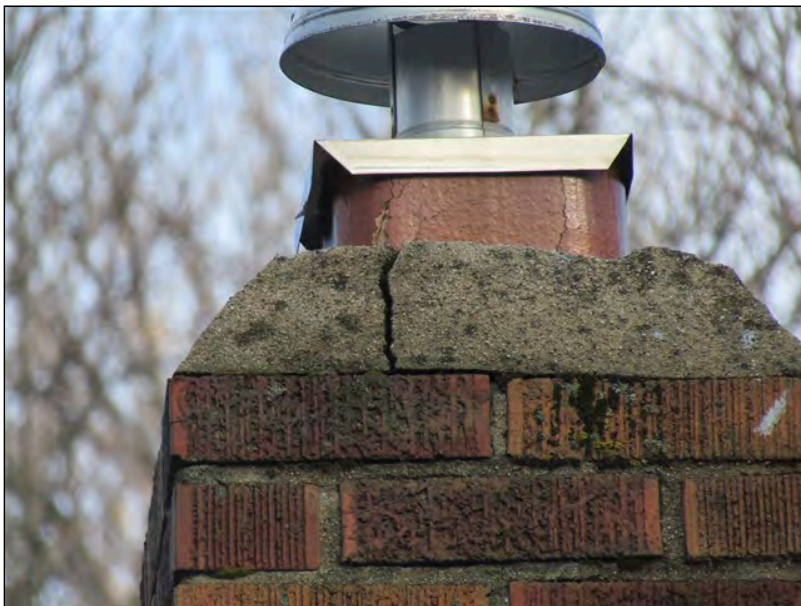
1.4 Defect: Concrete crown and flue were cracked. Mortar at the base of the chimney in the basement has turned into a powder.

Structural integrity of chimney is compromised.

Recommend further evaluation and repair as necessary by qualified chimney contractor.

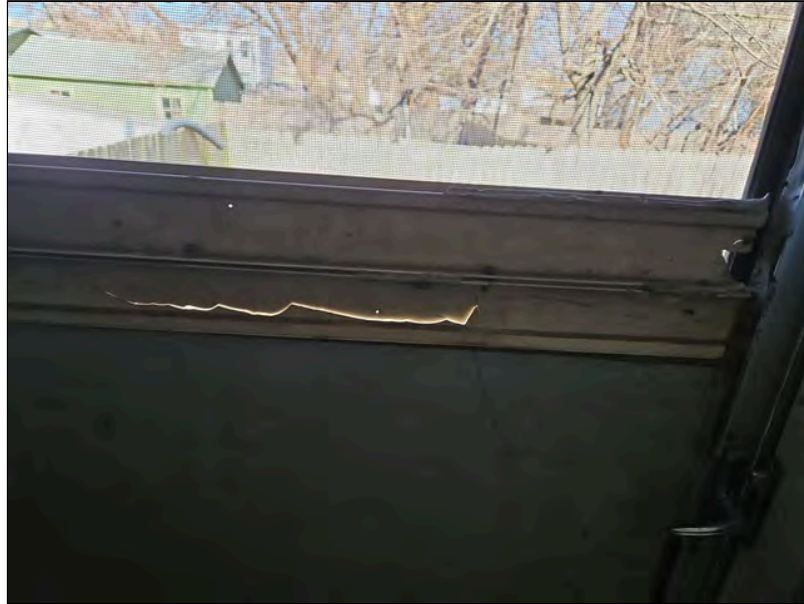
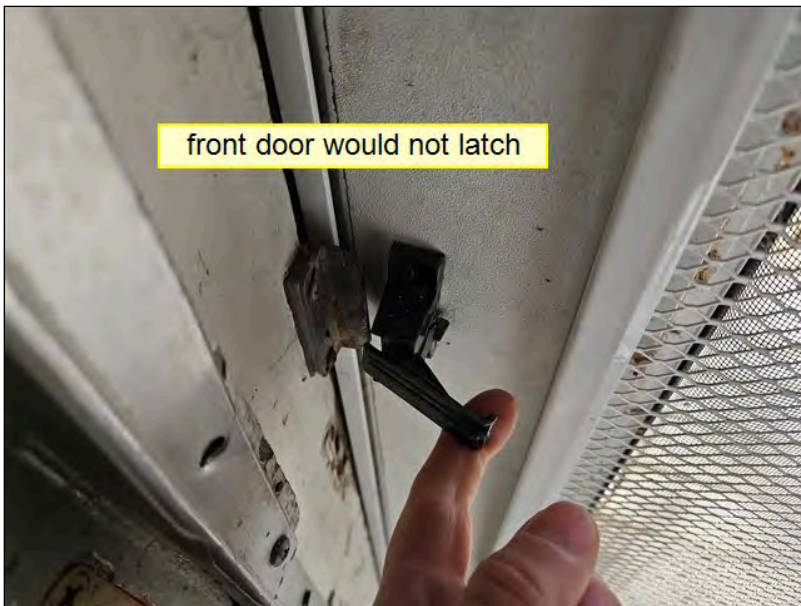
2.2 Repair: Both storm doors were damaged.

Recommend further evaluation and repair as necessary by a qualified contractor.

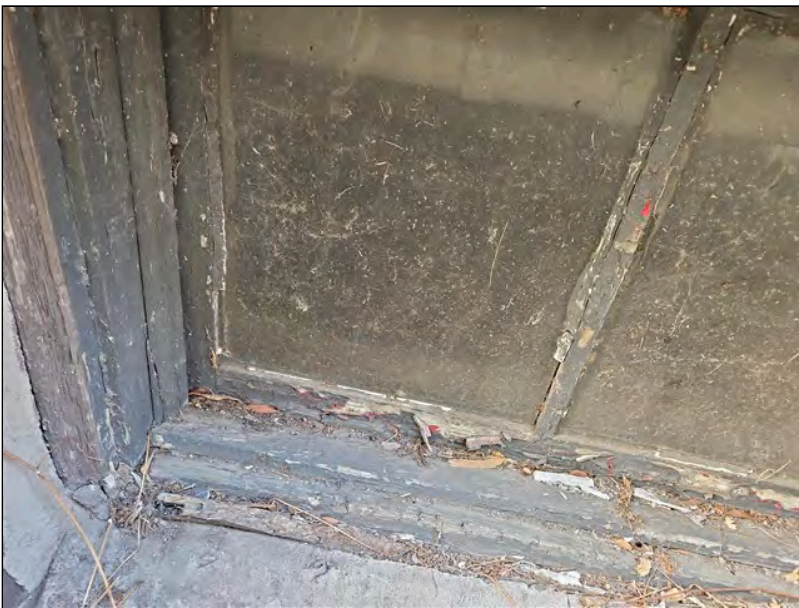
2.3 (2) Repair: Basement window frames were deteriorated. Their deterioration will result in moisture intrusion into the basement.

Recommend further evaluation and repair as necessary by a qualified contractor.

Given the age of the home, it is possible for lead paint to be present. Recommend testing and taking appropriate safety protocols as necessary.

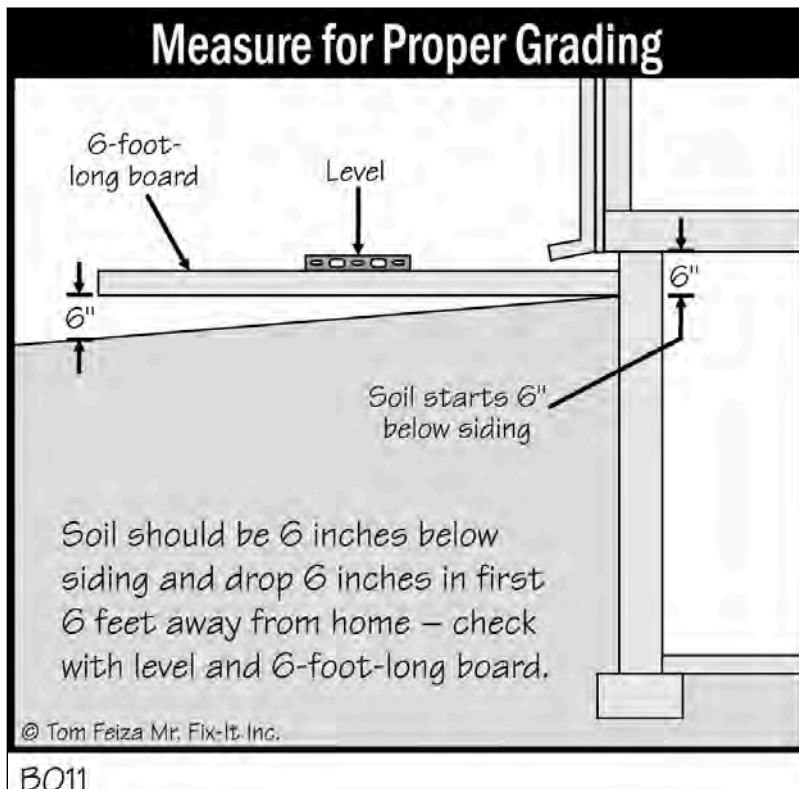
2.6 Repair: The landscaping was insufficiently sloped away from the home in multiple locations. This can cause excessively high levels of moisture at the foundation and cause damage to the foundation and moisture intrusion into the basement. Recommend correcting landscape to drain water away from home.

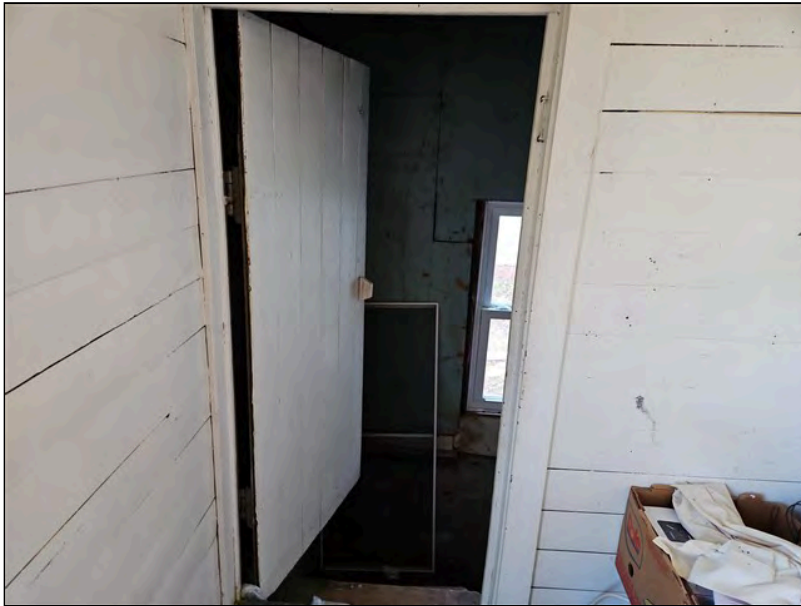
3.2 (2) Defect: A door opens over stairs without a landing being present. This is a fall hazard.

Recommend further evaluation and repair by a qualified contractor.

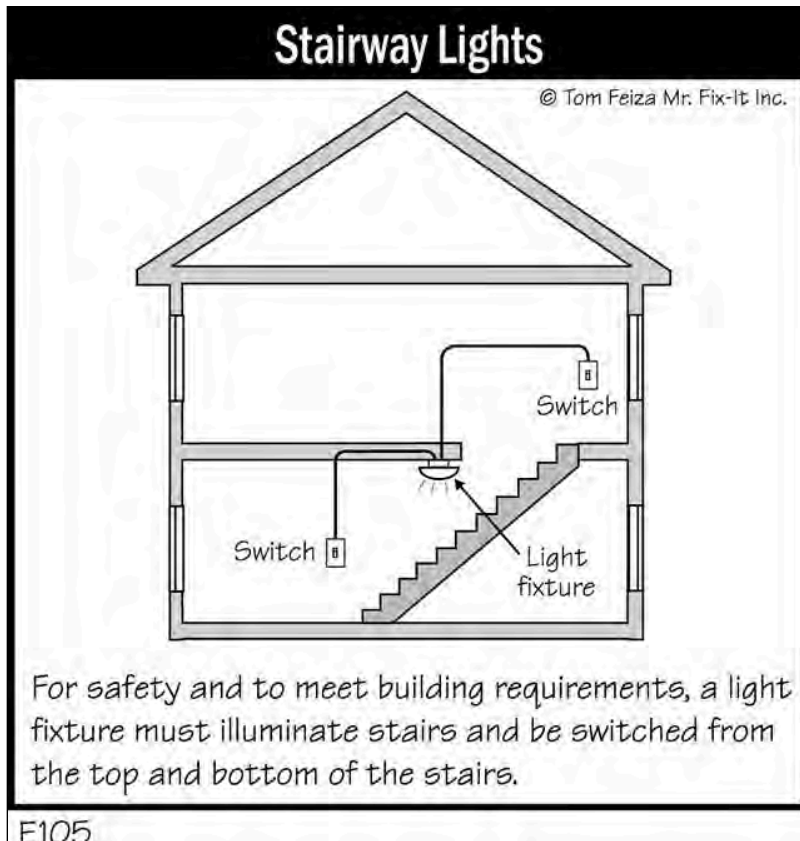
3.2 (3) Defect: There were no switches at the bottom and top of the stairs that would have turned on the light in the stairs to the basement - if there was a light bulb.

Recommend further evaluation and repair as necessary by a licensed electrician.

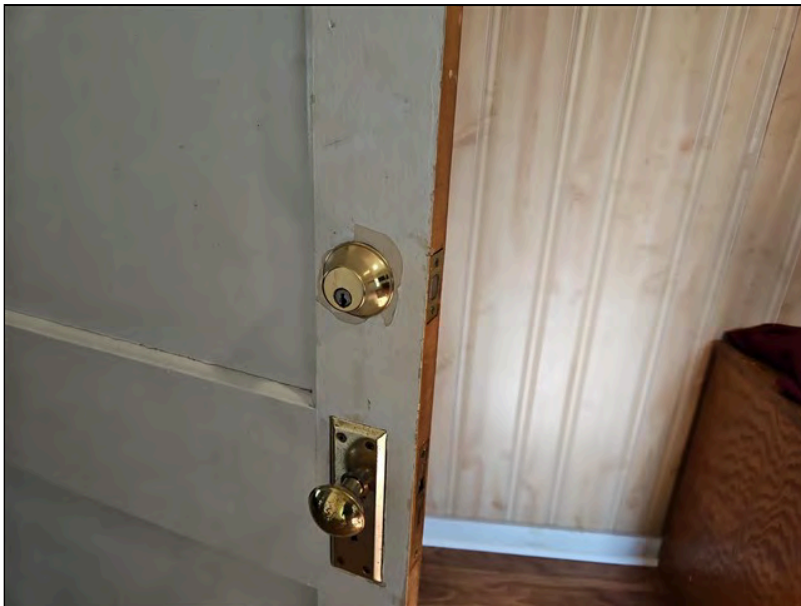
3.3 Defect: Bedroom doors could be locked using a deadbolt. The exterior of the doors could only be opened with a key. This is a potential safety hazard.

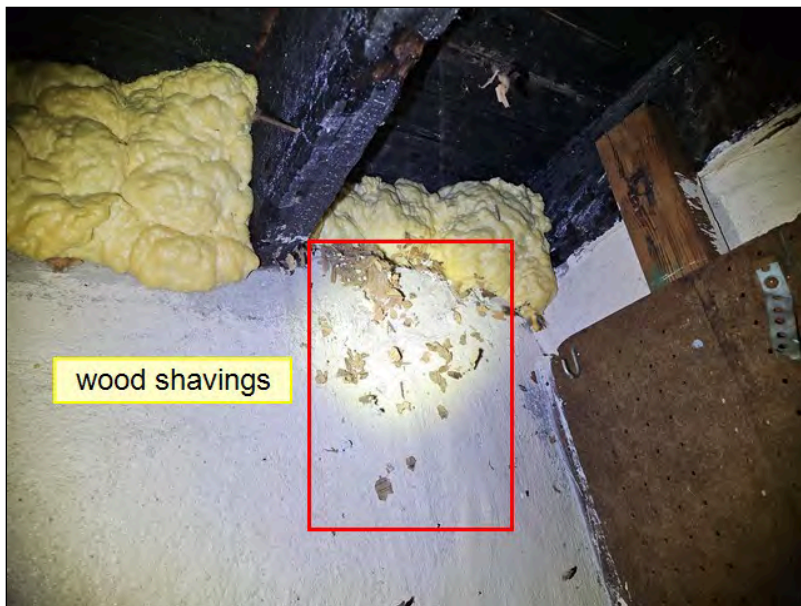
3.6 (1) Further Evaluation: Evidence of potential vermin/insect activity was present in the basement.

Recommend further evaluation by a qualified professional.

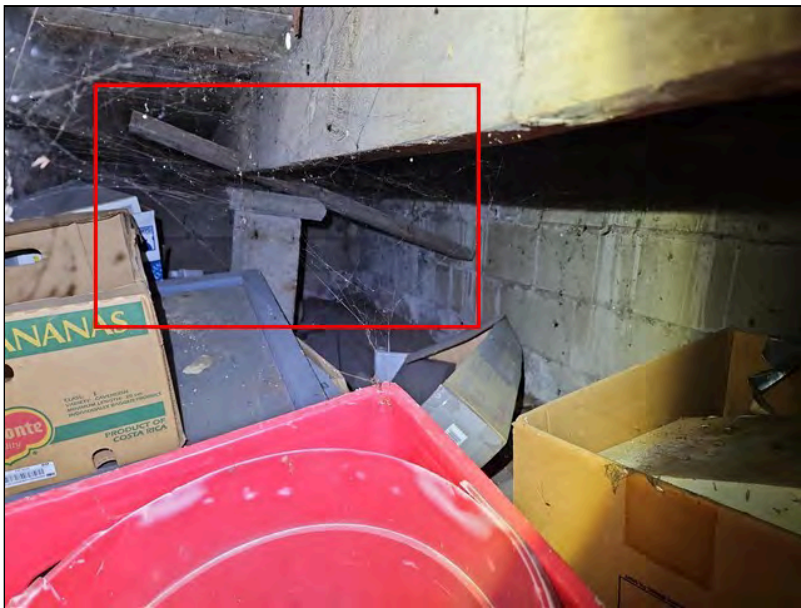
4.2 Defect: Columns were not constructed in a manner or in a condition to adequately support the floor structure.

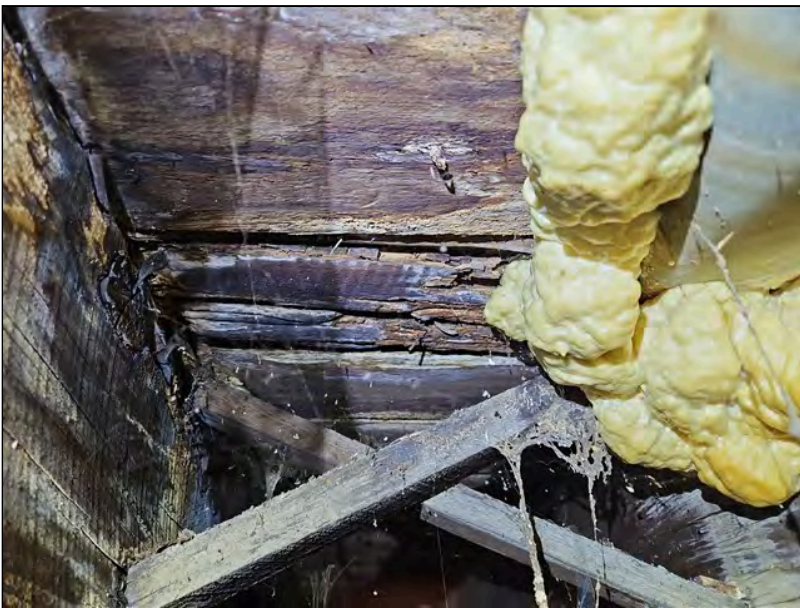
4.3 Defect: Joist(s) were altered in a manner that impact their structural integrity. Main beam was resting on chimney corbels - cracks were present. Please see note 1.4 about the condition of the bottom of the chimney. Subfloor was deteriorated.

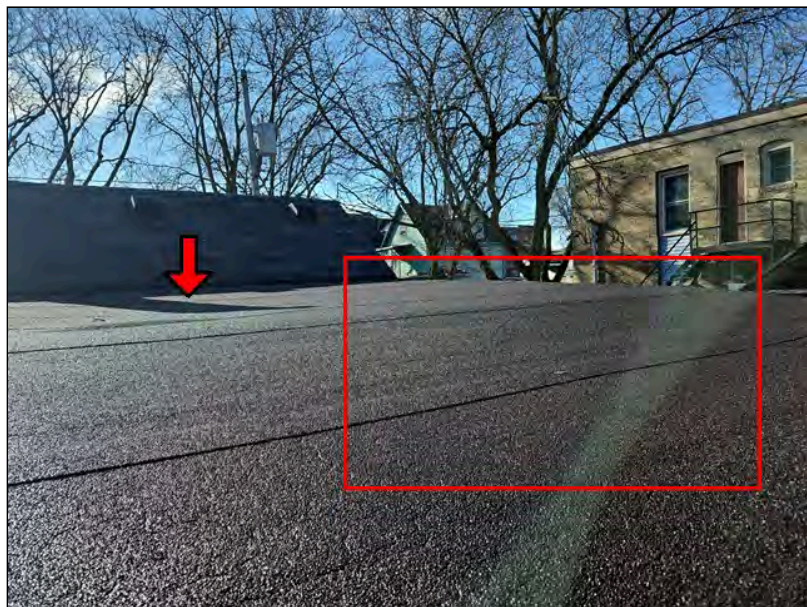
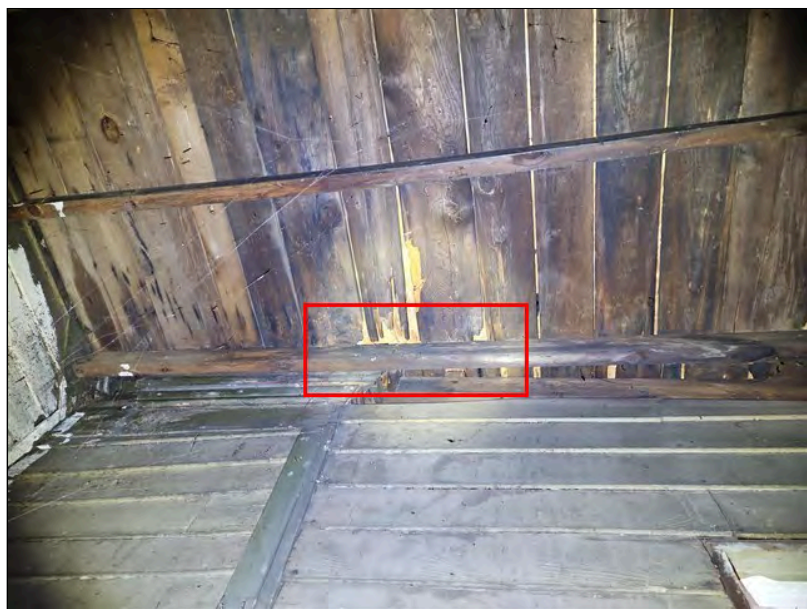
4.4 (1) Defect: Roof decking was wavy and depressions were present. Above the stairs to the basement, the wood planks were deteriorated and the OSB did not appear to be resting on the rafters.

Recommend further evaluation and repair as necessary by a qualified professional.

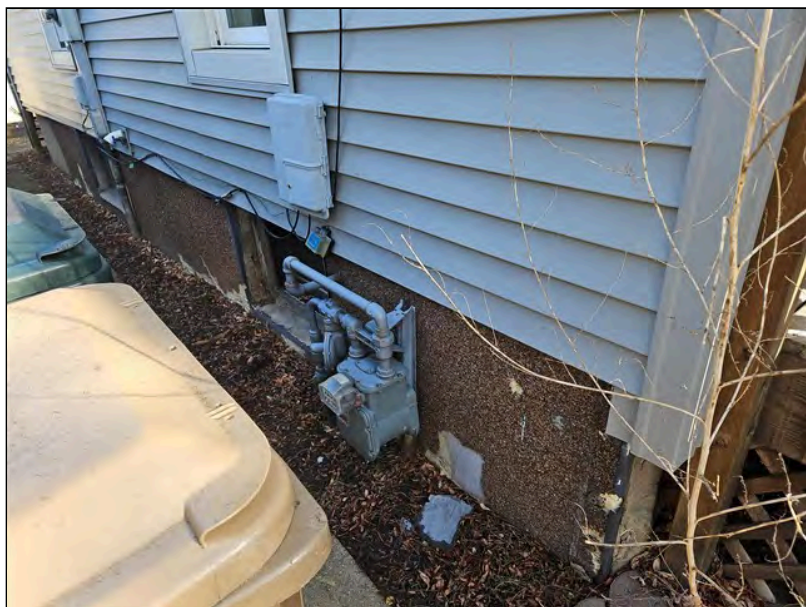
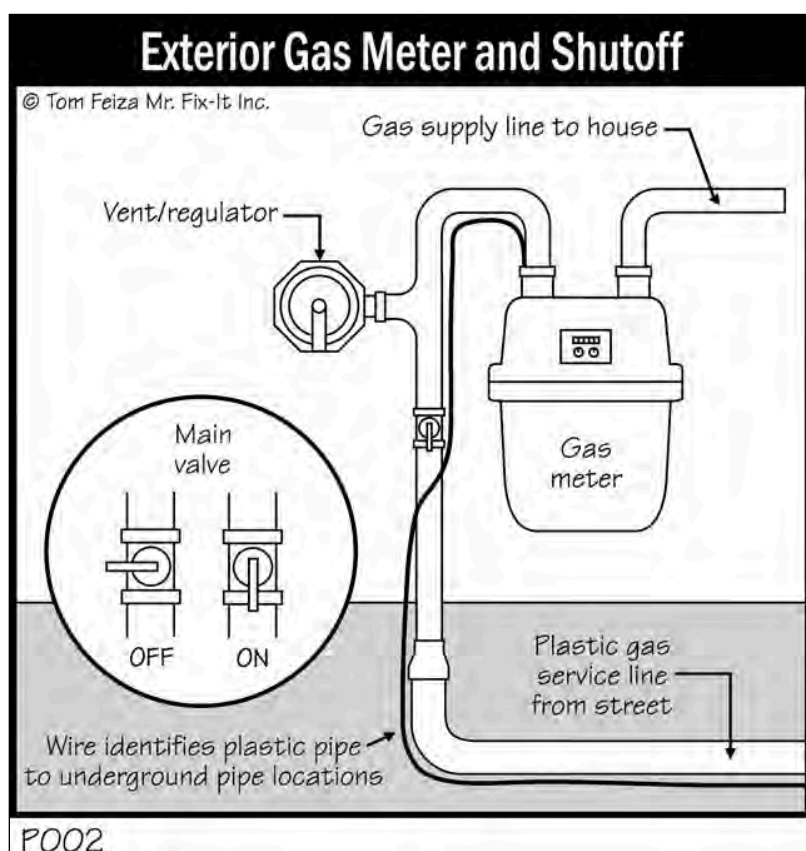
5.5 (1) Defect: CSST is a flexible fuel line. When installed inside or attached to a building it should be bonded to the electrical grounding system of the building. This is to help mitigate the potential of an electrical surge from forming holes in the CSST resulting in the leaking of fuel.

Bonding is attaching a conductor between the rigid fuel line before its connection to the CSST and the home's electrical grounding system.

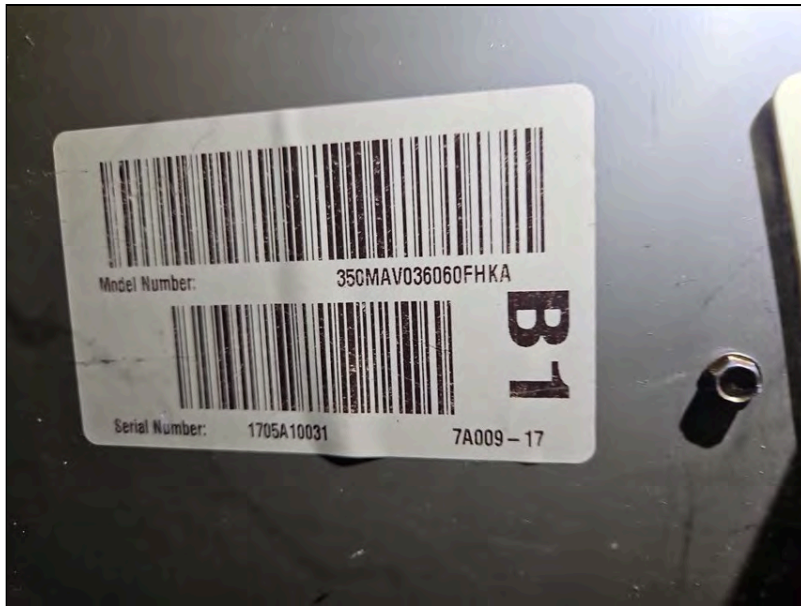
7.0 (2) Maintenance/Further Evaluation: No records were available to indicate that the heating system had a service/maintenance/safety check visit by a licensed HVAC professional in the last 12 months.
