2412 Waunona Way, WI – Condition Assessment 11/11/2022

Prepared by Lindsey Shotwell, AIA

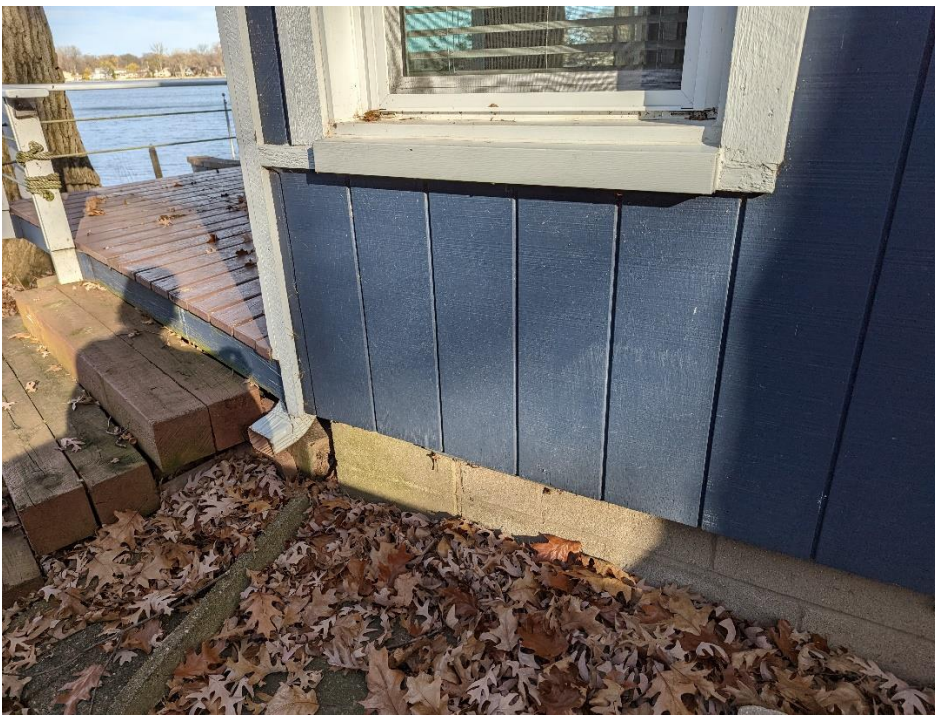
Foundation – The foundation of the building has significant settling and is contributing to floor canting and roof sagging. There is dampness at the crawl space.

Deck & Enclosed Screen Porch – A previous screen porch has been enclosed on the lake side of the home with under insulated roof. Deck is deteriorating and structure is sagging.

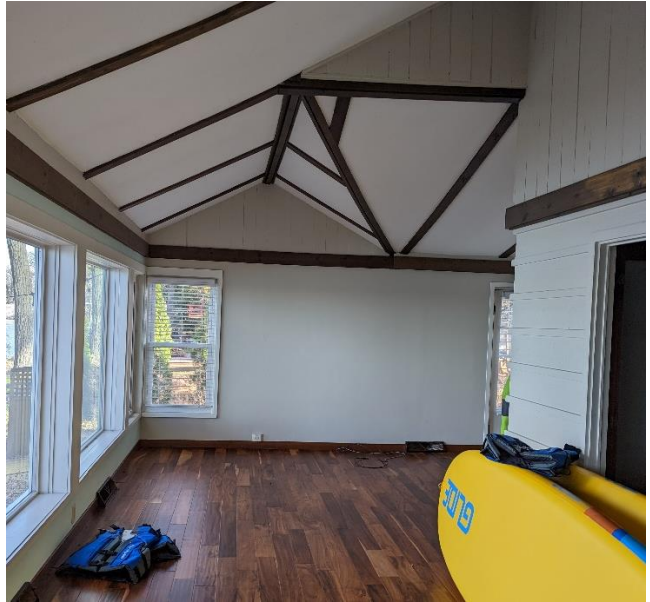
Main Level Kitchen & Living – Enclosed screen porch with poor thermal performance. Canted main level floors due to foundation settling. Laminate flooring at enclosed porch addition.

Images of first floor interior spaces, additions to original building with xtg laminate flooring.

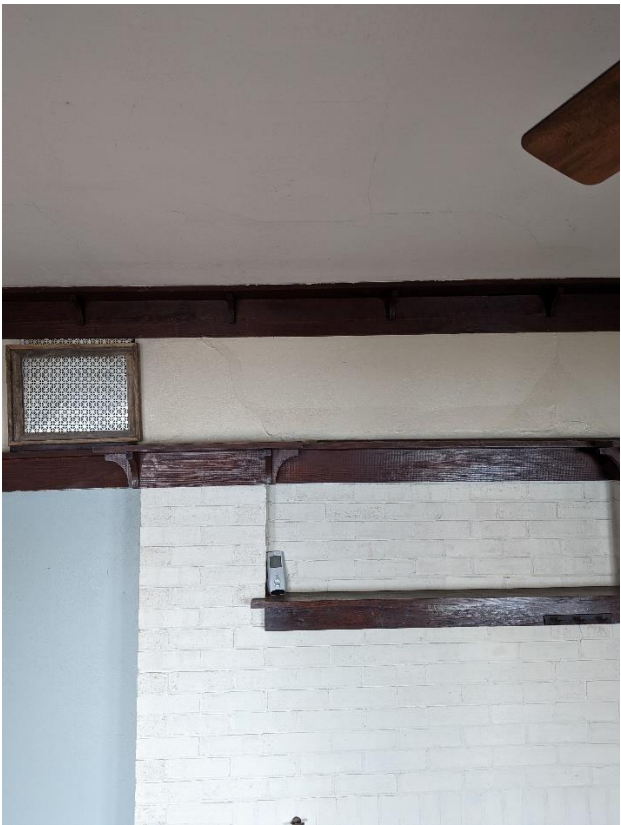
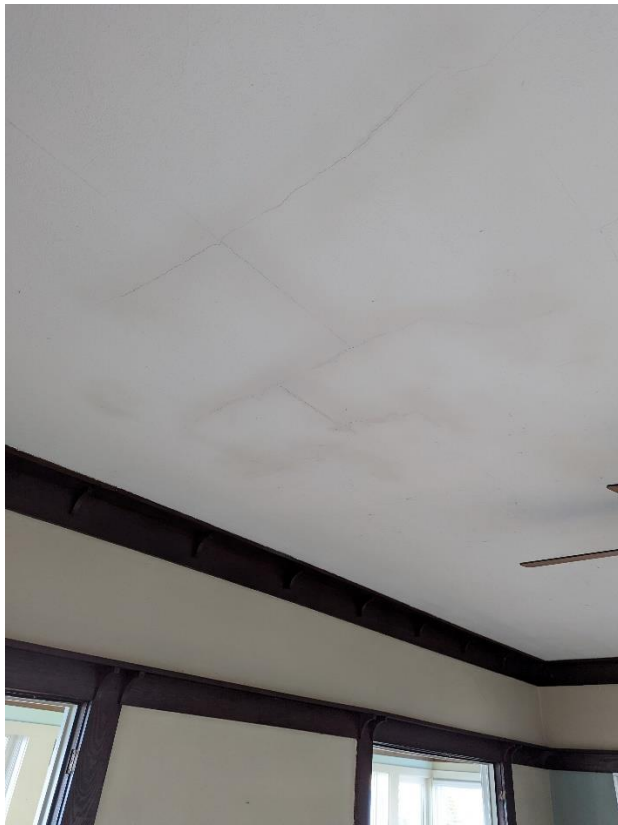
Images of first floor settling and cracking at original building living spaces.

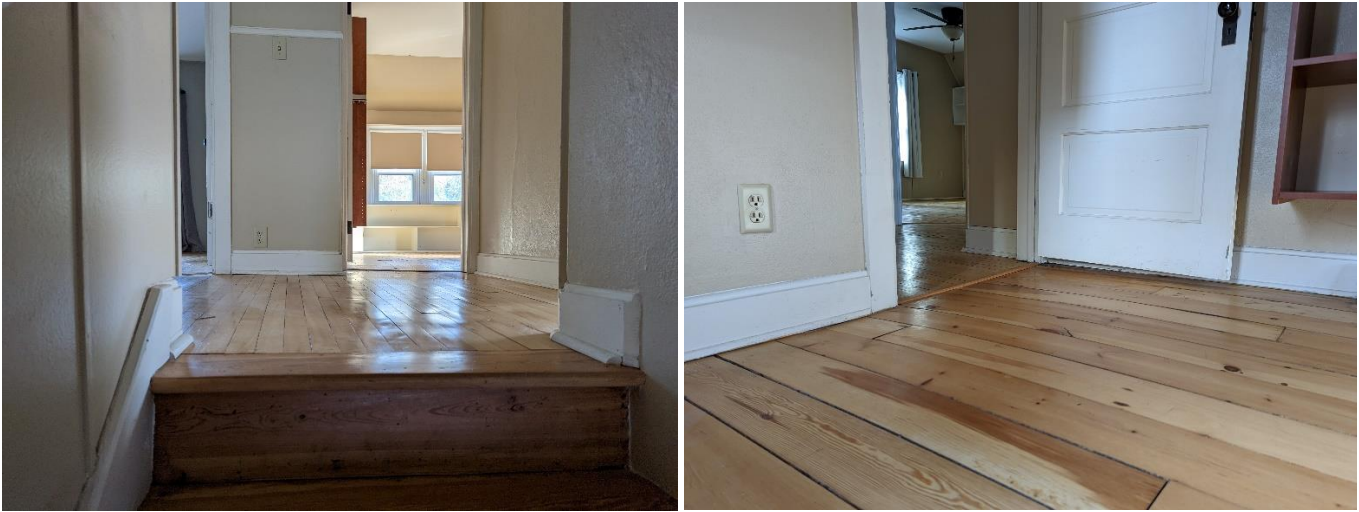
Upper Bedrooms – Undersized floor and roof structure are resulting in uneven and canted floors. Some 2nd floors slope 1-2". Ceilings and roof transitions display poor roof structure performance. Cracking and settling at roof transitions.

Images of upper level canted floors and uneven structure settling.

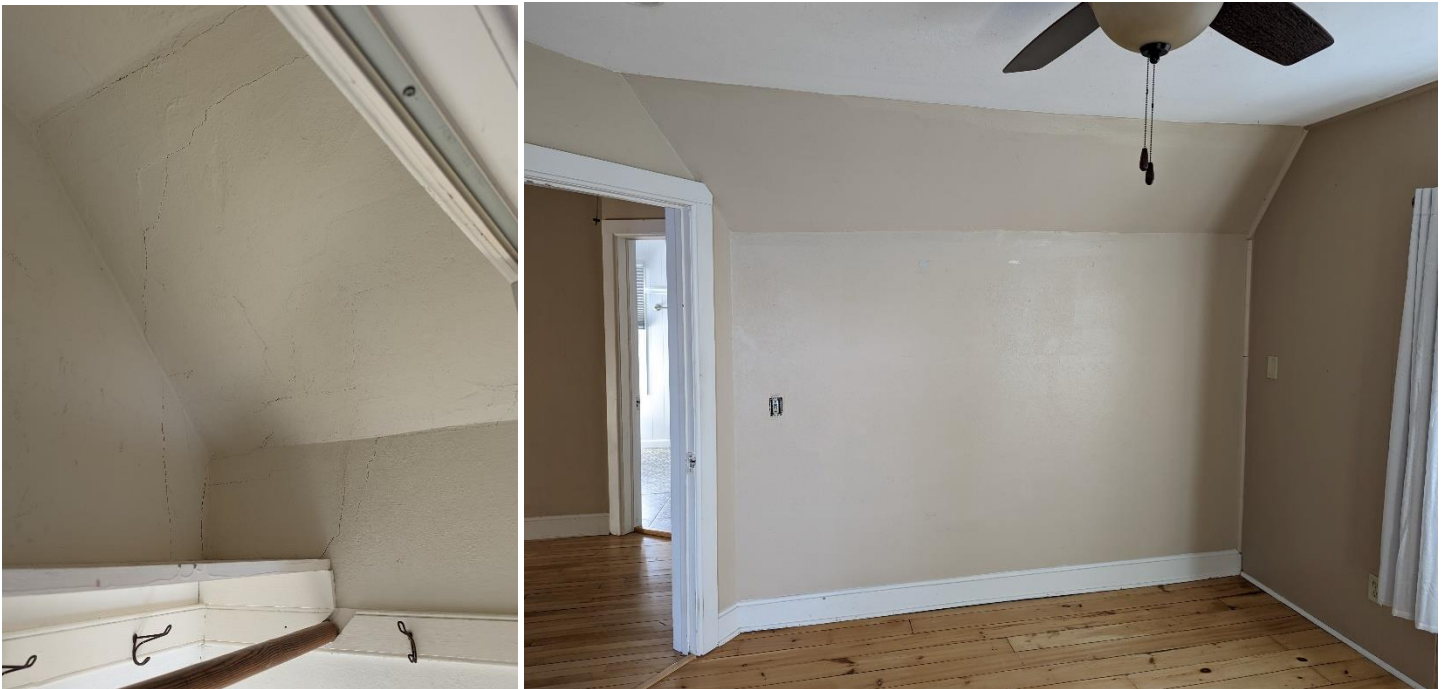
Images of upper level plaster cracking and roof structure deformation.
