**RAILROAD ARCH CULVERT  
PRELIMINARY ASSESSMENT  
GLENWOOD CHILDREN'S PARK  
MADISON, WISCONSIN**

## Railroad Arch Culvert Preliminary Assessment

## Glenwood Children's Park, Madison, WI

June 5, 2018

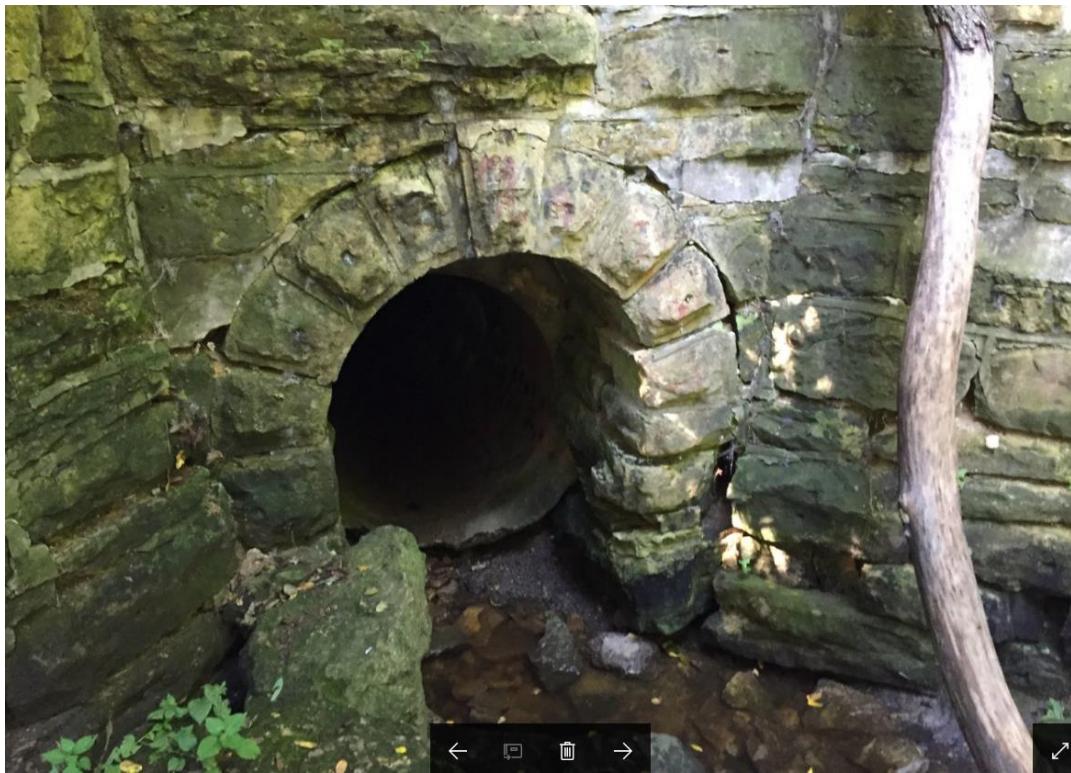
Existing Limestone Railroad Arch Summer 2017

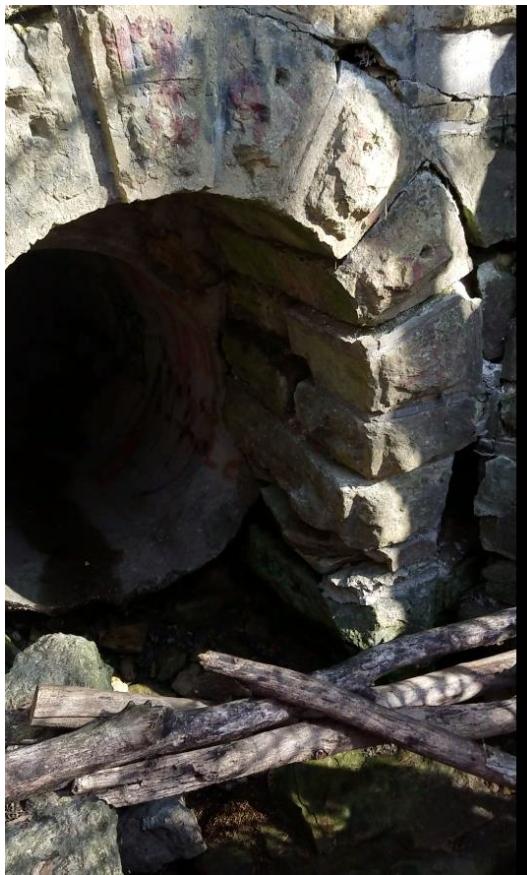
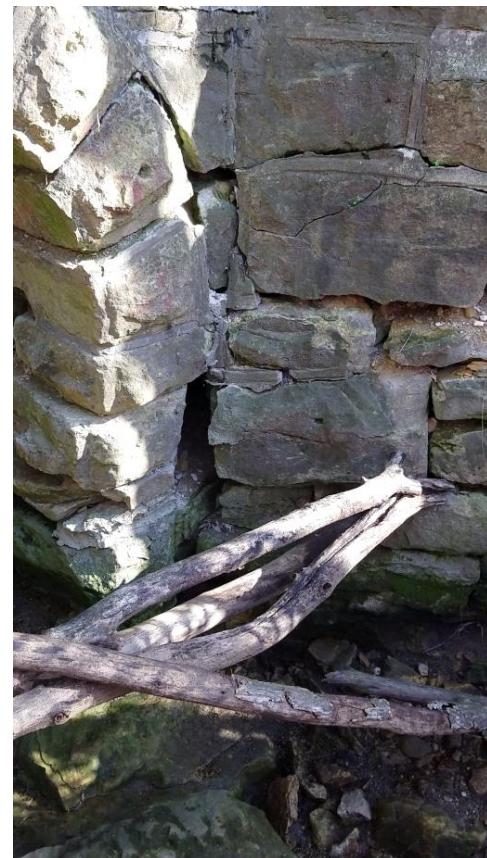
Existing Limestone Railroad Arch Spring 2018

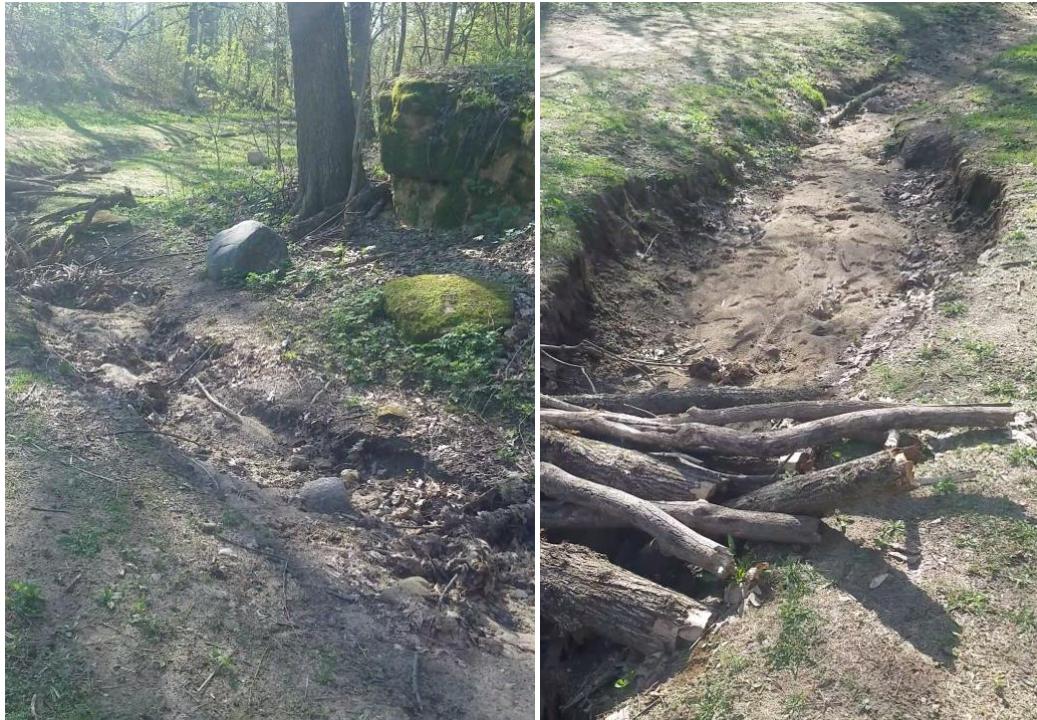
Erosion Downstream of Existing Inlet

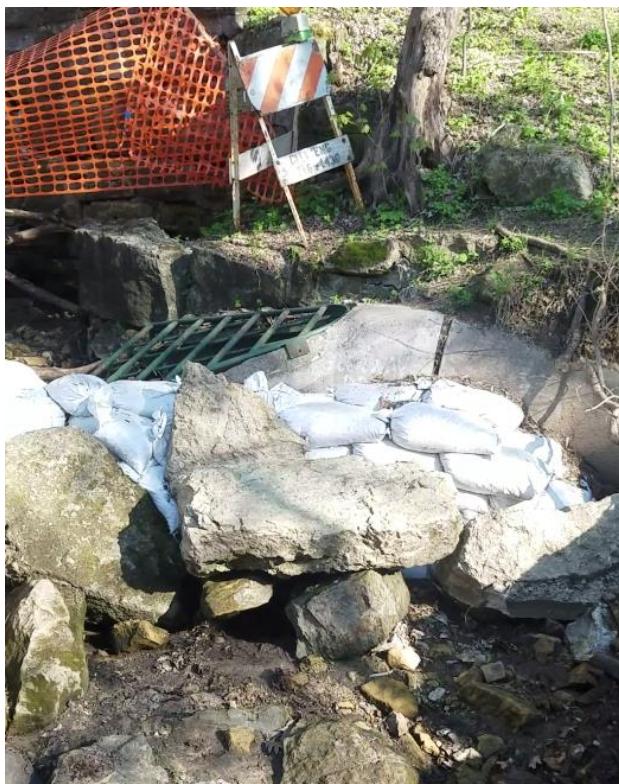
Erosion at the upstream storm sewer caused by failure of the diversion wall

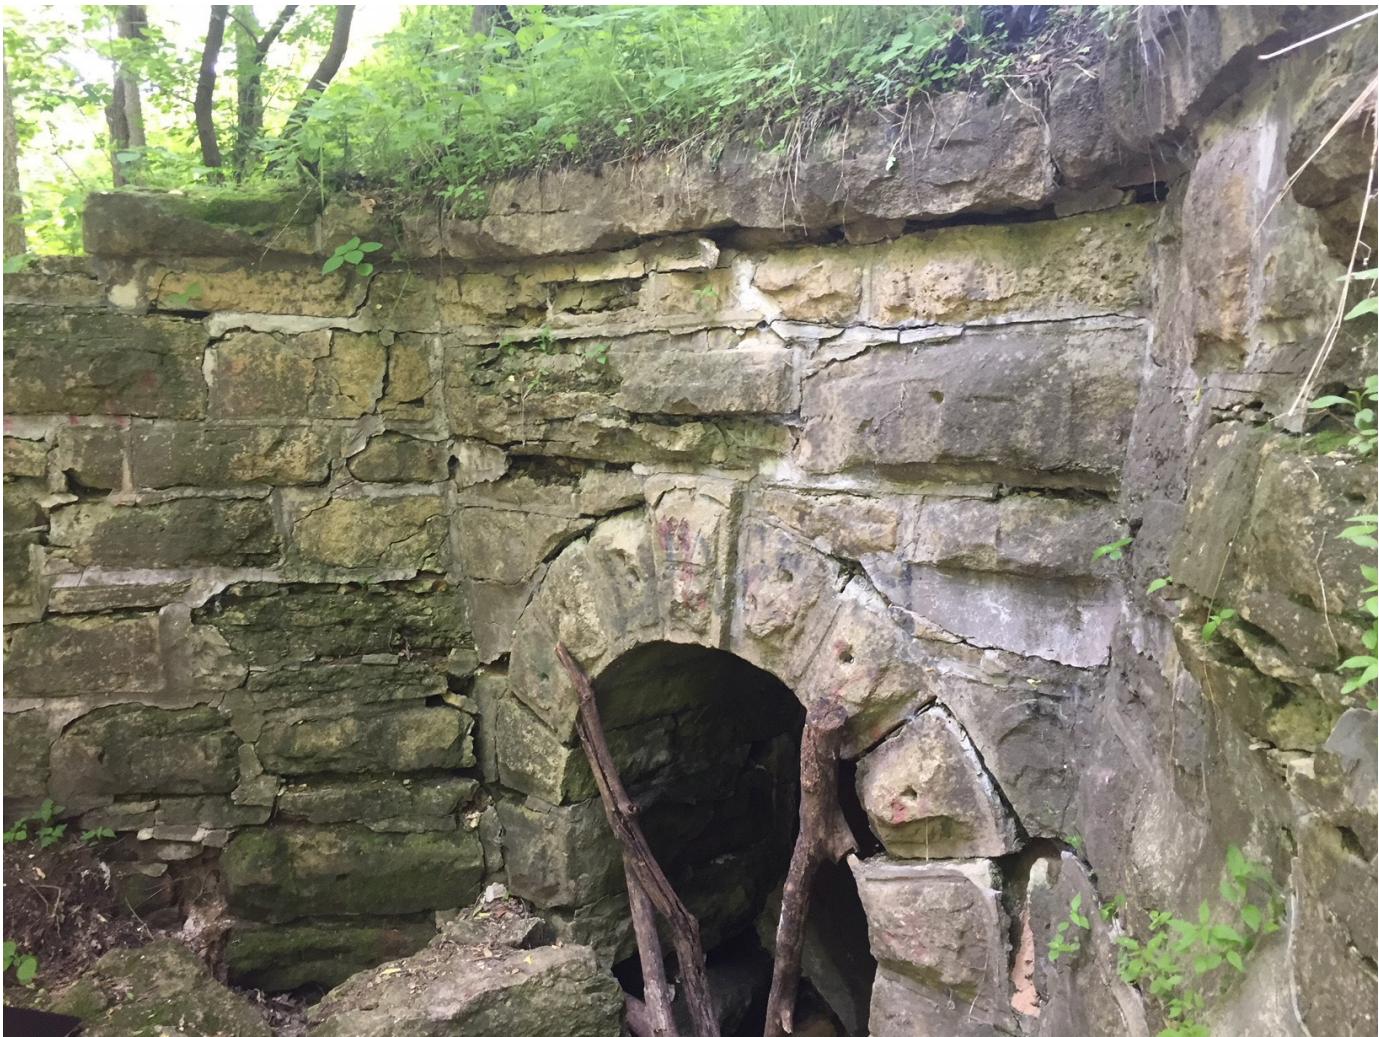
Figure 1: Height of arch and overburden above.

Height varies maximum ~8-9'

Central arch wall width varies: ~ 7' at base, ~13' at top

Wing-walls (splay backwards going up) at base: ~15' w.

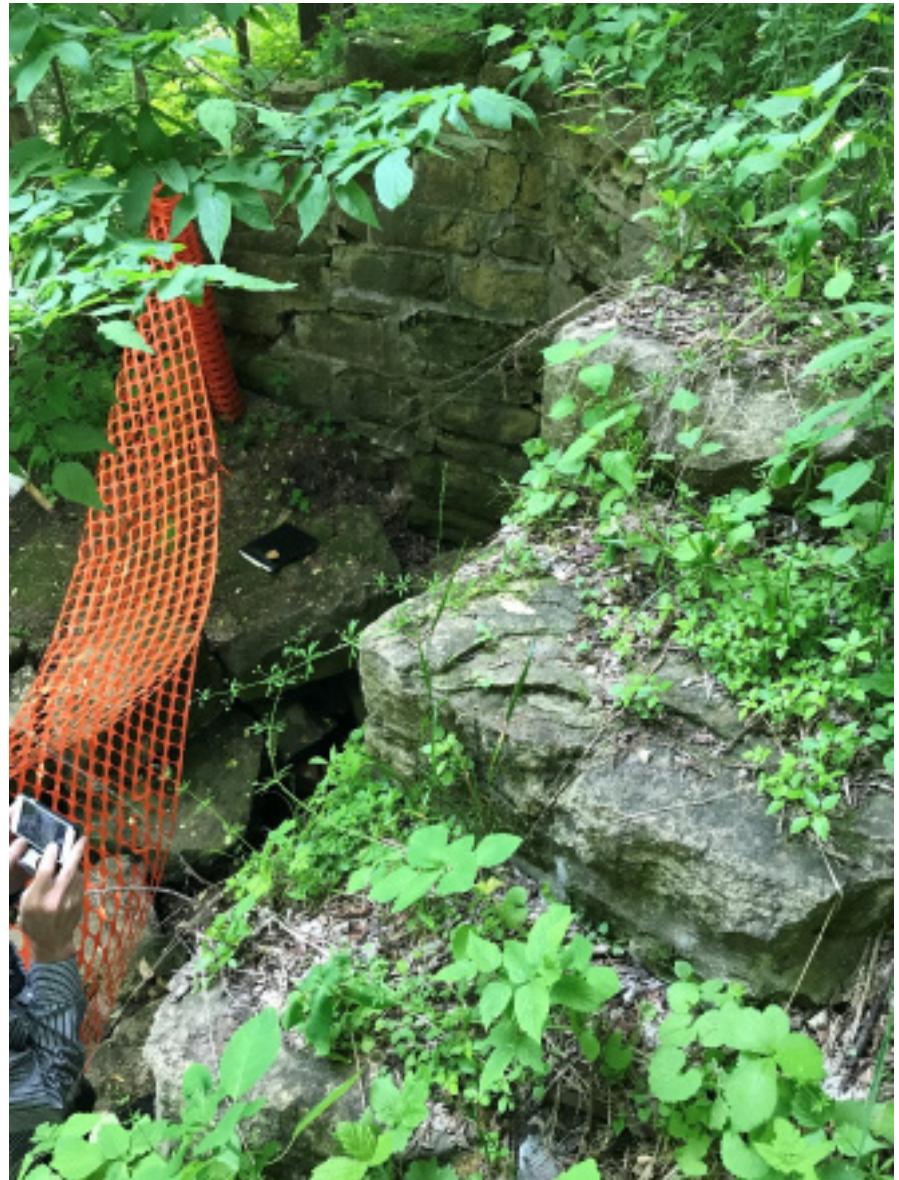
*Figure 2: View of capstones and minimal overburden above the wing walls (additional soil over the ventral arch wall.)*

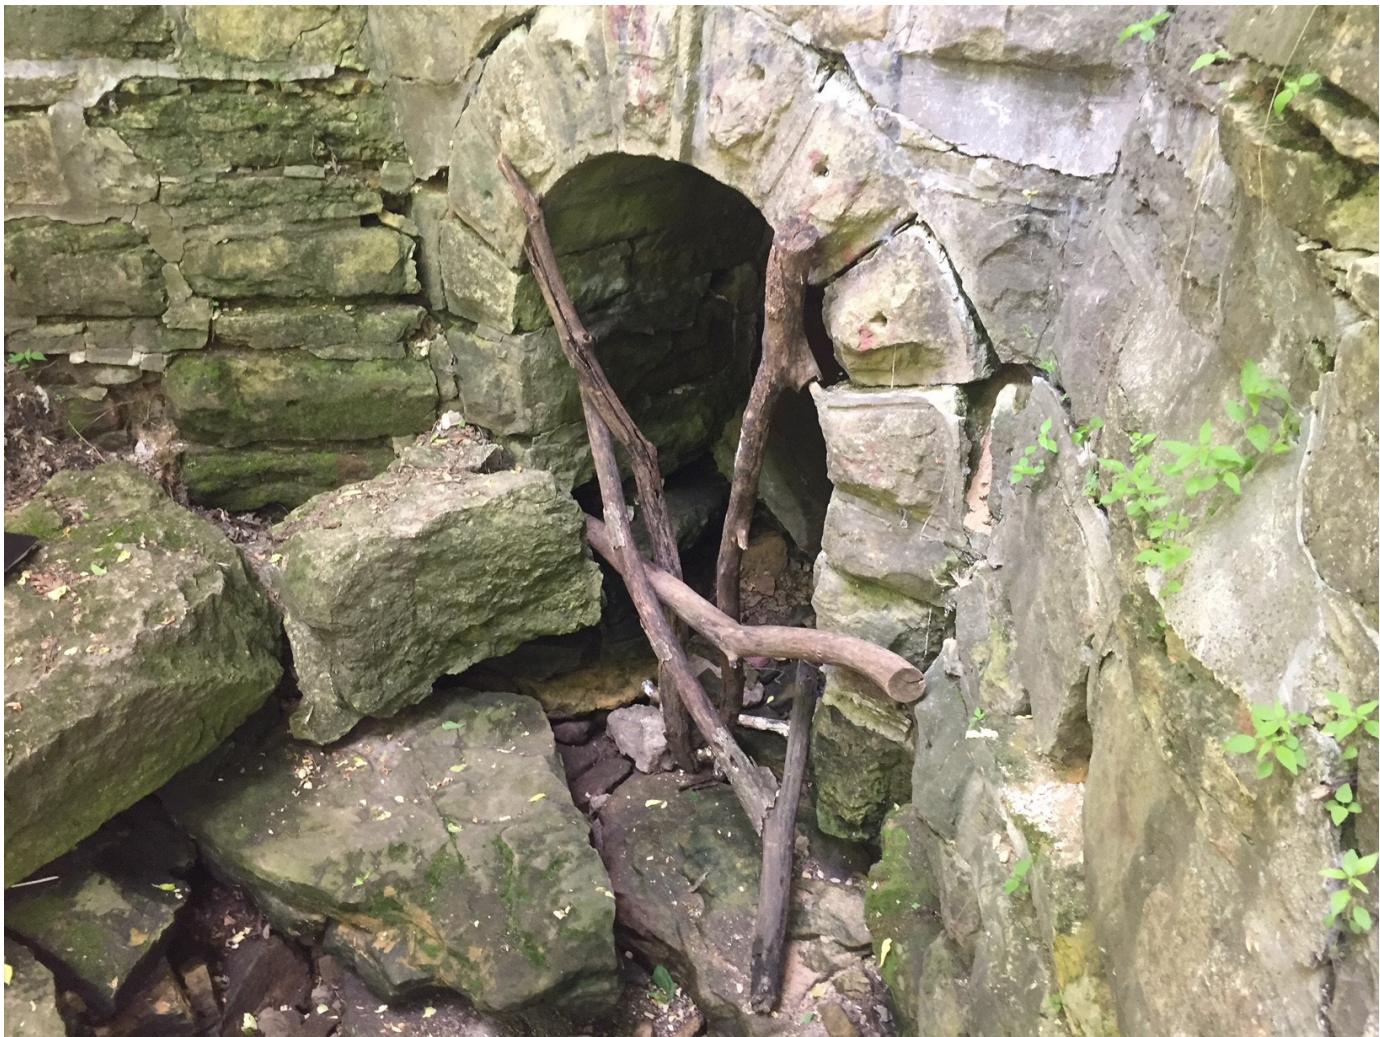
The general assessment is that the arch is deteriorating rapidly but is not in danger of eminent collapse.

Figure 3: Overall view of arch.

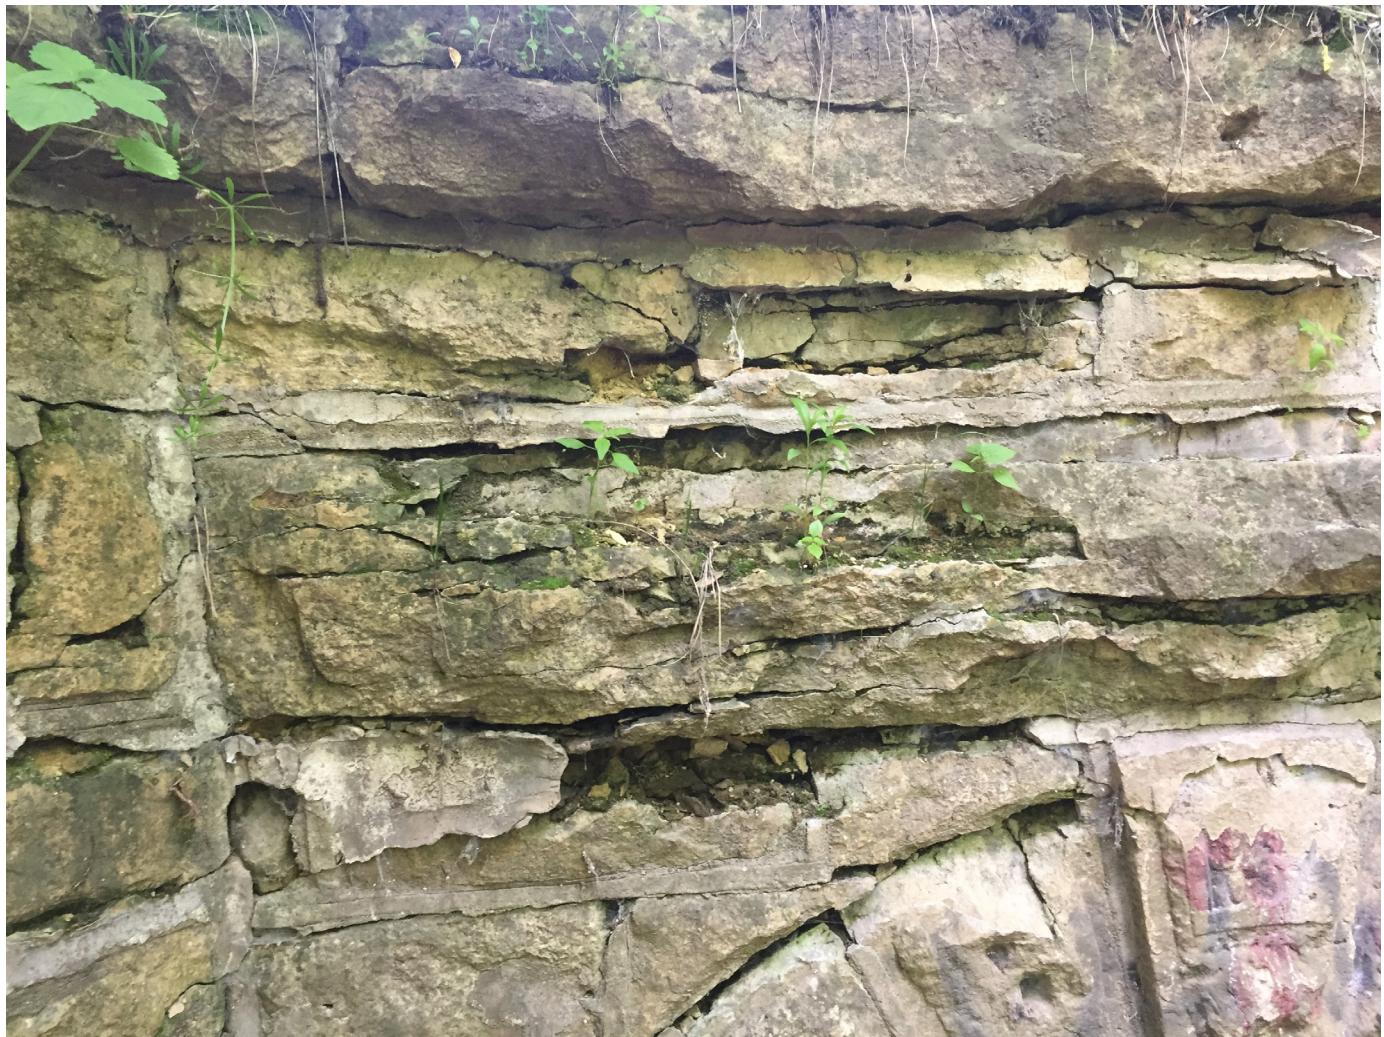
The settling and degradation of the base and surrounding stone is causing misalignment of the inner arch. Many of the surrounding stones are disintegrating so rapidly that only the mortar left suspended in space outlines where the stone head and bed faces had been.

Figure 4: General disintegration of stone above the arch.

The conclusion is that the entire masonry structure must be deconstructed and rebuilt in strict accordance with the Secretary of the Interior's Standards for the preservation of the historic elements of the arch and retaining wall. This should occur as soon as funds are available. The stones of the inner arch are in good enough condition to be used as templates to fabricate replacements (as required). The face rustication includes the original lifting holes which add interest and still might be usable in disassembly.

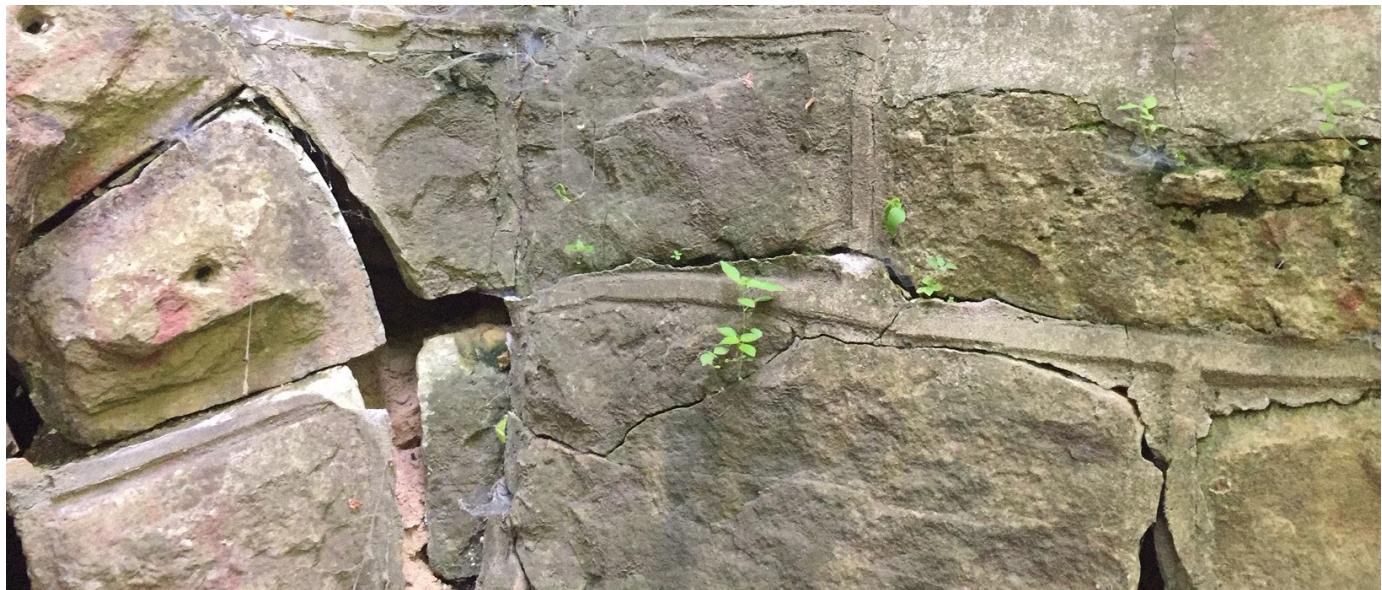
Figure 5: Right side of arch deflection and beginning of collapse.

Immediate Recommended Action: As part of any effort to mitigate stormwater run-off into the park through the culvert terminated with the historic sandstone area, we recommend a temporary stainless steel frame be constructed to hold the existing stone masonry in place. This would allow the stones to continue in their current position until a full restoration can take place. The cost for this work will be from \$10,000 - \$25,000 and will provide the stabilization required for the deferral period.

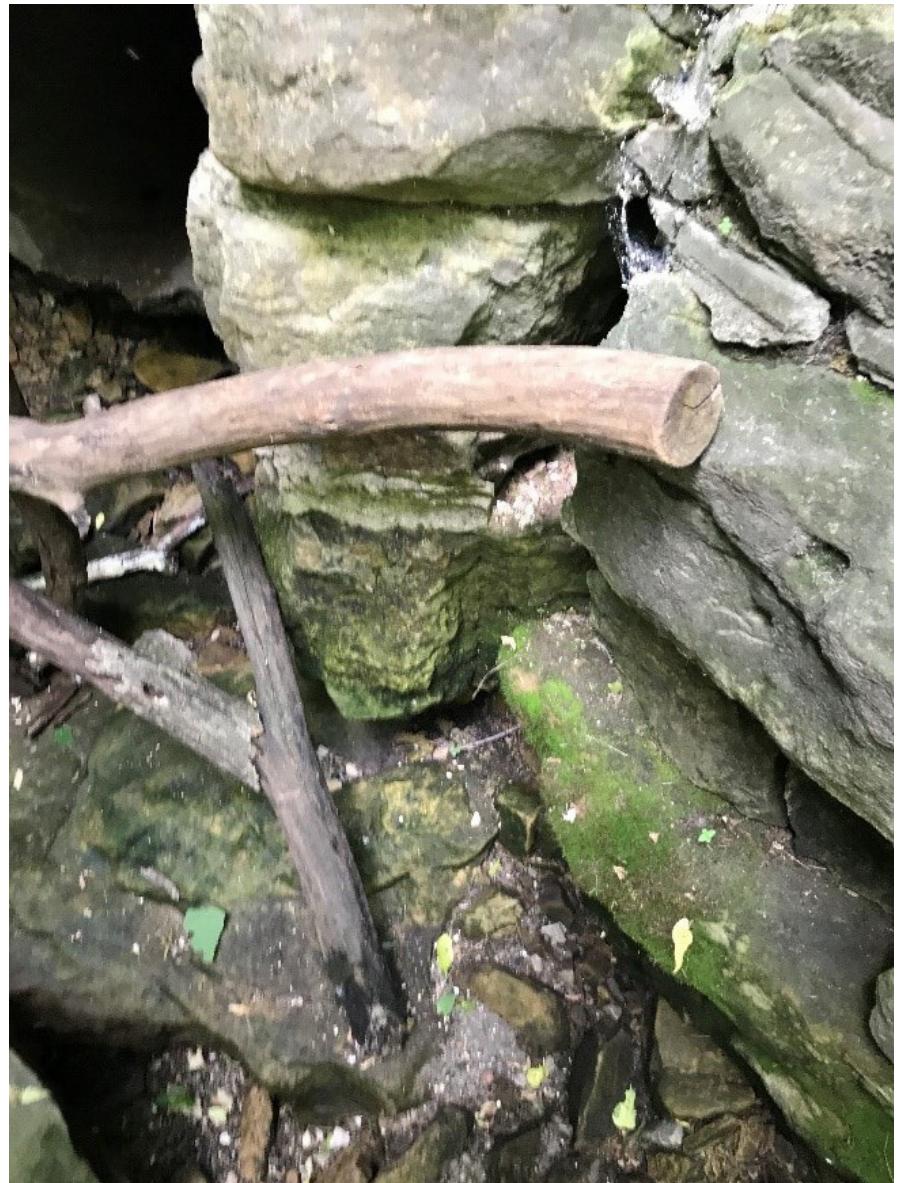
*Figure 6: Arch bearing condition at right.*

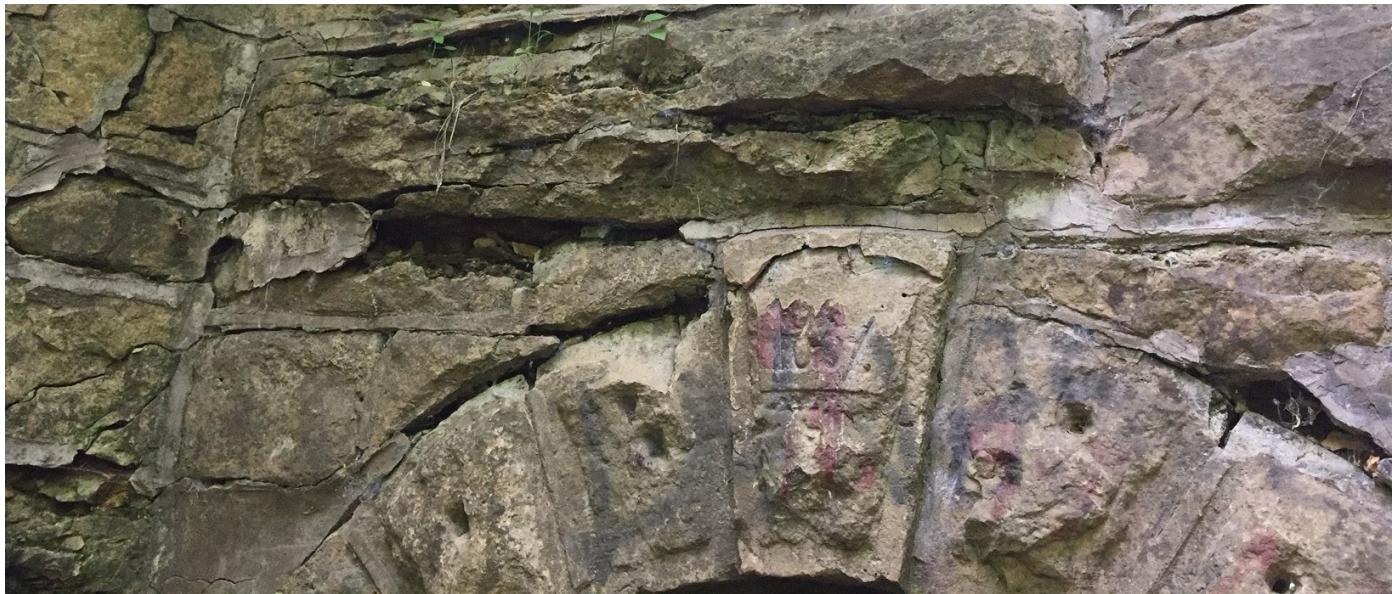
Figure 7: Defaced Keystone needs to be deciphered.

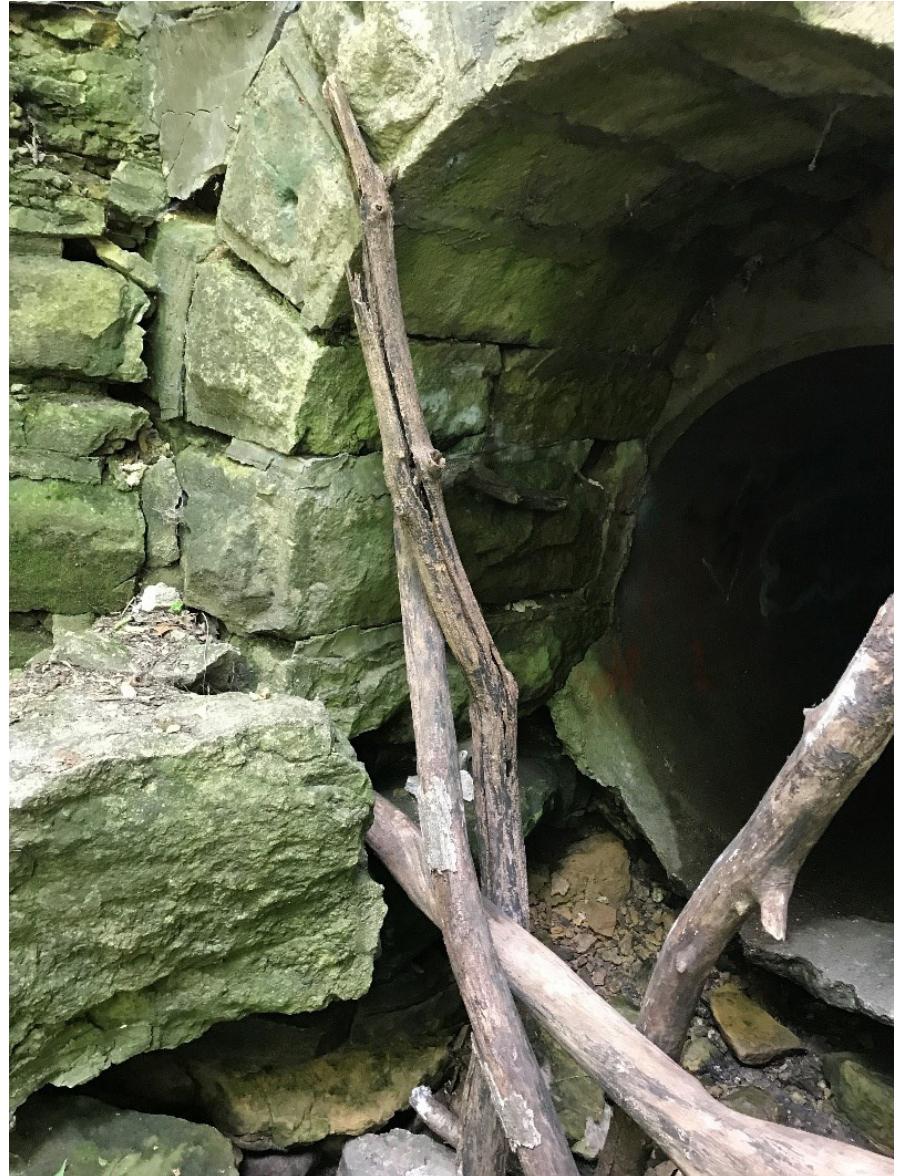
The arch has two primary threats. The failing physical integrity of the weathering sandstone and the undercutting and settling of the base layer of sand, stone and earth.

*Figure 8: Undercutting of the arch at left and 2-3' stone construction depth to the intact concrete culvert that conveys stormwater under the bike path.*

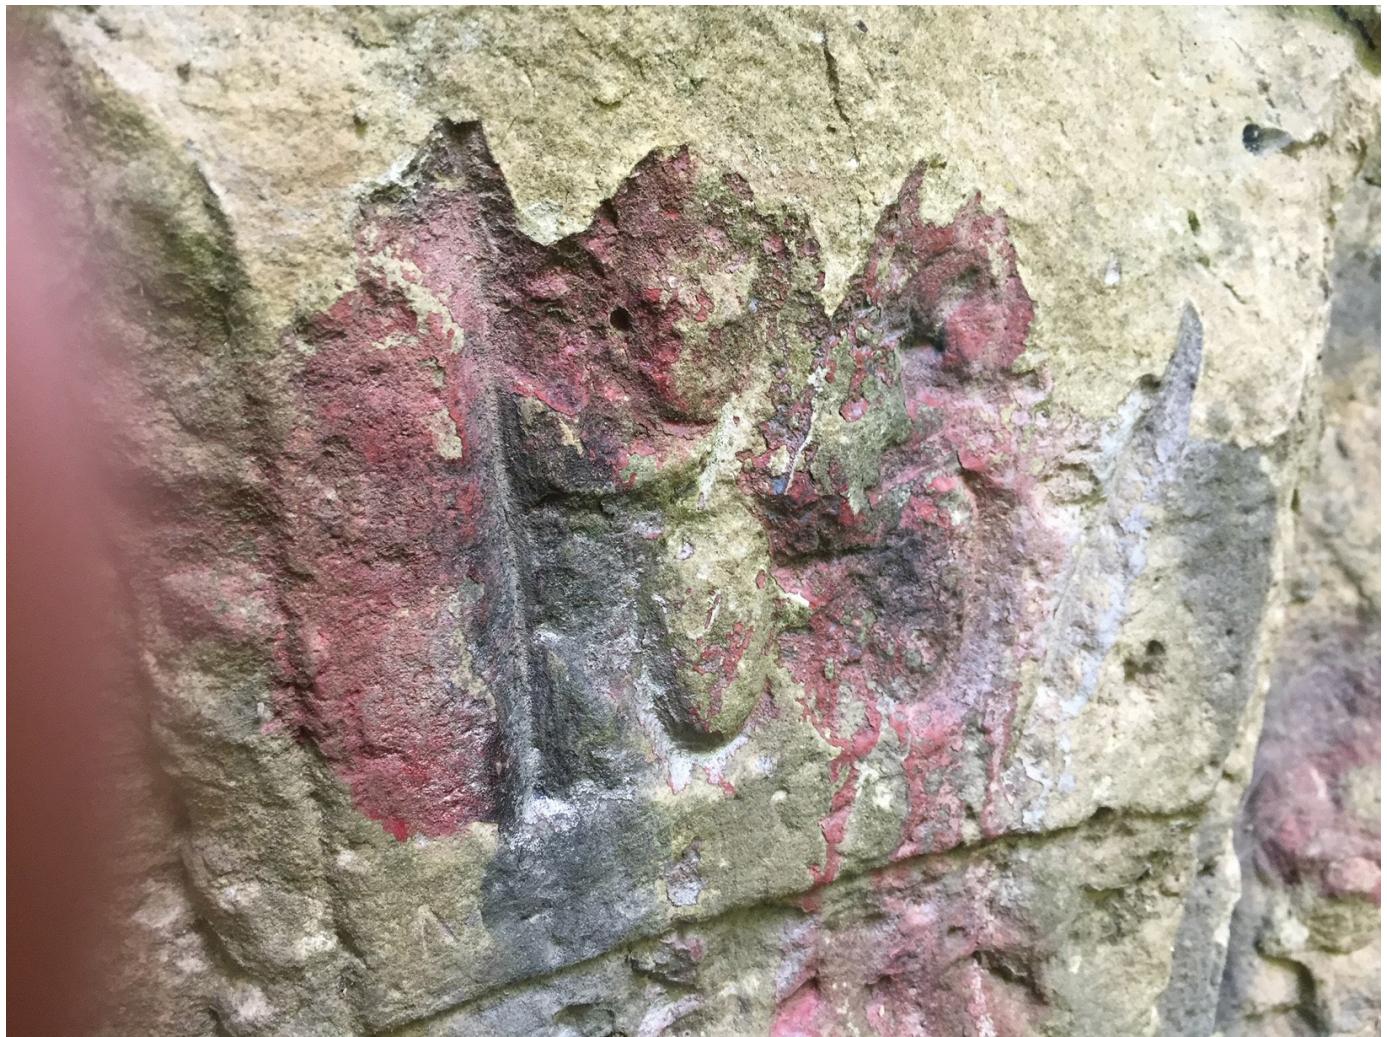
Figure 9: Defaced keystone needs to be deciphered.

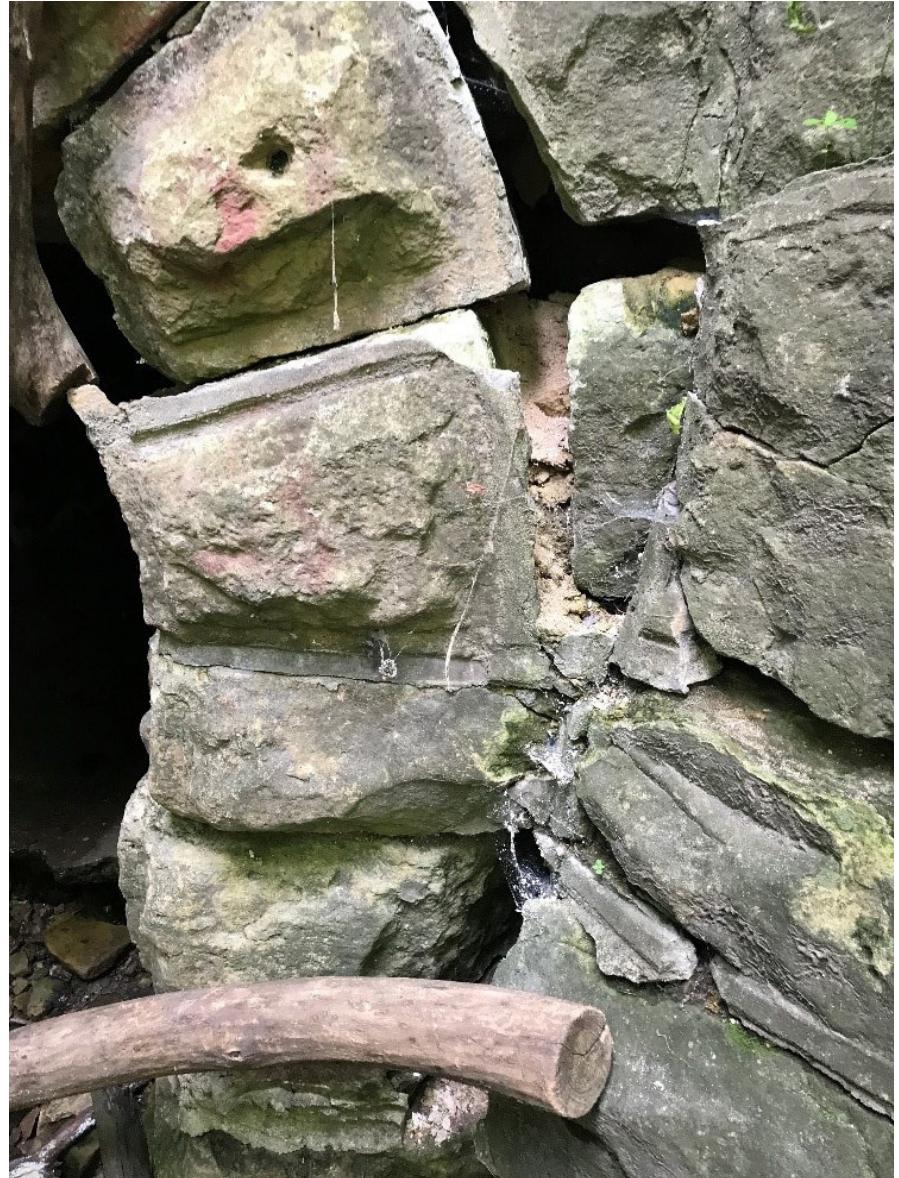
The ashlar blocks of the arch are in better condition than the flanking stones that are in more direct contact with soil and may have been cut from less cohesive sandstone. The consistency of the sandstone varies from easily crumbled to touch to more solid on dryer faces where stone is not perpetually wet.

*Figure 10: Degradation of the sandstone at the wing walls is most advanced at the face.*

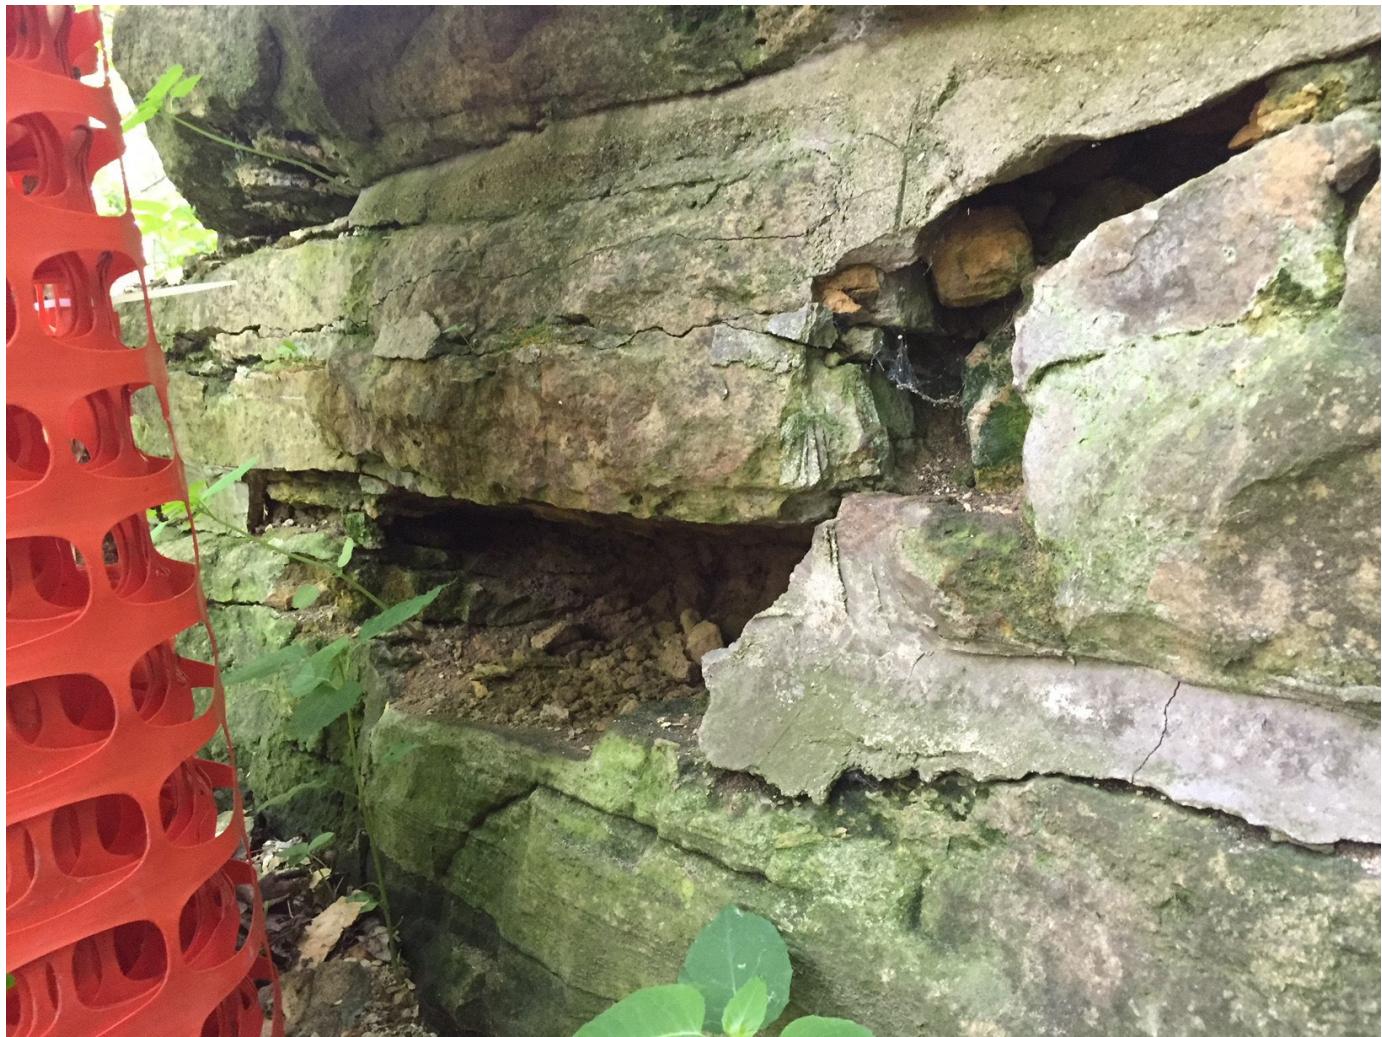
Figure 11: Degradation of the sandstone at the wing walls is most advanced at the face.

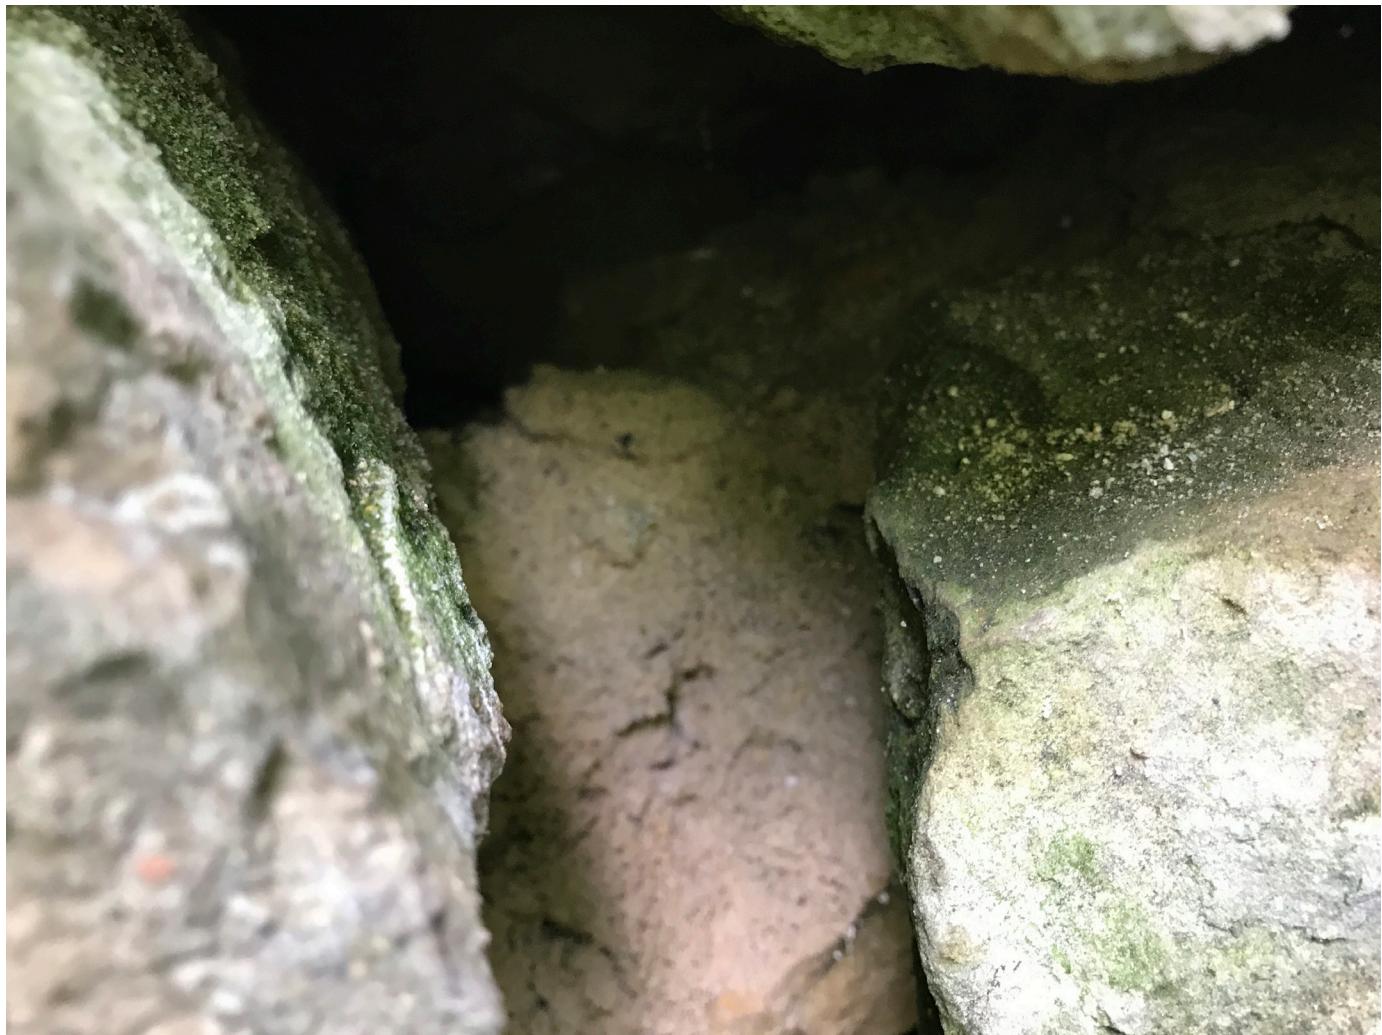
Figure 12: Degradation of the arch stones deeper in the wall is visible from the open joints where the arch has come out of alignment due to settling at the base at the right.
