127 W. Gilman Street - January 30, 2014

Kyle Bunnow – City of Madison Housing Inspection Supervisor, P.E.

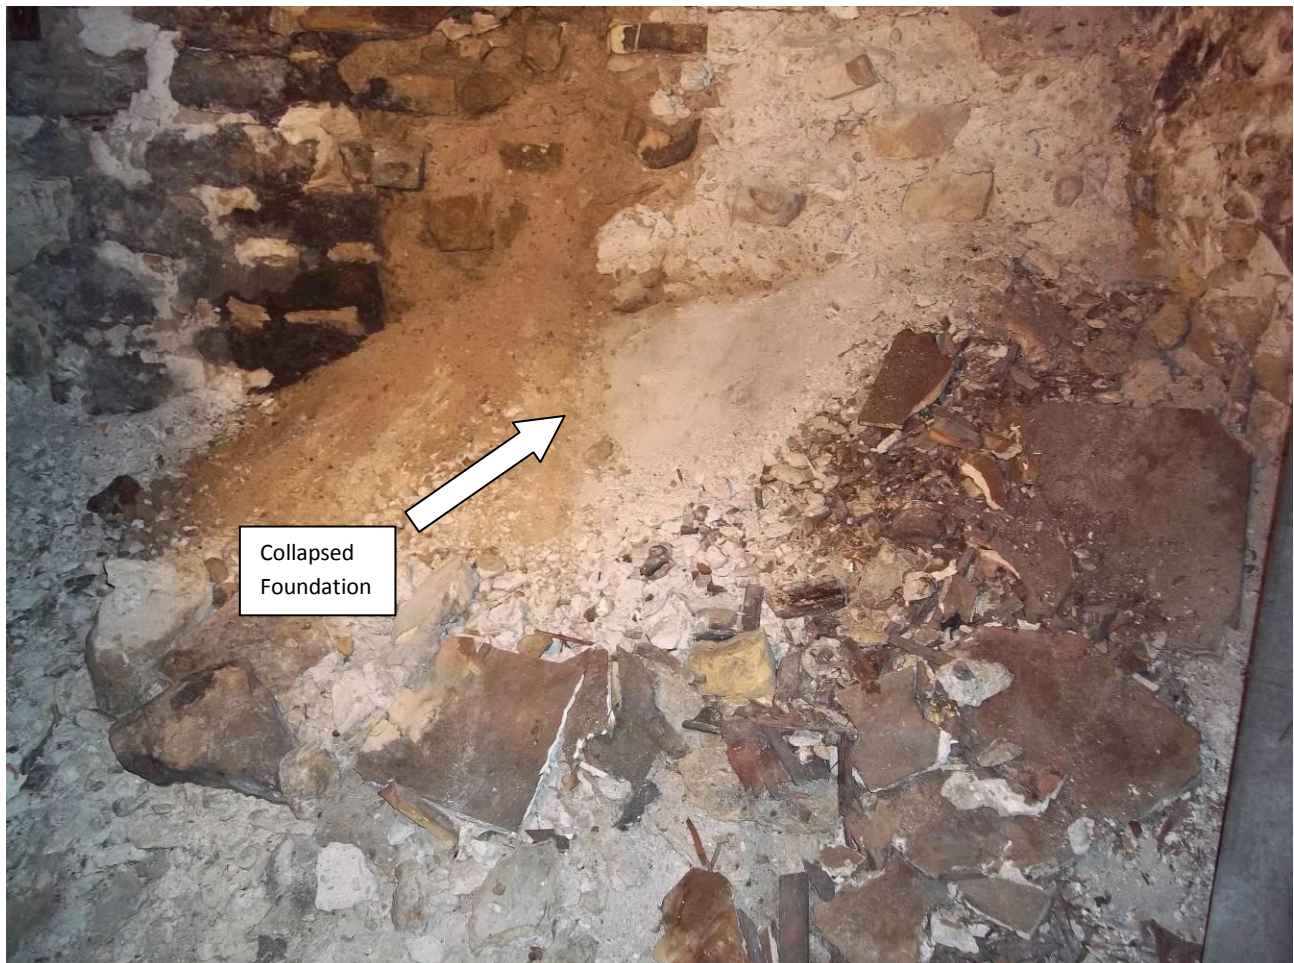
Figure 1 - Collapsed Foundation along East Wall

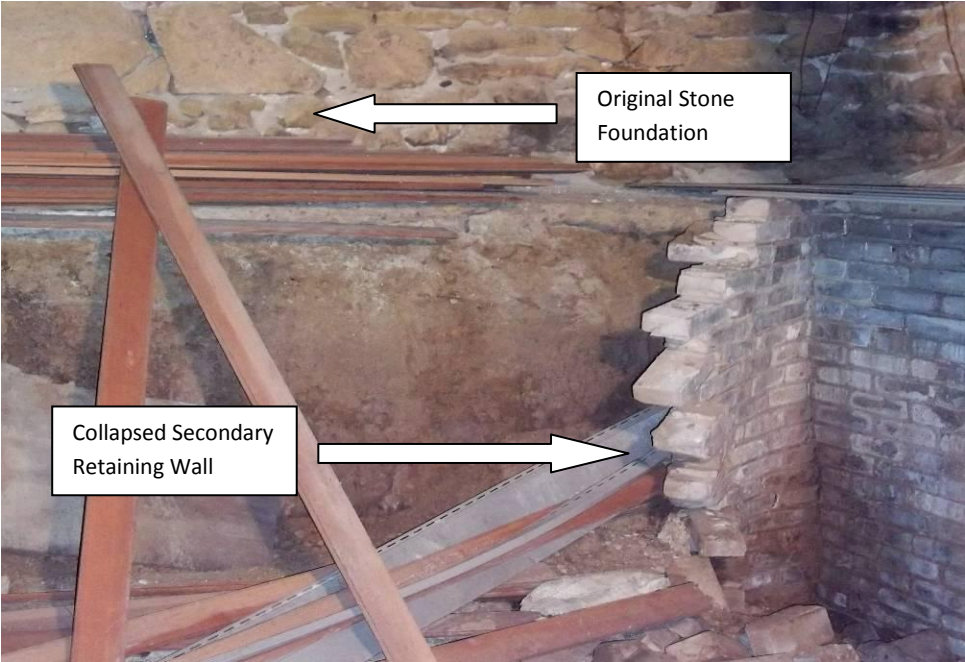
Figure 2 - Northeast Corner of Foundation with Collapsed Secondary Retaining Wall

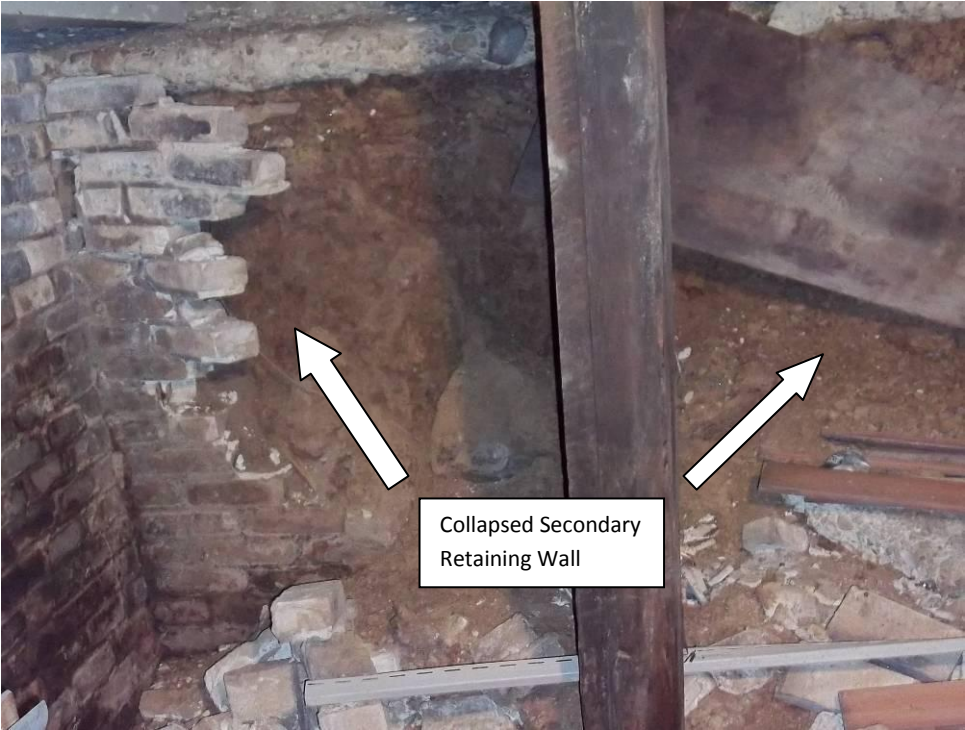
Figure 3 - Collapsed Secondary Retaining Wall along North End

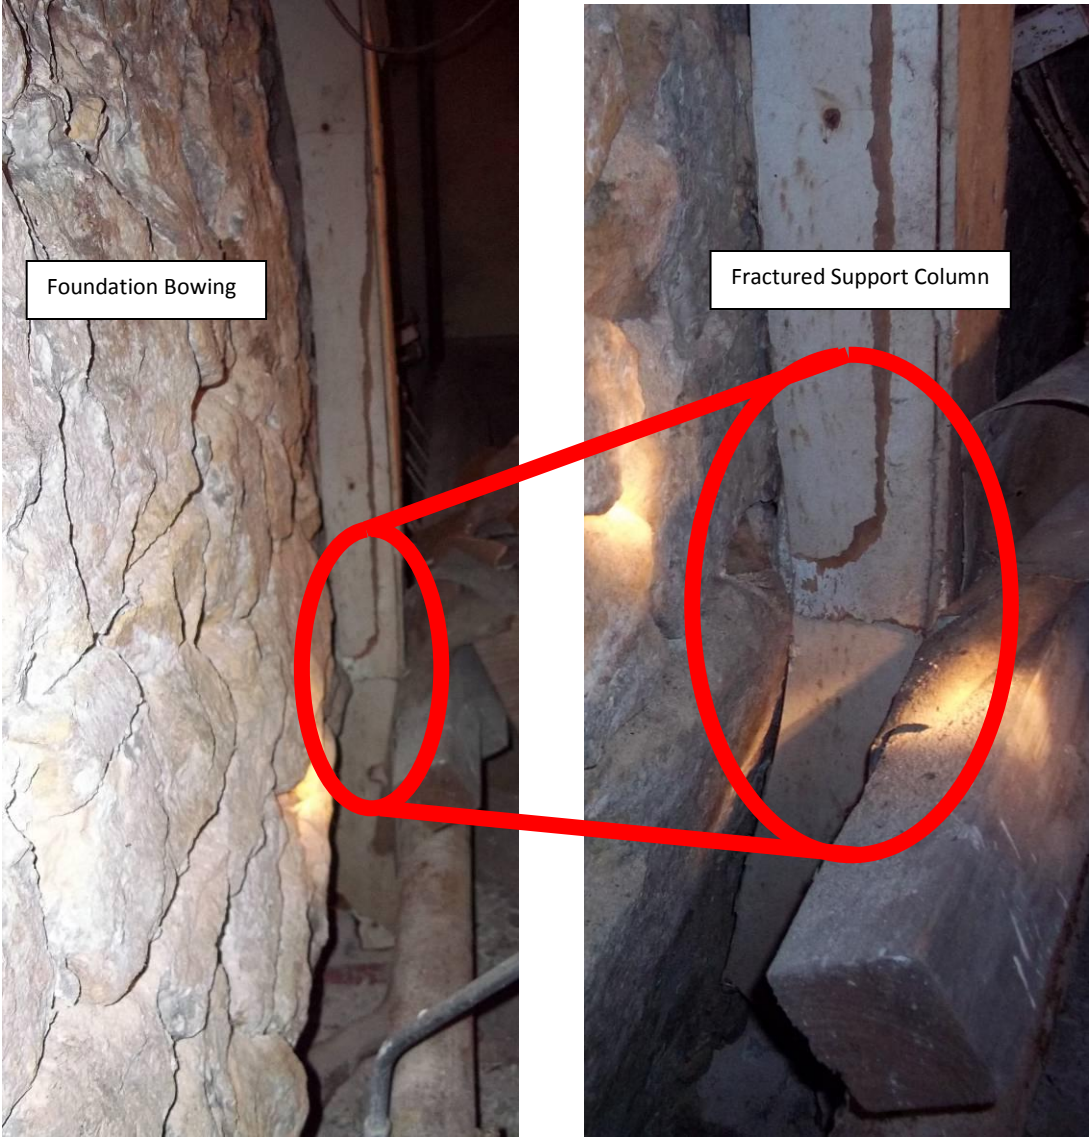
Figure 4 - East Foundation Wall Bowing Excessively and Fracture of a Wood Column

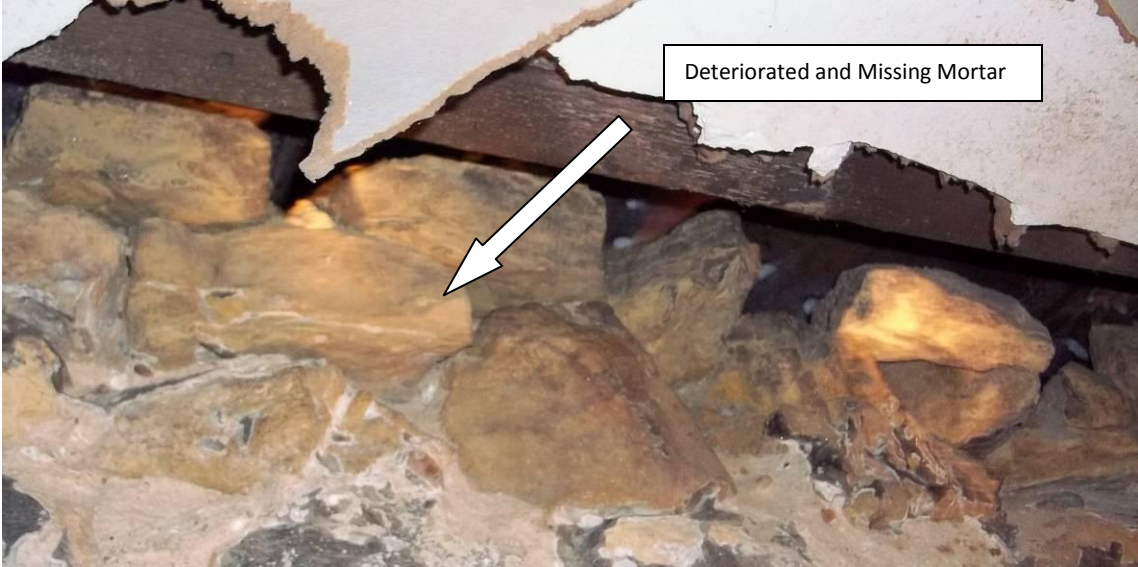
Figure 5 - Deteriorated and Missing Mortar

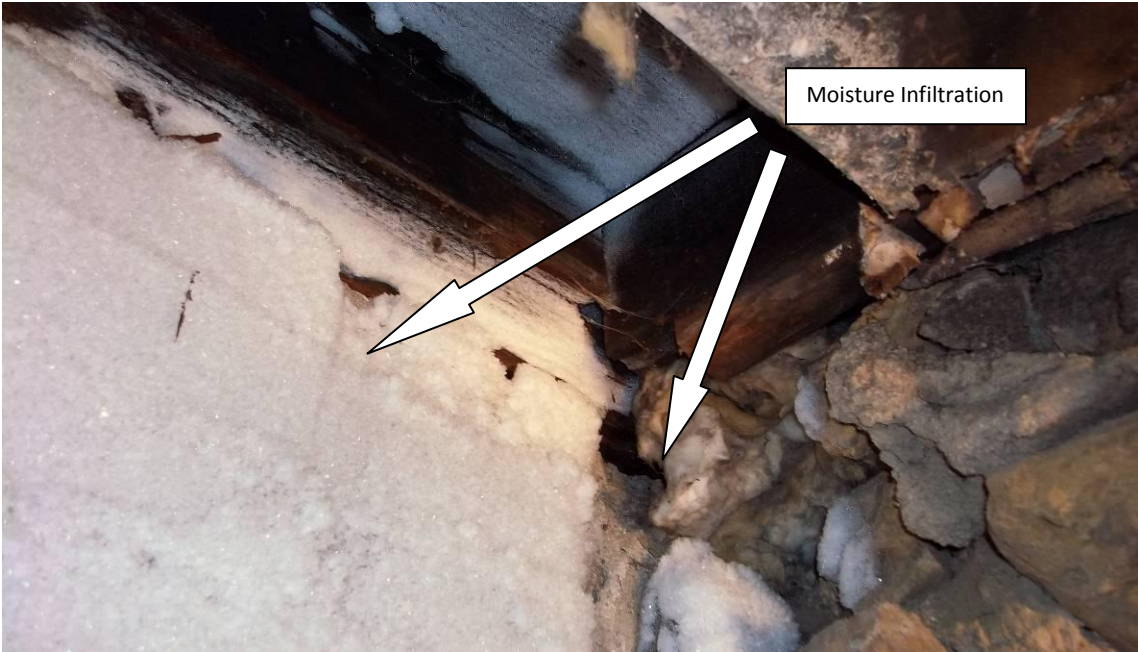
Figure 6 - Moisture Infiltration at the Upper Foundation

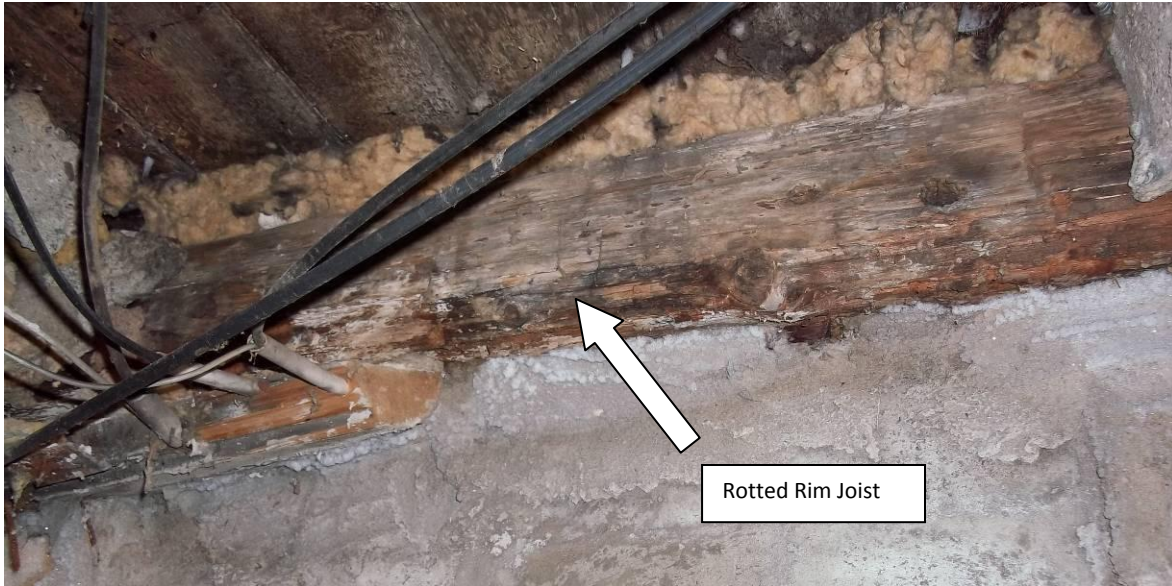
Figure 7 - Rotted Rim Joist

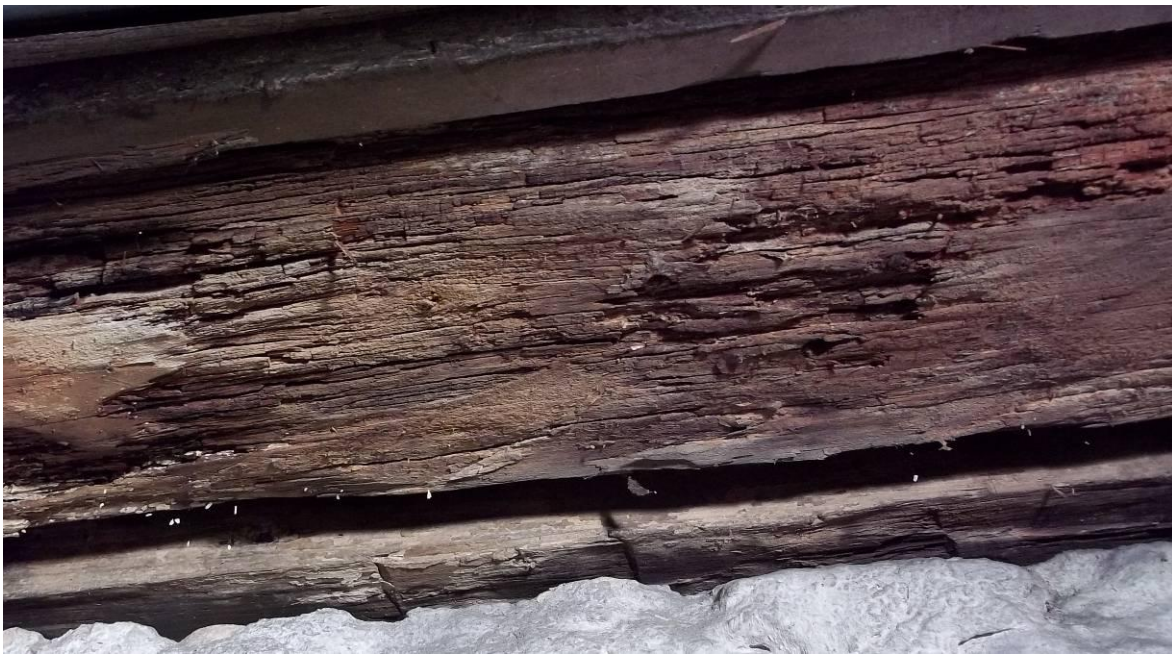
Figure 8 – Additional Example of Rotted Wood in Basement

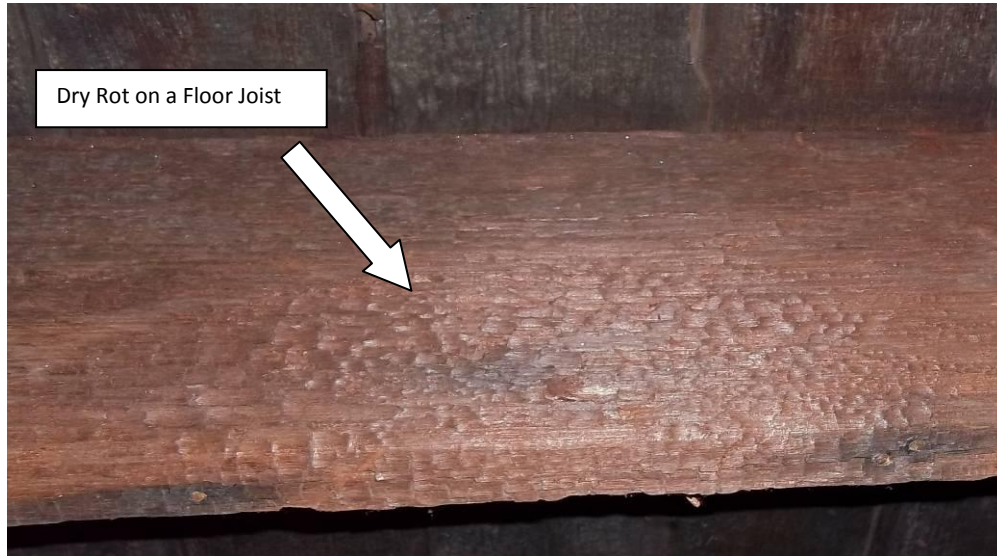
Figure 9 - Floor Joist with Dry Rot

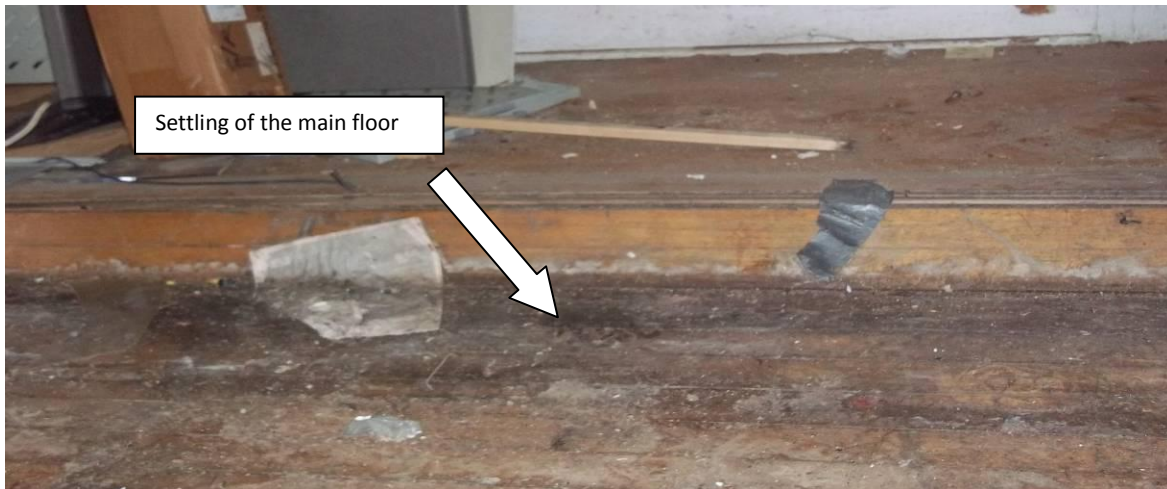
Figure 10 - Unevenness and Settling of the Flooring because of Inadequate Support

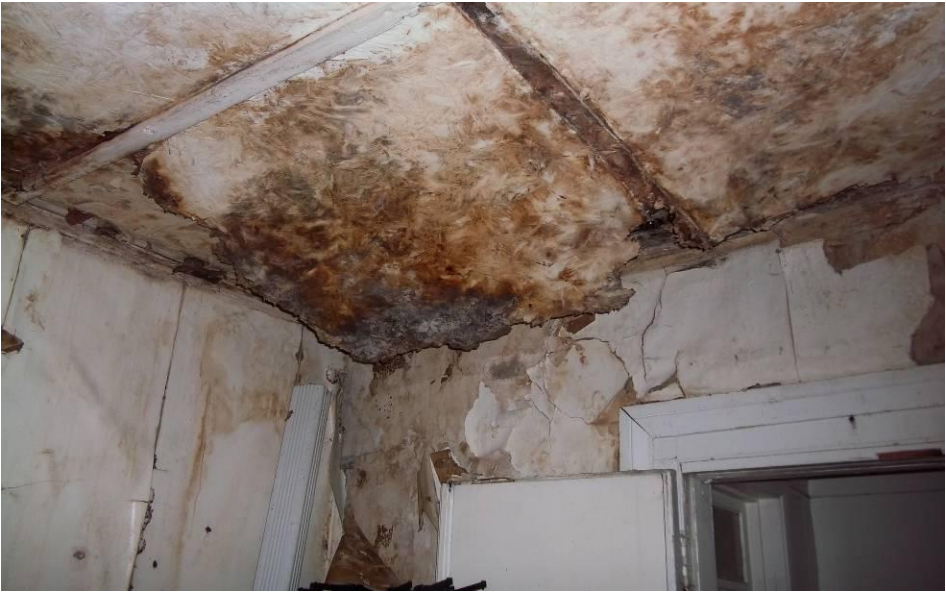
Figure 11 - Ceiling Collapse and Wall Damage on the Main Level

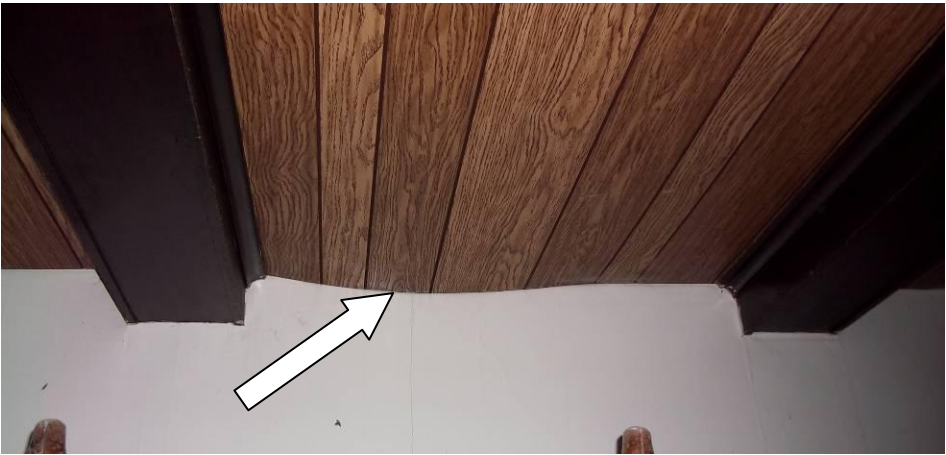
Figure 12 - Sagging In the Ceiling

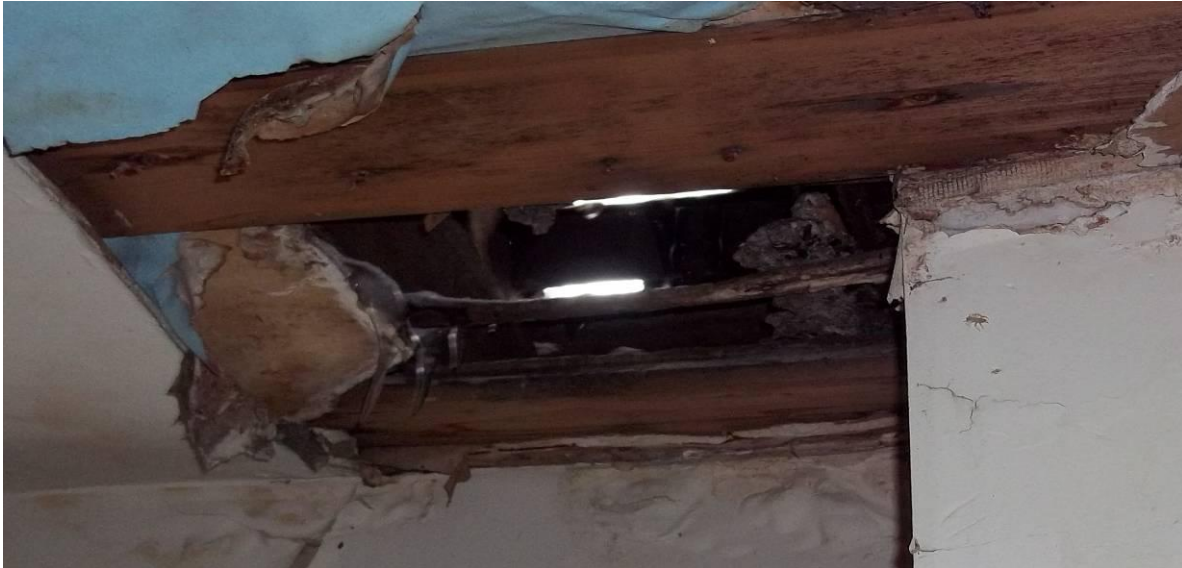
Figure 13 - Hole in the West Side of the Building

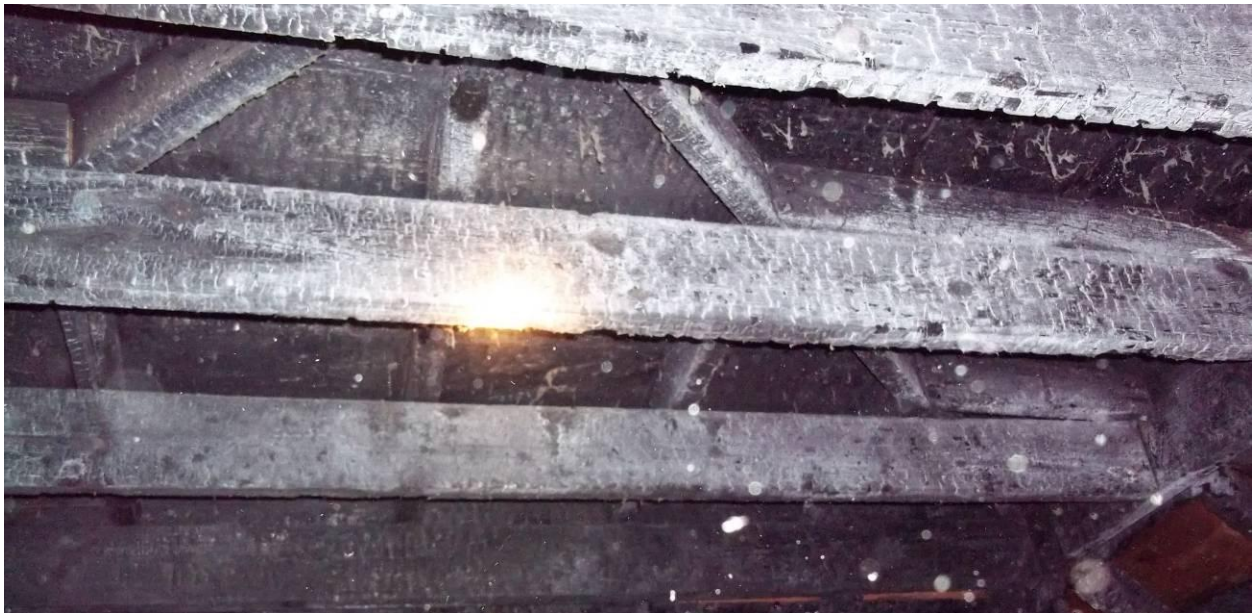
Figure 14 - Fire Damaged Trusses and Roof System
