**CITY OF MADISON
ZONING BOARD OF APPEALS
VARIANCE APPLICATION**

Address of Subject Property: 622 E 632 HOWARD PLACE

Description of Requested Variance: REAR YARD SETBACK BECAUSE OF
UNIQUE SITE GEOMETRY

**SUBJECT: 622 & 632 Howard Avenue Apartments
Structural Assessment
MP-Squared Project No: 1310034WI**

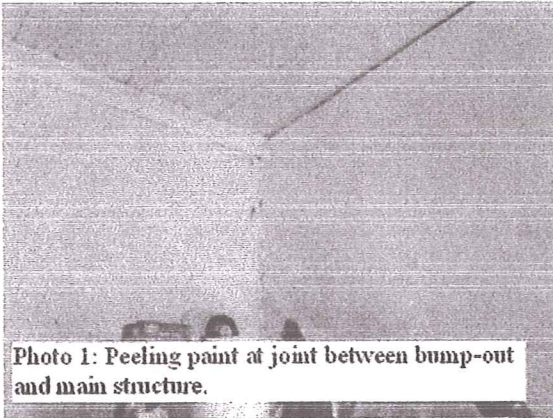
Nearly all the framing in the building is covered with wall/floor/ceiling sheathing; however, structural concerns are noticeable passively throughout the building. There are two "bump-outs" – one at the front of and one in the back of the building. Each bump-out appears to have once been an exterior, perhaps three season, porch that has been converted to livable space. There is a significant change in elevation between the main structure and the bump-out. Also, there appears to be differential movement between the bump-out and the main structure as seen by peeling paint at the intersection of the bump-out to the main building (see Photo 1); additionally, via conversations with the building

Photo 1: Peeling paint at joint between bump-out and main structure.

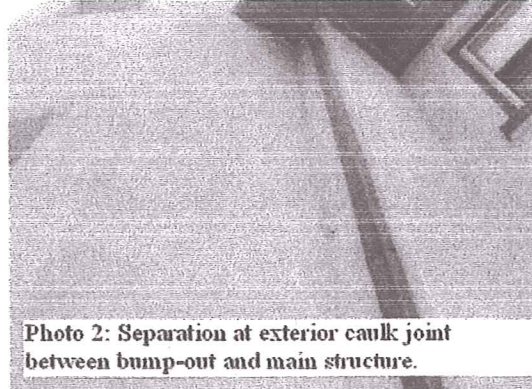
owner re caulking of exterior joint of the bump-out to the main structure, the caulking is replaced every one to two years because of visible separation (see Photo 2). The bump-out may not have a typical frost wall foundation which could be the cause of the relative movement.

Photo 2: Separation at exterior caulk joint between bump-out and main structure.

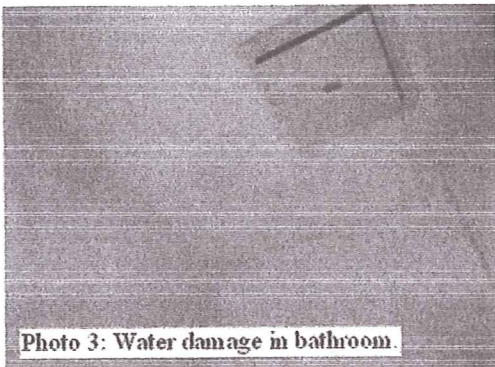
There are "soft" spots felt throughout the building. These may be due to localized water damage, undersized framing, or a combination of the two; however, without removing the sheathing and exposing the wall studs and/or floor framing it is not possible to determine how pervasive the damage is. Water damage of some degree can be assumed in nearly all bathrooms and kitchens (see Photo 3).

Photo 3: Water damage in bathroom.

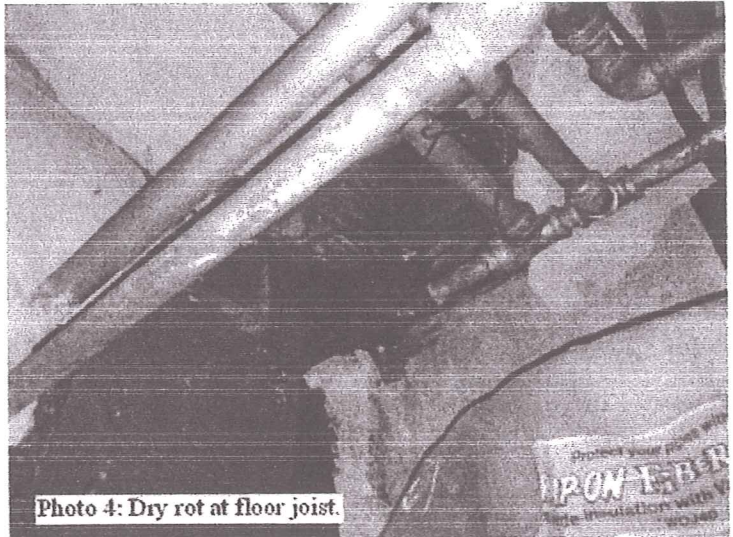
In the lower level some framing was exposed and dry rot was noted (see Photo 4). Again, without removing the sheathing and exposing the floor joists it is not possible to determine the extent of the rot.

Photo 4: Dry rot at floor joist.

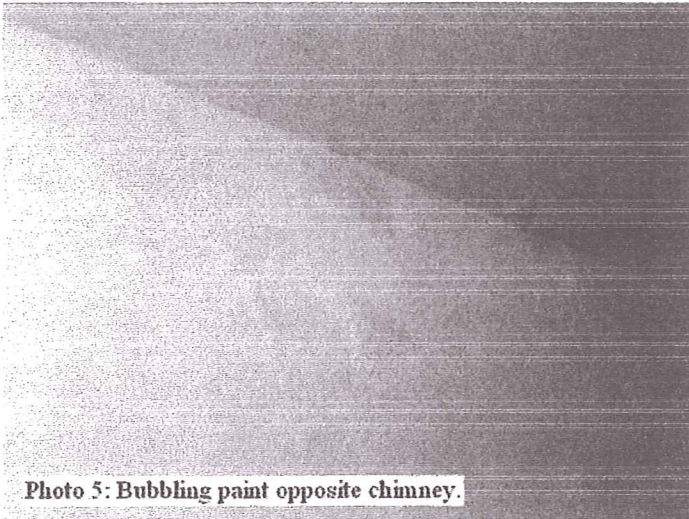
Photo 5: Bubbling paint opposite chimney.

Paint in the stairwell opposite the chimney has bubbled (see Photo 5). Per the Owner the bubbling paint has been repaired numerous times and a new liner has been installed in the chimney. It is our understanding the bubbling continued after the liner was installed. This may not indicate a structural issue; however, it is concerning and may be indicative of high heat.

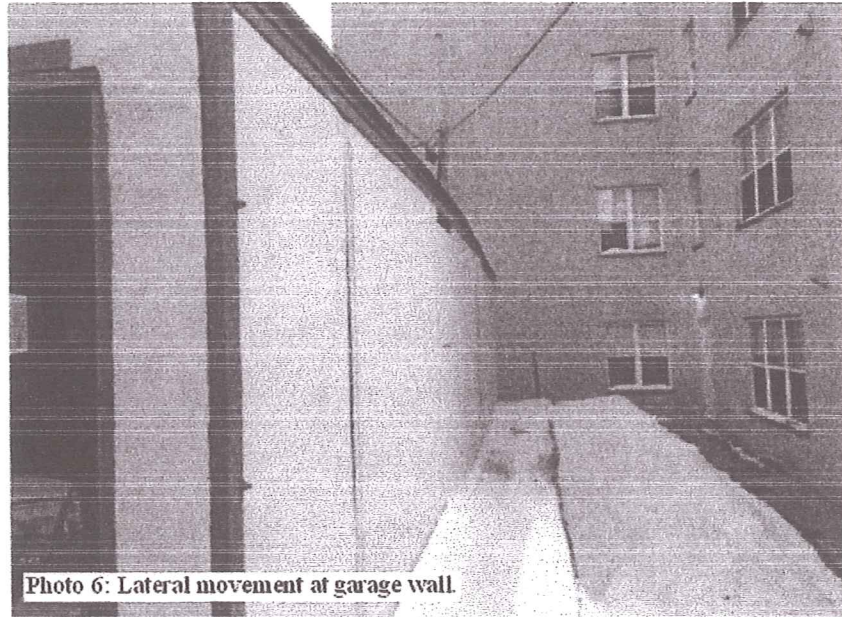
632's garage does not appear to have been originally designed per typical structural engineering standards. The trusses have not been properly fastened to the top of the wall. Steel tie rods have been installed to prevent the walls from kicking out; however, the structure appears generally unstable and possibly in danger of imminent collapse. See Photo 6.

Photo 6: Lateral movement at garage wall.

The garage at 632 Howard should be considered in danger of imminent collapse and should be repaired, shored, or demolished.

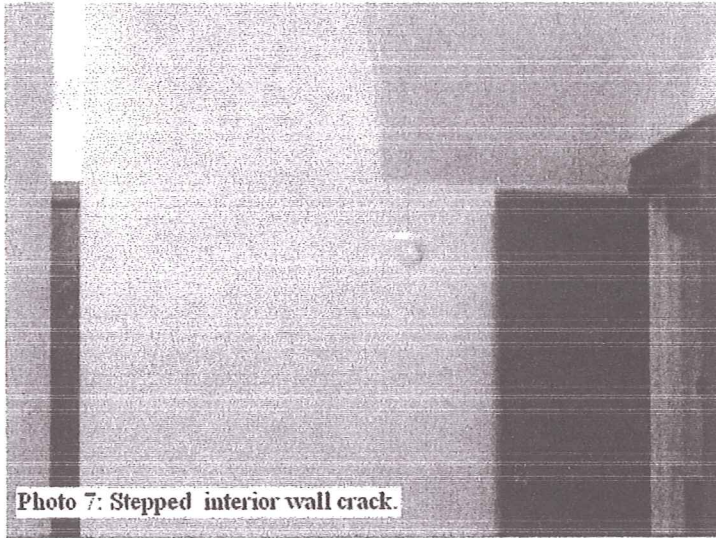
Photo 7: Stepped interior wall crack.

The most concerning structural behavior occurs approximately in-line with the ridge. The floor framing on the first and second floor significantly dips approximately 18'-0" from the front, exterior wall. On the second floor, there is a large, apparently active, stepped crack (see Photos 7 - 9). This is indicative of settlement. The exterior foundation and exterior wall framing show no signs of

distress. A possible origin may be due to the removal of an interior load bearing member, or perhaps continued settlement of an interior load bearing column/wall.

The structural issues in 622 Howard Avenue appear less pervasive, but could be a larger life safety issue than what we are observing in 632. Tracking down the cause of the settlement will require a rigorous evaluation and exposure of the framing system. It may be necessary to retain to geotechnical engineer if the structural load path is found to be sufficient to transfer the loads to the foundation.

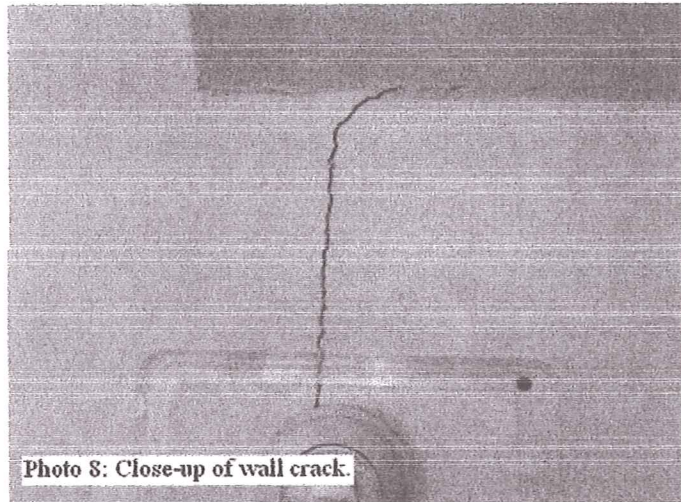
Photo 8: Close-up of wall crack.

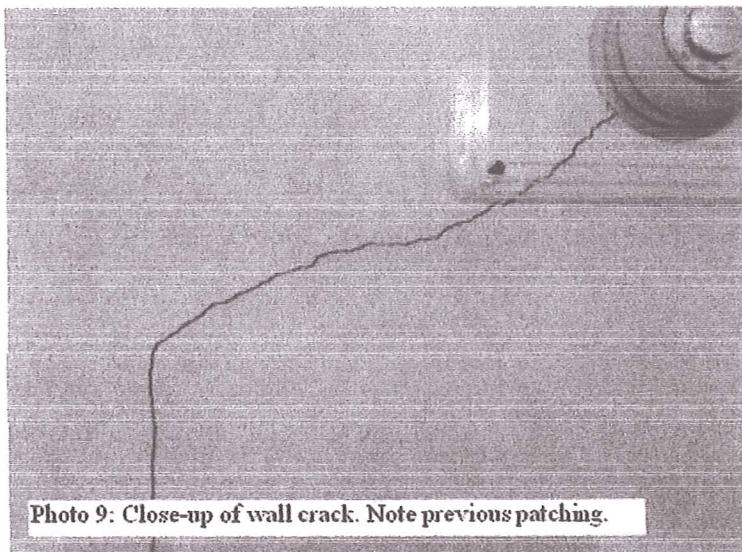
Photo 9: Close-up of wall crack. Note previous patching.

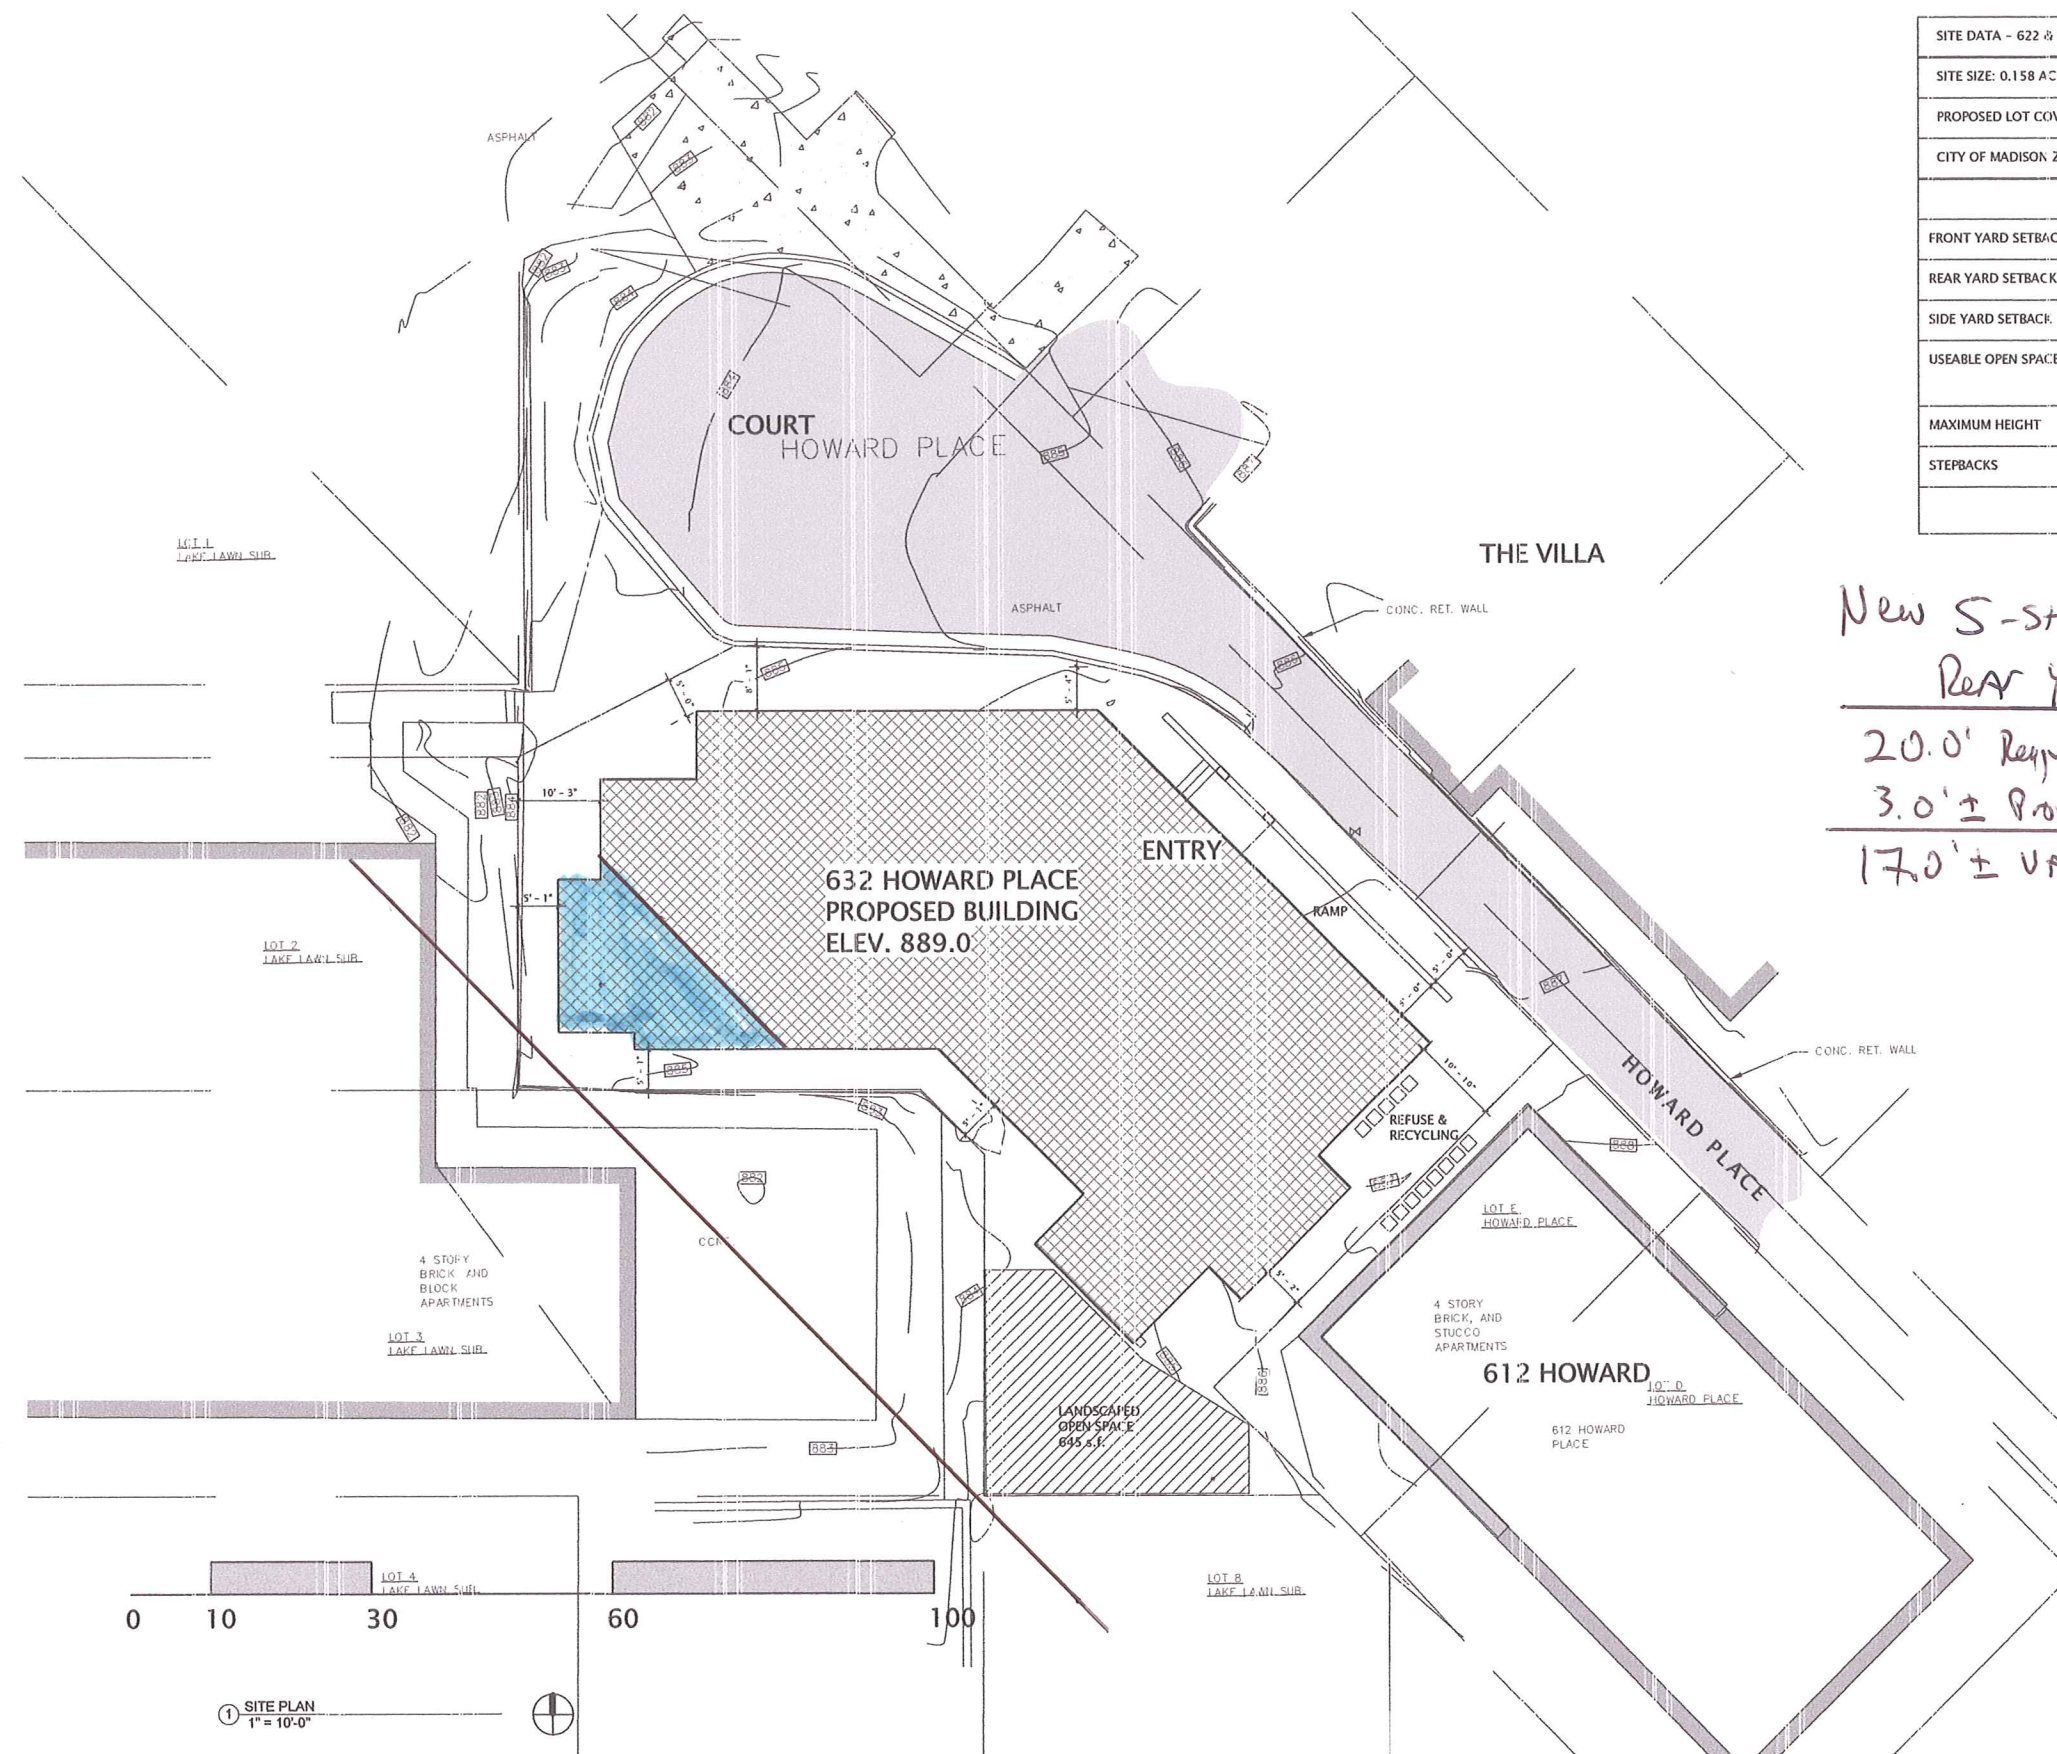
SHEET NUMBER
A100

*New 5-story apartment building
Rear yard
20.0' Required
3.0' ± Provided
17.0' ± Variance*
