City of Madison

**Madison Municipal
Building
Conceptual
Schematic
Design Study**

November 2013

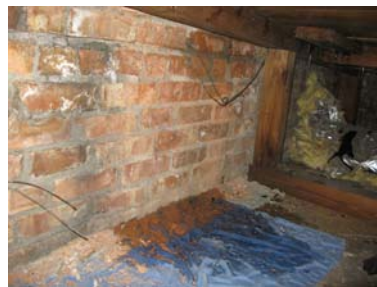
Like other buildings of the era and type, the majority of building issues at MMB reside in the construction and detailing of the parapet and roof systems. Water is finding its way through the roof flashing and deteriorated mortar joints in the parapet and cornice. The distance of travel for moisture to reach occupied interior spaces is too great but there are signs of water infiltration in the interstitial space between the roof deck (concrete) and the roof system (wood and asphalt.)

Figure 19 – Water Infiltration is occurring at the Raised Wood Roof Level.

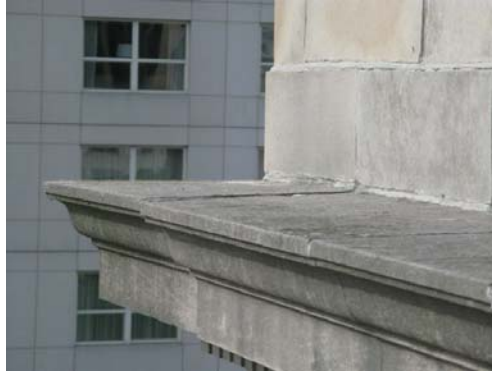
Figure 20 – All Four Major, Outside Parapet and Cornice Corners Show Slight Movement.

The cornice movement can be found at each of the outside building corners where the cornice cantilevers the most and it is more exposed to wind and weather. Parapet movement appears to be happening in all but a few locations; some more severe than others. Torqueing and sheering of the stone balusters is occurring and horizontal brick joints are expanding, which means outward movement of the parapet as a whole is occurring as well.

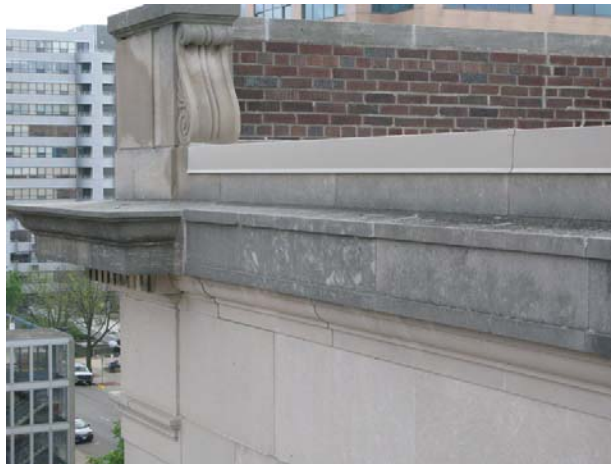
Brick is located on what is considered the rear of the building. Water infiltration at the parapet level within this “U” shape area is apparent. Moisture affecting the side walls is coming from deteriorated joints in the metal coping cap and/or flashing, not from the roof because these walls are on the high end of the roof slope located behind. The back wall parapet is showing signs of moisture infiltration that could be caused by deteriorated joints in the metal coping, flashing and from direct assault from the draining roof. The infiltration is at its worst where the metal coping meets the decorative stone scroll on both side walls.

Figure 21 – Darkening of the Stone below the Metal Coping indicates Water Saturation

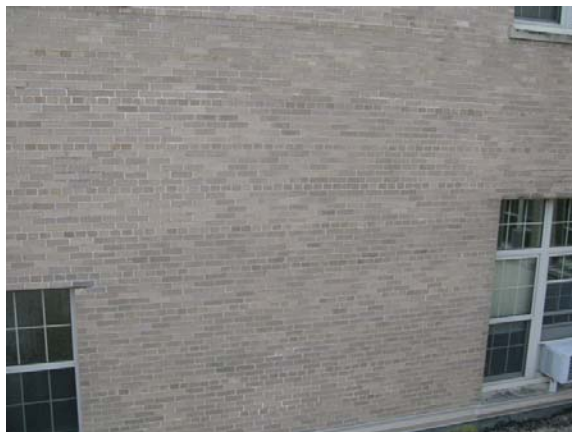
If steel in a masonry wall is not properly flashed, (water diverted away) overtime water will erode the protective surface and rust will start to occur. Left unchecked, the steel will expand in layers and surprisingly the separation of these layers has enough power to move the surrounding masonry. This phenomenon is called rust jacking. It appears that rust jacking is starting to occur at the steel relief angles used in the side walls. Deterioration of the brick faces, discoloration of the brick and slight bulging of the brick indicate movement is occurring. Rust jacking at the window opening steel lintels is more apparent because the supporting brick at the jambs are cracking and the sealant used to protect the steel at its bearing points is separating.

Figure 22 – Discoloration and Shifting of Brick indicates Rusting is occurring at the Hidden Relief Angles

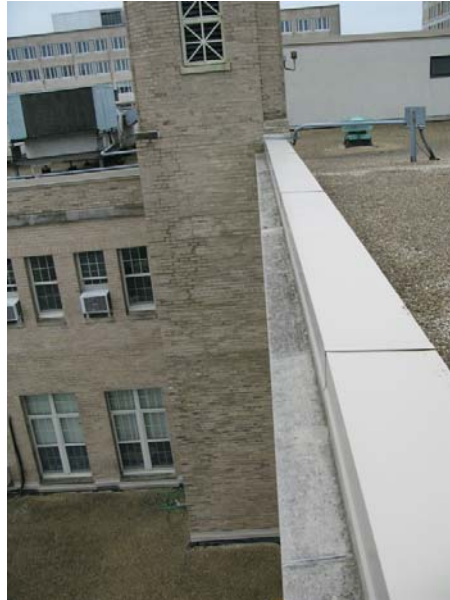
There are many movement cracks in the brick facades. Control, expansion and construction joints were not widely used in 1927 so when the building settled it found its own path for relief. The most serious cracking in the brick is located at the outside corner of the brick chimney where full height vertical cracks are occurring. It appears the chimney brick is linked with (rather than separated with a movement joint) the back and side walls so when the walls move independently and in different directions cracking is occurring at the weakest point; the chimney corner.

Figure 23 – Outside Corner of the Brick Chimney is Cracking Vertically on Both Sides

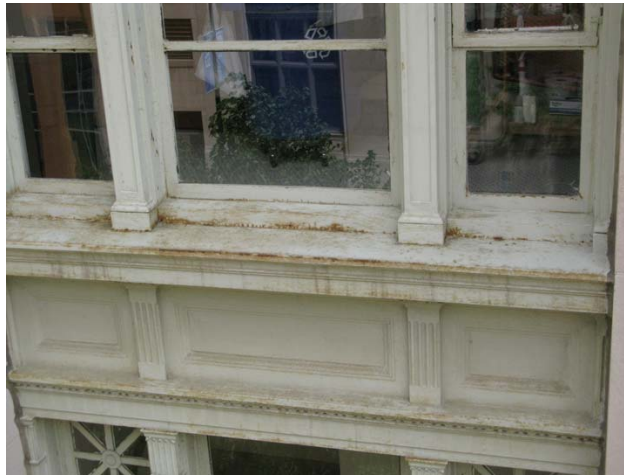
Unprotected cast iron and steel will rust when exposed to the elements. The coatings on the steel and cast iron frames and window units on the second and third floor have been compromised in several key locations. Typically we found rust occurring at the sills, at the bottom mullion of the operable casements and at the decorative ledge at the spring point of the circle top windows. The most severe of these occurrences is at the mullions. Over the years, as the original seals deteriorated, every type of caulk and sealant has been used to keep out the draft. Applied with care and good intent to aid the occupant, the sealant has aided in the accelerated deterioration of the coatings and obstructed moisture from exiting the system causing rusting. The excessive sealant has also rendered many of the operable sashes inoperable.

Figure 24 – Rust is Developing at Window Sills

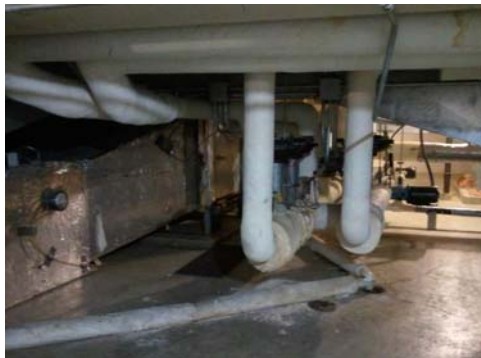
Ventilation air is provided to lower level and first floor through a 100% outside air unit located in a crawl space on first floor. The ventilation unit is currently very difficult to provide maintenance because of the limit dimensions of the crawl space.

Figure 38 – Ventilation Air Unit for Lower Level and First Floor

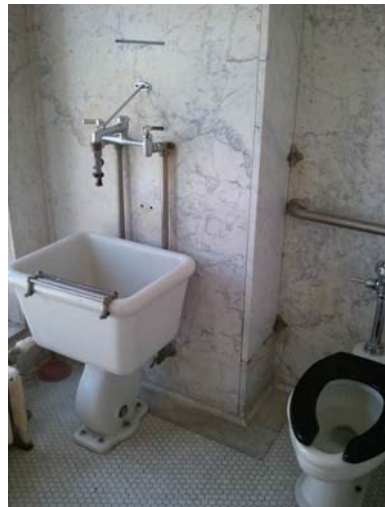
The existing plumbing distribution system consists of steel and copper piping for domestic water and cast iron and galvanized piping for sanitary and vent. Most of the piping is original to the building, and with the exception of some leaking shutoff valves, the system is reported to be in good working condition. There are various vintages of plumbing fixtures installed throughout the building. Many of the plumbing fixtures are antiquated, and some have been abandoned in place due to infrequent use. The current fixtures do not meet current EPA regulations for water flow requirements.

Figure 42 – Antiquated Plumbing Fixtures

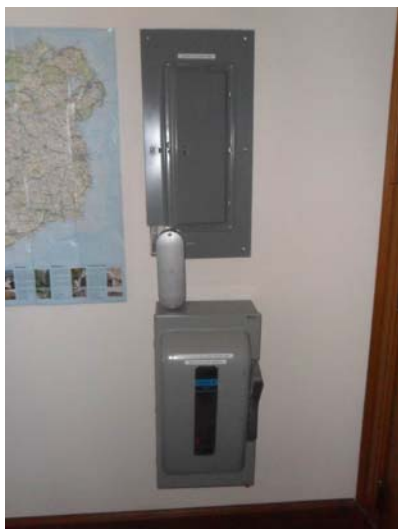
Figure 50 – Exposed Disconnect Electrical Device
