0 100 200 FT.  
LANGDON  
NEIGHBORHOOD  
N. 12. 15.

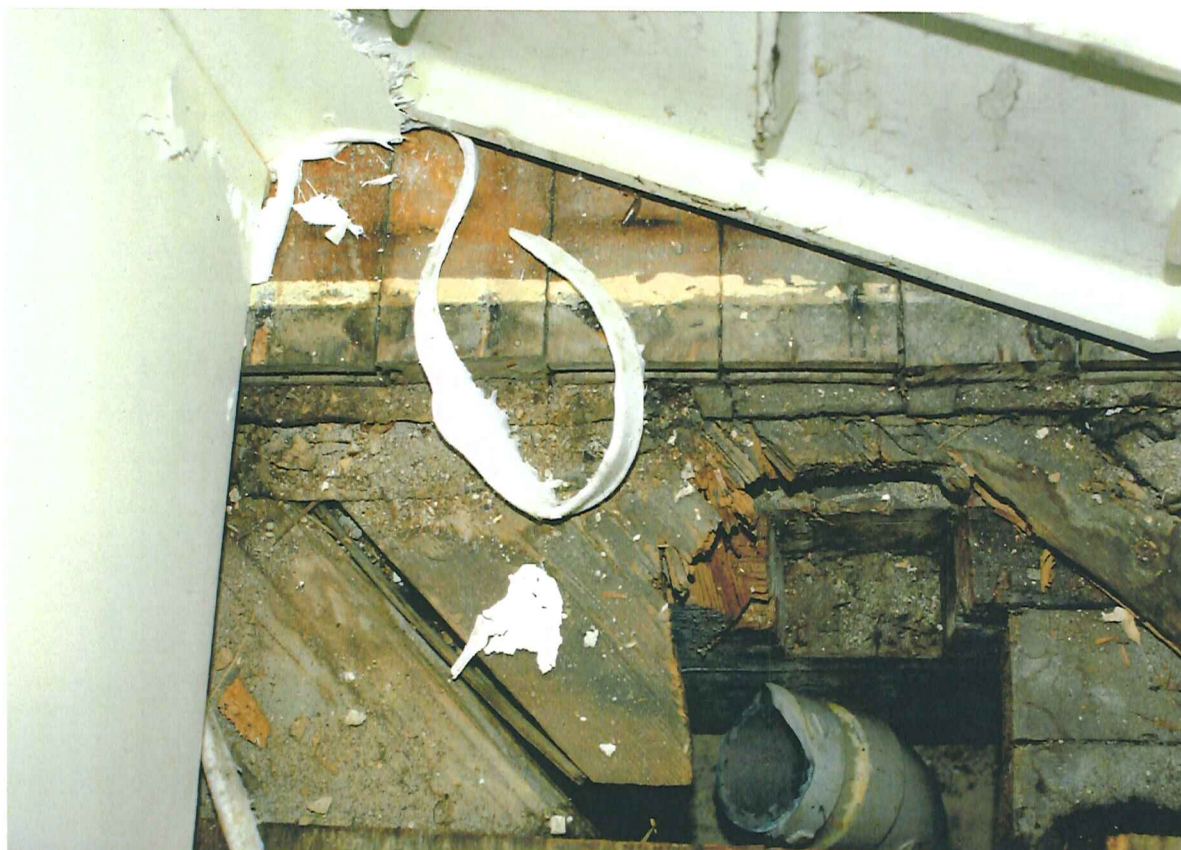
632 HOWARD PLACE  
EXISTING CONDITION UNDERNEATH  
THE FLOOR - NOTE SEVERE  
DETERIORATION OF THE FLOOR  
SHEATHING AND COMPROMISED  
FLOOR STRUCTURAL FRAMING DUE TO  
PREVIOUS MECHANICAL, ELECTRICAL  
AND PLUMBING INSTALLATION AND  
REPAIR - THIS CONDITION IS  
NOTICEABLE AND LIKELY PRESENT IN  
ALL UNITS - THE SOLUTION TO THIS  
CONDITION WOULD LIKELY REQUIRE A  
TOTAL FOUNDATION UP REBUILD OF  
THE ENTIRE STRUCTURE

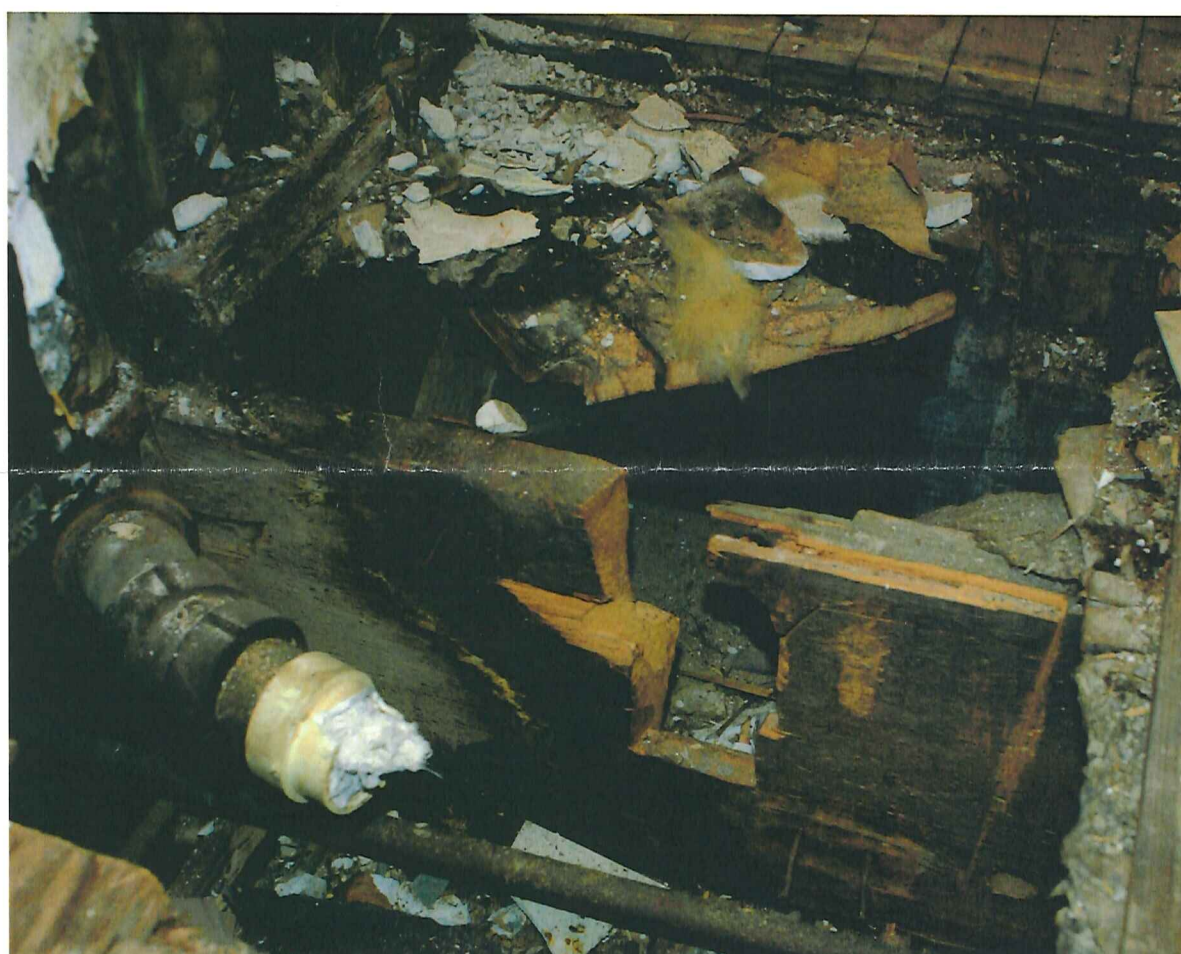
632 HOWARD PLACE  
IMAGE TAKEN OF UNDERSIDE OF FLOOR  
FRAMING AND FLOOR DECKING  
SHOWING SEVERE AND PERVASIVE  
WATER DAMAGE - THIS CONDITION IS  
NOTICEABLE IN EACH UNIT AND IS  
LIKELY PERVASIVE THROUGHOUT  
THE ENTIRE BUILDING
