This is the front facing windows at 1014 Williamson Street.

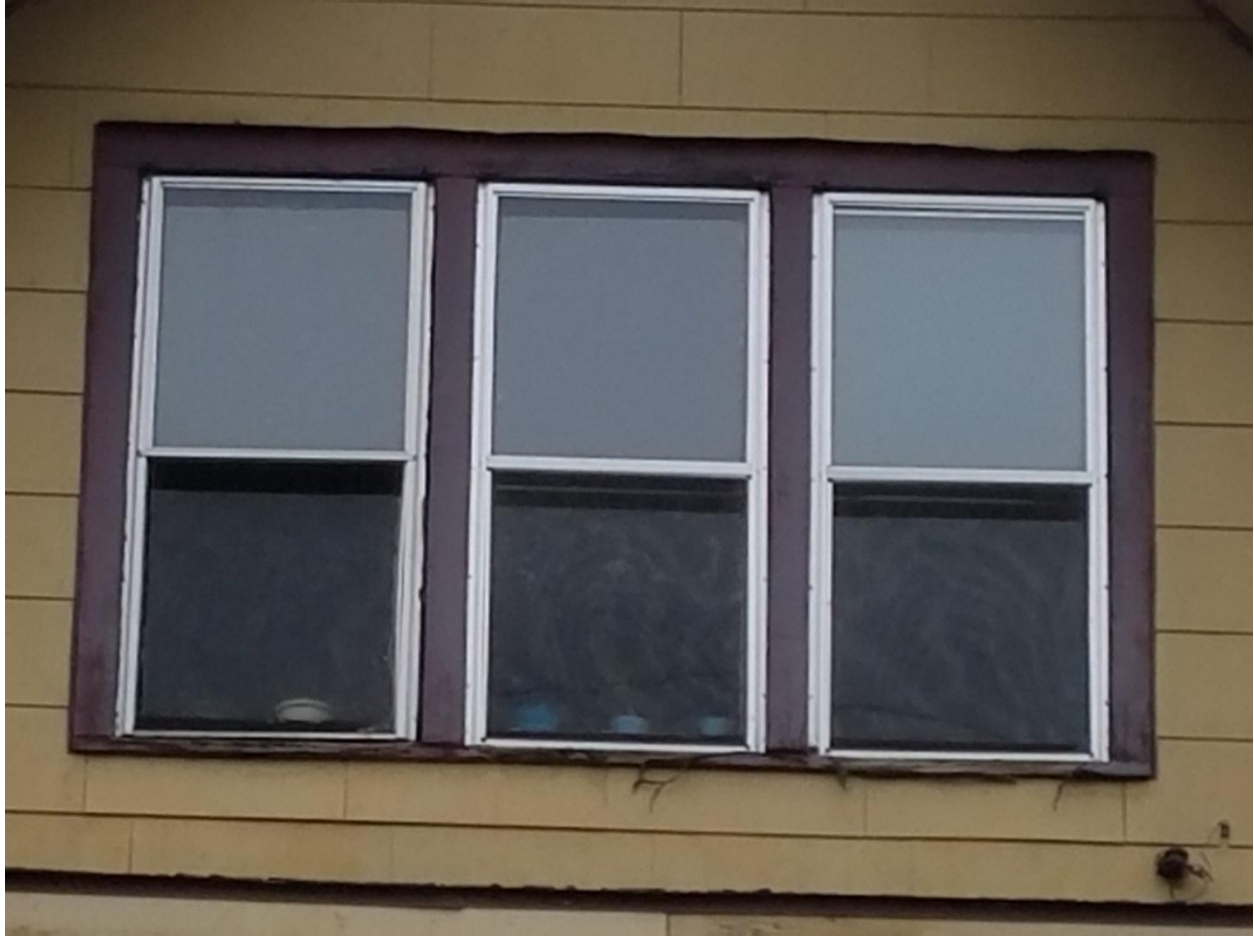
3rd floor

It was extremely difficult to obtain close up photos of these windows. You can tell from this picture that there is wood rot below these windows.
