## **EXISTING BUILDING REVIEW**

### **122-124 W. Mifflin Street**

Name: Fairchild Building Corporation

## **122–124 West Mifflin Street – Architectural Review**

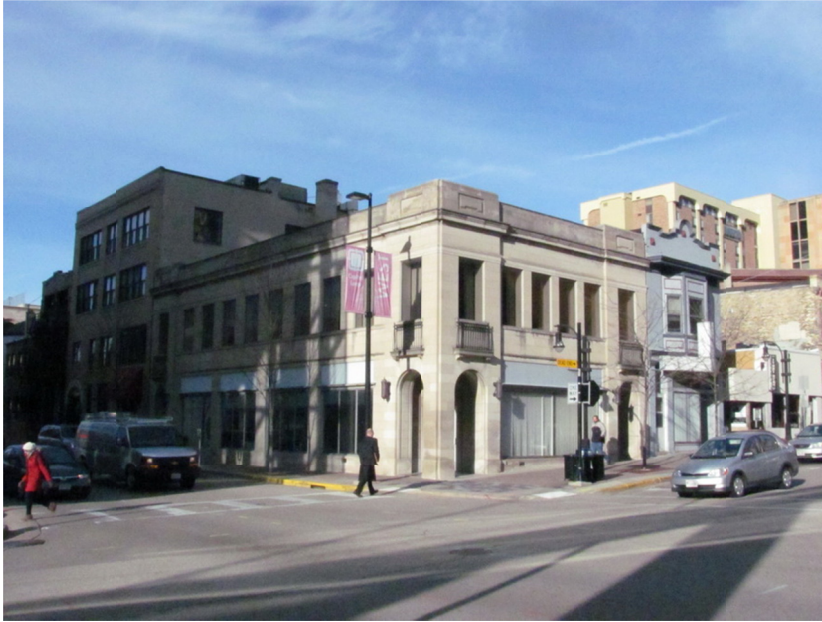
The masonry exterior of the building is constructed of limestone, likely Indiana limestone (Figure 1). Ornamental features of the facade include decorative brass and glass exterior wall-mounted light fixtures and decorative iron balustrades below the second story windows above the entrances (Figure 2 and Figure 3).

*Figure 1. Overall view of 124 West Mifflin. The Mifflin Street facade is at right, while the Fairchild Street facade is at left.*

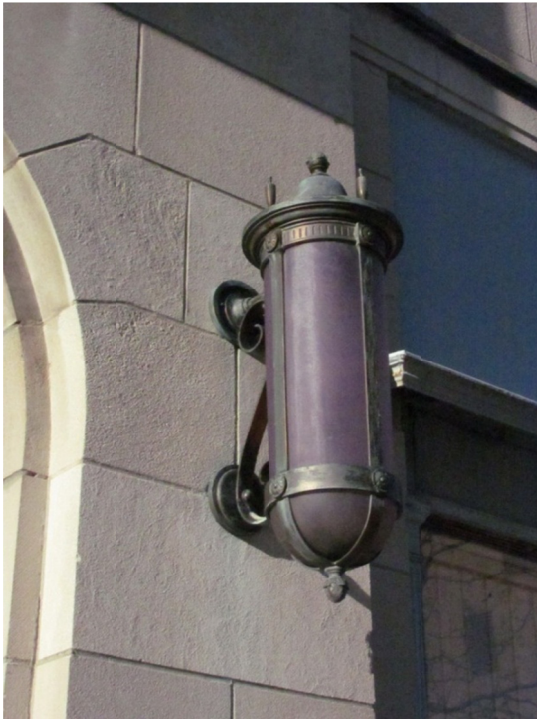
*Figure 2. Left. Decorative brass and glass exterior light fixture.*

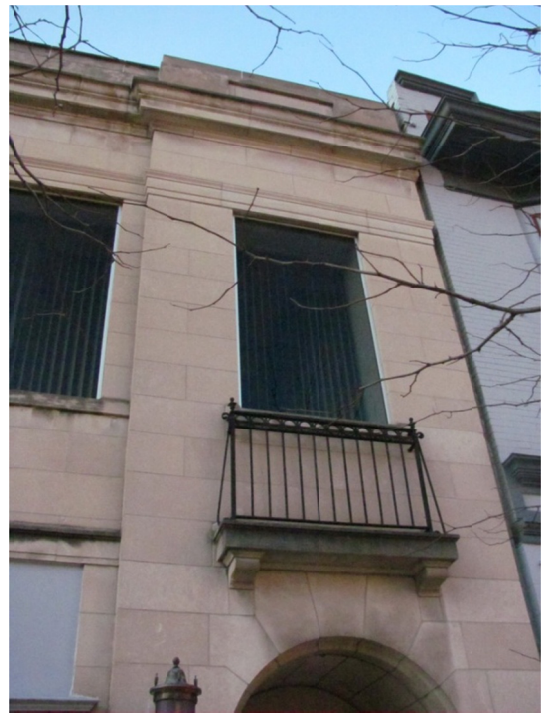
*Figure 3. Right. Decorative iron balustrade.*

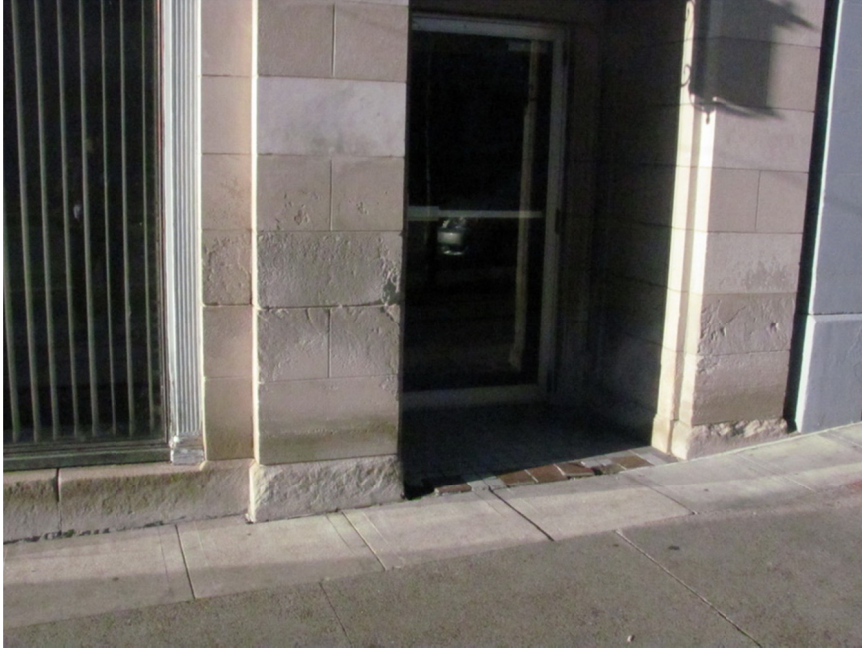
Localized distress was observed in the limestone masonry. Portions of the stone near grade exhibit erosion and pitting of the face (Figure 4). Erosion of this type is often related to water splash-back from sidewalk paving, snow accumulation, and the use of de-icing salts. Dark staining was observed at the recessed entrances and at the parapet walls. Occasional cracked or open mortar joints are present throughout the facade. Cracking and spalling were observed at the head of many of the first floor window openings; this type of distress is likely related to corrosion of embedded steel lintels (Figure 5).

*Figure 4. Portions of the limestone masonry near grade exhibit erosion and pitting of the face.*

Based on this limited survey, the limestone masonry of the street facades would require localized repairs to address spalling, cracking, loss of mortar, and staining. The condition of the embedded steel window lintels requires further study to evaluate existing conditions and determine an appropriate repair. The integration of the roof assembly with the cornice, parapet, and coping requires further study to provide a watertight envelope. If required by code, provision for overflow roof drainage will need to be created.

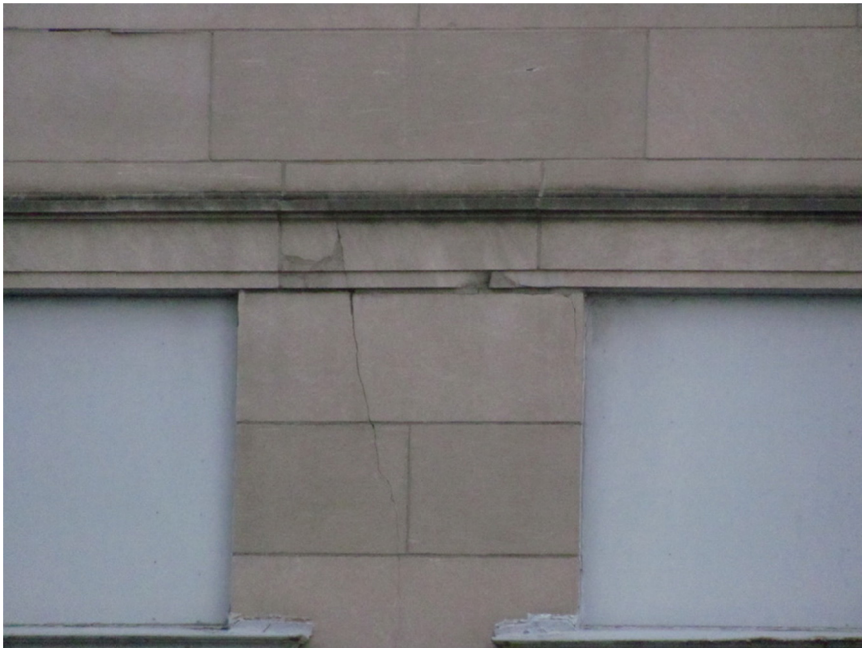
*Figure 5. Cracking and spalling of limestone masonry at the head of a first floor window opening.*

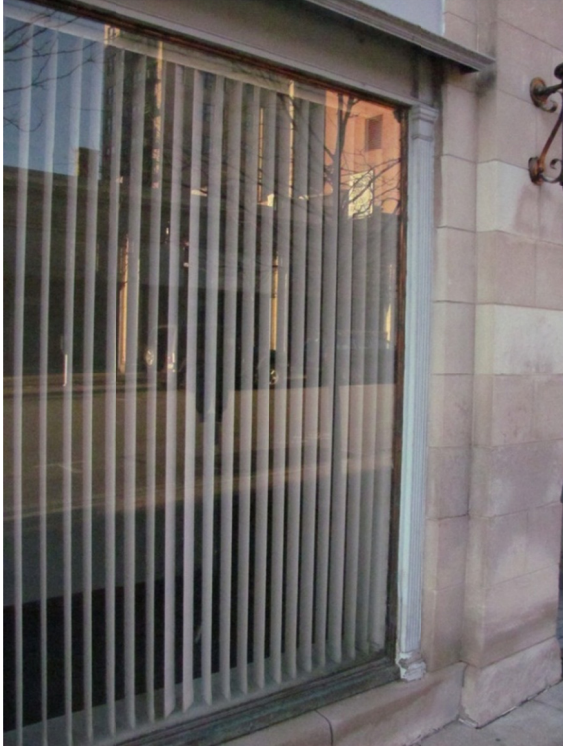
*Figure 6. The storefront facing Mifflin Street has a bronze frame and fluted bronze pilasters as window jambs.*

The window and door system at most areas dates to the late 1960s. It is likely not cost effective to retrofit the system for improved performance. Therefore, consideration could be given to replacing the windows and doors with new thermally improved aluminum-framed assemblies. The existing first floor transom windows and the one bay of bronze storefront at Mifflin Street appear intact and could be rehabilitated and reused.

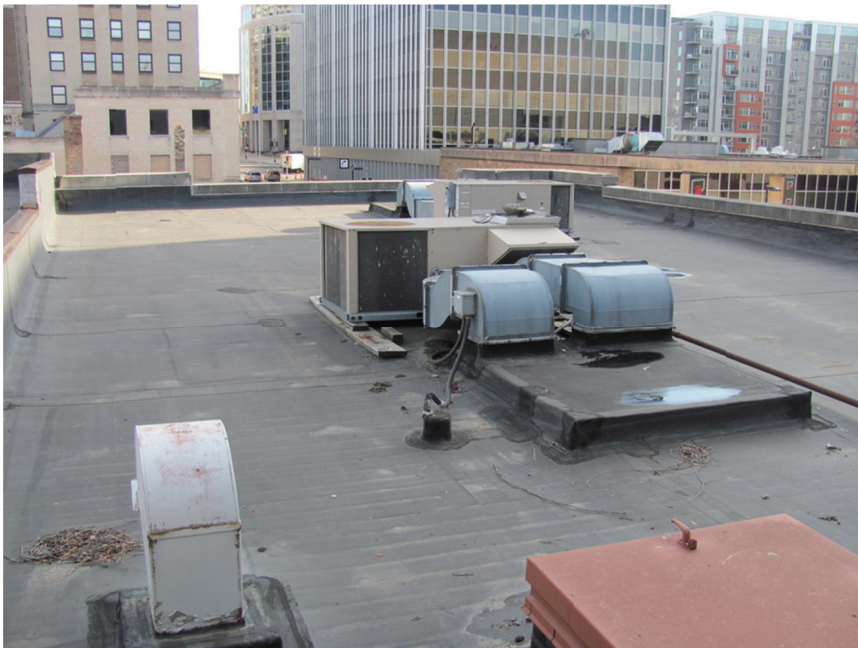
The roof is covered by a relatively new EPDM rubber membrane (Figure 7). The roof membrane extends up the back face of the parapet walls to a termination bar below the limestone coping of the street facades

and to a sheet metal coping at the rear and side party walls. The roof drains to a single drain at the northwest corner.

*Figure 7. Overview of the roof.*

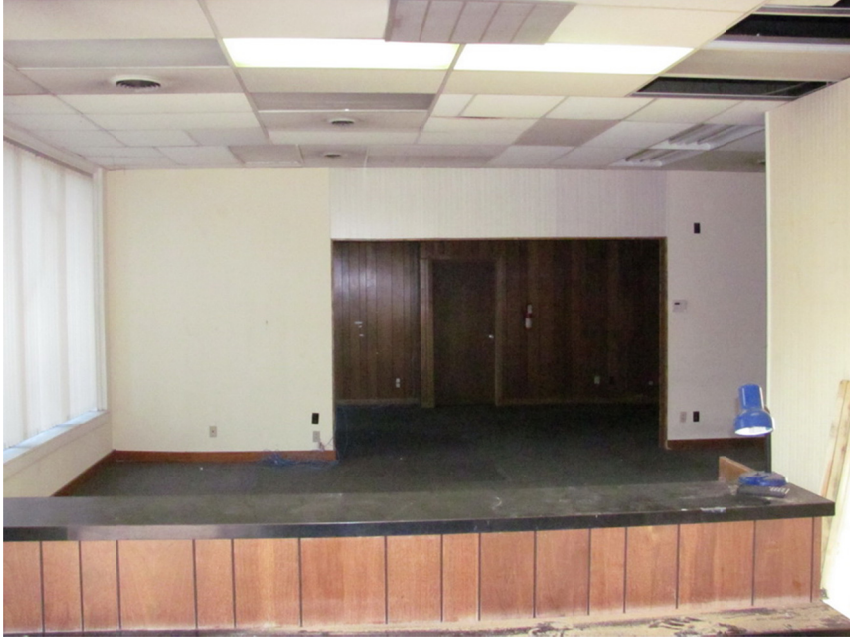
The interior of the basement, first, and second floors consists of office interiors, with carpeting or vinyl tile, wood-framed partition walls clad with gypsum board or wood paneling, suspended acoustic tile ceilings, flat panel hollow core wood doors, and simple wood trim (Figure 8). All of these materials apparently date to the circa 1969 renovation. The interior finishes are generally intact but worn.

*Figure 8. View of the interior.*

The existing interior finishes predominantly date to the late 1960s, although original ceilings and moldings are present at some locations. Repair or replacement of interior finishes would be necessary for continued use.

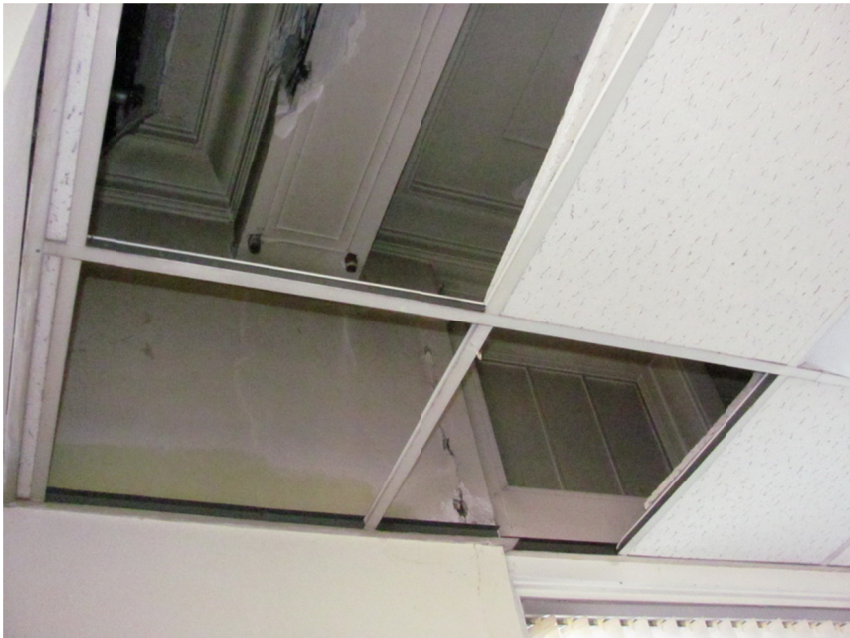
Where observed at a few locations at the first and second floors, portions of the original ceilings consisting of plaster on expanded metal lath are present above the suspended acoustic tile ceilings. The original ceilings include boxed-beams and molded cornices (Figure 9). The full extent and condition of the original ceiling finish is not known. Also visible above the suspended ceiling at the first floor were original wood-framed transom windows.

*Figure 9. The original plaster ceiling and cornice are present above the suspended acoustical ceiling system. Also note the original transoms at the first floor storefront.*

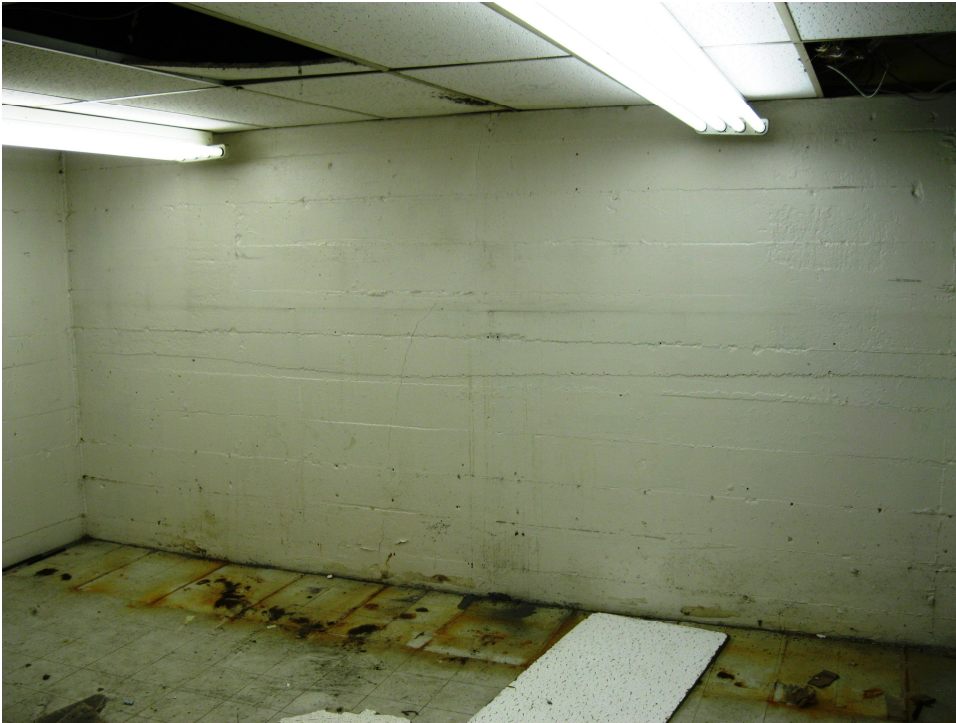
The basement walls are constructed of board formed concrete. Where exposed they appear in good condition and serviceable. No evidence of significant water infiltration is noted. The southwest grade level entry has a formed

**Photo 1** – Concrete basement wall at Mifflin / Fairchild corner

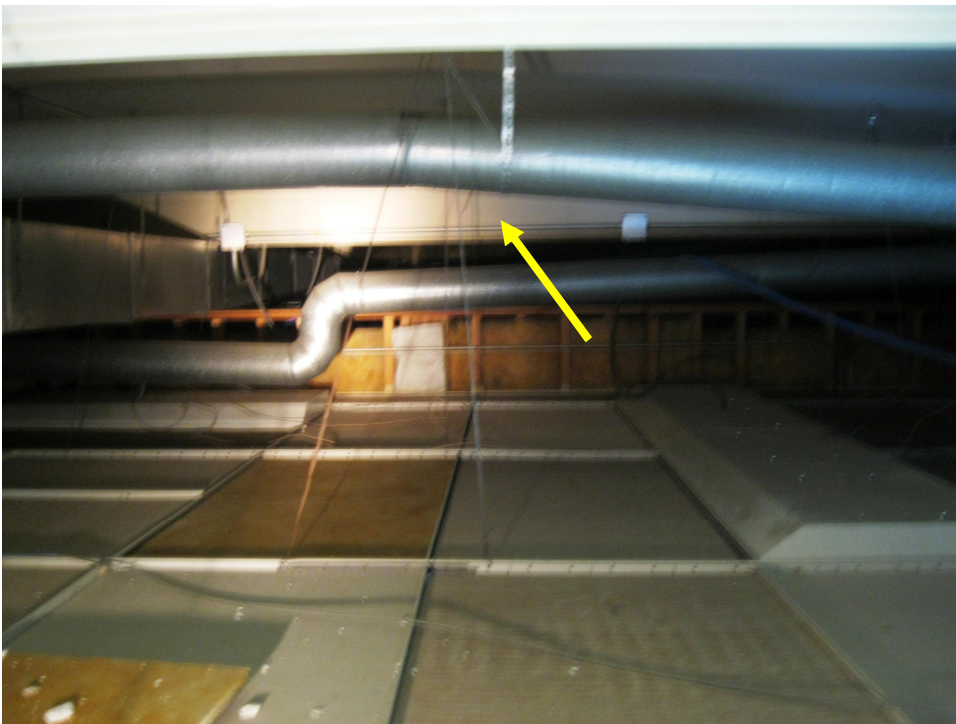
The second floor is also constructed of wood joists. They measure 2x12 @ 16" oc and span north/south. They are supported on interior steel beam lines taken as a W21x 44. The steel beams bear on the brick bearing wythe at the west wall. Along the east wall the beams are supported on steel columns adjacent and stabilized into the building to the east. The steel beams clear span the first floor space and are placed at roughly 13' oc. The span for calculation is taken at 37'. The floor joists bear atop the steel beams. A plaster ceiling is placed below the wood joists with a later acoustical tile ceiling placed below that. Floor capacity is calculated at 80 psf based on the joists and 45 psf based on the steel beam. Again present day code required live load is  $50+15=65$  psf for office occupancy.

**Photo 2** – Typical steel girder (encased) supporting 2<sup>nd</sup> floor wood joists

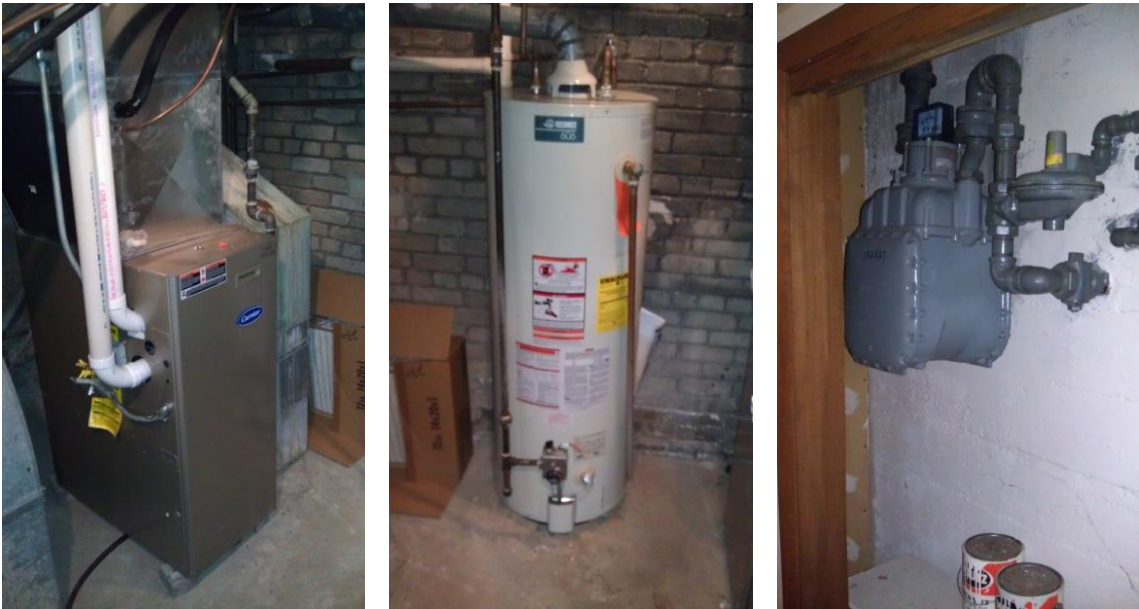
One of four identical furnaces, the water heater, and gas meter

The furnaces are new and are in very good condition. Roof mounted condensing units are of various types and sizes but all appear to be quite new. The packaged rooftop units are estimated to be about 10-15 years old which is about the normal life expectancy for that equipment. The domestic hot water heater is new and in very good condition. None of the hot water piping appears insulated. Sanitary piping is mostly cast iron and original.

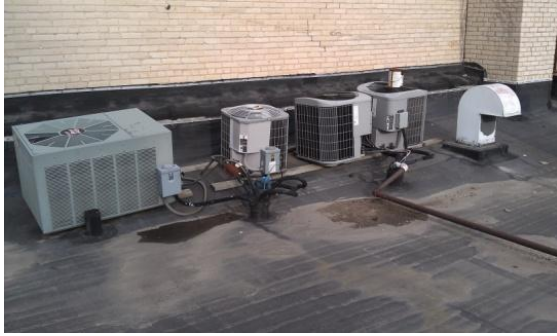
Condensing units serving the furnaces

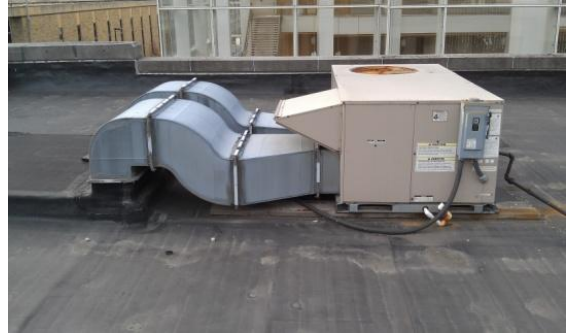
One of two packaged rooftop units

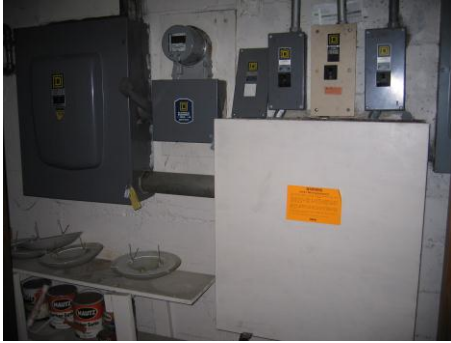
Electrical equipment age is from the 1980's. The telephone PBX appeared to be from the 1980's. There were no noted obvious failures of electrical equipment, such as evidenced by heat or smoke discoloration. The MG&E electrical service equipment appeared to be in good condition.

Electrical service in the basement.

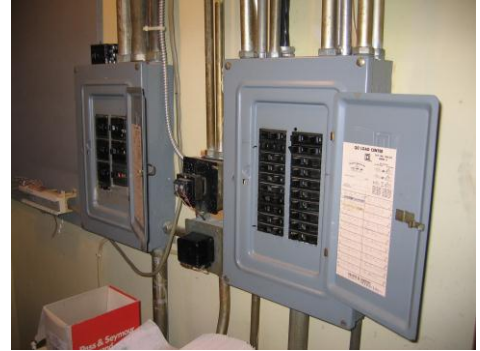
Electrical panels on 2<sup>nd</sup> floor.

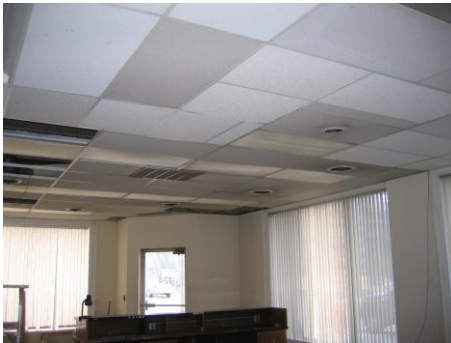
Light fixtures were primarily fluorescent (about 1980's). Some light fixtures were missing or removed. Wiring devices also appeared to be from the 1980's. Branch circuits ranged from flexible metal conduit to EMT conduit. Although the condition of the branch circuit wiring is not known, it appeared that the installation was from the 1980's.

First floor lights.

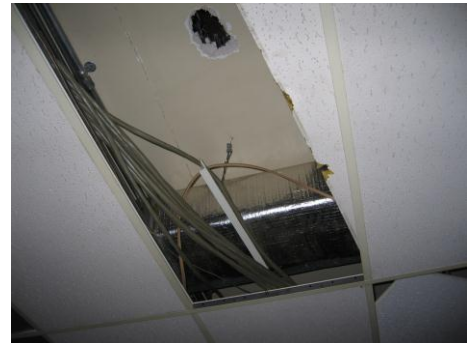
The telephone PBX cabling is supported by the suspended ceiling grid, which if constructed now would be a violation of the current code.

Electrical cables on 2<sup>nd</sup> floor.
