EXISTING BUILDING REVIEW

122-124 W. Mifflin Street

Name: Fairchild Building Corporation

122–124 West Mifflin Street – Architectural Review

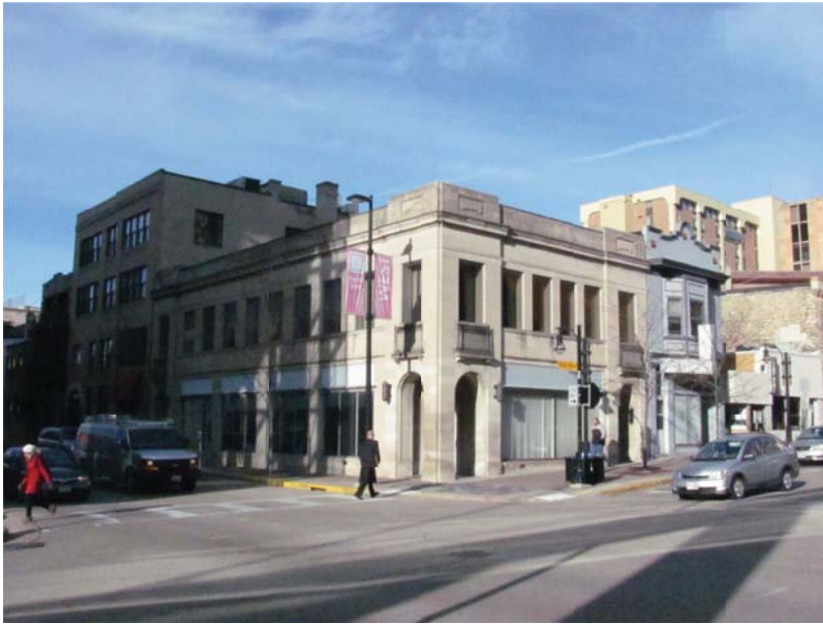
The masonry exterior of the building is constructed of limestone, likely Indiana limestone (Figure 1). Ornamental features of the facade include decorative brass and glass exterior wall-mounted light fixtures and decorative iron balustrades below the second story windows above the entrances (Figure 2 and Figure 3).

Figure 1. Overall view of 124 West Mifflin. The Mifflin Street facade is at right, while the Fairchild Street facade is at left.

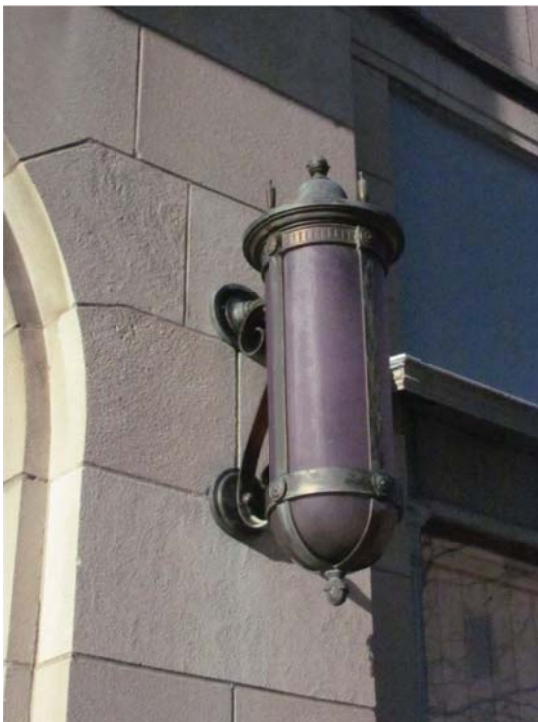
Figure 2. Left. Decorative brass and glass exterior light fixture.

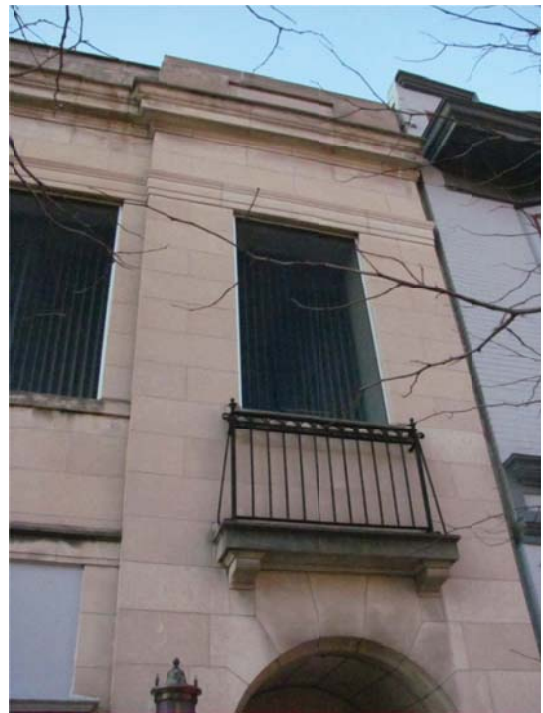
Figure 3. Right. Decorative iron balustrade.

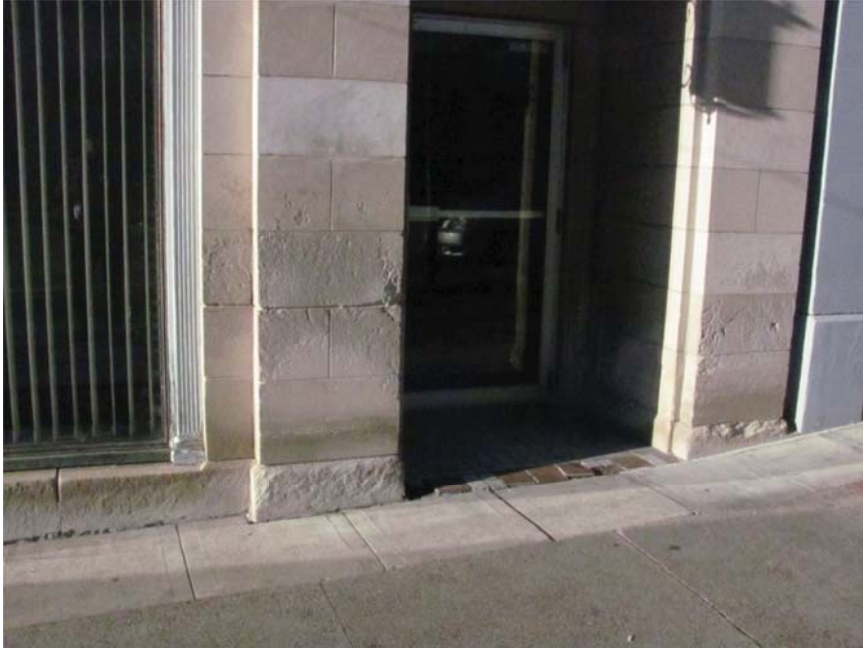
Localized distress was observed in the limestone masonry. Portions of the stone near grade exhibit erosion and pitting of the face (Figure 4). Erosion of this type is often related to water splash-back from sidewalk paving, snow accumulation, and the use of de-icing salts. Dark staining was observed at the recessed entrances and at the parapet walls. Occasional cracked or open mortar joints are present throughout the facade. Cracking and spalling were observed at the head of many of the first floor window openings; this type of distress is likely related to corrosion of embedded steel lintels (Figure 5).

Figure 4. Portions of the limestone masonry near grade exhibit erosion and pitting of the face.

Based on this limited survey, the limestone masonry of the street facades would require localized repairs to address spalling, cracking, loss of mortar, and staining. The condition of the embedded steel window lintels requires further study to evaluate existing conditions and determine an appropriate repair. The integration of the roof assembly with the cornice, parapet, and coping requires further study to provide a watertight envelope. If required by code, provision for overflow roof drainage will need to be created.

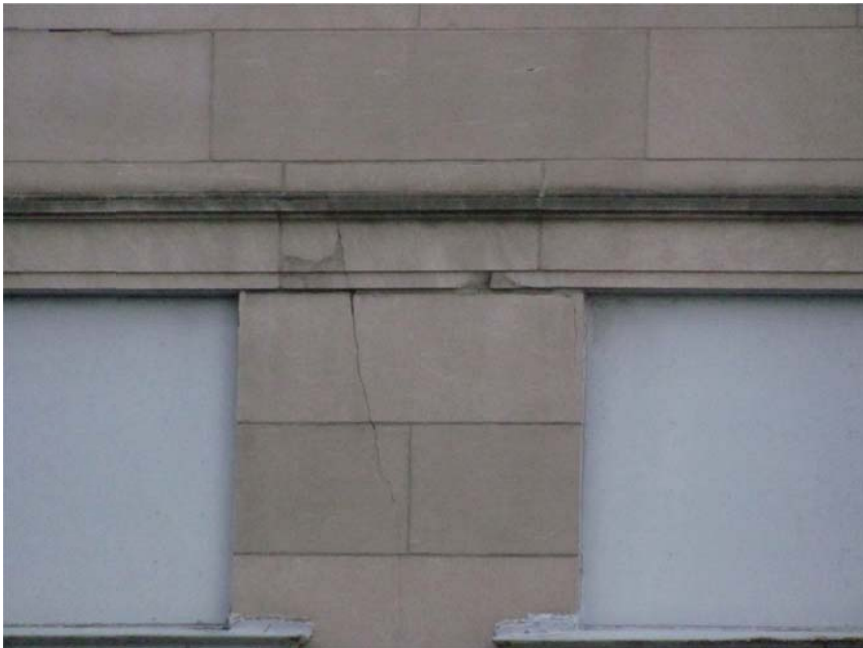
Figure 5. Cracking and spalling of limestone masonry at the head of a first floor window opening.

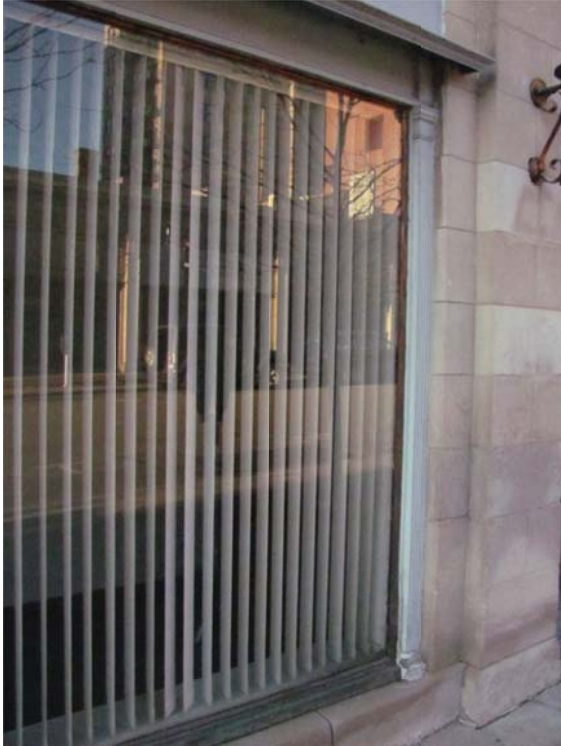
Figure 6. The storefront facing Mifflin Street has a bronze frame and fluted bronze pilasters as window jambs.

The window and door system at most areas dates to the late 1960s. It is likely not cost effective to retrofit the system for improved performance. Therefore, consideration could be given to replacing the windows and doors with new thermally improved aluminum-framed assemblies. The existing first floor transom windows and the one bay of bronze storefront at Mifflin Street appear intact and could be rehabilitated and reused.

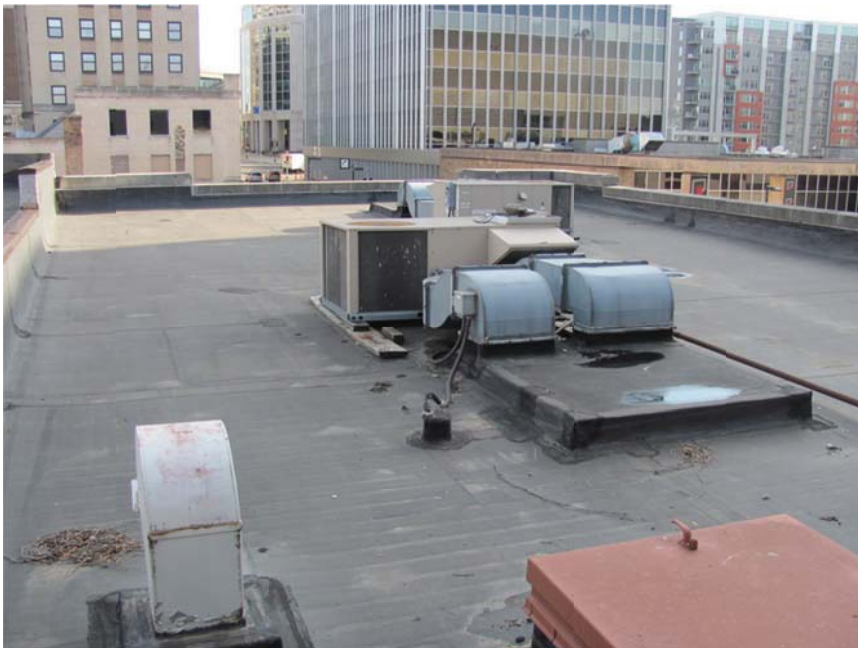
The roof is covered by a relatively new EPDM rubber membrane (Figure 7). The roof membrane extends up the back face of the parapet walls to a termination bar below the limestone coping of the street facades

and to a sheet metal coping at the rear and side party walls. The roof drains to a single drain at the northwest corner.

Figure 7. Overview of the roof.

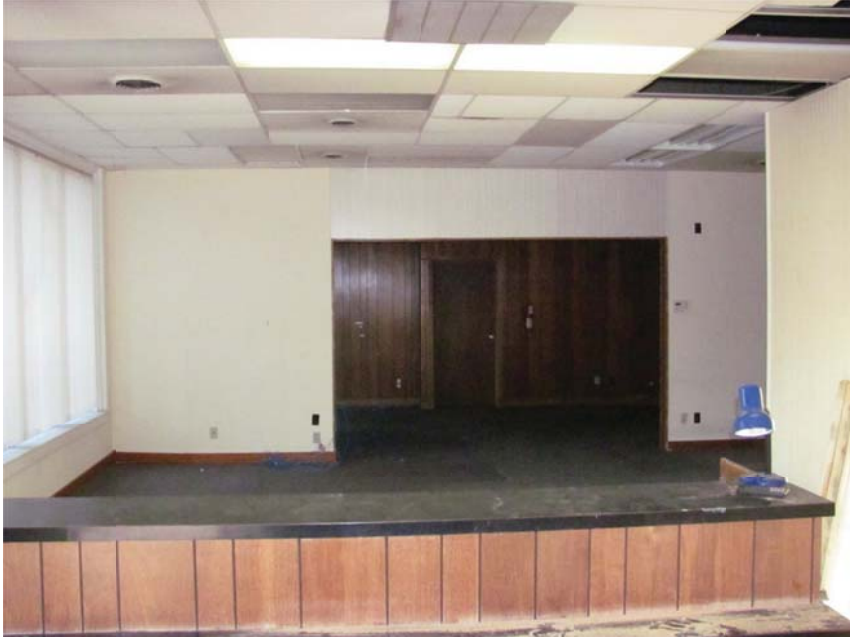
The interior of the basement, first, and second floors consists of office interiors, with carpeting or vinyl tile, wood-framed partition walls clad with gypsum board or wood paneling, suspended acoustic tile ceilings, flat panel hollow core wood doors, and simple wood trim (Figure 8). All of these materials apparently date to the circa 1969 renovation. The interior finishes are generally intact but worn.

Figure 8. View of the interior.

The existing interior finishes predominantly date to the late 1960s, although original ceilings and moldings are present at some locations. Repair or replacement of interior finishes would be necessary for continued use.

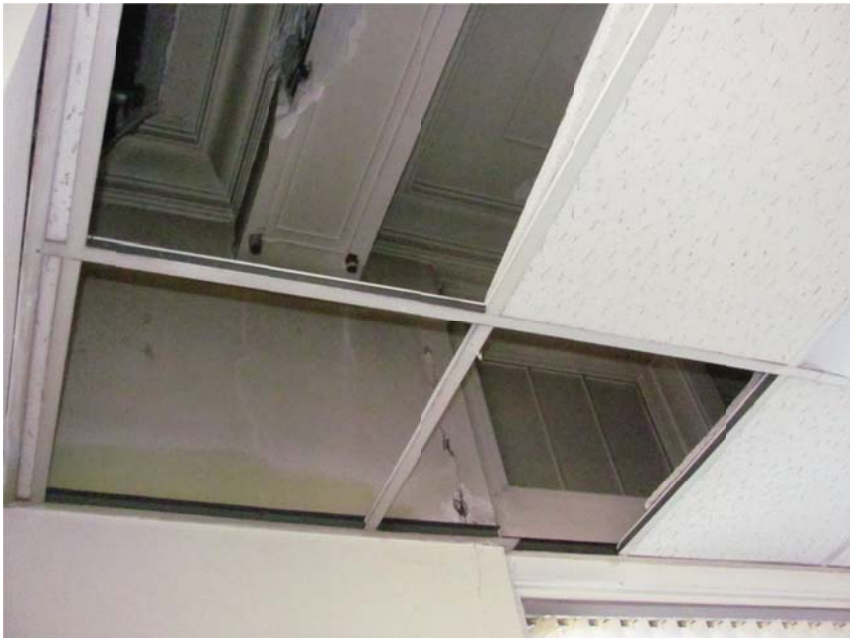
Where observed at a few locations at the first and second floors, portions of the original ceilings consisting of plaster on expanded metal lath are present above the suspended acoustic tile ceilings. The original ceilings include boxed-beams and molded cornices (Figure 9). The full extent and condition of the original ceiling finish is not known. Also visible above the suspended ceiling at the first floor were original wood-framed transom windows.

Figure 9. The original plaster ceiling and cornice are present above the suspended acoustical ceiling system. Also note the original transoms at the first floor storefront.

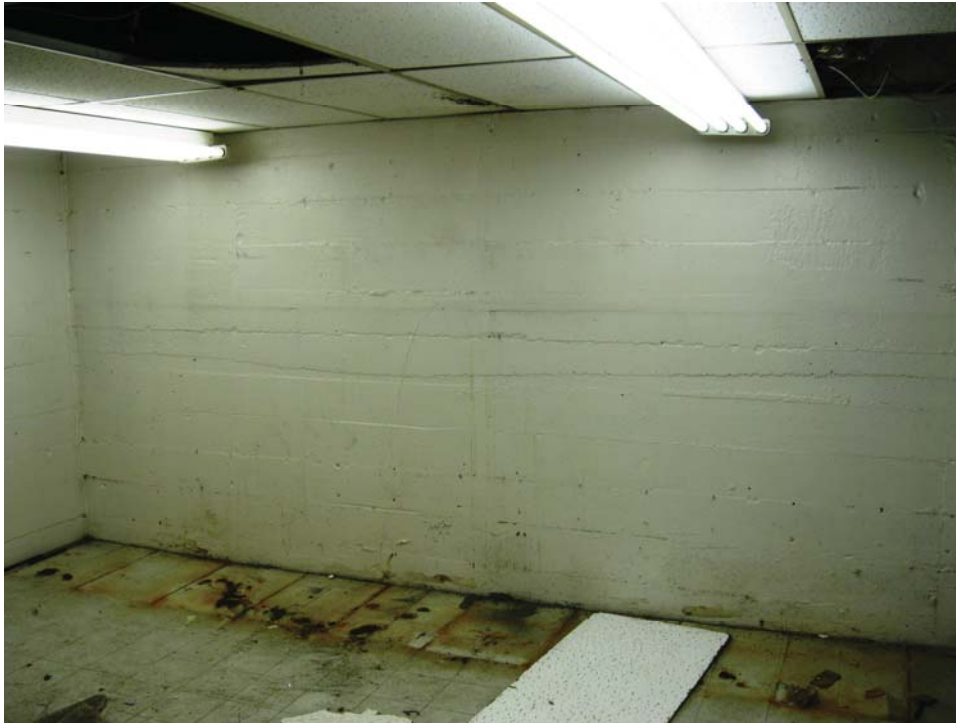
The basement walls are constructed of board formed concrete. Where exposed they appear in good condition and serviceable. No evidence of significant water infiltration is noted. The southwest grade level entry has a formed

Photo 1 – Concrete basement wall at Mifflin / Fairchild corner

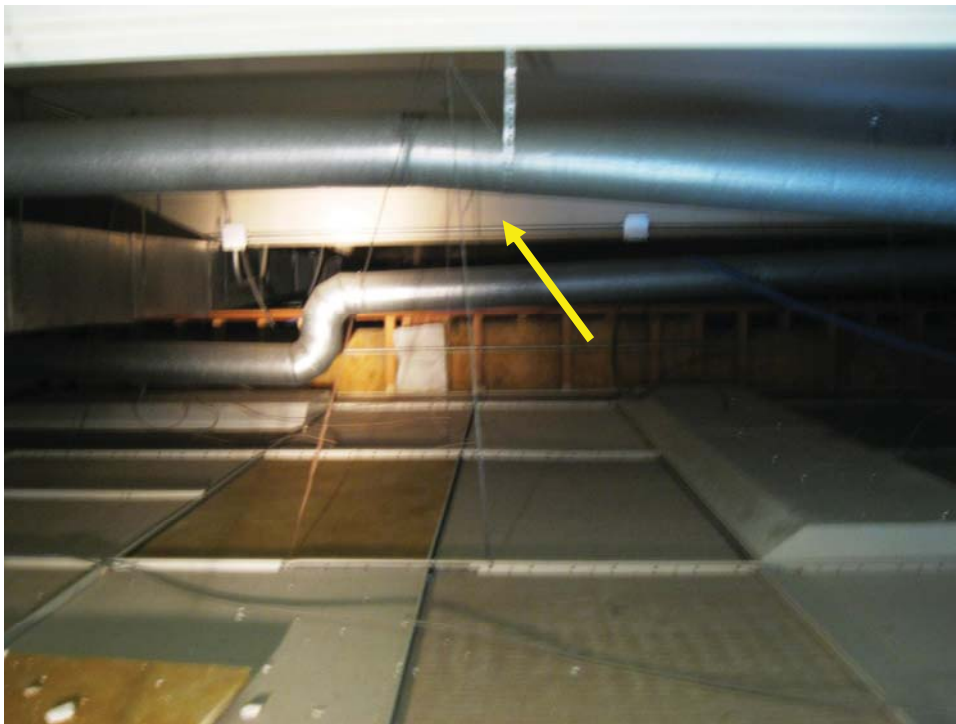
The second floor is also constructed of wood joists. They measure 2x12 @ 16" oc and span north/south. They are supported on interior steel beam lines taken as a W21x 44. The steel beams bear on the brick bearing wythe at the west wall. Along the east wall the beams are supported on steel columns adjacent and stabilized into the building to the east. The steel beams clear span the first floor space and are placed at roughly 13' oc. The span for calculation is taken at 37'. The floor joists bear atop the steel beams. A plaster ceiling is placed below the wood joists with a later acoustical tile ceiling placed below that. Floor capacity is calculated at 80 psf based on the joists and 45 psf based on the steel beam. Again present day code required live load is $50+15=65$ psf for office occupancy.

Photo 2 – Typical steel girder (encased) supporting 2nd floor wood joists

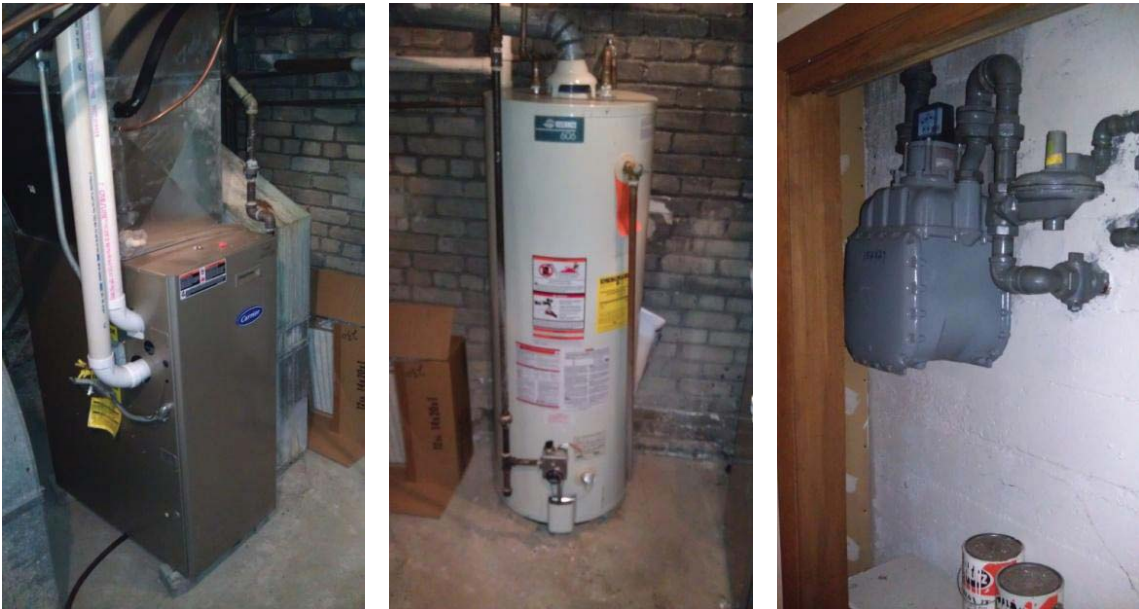
One of four identical furnaces, the water heater, and gas meter

The furnaces are new and are in very good condition. Roof mounted condensing units are of various types and sizes but all appear to be quite new. The packaged rooftop units are estimated to be about 10-15 years old which is about the normal life expectancy for that equipment. The domestic hot water heater is new and in very good condition. None of the hot water piping appears insulated. Sanitary piping is mostly cast iron and original.

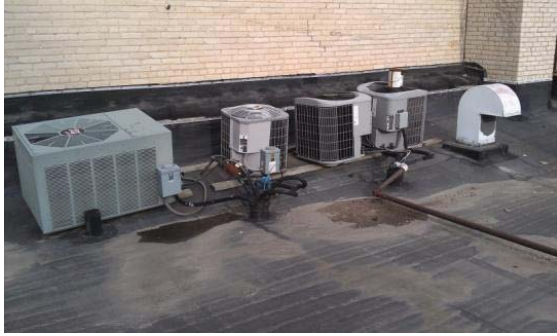
Condensing units serving the furnaces

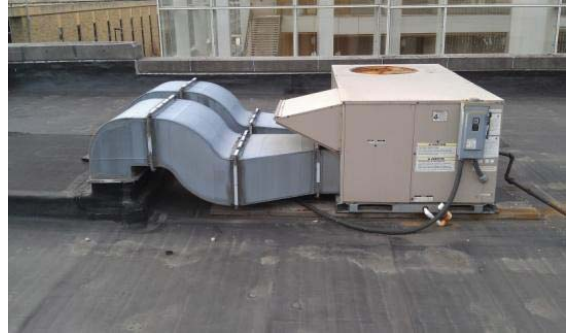
One of two packaged rooftop units

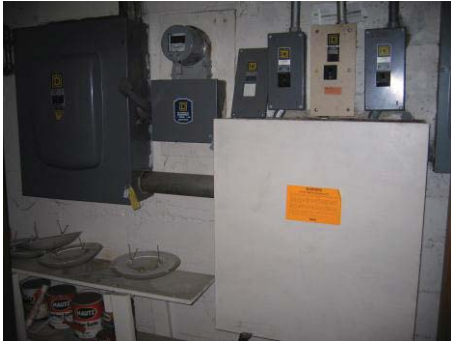
Electrical equipment age is from the 1980's. The telephone PBX appeared to be from the 1980's. There were no noted obvious failures of electrical equipment, such as evidenced by heat or smoke discoloration. The MG&E electrical service equipment appeared to be in good condition.

Electrical service in the basement.

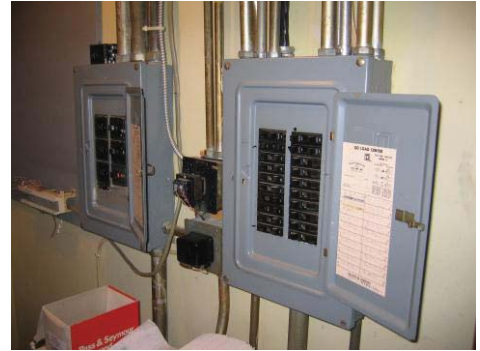
Electrical panels on 2nd floor.

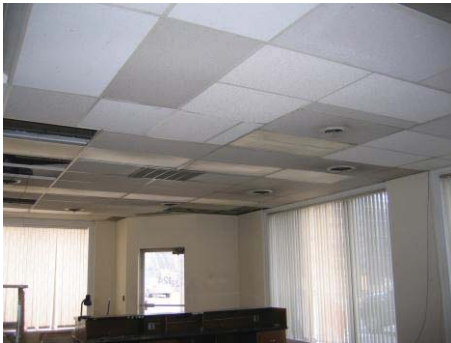
Light fixtures were primarily fluorescent (about 1980's). Some light fixtures were missing or removed. Wiring devices also appeared to be from the 1980's. Branch circuits ranged from flexible metal conduit to EMT conduit. Although the condition of the branch circuit wiring is not known, it appeared that the installation was from the 1980's.

First floor lights.

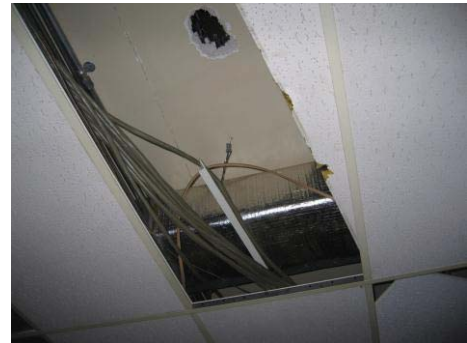
The telephone PBX cabling is supported by the suspended ceiling grid, which if constructed now would be a violation of the current code.

Electrical cables on 2nd floor.
