Re: 122 State Street Façade Historic Fabric
Madison, WI.

The following is my report on the 122 State Street façade.

122 State Street, Façade Historic Fabric
Selected Images (August 20, 2015 & October 1, 2015)

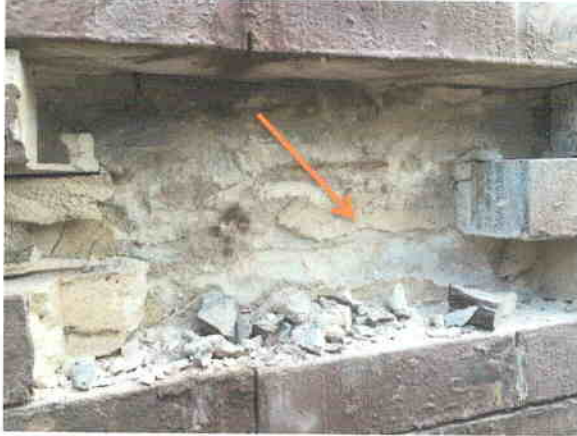
Image 1

Partial view of the State Street façade where the current brick surface was removed to expose the substrate. Some areas of the original stone remain but are busted back and covered with a cement parging (orange arrow) . The brick has been adhered to the face of the stone with a Portland mortar. August 20, 2015

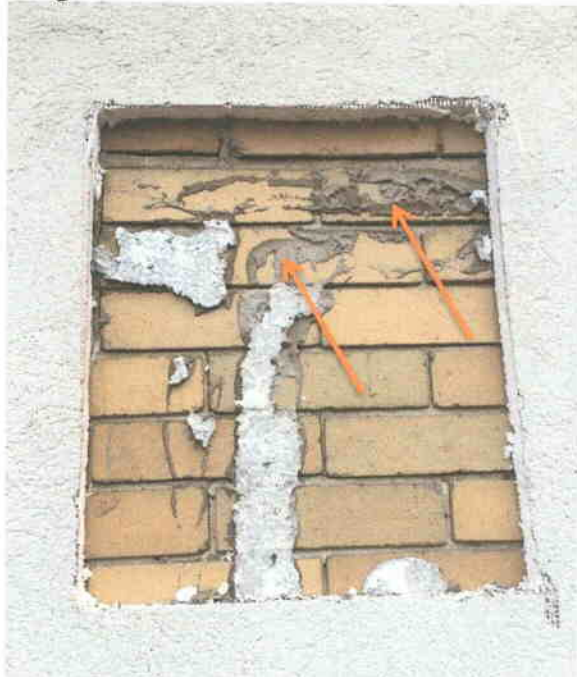
Image 2

View of the State Street façade where the stucco surface has been removed to expose the original brick masonry wall. Note the adhesive on the brick (orange arrows) used to attach the stucco substrate. August 20, 2015.

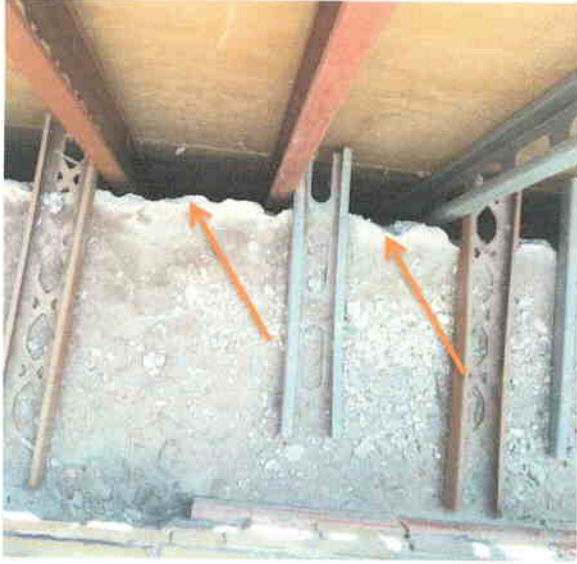
Image 3

View looking down at the cornice area on the State Street façade. At the bottom of the image is the brick masonry parapet wall as it meets the projecting terra cotta cornice. Note that the front edge of the cornice has been removed or cut back (orange arrows) to allow the metal framing for the stucco to pass by. August 20, 2015.

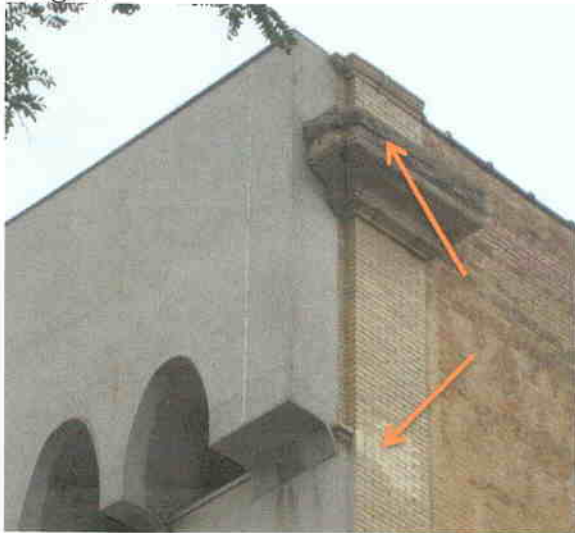
Image 4

View of the right side of the State Street façade at the cornice level. Note the damage to the terra cotta cornice and that the original stone belt course has been removed and infilled with brick. (orange arrows). August 20, 2015.

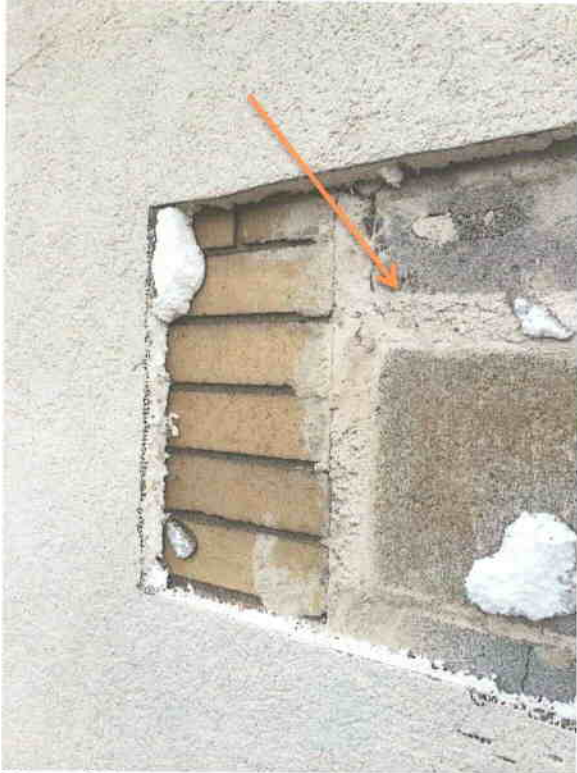
Image 5

View of the concrete block infill used where original windows and doors were removed. August 20, 2015.

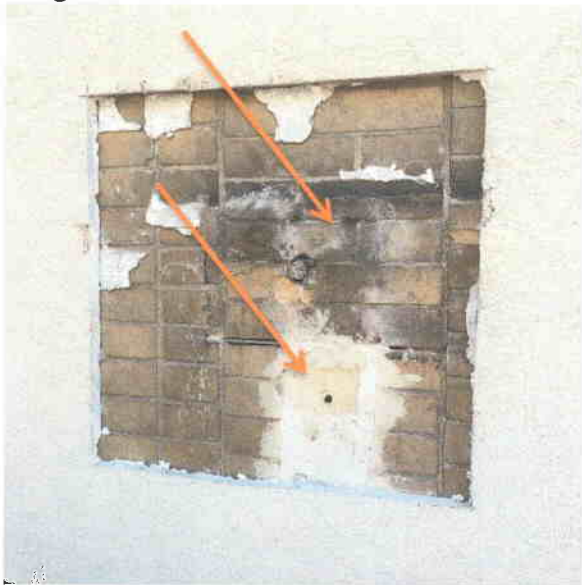
Image 6

Image of brick area where original applied decorative trim was removed and void infilled with mortar. October 1, 2015

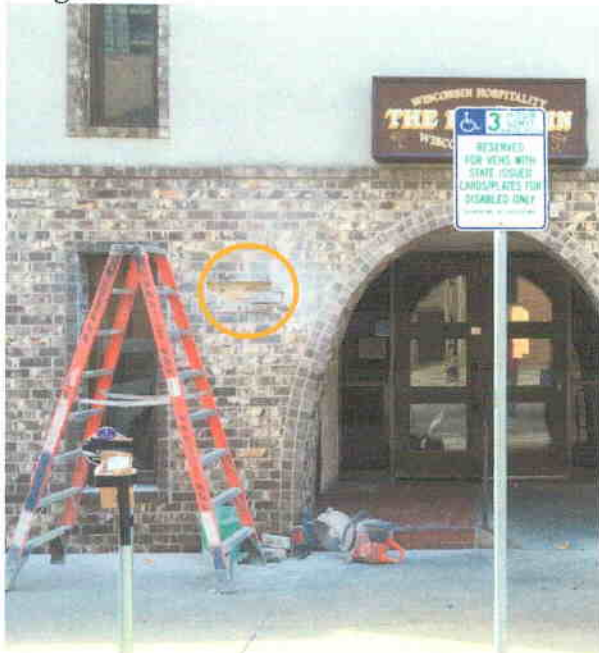
Image 8

View of one probe location on the Carroll Street façade. October 1, 2015.
