## 2412 Waunona Way, WI – Condition Assessment 11/11/2022

Prepared by Lindsey Shotwell, AIA

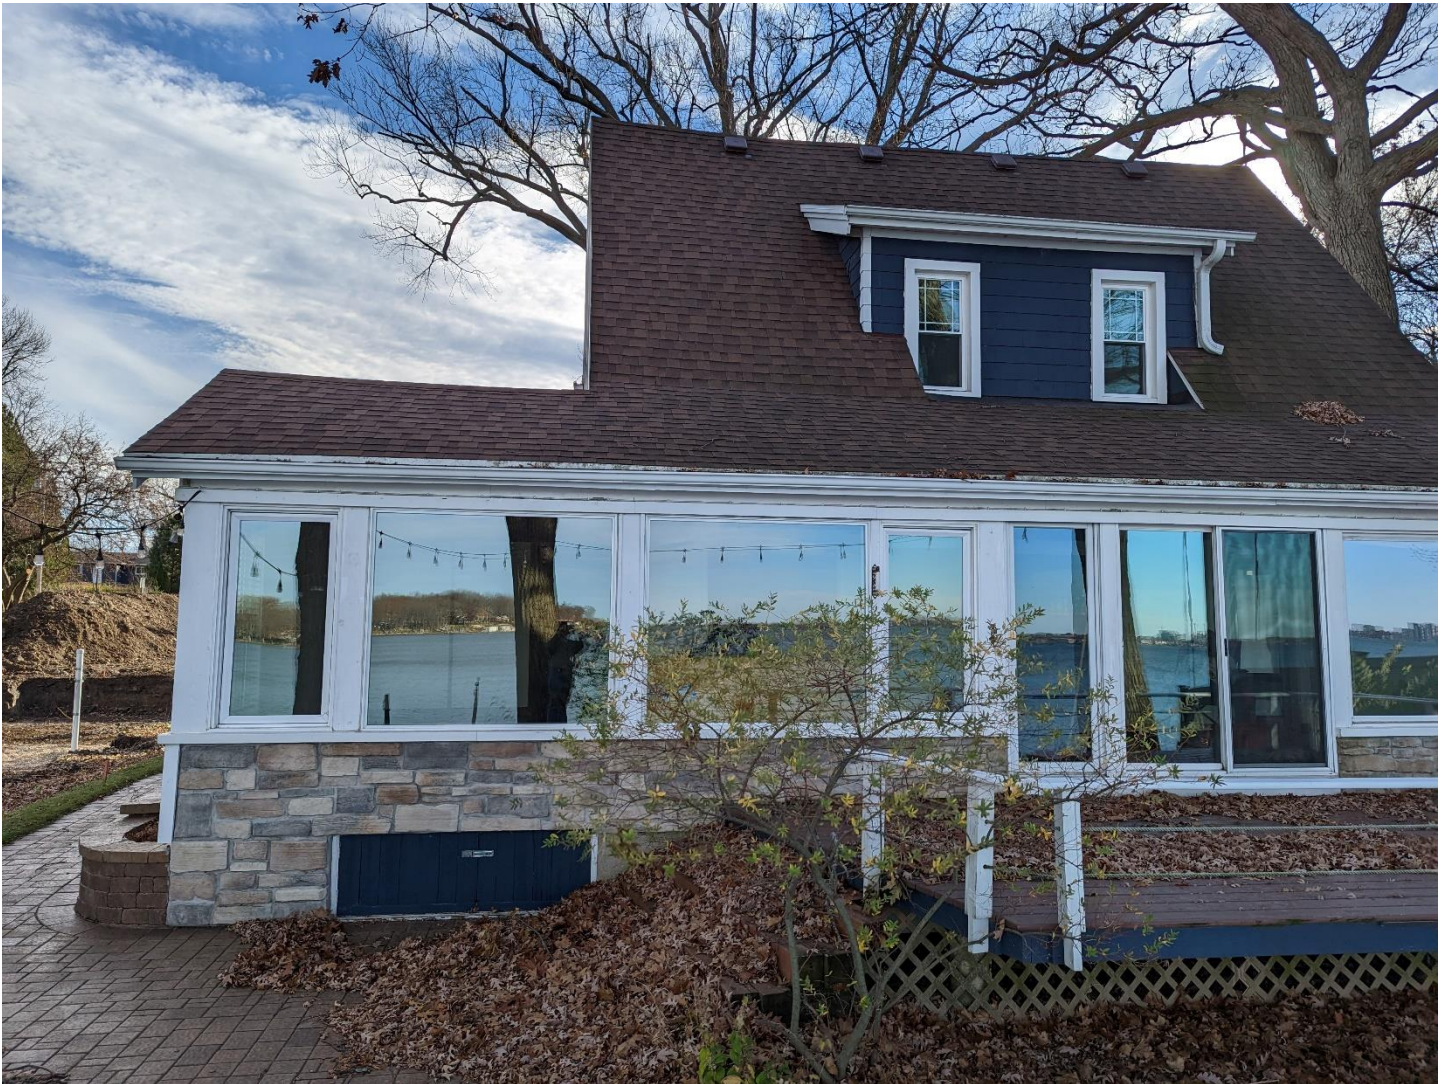
Lake Facing Building Elevation – Note sagging roofline at lower and upper roof ridges.

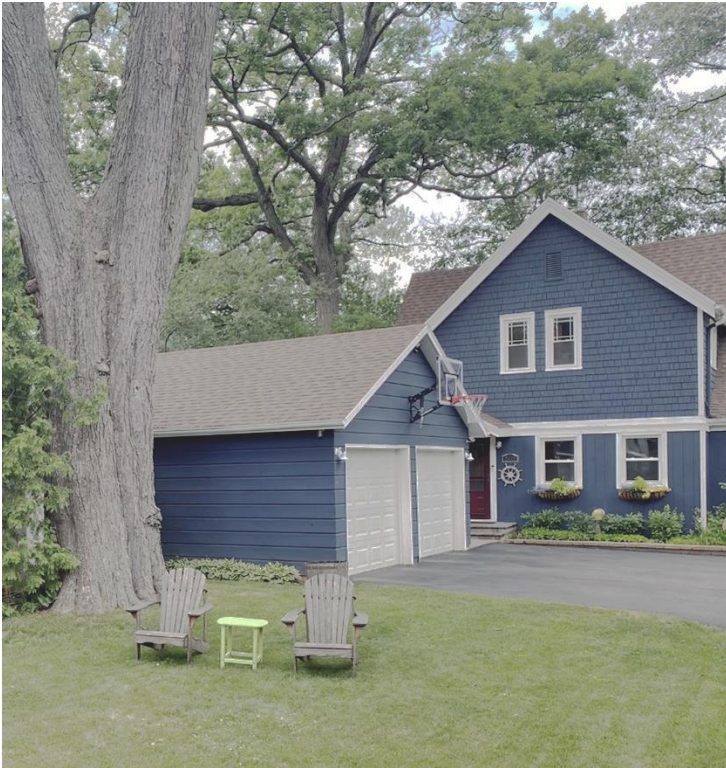
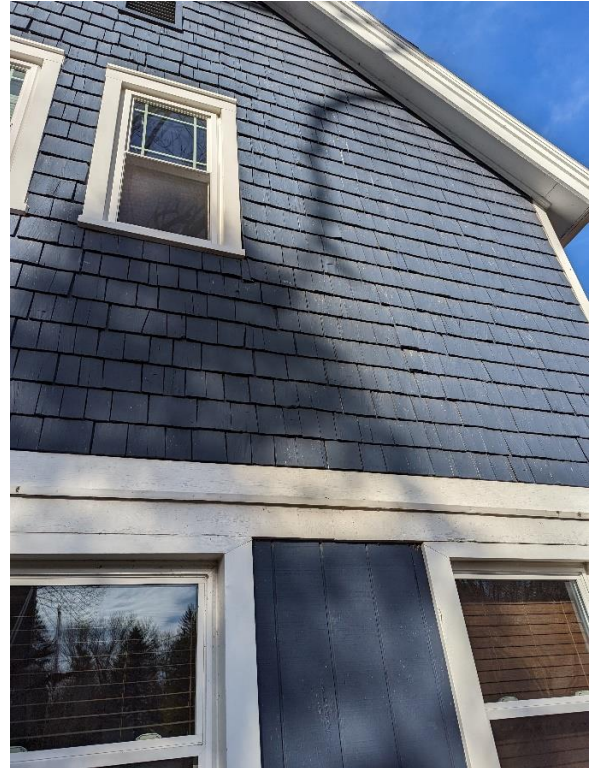
Street facing building elevation & detached garage.

**Street Elevation** – Deteriorating cedar shingle siding at east elevation. Landscaping pavers and front door – recommend recycle and re-use. Windows throughout house are not original, salvage and reuse wherever possible.

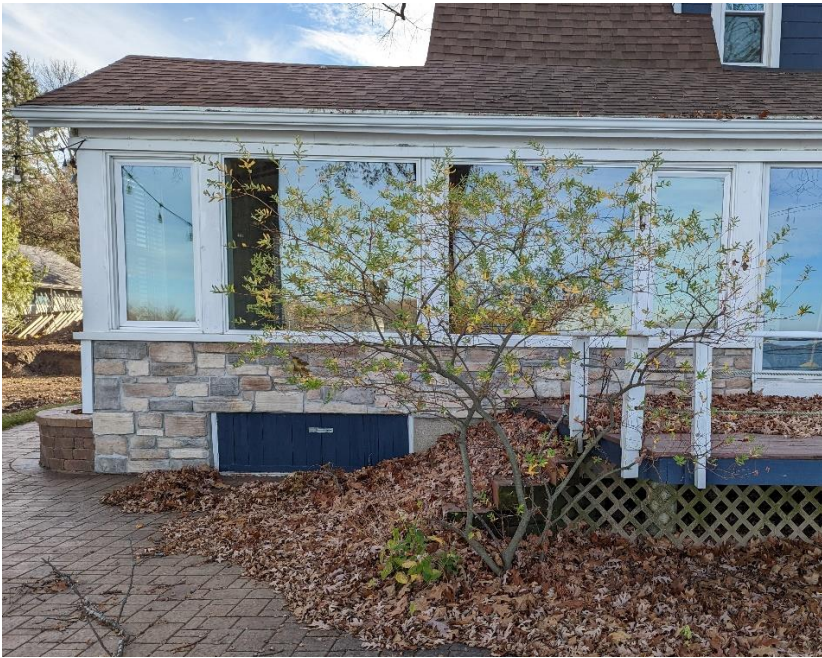
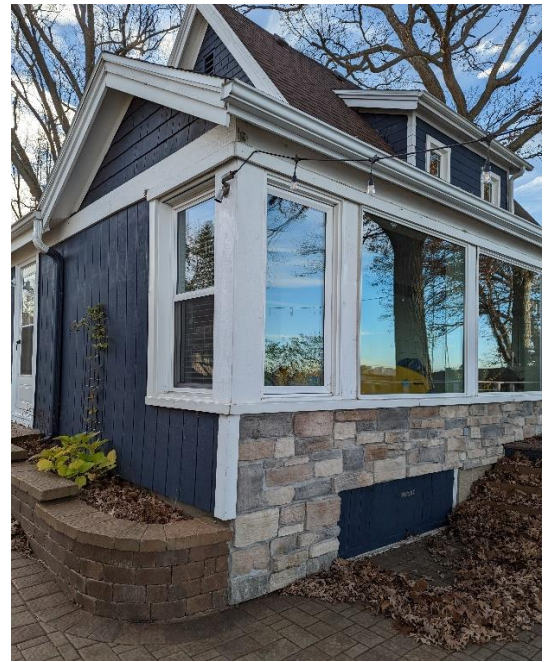
**Lake Side of House** – The upper windows are non historic vinyl inserts, deck is deteriorating and near end of life. Roof ridge shows sagging structure and settling of foundation.

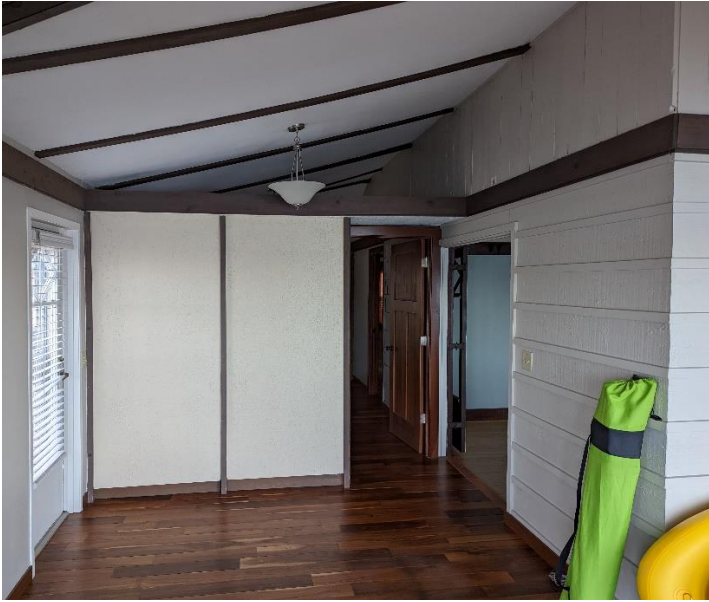
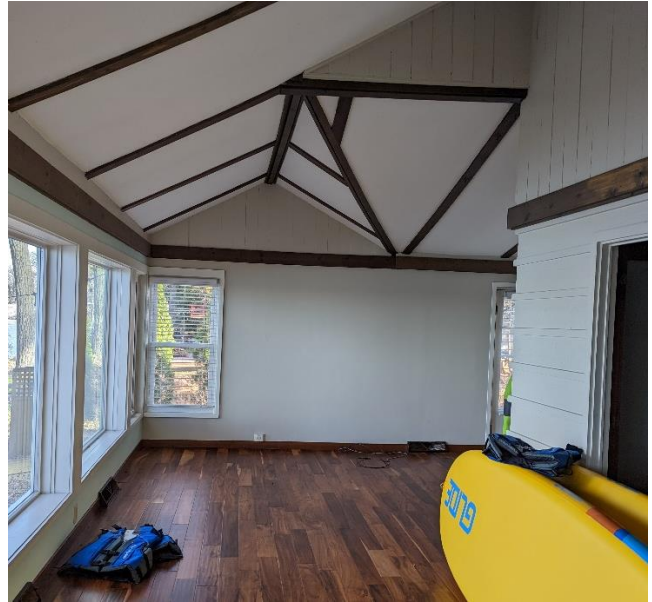
**Main Level Kitchen & Living** – Enclosed screen porch with poor thermal performance. Canted main level floors due to foundation settling. Laminate flooring at enclosed porch addition.

Images of first floor interior spaces, additions to original building with xtg laminate flooring.

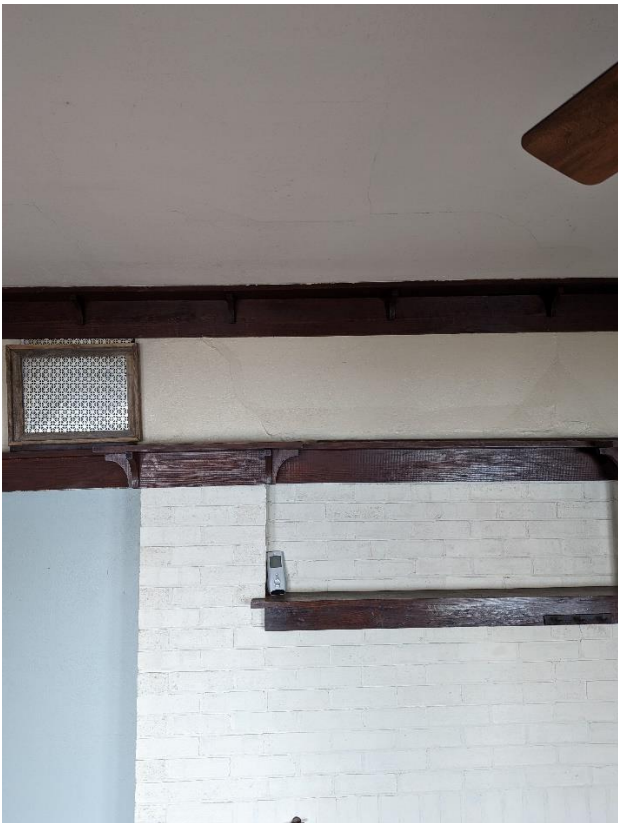
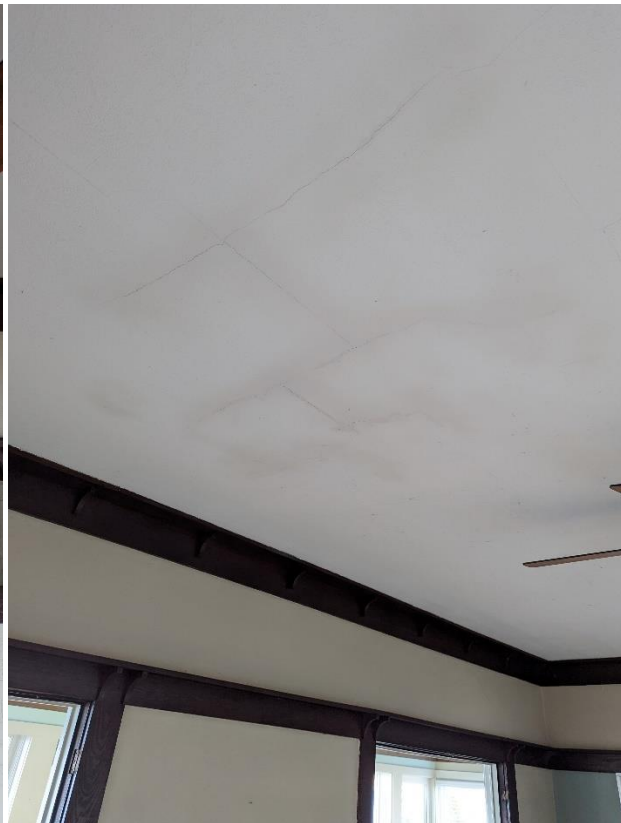
Images of first floor settling and cracking at original building living spaces.

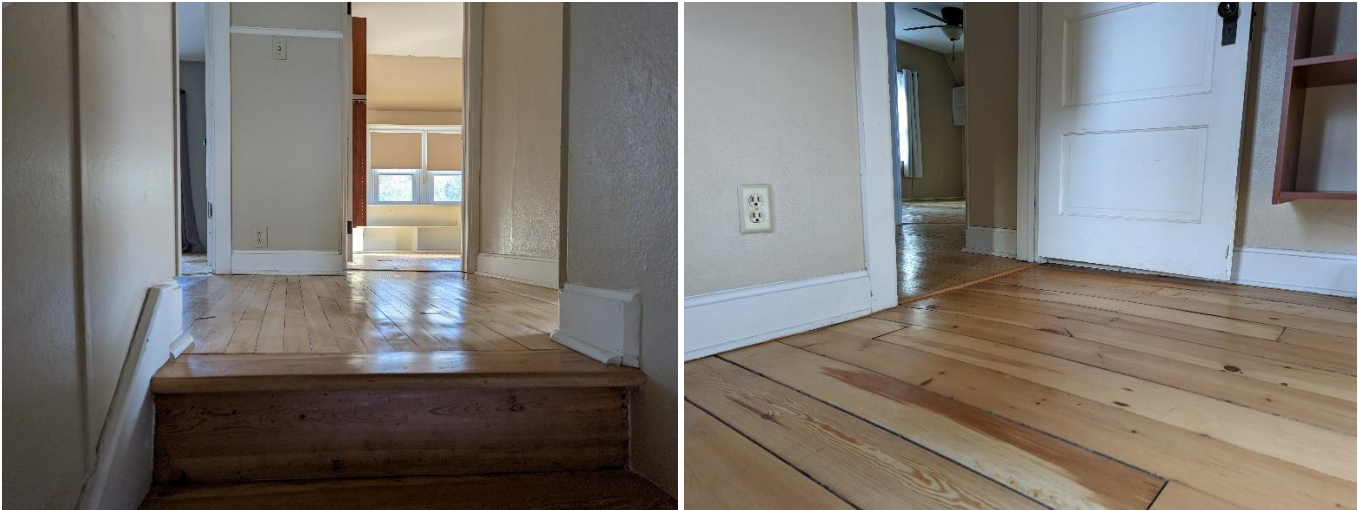
**Upper Bedrooms** – Undersized floor and roof structure are resulting in uneven and canted floors. Some 2<sup>nd</sup> floors slope 1-2". Ceilings and roof transitions display poor roof structure performance. Cracking and settling at roof transitions.

**Images of upper level canted floors and uneven structure settling.**

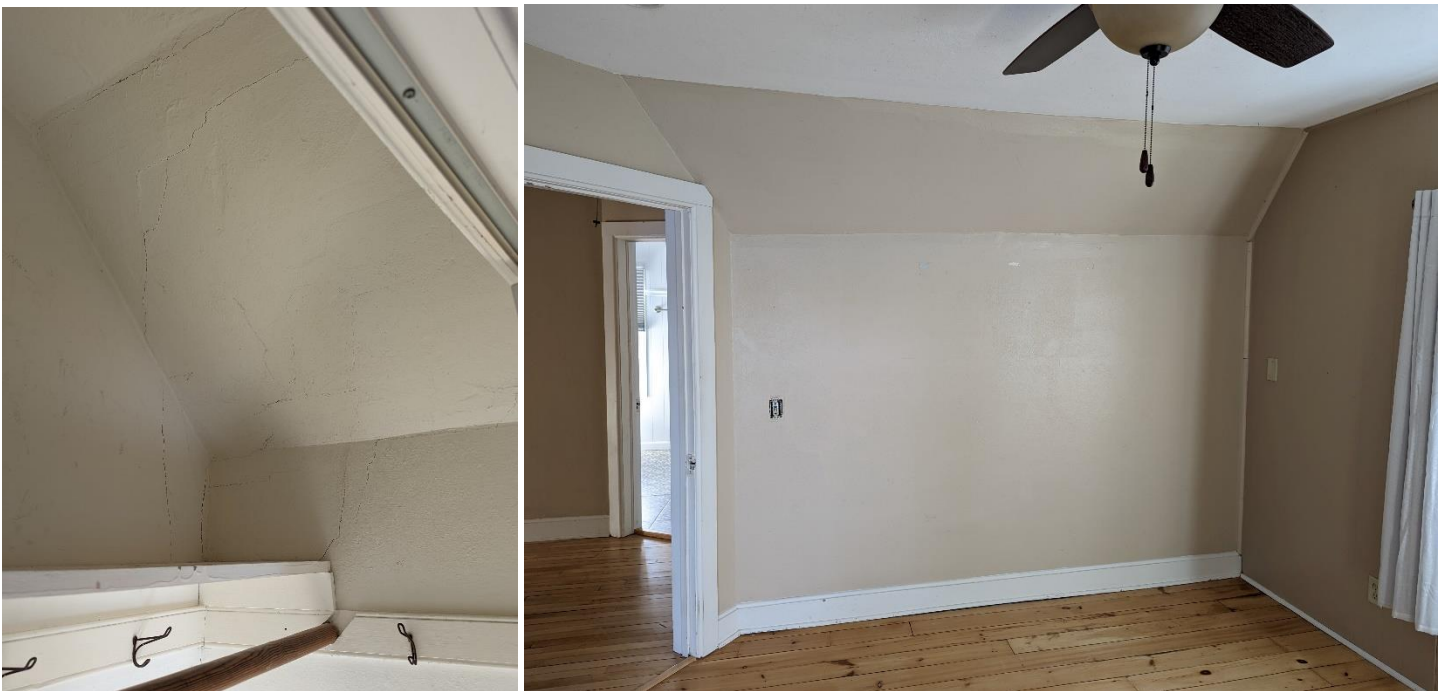
**Images of upper level plaster cracking and roof structure deformation.**
