05 Jun 2019 - 11:06 AM \\wvds01\work\3781 & 5817 Cottage Grove Rd. Madison\CADD\190138\_Bone.dwg by:pbw

**DEMOLITION PLAN LEGEND**

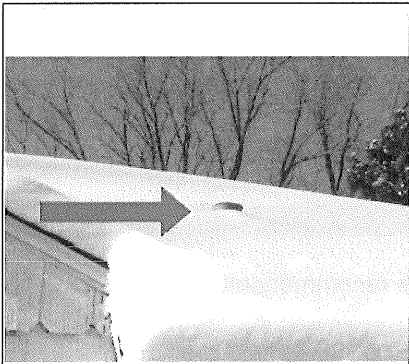
- Plumbing vents on roof are to low. Recommend repair.

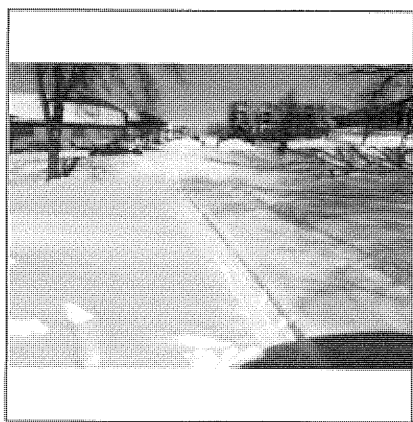
None    Not Visible  
**Material**    Concrete    Asphalt    Gravel/Dirt    Brick   Other:  
**Condition**    Satisfactory    Marginal    Poor    Settling Cracks    Typical cracks    Pitched towards home  
 Trip hazard    Fill cracks and seal  
**Comments**  
**Photos**

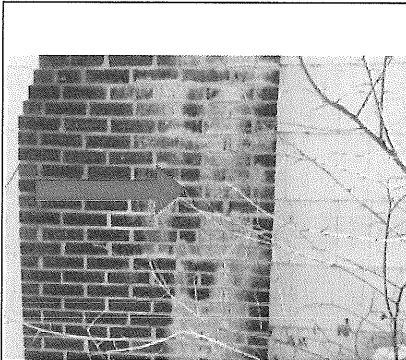
- Chimney brick is covered with Efflorescence indicating water is getting behind the brick. Recommend further evaluation and repair.

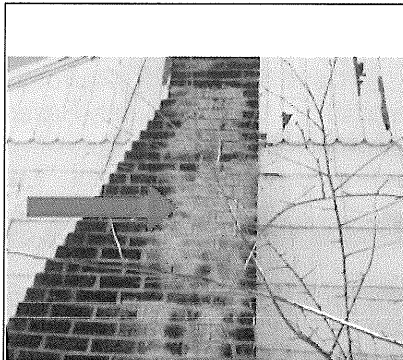
- Chimney brick is covered with Efflorescence indicating water is getting behind the brick. Recommend further evaluation and repair.

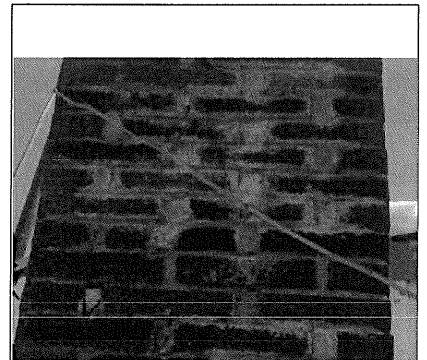
- Chimney brick is covered with Efflorescence indicating water is getting behind the brick. Recommend further evaluation and repair.

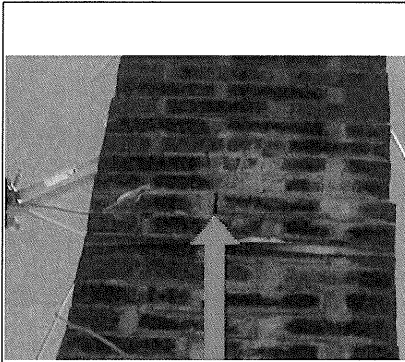
Mortar joints are missing in areas on chimney. Recommend repair

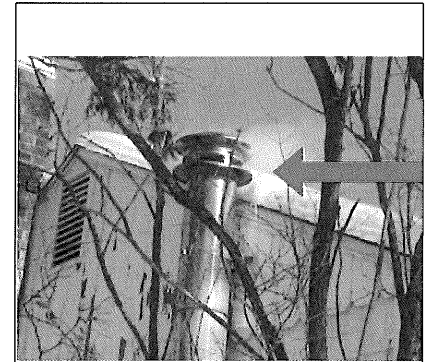
- Metal furnace chimney is not high enough over roof. Recommend repair.

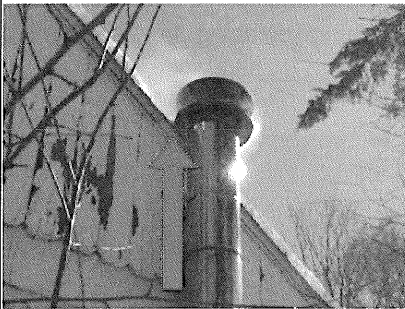
- Metal furnace chimney is not high enough over roof. Recommend repair.

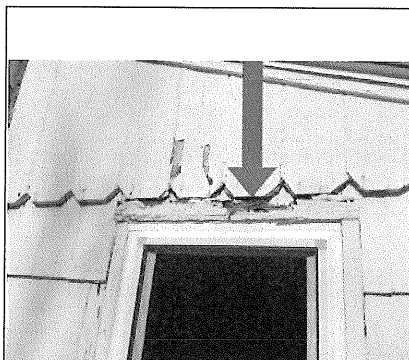
- Some rotted trim boards on siding corners and around windows, recommend repair/replacing damaged sections

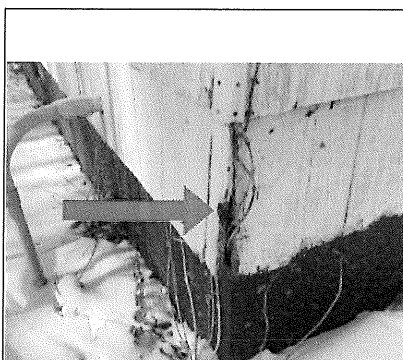
- Some rotted trim boards on siding corners and around windows, recommend repair/replacing damaged sections

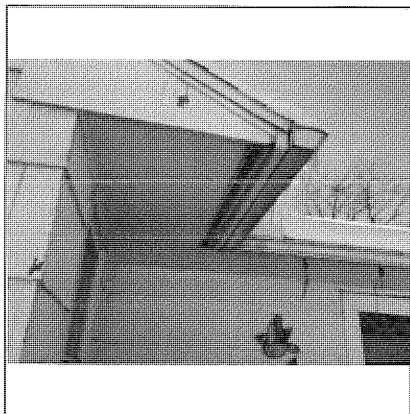
**Comments**  
**Photos**

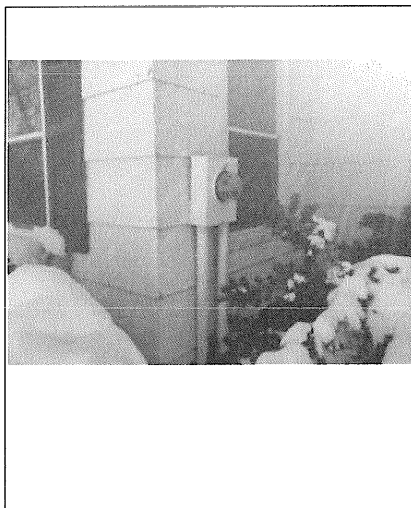
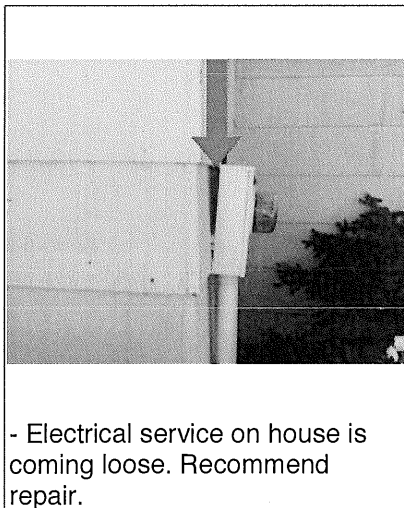
- Electrical service on house is coming loose. Recommend repair.

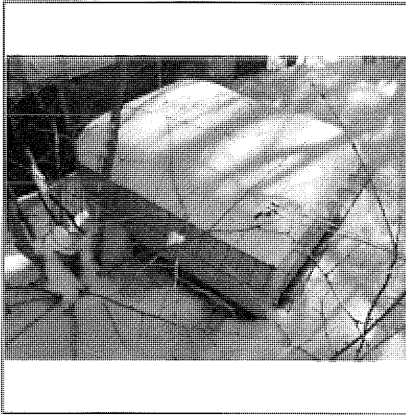
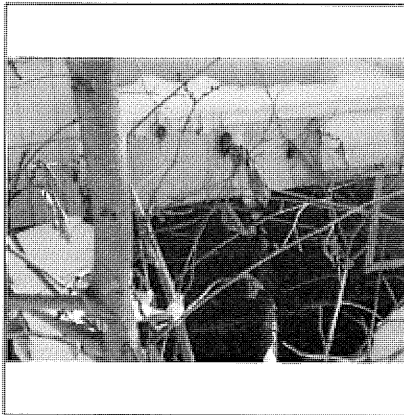
## Exterior A/C - Heat pump #2

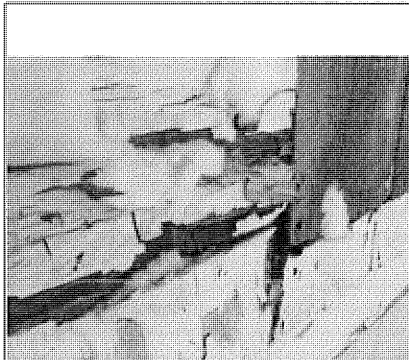
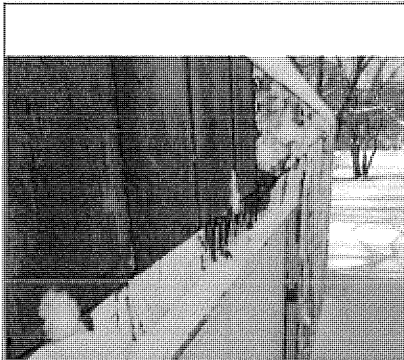
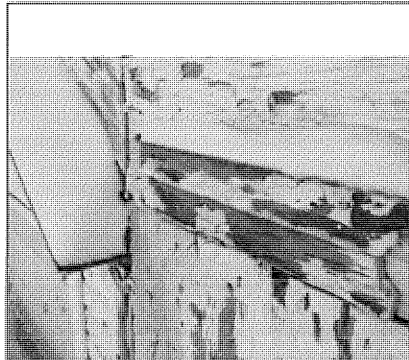
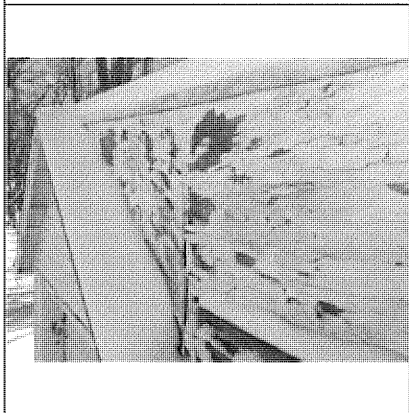
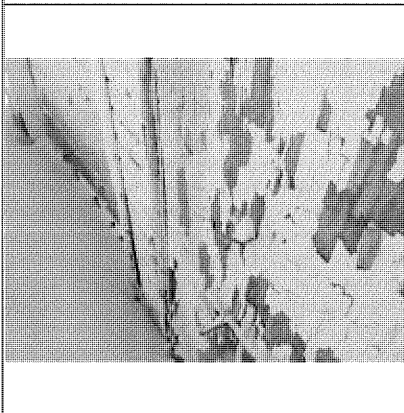
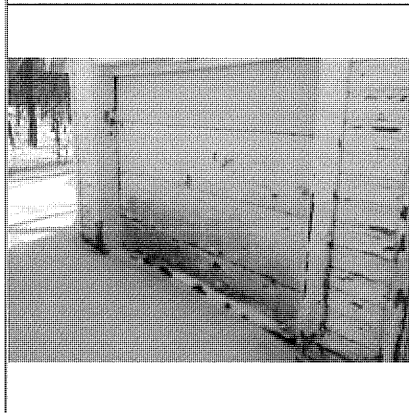
N/A  
**Material**  Same as house  Wood  Metal  Vinyl  Stucco  Masonry  Slate  Fiberboard  
**Condition**  Satisfactory  Marginal  Poor  Recommend repair/replace  Recommend painting  
**Comments** - Wood siding is in poor condition / rotted and in need of paint. Recommend replacing siding on garage  
**Photos**

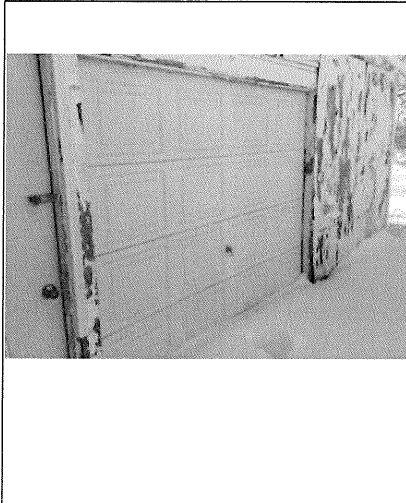
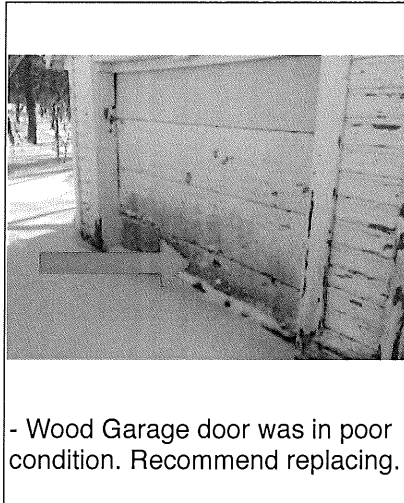
- Wood Garage door was in poor condition. Recommend replacing.

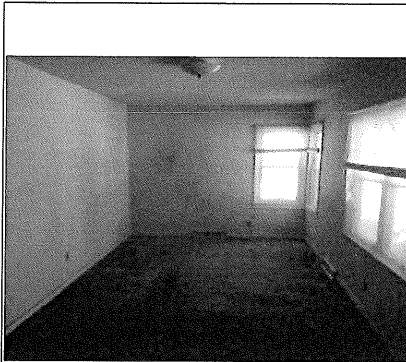
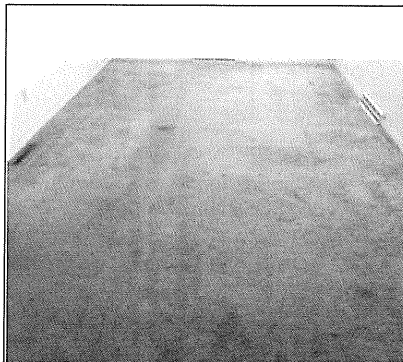
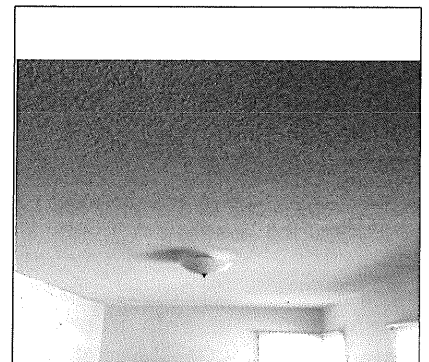
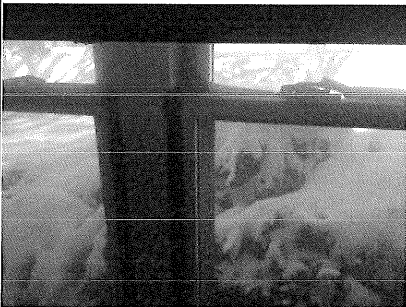
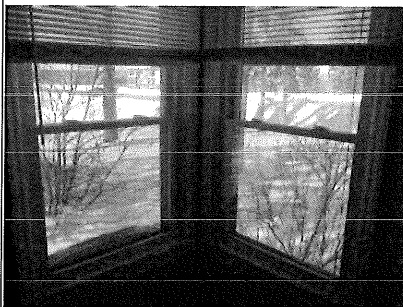
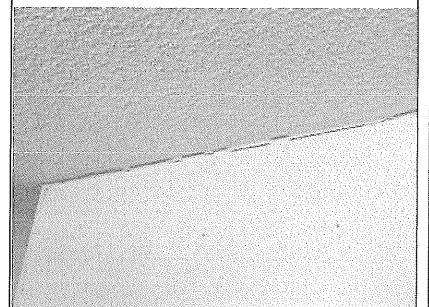
- Windows in living room appear to leak. Windows are taped off at the track and visqueen covering windows. Recommend repair

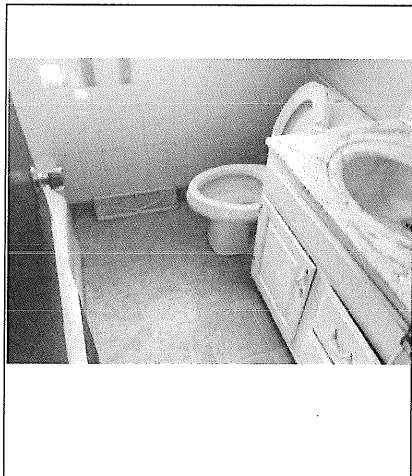
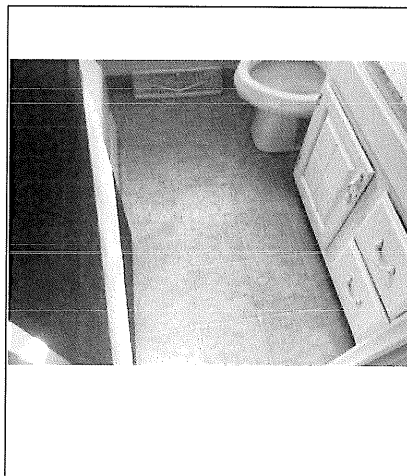
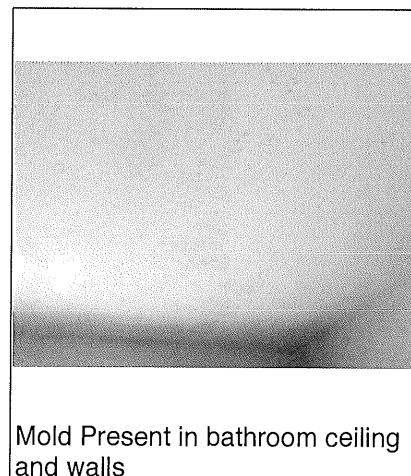
Mold Present in bathroom ceiling and walls

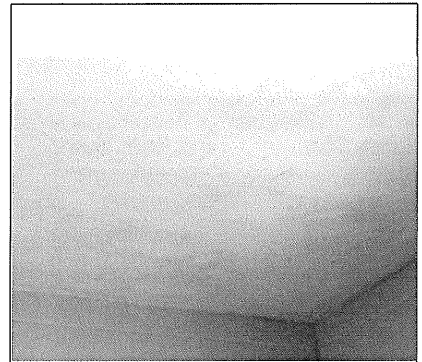
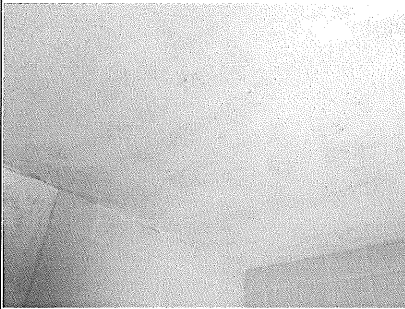
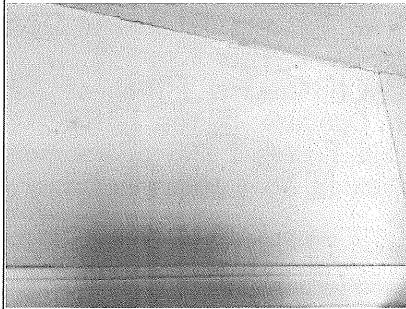
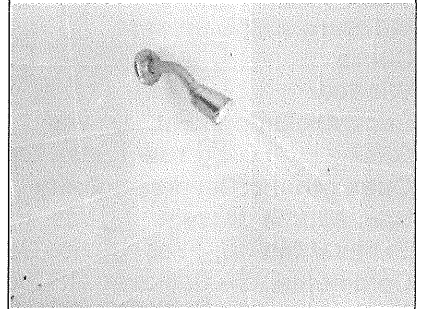
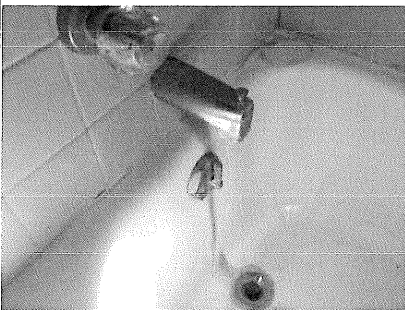
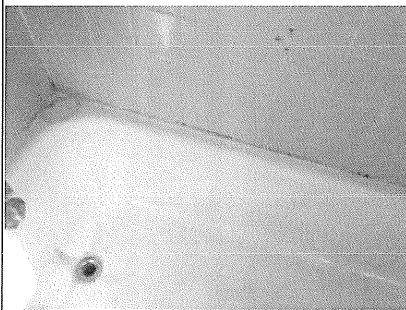
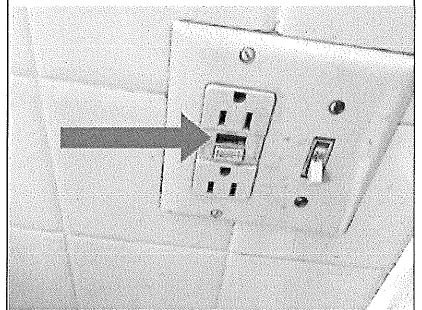
GFCI outlet is broken.  
Recommend repair.

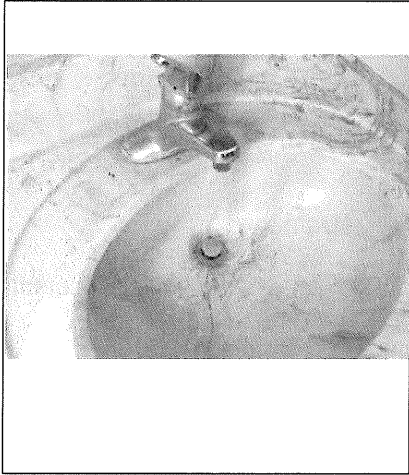
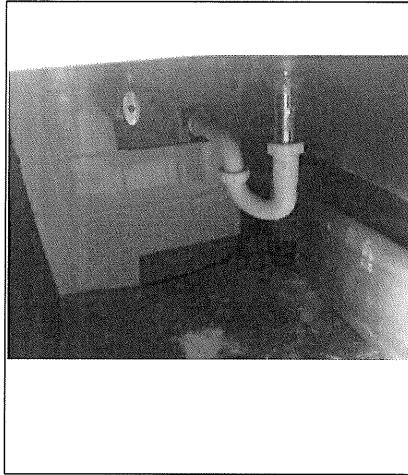
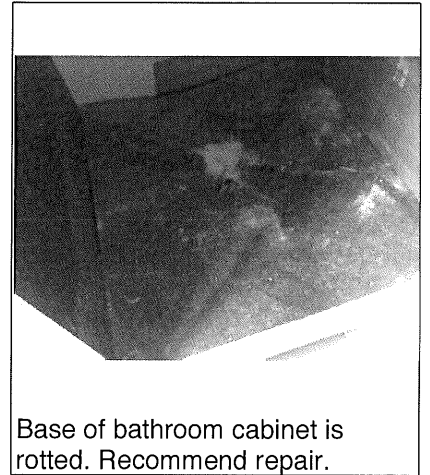
Base of bathroom cabinet is rotted. Recommend repair.

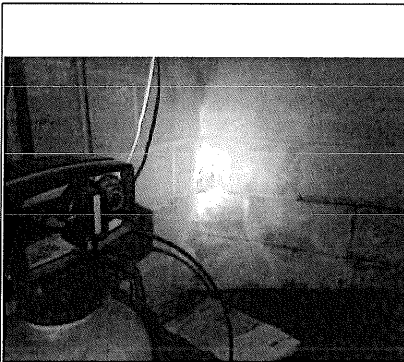
- Basement walls have Efflorescence present. Indicating water is present on exterior of wall pushing through. Recommend further evaluation and maintaining a positive grade away from foundation.

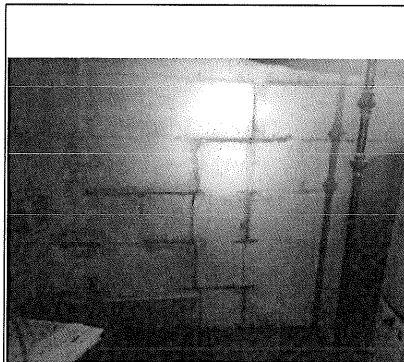
- Basement walls have Efflorescence present. Indicating water is present on exterior of wall pushing through. Recommend further evaluation and maintaining a positive grade away from foundation.

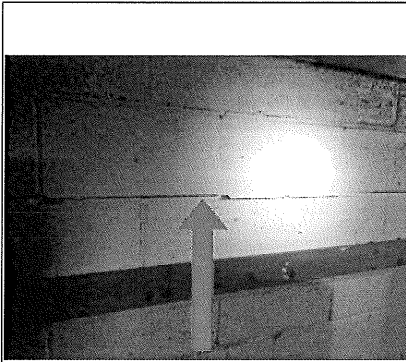
Horizontal cracking present

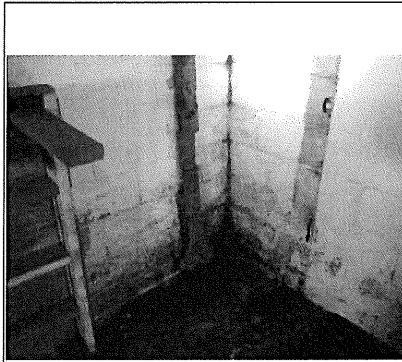
- Basement walls have Efflorescence present. Indicating water is present on exterior of wall pushing through. Recommend further evaluation and maintaining a positive grade away from foundation.

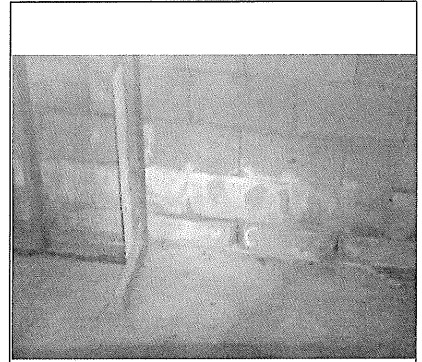
- Basement walls have Efflorescence present. Indicating water is present on exterior of wall pushing through. Recommend further evaluation and maintaining a positive grade away from foundation.

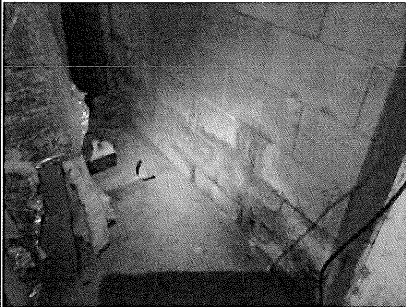
- Basement walls have Efflorescence present. Indicating water is present on exterior of wall pushing through. Recommend further evaluation and maintaining a positive grade away from foundation.

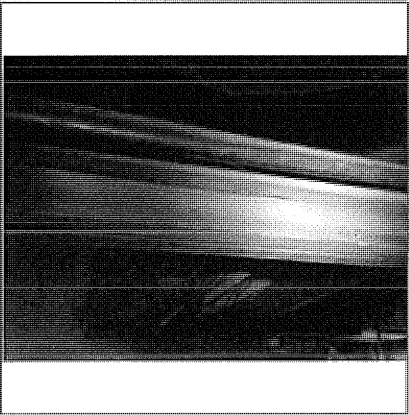
**Condition**  
**Material**  
**Comments**  
**Photos**

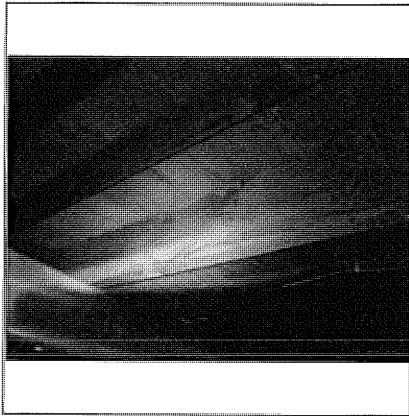
**Comments**  
**Photos**
