City of Madison

Proposed Demolition, Rezoning & Conditional Use

17-25 North Webster Street &
201 East Mifflin Street

DEMOLITION STANDARDS & PHOTOS

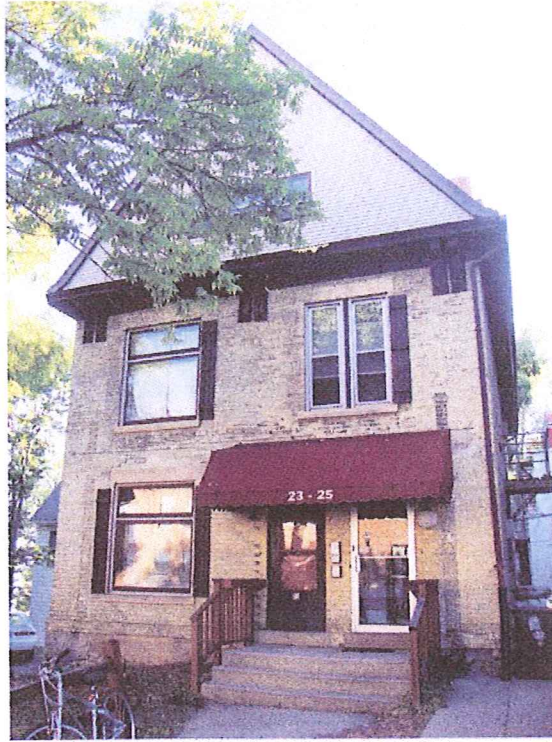
*Front view 23/25 N. Webster Street.
Original front porch and related details removed.*

All of the front porches on these structures have been altered or removed as part of general exterior changes or to comply with code requirements related to railings. Most rear porches exhibit settlement issues with noticeable deflections, tilting and/or sagging. Rear porches are in generally poor to fair condition and retain less original character.

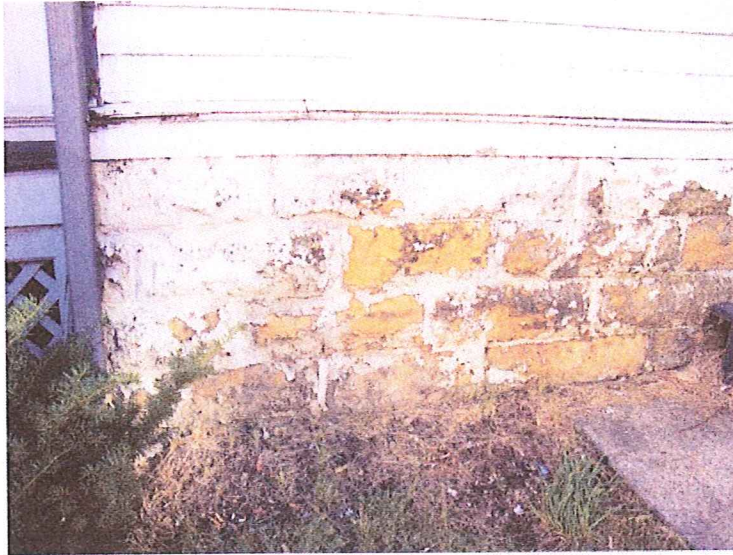
The stone exterior basement walls of the buildings have areas of delamination and deterioration especially right above ground level. Retained moisture freezes and spalls off layers of the stone.

Image of 201 E. Mifflin St. showing the deterioration of the stone masonry foundations walls

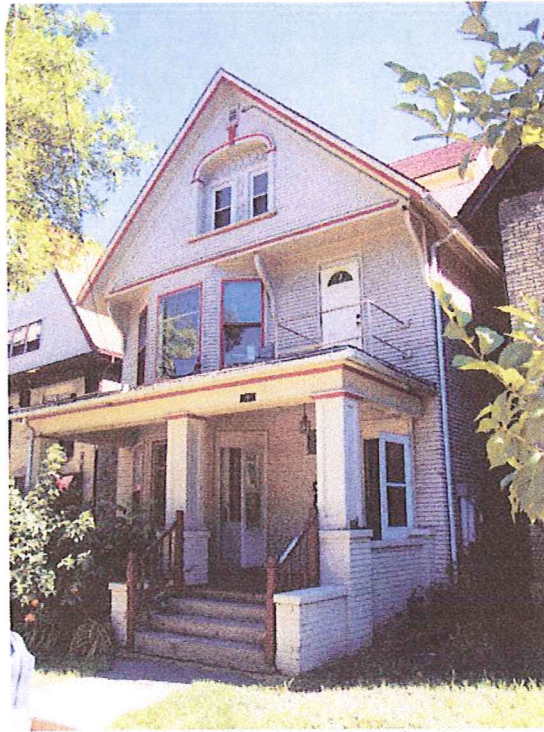
*View of the front 19 N. Webster.
The porch has several deterioration issues.*

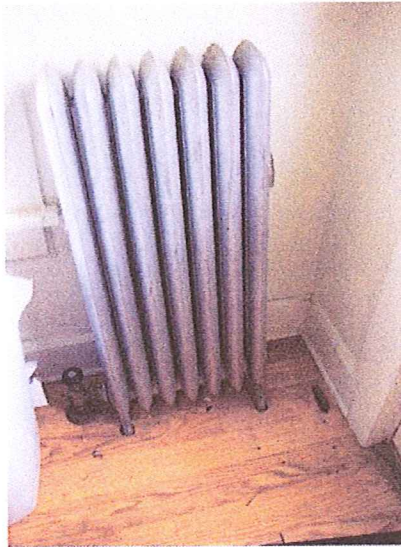
*Typical hot water radiator.
17 N. Webster St first floor apartment.*

In all four buildings the existing mechanical, electrical and plumbing systems are functional and apparently generally code compliant. However, the age and state of maintenance of the equipment indicates upgrades and replacement that are not too far in the future. The buildings are heated by boilers supplying hot water to perimeter radiators or fin tube enclosures. These are controlled by thermostats. Electrical systems are a combination of knob and tube and contemporary Romex wiring. Evidence of original gas lighting remains in 201 E. Mifflin and 17 N. Webster.

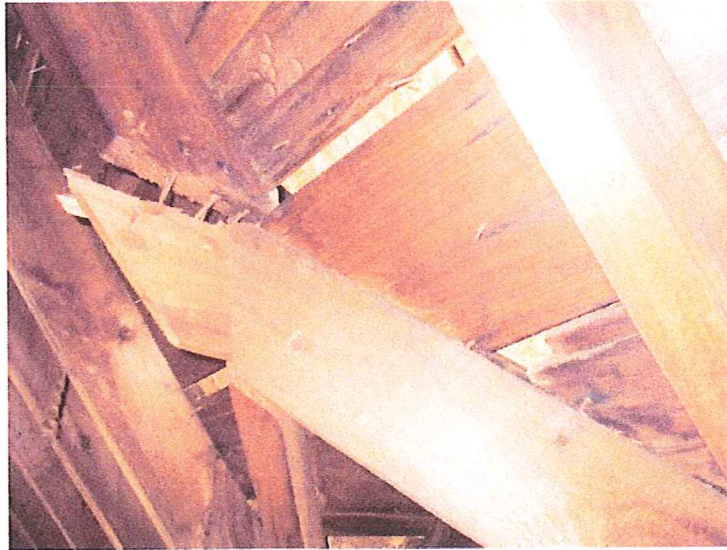
Other portions of the basement are an inaccessible crawlspace. The roof lines in the front of the building were generally poor. Significant deformations were observed in the regions of the dormers. On the exterior, large areas of masonry on the north and south elevations have spalled faces, likely due to the presence of water and freeze thaw cycling.

*Image showing damaged roof framing at dormer framing.
17 N. Webster St.*

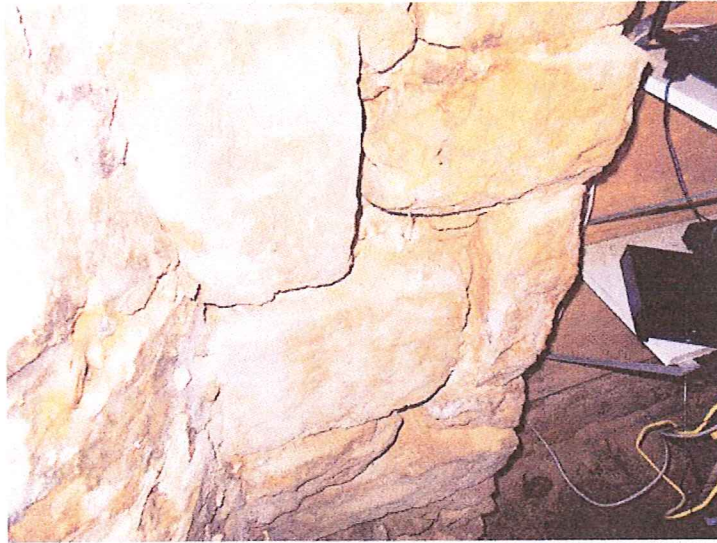
Structural issues at 17 North Webster Street were noted in the basement. The basement is divided into three spaces; two were accessible. Most of the basement has a dirt floor. The presence of fuel oil smell was noted in the west section. The interior surfaces of the foundation walls were in poor condition. Significant deterioration was noted in the mortar. Several holes were observed that were crudely punched in the walls in various locations for access to services and other areas.

*Image showing significant deterioration
of mortar in foundation walls 17 N. Webster St.*

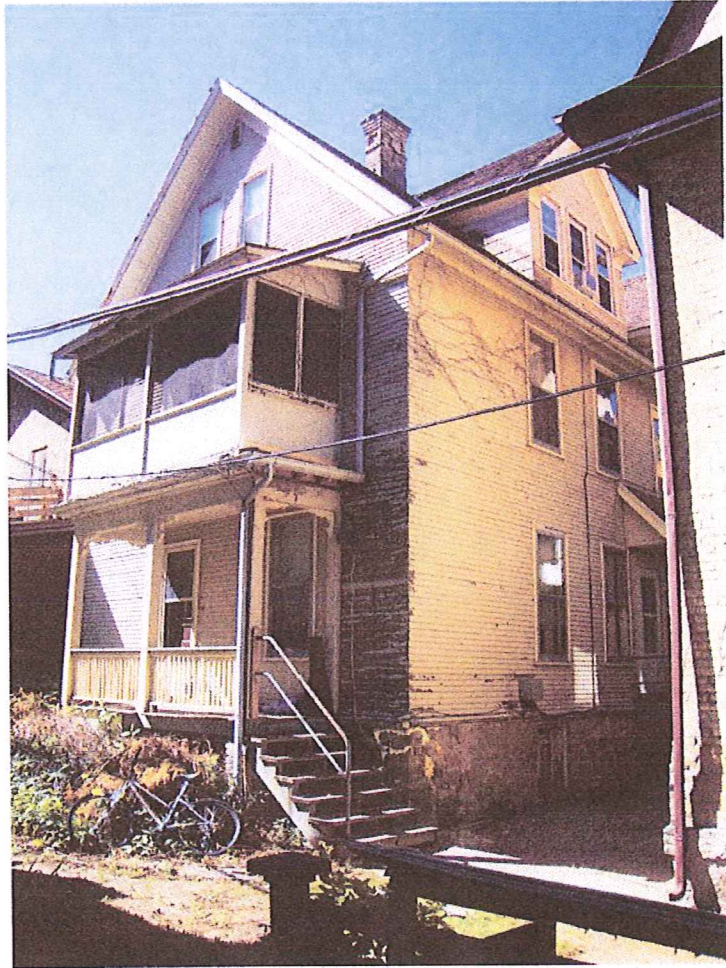
At 19 North Webster Street the most significant issues is the poor condition of the rear porch. This porch is leaning and floors and roof are deteriorated. Some recent repairs to deteriorated floor framing have been carried out. More similar repairs will be likely, soon. At the front porch there is deterioration within at least one of the wooden roof support columns and at the interface where the brick pier of the porch abuts the house framing at the north side.

*Image showing dilapidated rear porch.
19 N. Webster St.*

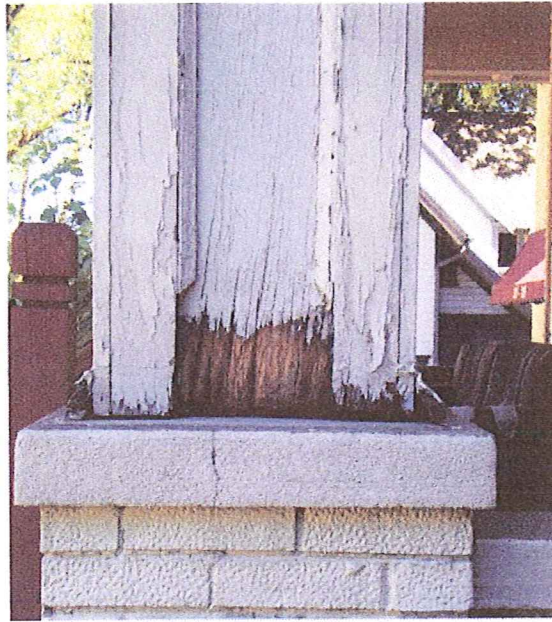
*Deteriorated porch column.
19 North Webster St.*

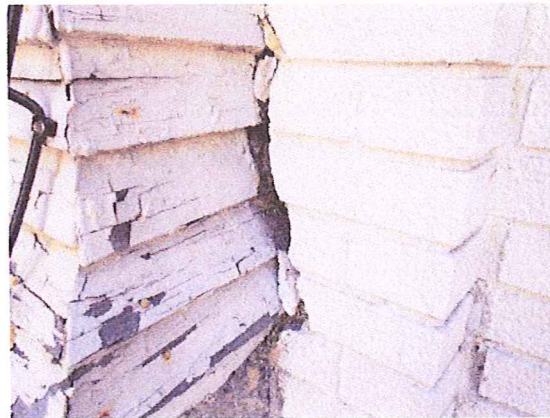
*Image showing the path of water infiltration
into framing areas at the porch and house intersection.
19 N. Webster St.*

Water has gotten behind the siding and likely caused damage to some wood framing behind. The extent of the damage is unknown due to the presence of finishes. On the interior many cracks were observed in the ceilings of the upper floor. The roof and ceiling framing is likely lightly built allowing the cracking to result over time. The basement foundation wall at the northeast corner is significantly deteriorated. Spray foam has been used to fill gaps in the foundation wall to prevent water intrusion.

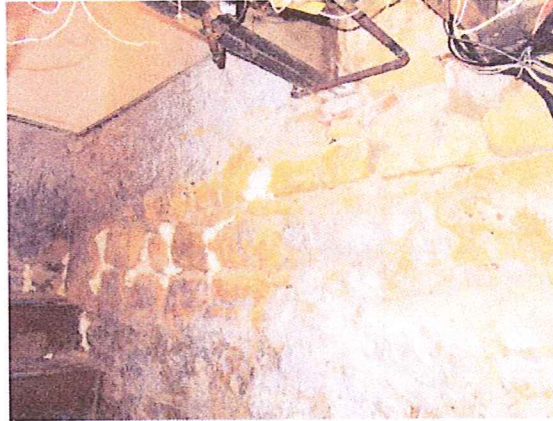
Image showing deteriorated stone foundations and spray insulation filler at 19 N. Webster St.

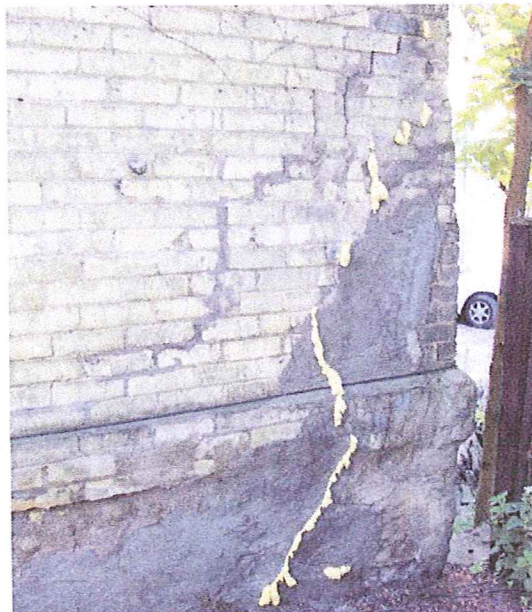
Northeast corner of 23/25 N. Webster St.

23/25 North Webster has some significant structural issues. The exterior walls are constructed of brick. Although most areas are in fair condition, some portions of the exterior brick wall at first floor and foundation wall along the north wall and most significantly at the northeast corner are in poor condition. Significant damage was noted due to the lack of adequate support offered by a retaining wall at a lower parking lot.

Movement in the lower retaining wall or soil erosion (or both) at this wall has likely led to foundation settlement and rotation in the wall present today. The outward movement (bulge) in the foundation wall at the northeast corner is approximately two to four inches. A heavily patched section of the masonry brick is present on the back of the building (east). The condition currently appears somewhat precarious and eventually may become unstable and lead to a partial collapse of the wall, floors, and roof.

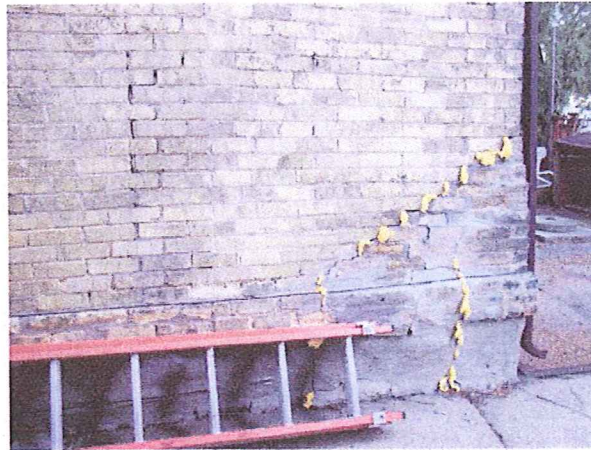
Southeast corner of 23/25 N. Webster St.

Cracking was observed in many of the masonry stone lintels. The brick mortar lines of the walls appeared to sag near corners suggesting that there have been some ongoing settlements at the corners likely the result of long term washing of fine soil particles with in the bearing regions of the soils below the masonry foundations. An interior survey confirmed issues with the north wall, especially at the northeast corner of the building. Large cracks were present near the corner at the east wall. There were also large cracks and gaps between the exterior north wall and several interior walls that had originally been integrated into it. Some roof framing deformations were noted in the area of the dormers possibly attributable to undersized headers and collecting rafters at the dormer edges.

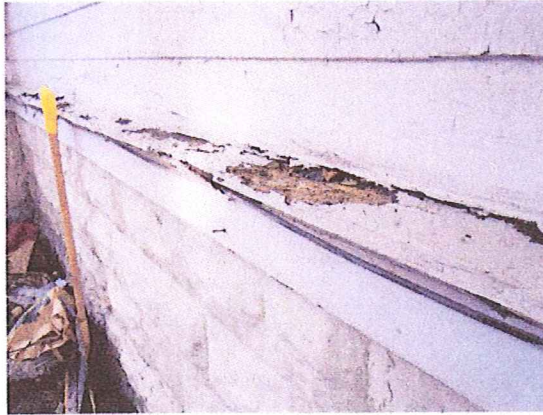
Some deterioration of the trim along the water table located at the height of the first floor rim joist was observed at 201 East Mifflin Street. The trim has been channeling water into the interior of the wall in some locations. It is likely that some framing deterioration exists behind the deteriorated water table.

Image showing water infiltration and location of possible damage to framing at the water table trim. East side of 201 E. Mifflin St.

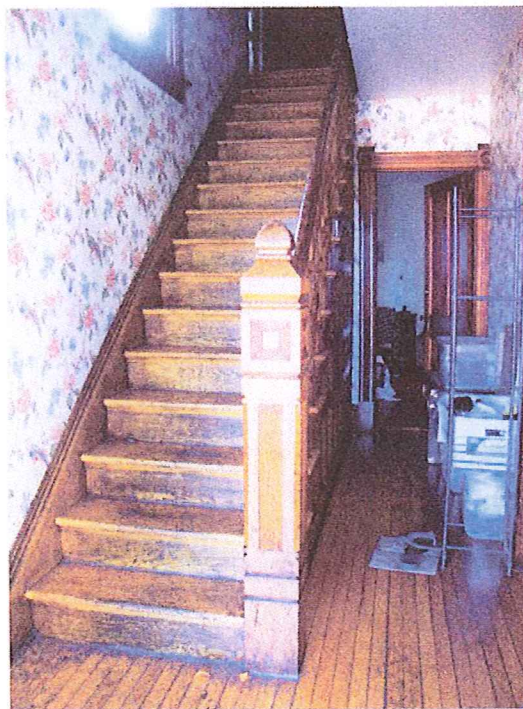
The overall integrity of the 201 E. Mifflin Street property interior is estimated to be 80% with much of the character defining elements still in place and in good condition.

Entry hall and stair of 201 E. Mifflin Street.

In the case of the 201 E. Mifflin Street building, I suggest that the due to its integrity and interior architectural features, generally good overall condition and its narrow floor plate, that consideration should be given to offering the public the opportunity to purchase the house for a nominal amount, with the condition that it be relocated. Relocating the house to a vacant parcel in close proximity would be a very green and sustainable effort. The house could be cost effectively rehabilitated for single family use or possibly upgraded for multiple tenant usage.
