November 5, 2010

**RE: OVERTURE CENTER
FACILITY ASSESSMENT VERIFICATION
MADISON, WISCONSIN**

Mortenson Construction is very pleased to present the assessment verification for Overture Center located in Madison, Wisconsin.

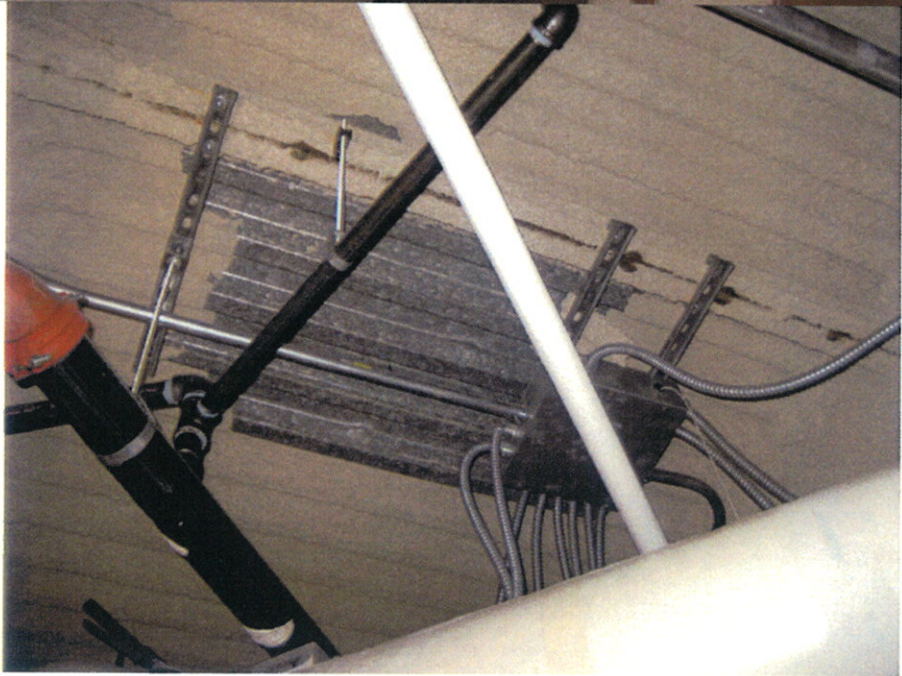
PHOTO PAGE #5 – SPRAYED FIREPROOF PATCHING

NEW ITEM 1 – Cementitious Fireproof Patching - At the Mechanical Penthouse of the Capital Theater - part of the existing structure from the previous building - there are steel columns and metal decking that is exposed, where the fireproofing has been removed to facilitate equipment installation. This fireproofing requires patching to maintain the required levels of fire protection on the structure in these areas. Mortenson Construction recommends a full inspection of the existing structure in the Capital Theater building areas and patching of fireproofing as required. We have included an allowance for this effort in the Expenditure Log in Section C. Photo page #5 of Section D provides a visual reference.

ITEM	PHOTO PAGE	ITEM	ESTIMATED COST - ORIGINAL REPORT	ESTIMATED COST - MAJOR MAINTENANCE	ESTIMATED COST - CAPITAL REPLACEMENT	COMMENTS
NI 1						
5		Sprayed Cementitious Fireproof Patching	\$0	\$20,000	\$0	Expected Year of Expenditure - 2011. The mechanical room serving the Capital Theater contains structural steel which has spray fireproofing missing from columns and metal deck. Patching can be done to cover the exposed steel.
NI 2		EIFS Artwork on Brick Façade	\$0	\$27,000	\$0	Expected Year of Expenditure - 2018. The south façade of the building contains artwork applied to the brick facing that is constructed out of EIFS. EIFS can have a short life span if the top coating is not maintained properly.
NI 3		Parapet Sheet Metal Gap Repair	\$0	\$30,000	\$0	Expected Year of Expenditure - 2011. Sheet metal cap flashing located on top of exterior brick and stone clad walls appears to have a gap in which water can access the wall cavity. This water infiltration appears to be causing discoloration of the brick and stone. A line of backer rod and joint sealant could be added immediately to stop the infiltration.
