Position Paper Regarding Detectable Warning Fields

2-17-10

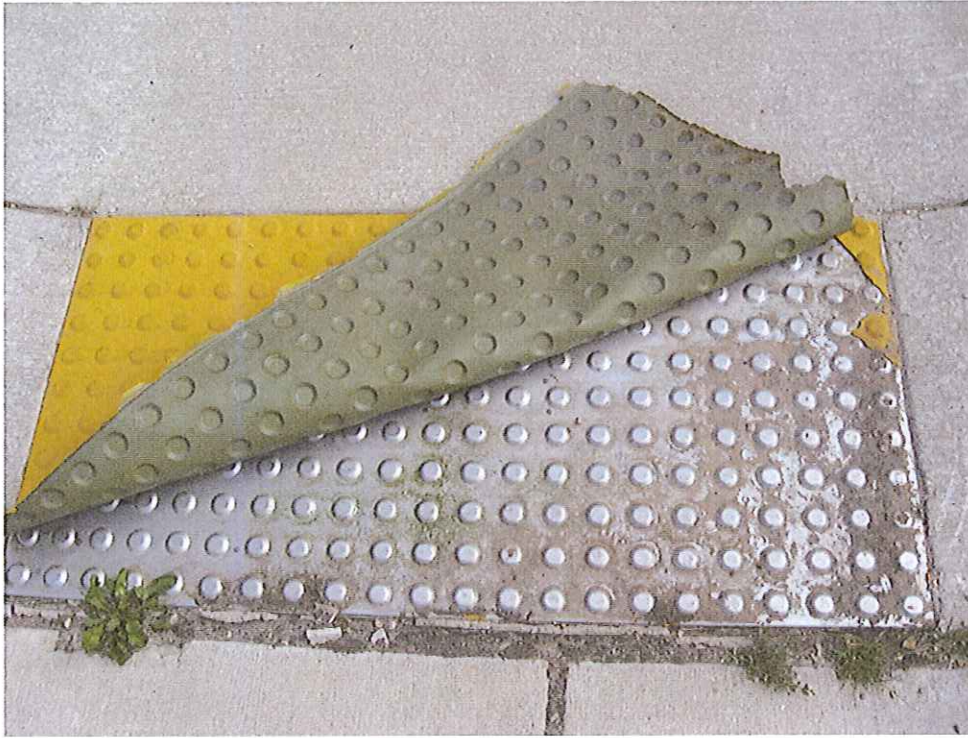
Stainless steel plate with peeling surface

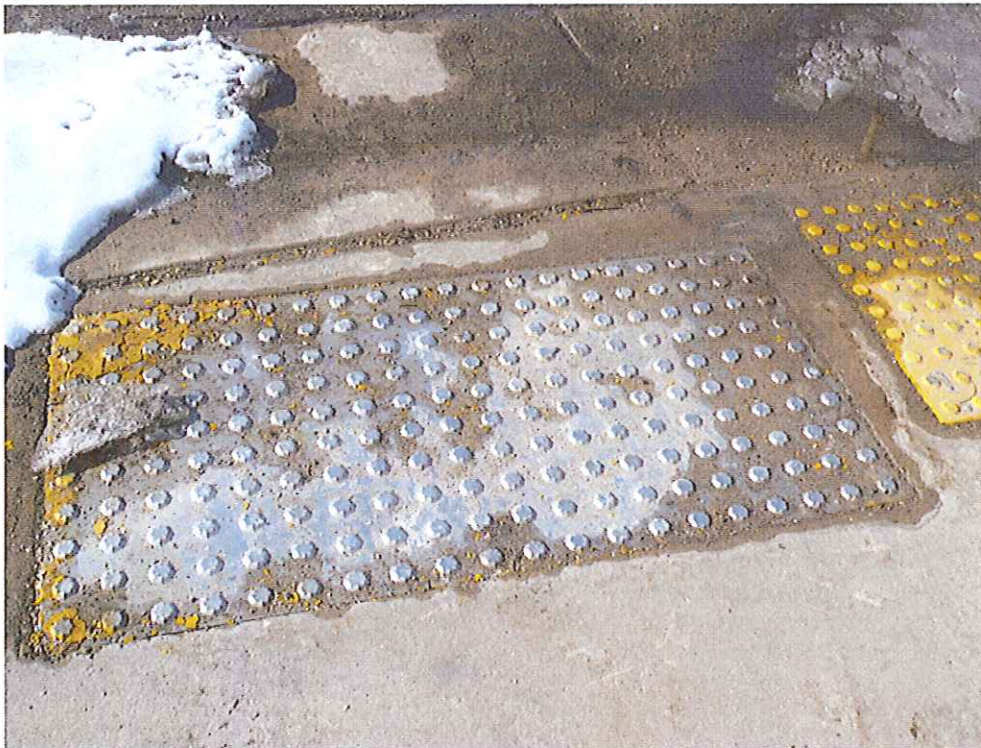
Stainless steel panel with complete surface failure

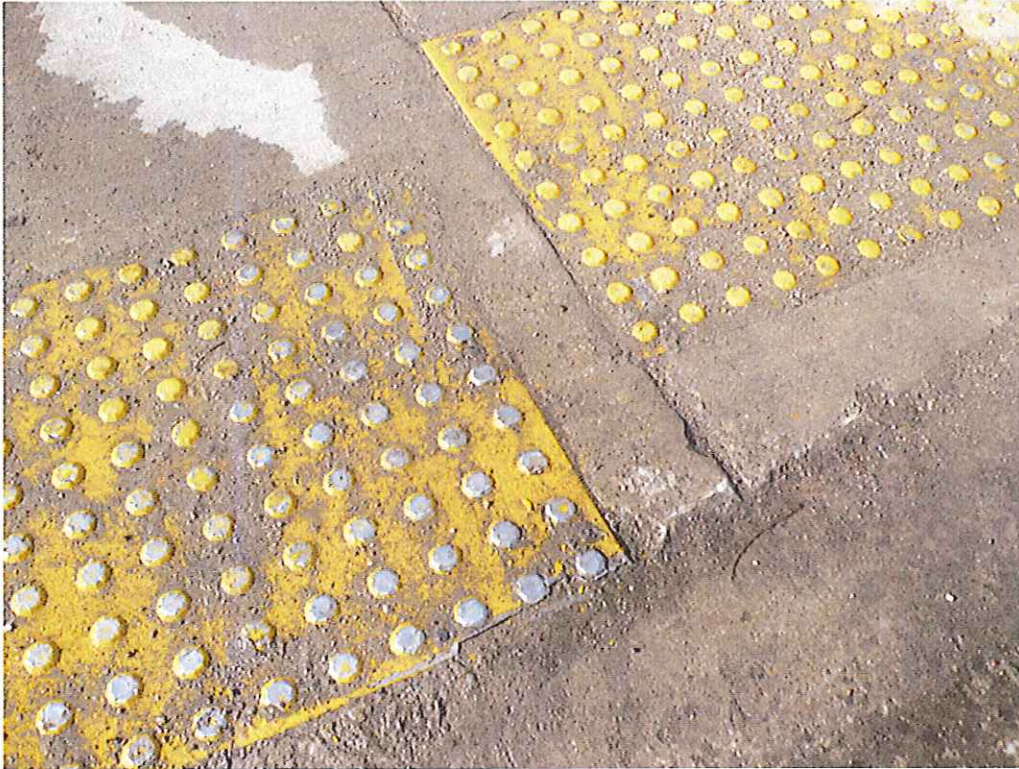
Stainless steel panel with surface wear. Beginning to tear on bottom corner creating sharp edges. Located on bike path.

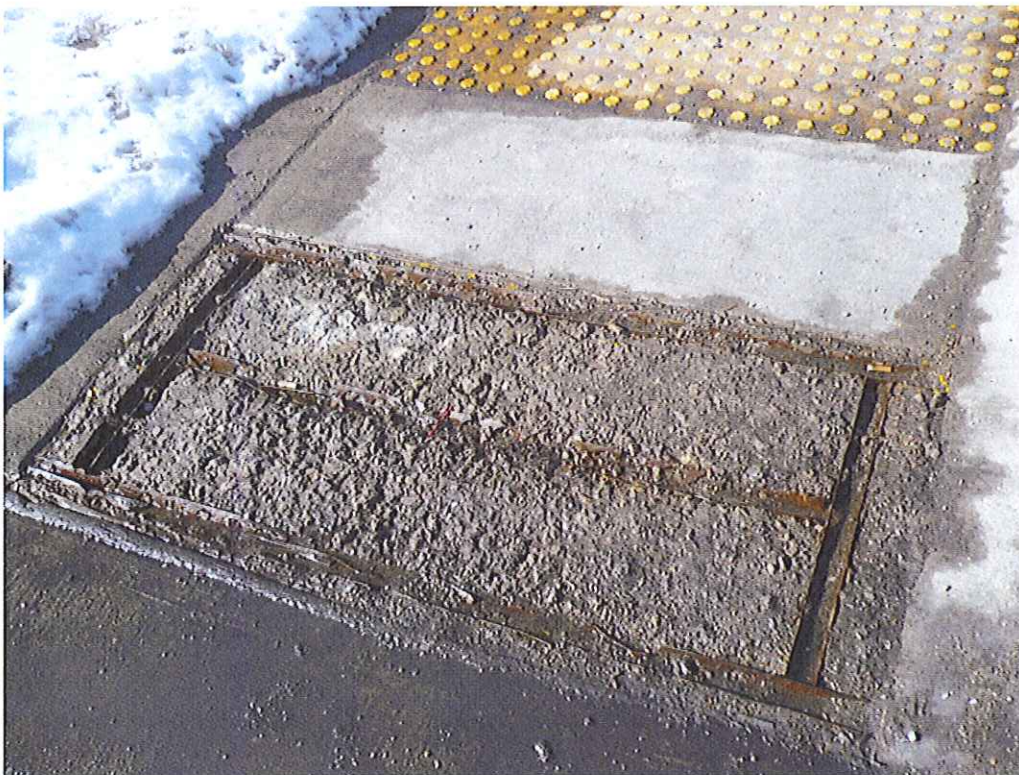
Stainless steel panel torn from concrete surface after edge pulled up at 2nd Street and E. Washington Ave.

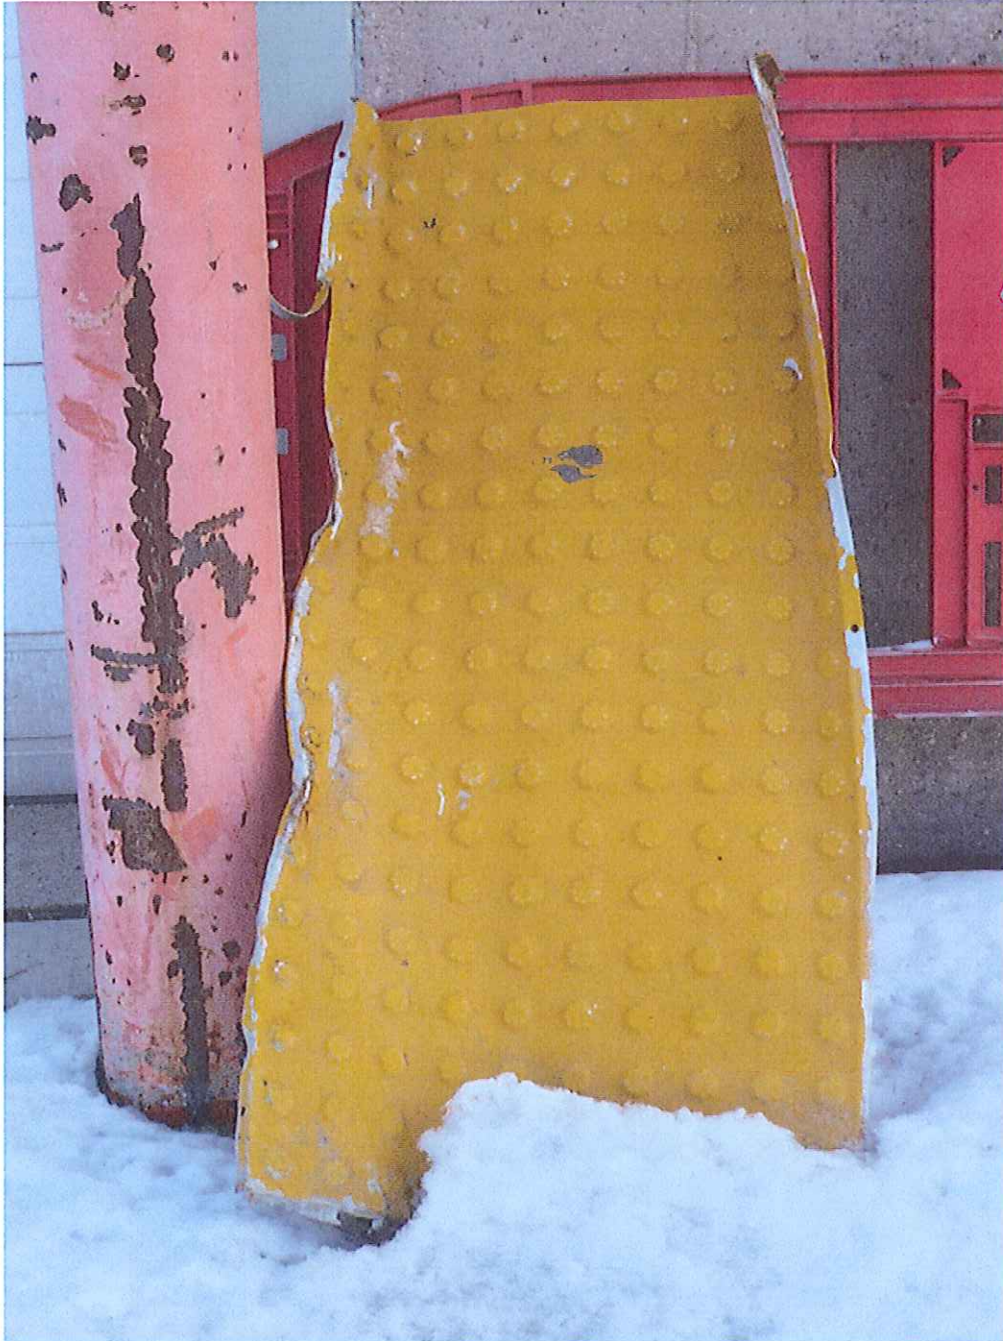
Stainless steel panel removed after citizen report of sharp and peeling edges

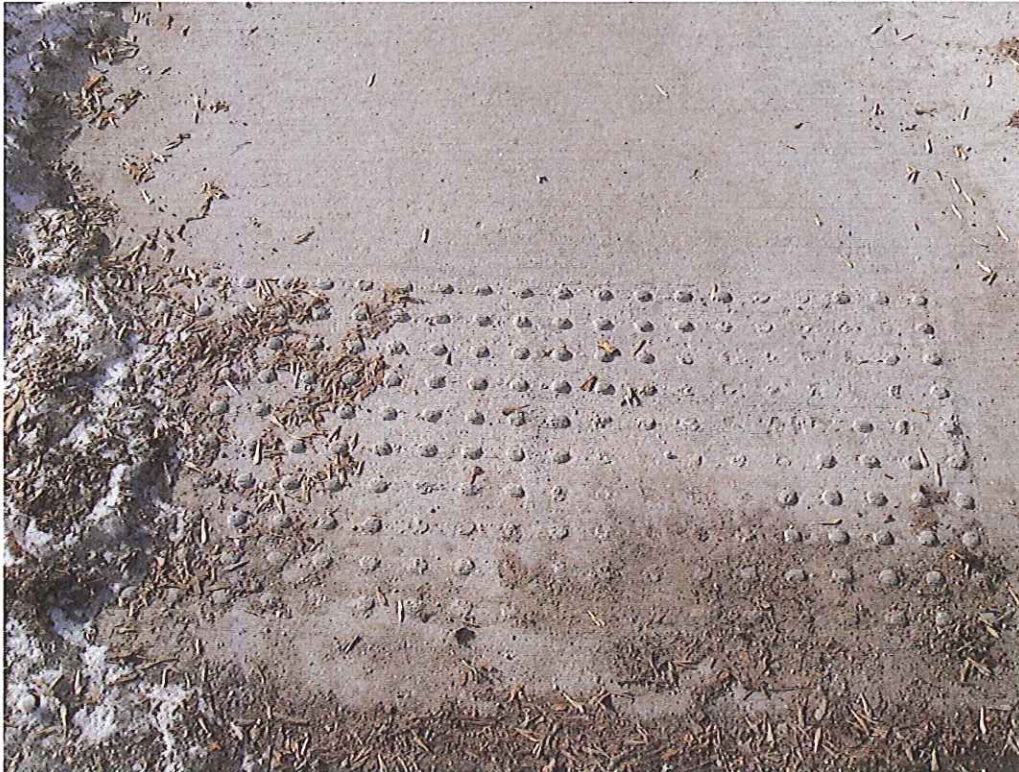
Stamped Surface – Domes removed from wear and/or snow removal operations

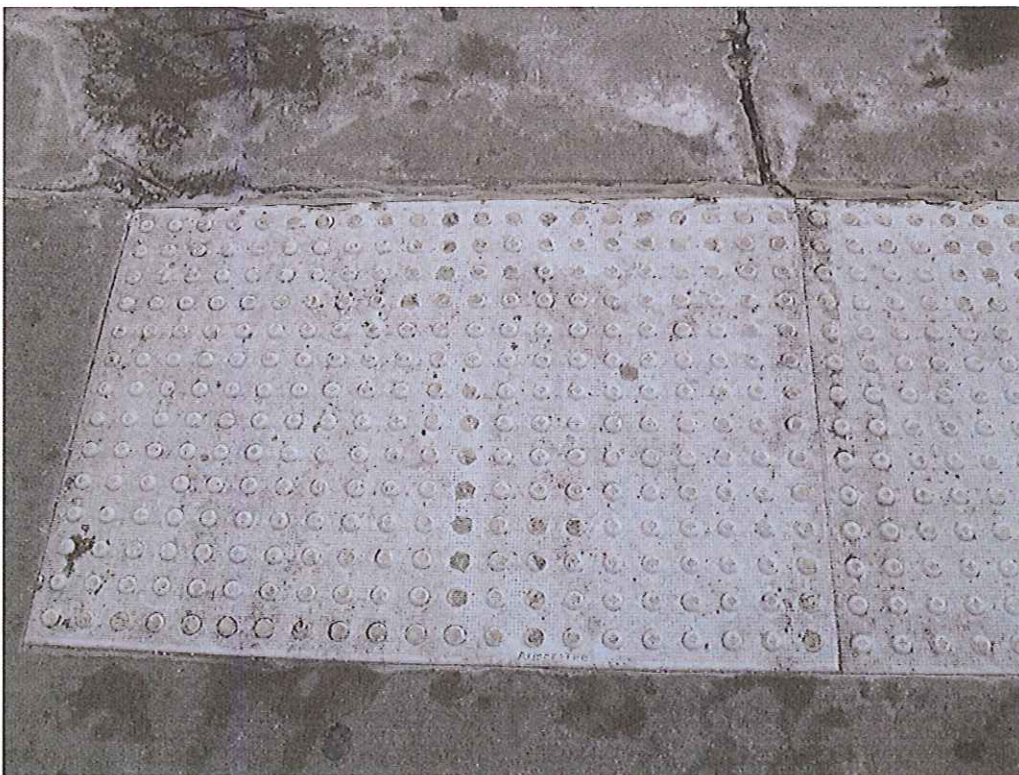
Composite Panel – Domes removed from wear and/or snow removal operations

Few composite panels are used throughout the City.
