Edgewater Tree Inventory and Waterfront Vegetation Survey

January 22, 2010

Prepared by : Allison Tree Care, Inc.

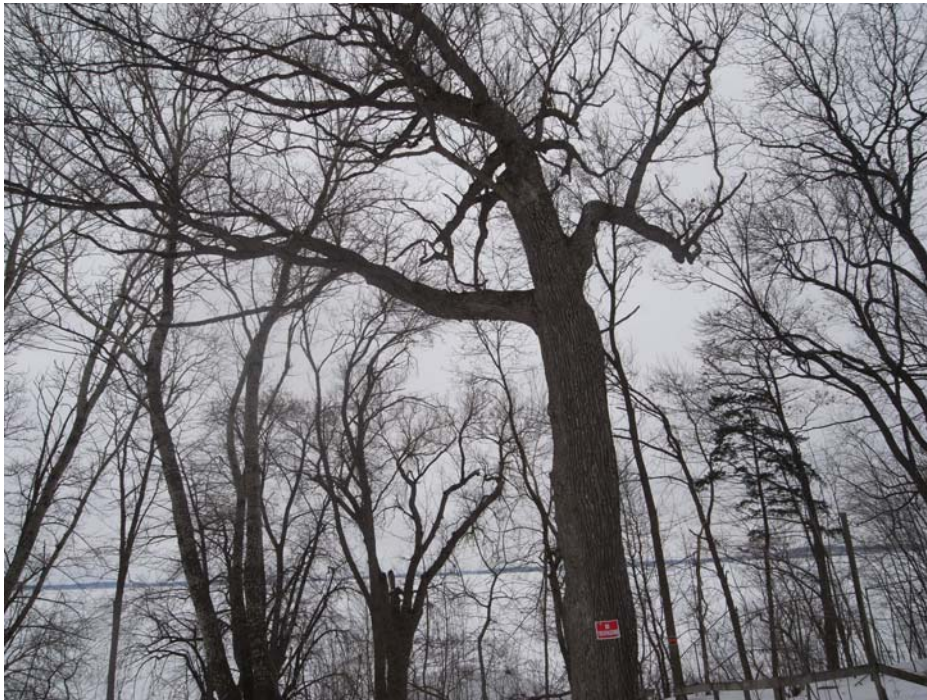
The bulging at the trunk base of the white oak is suggestive of internal decay. A micro-drill resistance test to measure the internal condition of the trunk is recommended prior to making a decision regarding efforts to protect that tree. As always on proposed construction sites, a tree protection plan including fencing and equipment access restrictions is recommended to protect those trees designated for preservation in and around the proposed building zone.

Photo 6 White Oak in group of trees east of Parcel 4
